Damage accumulation during high temperature fatigue of Ti/SiC_f metal matrix composites under different stress amplitudes

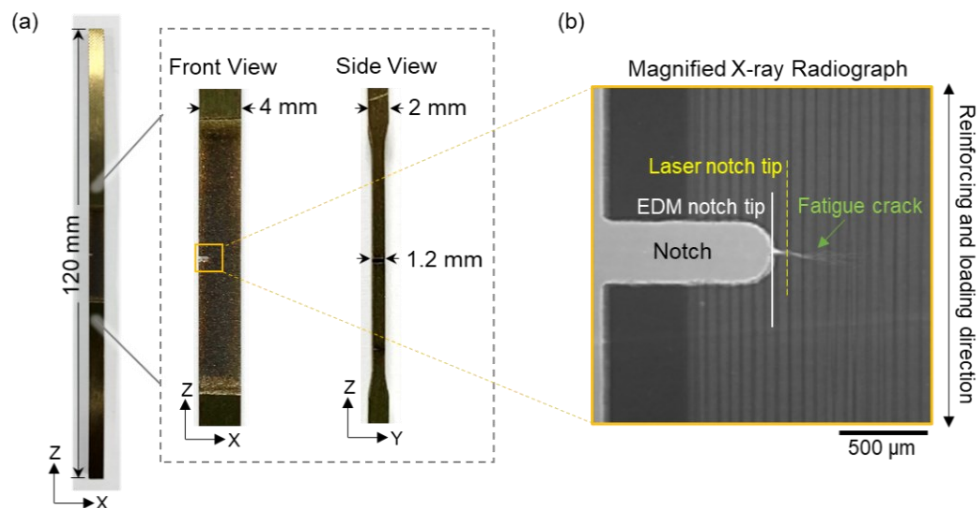
Fig. 1. Geometry of the test specimen (S1). (a) Photographs of the front and side views showing the specimen dimensions. (b) X-ray radiograph of the region around the notch as marked on the magnified front view in (a), showing the notch introduced by EDM and laser machining, and the fatigue crack.

samples measuring $120 \times 4 \times 2$ mm (see Fig. 1(a)). In the reinforced region the fibre volume fraction was $\sim 45\%$. Electron discharge machining (EDM) was used to remove some of the TC17 cladding from the sample surfaces and to machine the test-piece geometries, resulting in a 20 mm long gauge section with 1.2 mm thick by 4 mm wide cross-section (see Fig. 1(a)). Some cladding (~ 330 μm) was retained on each side. A through-thickness edge notch (~ 1 mm deep) was introduced into each sample by EDM to act as a crack initiator. However, in preliminary tests it was found that multiple cracks tended to initiate from the relatively blunt tip of the EDM notch as has been observed previously for similar systems [19]. Therefore, in order to initiate a single fatigue crack, a sharper notch (~ 0.05 mm deep) was introduced by high pulse laser ahead of the EDM notch using a microPREPTM milling machine (3D-Micromac), see Fig. 1(b).

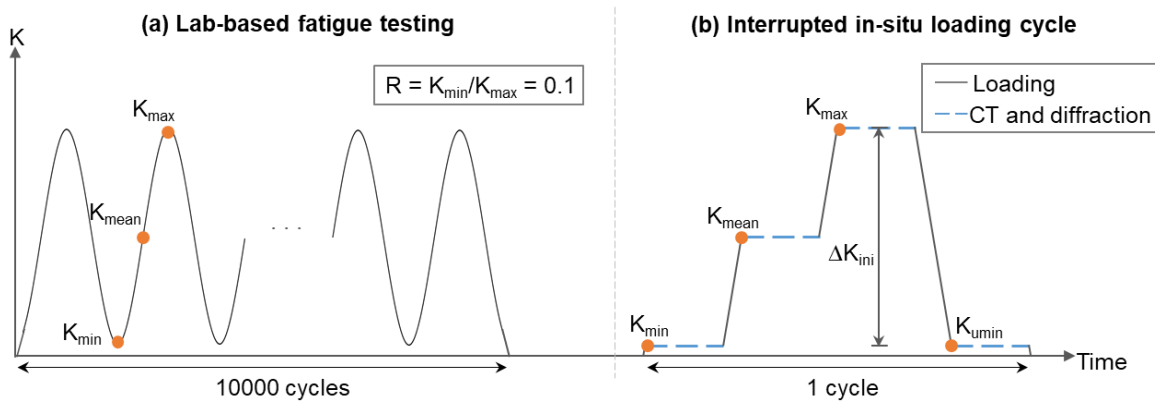
Fig. 2. The loading history of the tested specimens. The specimens were (a) pre-fatigued to initiate and grow fatigue cracks, followed by (b) *in situ* loading on the synchrotron beamline to image the damage and map the stress distribution local to the crack as a function of load through the fatigue cycle.

The Deben-Manchester Open Frame Rig was used for *in situ* loading and heating [23]. It was fitted with a bespoke high-temperature furnace [24], and was mounted on the sample stage on the I12 beamline (see Fig. 3(a)). The fatigued specimens (S1 and S2) were heated to $350\ \text{°C}$ while the tensile load was actively maintained at $0\ \text{N}$, then quasi-statically loaded under tension through a fatigue cycle on the beamline following the scheme shown in Fig. 2(b). By translating the imaging and diffraction detectors into and out of the beam, both tomography and diffraction measurements were acquired at K_{\min} , K_{mean} and K_{\max} during loading and K_{umin} during unloading for each specimen (see Fig. 2(b)).

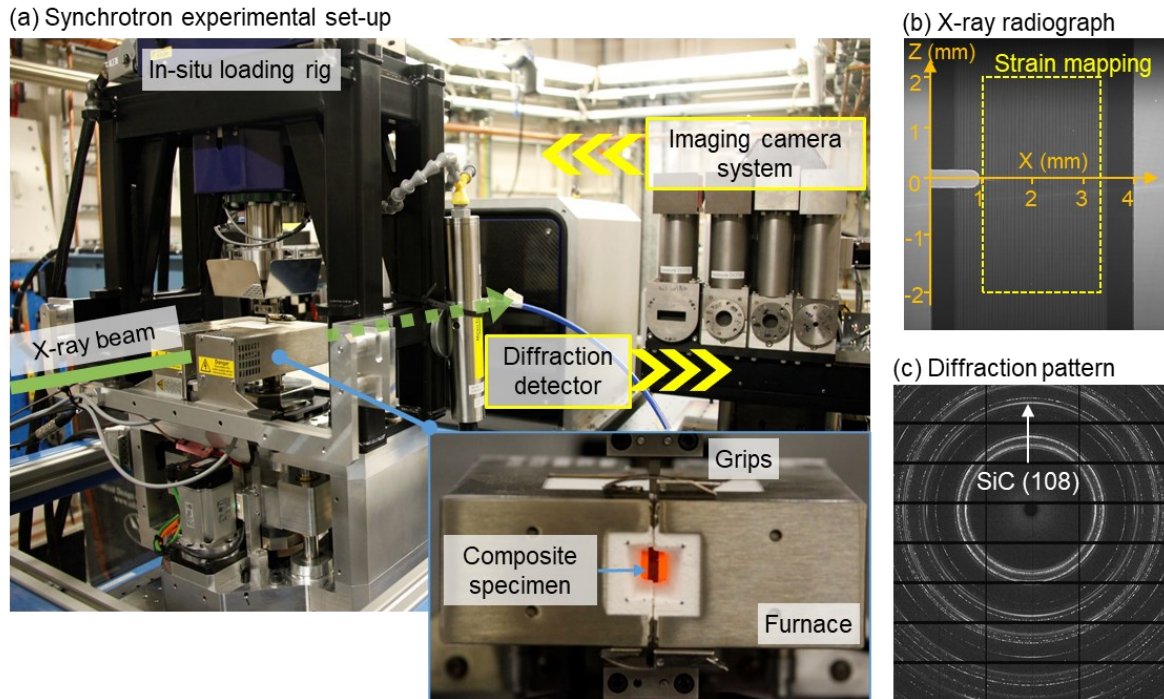
Fig. 3. Experimental set-up for *in situ* transmission XRD and X-ray CT on the I12 beamline at Diamond Light Source. (a) Photograph showing the *in situ* loading rig. The inset shows the gauge length of the sample within the furnace mounted on the *in situ* loading rig, while the grips are located outside of the furnace. (b) A typical X-ray radiograph, on which the X and Z coordinate system is indicated. (c) A typical diffraction pattern indicating the (108) SiC reflection used to infer the fibre strains.

(see Fig. 3(c)) was used to infer the fibre strains. The reflections for the titanium phases were not quantified, because the transmitted signal is averaged over the whole path length through the samples which includes both the reinforced and un-reinforced Ti-alloy regions, making it unrepresentative of the alloy behaviour within the composite. It should be noted that each specimen contained roughly four plies of SiC fibres, thus each measurement point represents an average strain over all fibres through the thickness having the same X and Z positions. The centre (2θ) of the (108) SiC peak was found by Pseudo-Voigt peak fitting using Python. By applying Bragg's Law, the 2θ data was converted into d spacing values. The axial elastic strain, ε_f , in the fibre is then inferred from the change in lattice spacing;

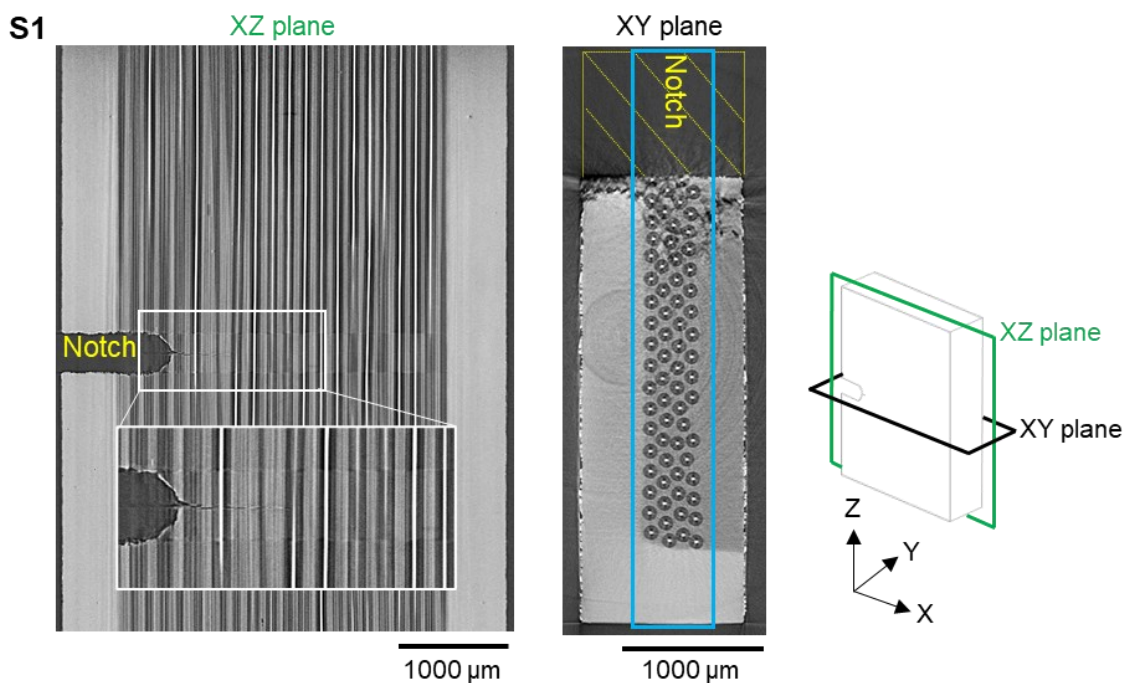
Fig. 4. Fatigue crack morphology during the stable-growth stage. X-ray CT virtual XZ and XY sections for S1 at K_{max} (16.5 MPa \sqrt{m}). The fibre reinforced region, which will be analysed further, is highlighted by the blue box on XY sections. The fact that the crack surface is not completely flat means that it is difficult to discern in the XY section. The W cores are evident as bright contrast, the Ti matrix as light grey the SiC fibre somewhat darker and the cracks darkest of all.

The 3D fatigue crack morphology during stable crack growth can be appreciated from the CT scan at K_{\max} for S1. It is evident from the magnified view of the XZ section in Fig. 4 that, in contrast to Barney et al. [28] and Hung et al. [19], a single fatigue crack initiated from the

notch, promoted by sharpening the notch tip by laser machining. The presence of the Ti cladding is clear in the XY view.

The fatigue crack within the fibre reinforced composite region, as highlighted by the blue box on the XY section in Fig. 4, was segmented and extracted for 3D visualisation in Fig. 5. It can be seen that the fatigue crack grows through the matrix bypassing the fibres which remain intact in agreement with previous work [5,19,29]. This imparts significant crack bridging and hence crack-tip shielding during stable fatigue crack growth. There is no evidence from the CT of the propagation of any opened cracks along the interfaces. The 3D volume rendering (see Fig. 5) shows that a single crack is propagating but is deflected along its path. Although slightly shorter on one side than the other (probably due to there being more cladding on one side than the other), the fatigue crack front is relatively straight. There is no evidence of the middle of the crack front being significantly behind or ahead of the edges of the crack.

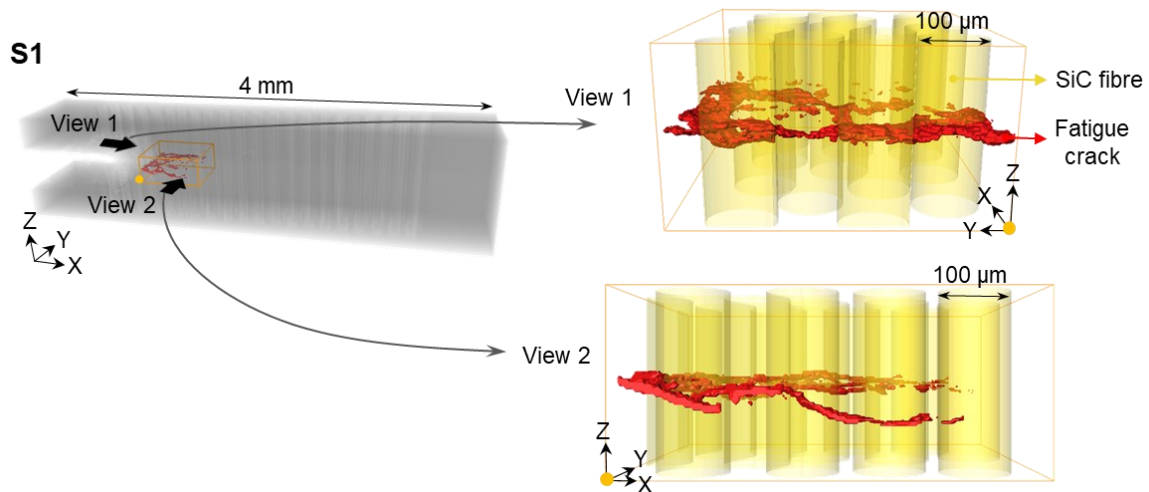
Fig. 5. 3D fatigue crack morphology during the stable-growth stage, showing fibre bridging and crack deflection. 3D volume rendered X-ray CT image of the fibre reinforced region of interest (grey), with the fatigue crack (rendered red) and SiC fibres (rendered yellow) for S1 (low ΔK_{ini}) at K_{max} ($16.5 \text{ MPa}\sqrt{\text{m}}$). The magnified views (with the matrix rendered transparent) show head on (View 1) and side on (View 2) views of the crack.

Based on the 3D crack renderings in Fig. 5, the deviation of the fatigue crack from the median crack plane was quantified in MATLAB and shown in Fig. 6. This shows considerable crack deflection as the crack bifurcates to run around each fibre, in common with the observations of Hung *et al.* [19]. The extent of the crack deviation tends to be less than $100 \mu\text{m}$ from the median plane.

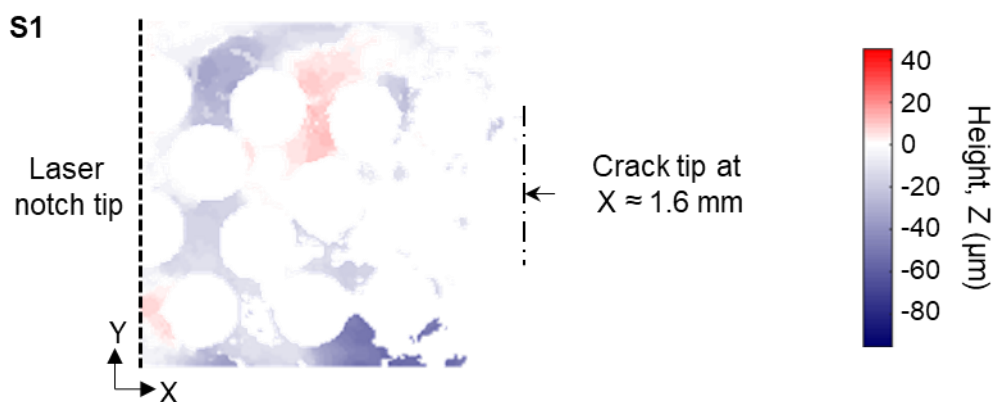
Fig. 6. The map of crack height (distance from the median plane) for S1 at K_{max} ($16.5 \text{ MPa}\sqrt{\text{m}}$) showing fatigue crack deflection during the stable-growth stage. The height of the fatigue crack plane above and below $z = 0 \text{ mm}$ (the height of notch tip) is calculated based on the X-ray CT segmentation of the crack.

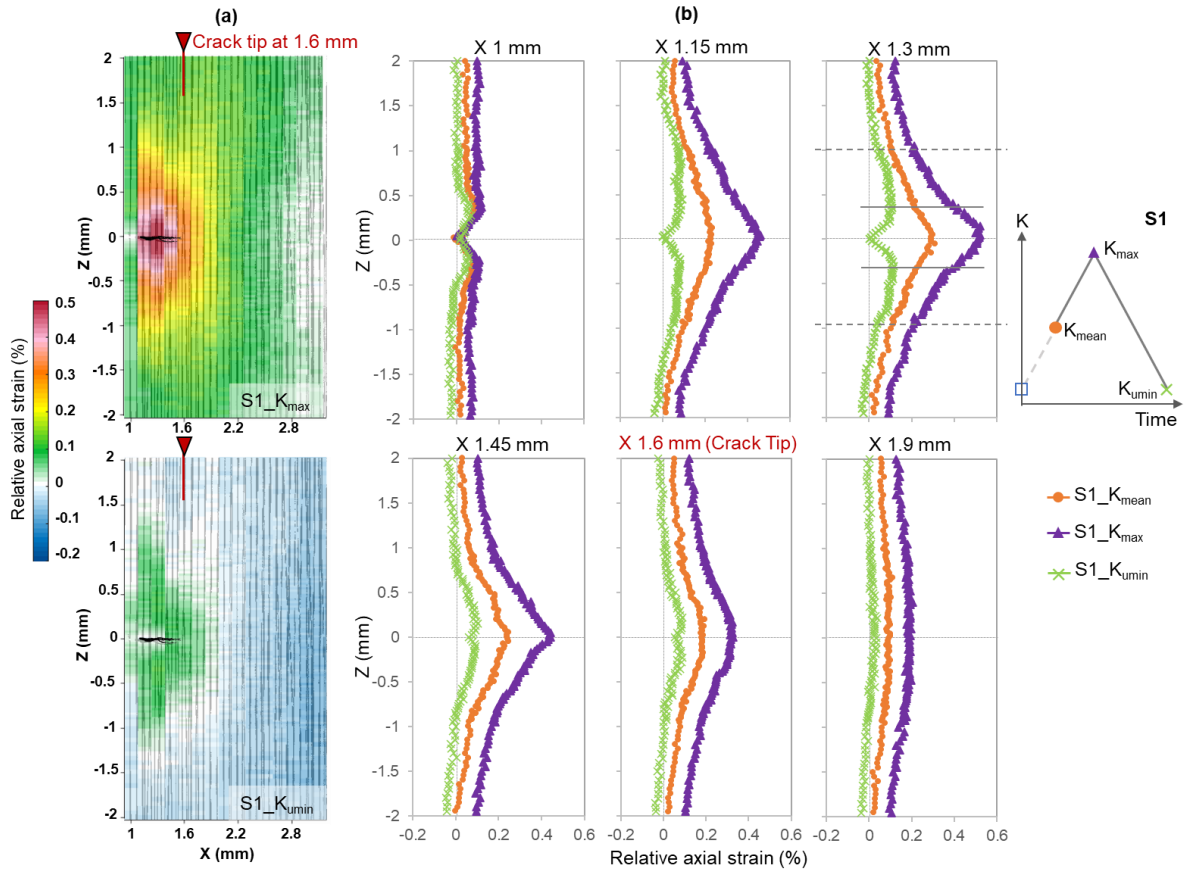
Fig. 7. Variation in relative axial elastic strain along the fibres as a function of load and position (where $z = 0$ is the notch-tip height) for S1 at 350 °C. (a) The fibre strain map at K_{\max} (top) and K_{\min} (bottom); superimposed on a rendering of the W cores of the SiC fibres (in grey vertical lines) and the ~ 1.6 mm fatigue crack (rendered black). (b) The fibre elastic strain profiles at X positions of 1, 1.15, 1.3, 1.45 (in the crack wake), 1.6 (at the crack tip) and 1.9 mm (ahead of crack tip) recorded at K_{mean} , K_{\max} and K_{\min} . In a) each coloured pixel corresponds to one through-thickness averaged diffraction measurement, i.e. over a window of $150 \mu\text{m}$ (along the X axis) \times $50 \mu\text{m}$ (along the Z axis).

The strain distribution in the SiC fibres local to the crack has been mapped by X-ray diffraction as described in section 2.3. Fig. 7(a) shows the relative axial elastic strain maps for the fibres in S1 at K_{\max} and K_{\min} in the region of the crack tip (located at $x = 1.6$ mm). It should be remembered that each measurement is collected in transmission through the entire specimen and is an average for all fibres (along the Y axis) at each measurement position, (X, Z). This results in some convolution effects if individual fibres bear different loads. Given that the fatigue crack front was relatively straight and flat, the stress conditions should be similar through the specimen thickness.

As discussed in Section 2.3, the variation in fibre strains along the fibre direction and with distance from the crack tip in Fig. 7 reflects different interfacial and stress transfer conditions. When using Equation (2) to infer the ISS from the strain variation along the fibres it should be remembered that the position of the crack plane varies slightly across the specimen. This causes a smearing of the ISS variation due to a contribution from all the fibres throughout the thickness. Fig. 8 shows the ISS along fibres at different positions with respect to the crack tip for S1 calculated from the corresponding fibre strain profiles, where the sign of the ISS indicates the direction of the shear stress. The curves are broadly similar to those described for Ti-6Al-4V/SCS6 system [19] and the reader is referred to the schematics in that paper for more details as to their interpretation. In essence, the change of sliding direction (forward sliding under tensile loading as the fibres are pulled out of the matrix slightly and reverse sliding during unloading when the fibres are pushed back in) is evident in terms of a change in sign of the ISS between K_{\max} and K_{\min} . Sliding occurs when the shear stress reaches the interfacial frictional sliding stress (τ_{fr}) causing the shear stress to plateau. At $x = 1.3$ mm (0.3 mm behind the crack tip) this occurs at approximately $\tau_{fr} = 55$ MPa (at K_{\max}) reversing in sign at K_{\min} suggesting sliding lengths (denoted by the boxes in Fig. 8) of ~ 400 μm in the forward direction and just ~ 100 μm in the reverse direction. The curves are somewhat noisy, but at $x = 1.15$ mm the frictional sliding stress plateau is lower ($\tau_{fr} \approx 35$ MPa) and the sliding zone extends a little further from the crack plane (~ 600 μm). For $x = 1$ mm (see Fig. 8), there is very little change in the ISS profile between K_{\max} and K_{\min} , suggesting that there is no sliding and the shear stress introduced when the fibres at the notch fractured is largely retained through the whole fatigue cycle. Immediately behind the crack tip ($x = 1.45$ mm) there is evidence of forward sliding, but reverse sliding is difficult to discern. This may be because the sliding lengths are even smaller than those for $x = 1.3$ mm and so difficult to measure or

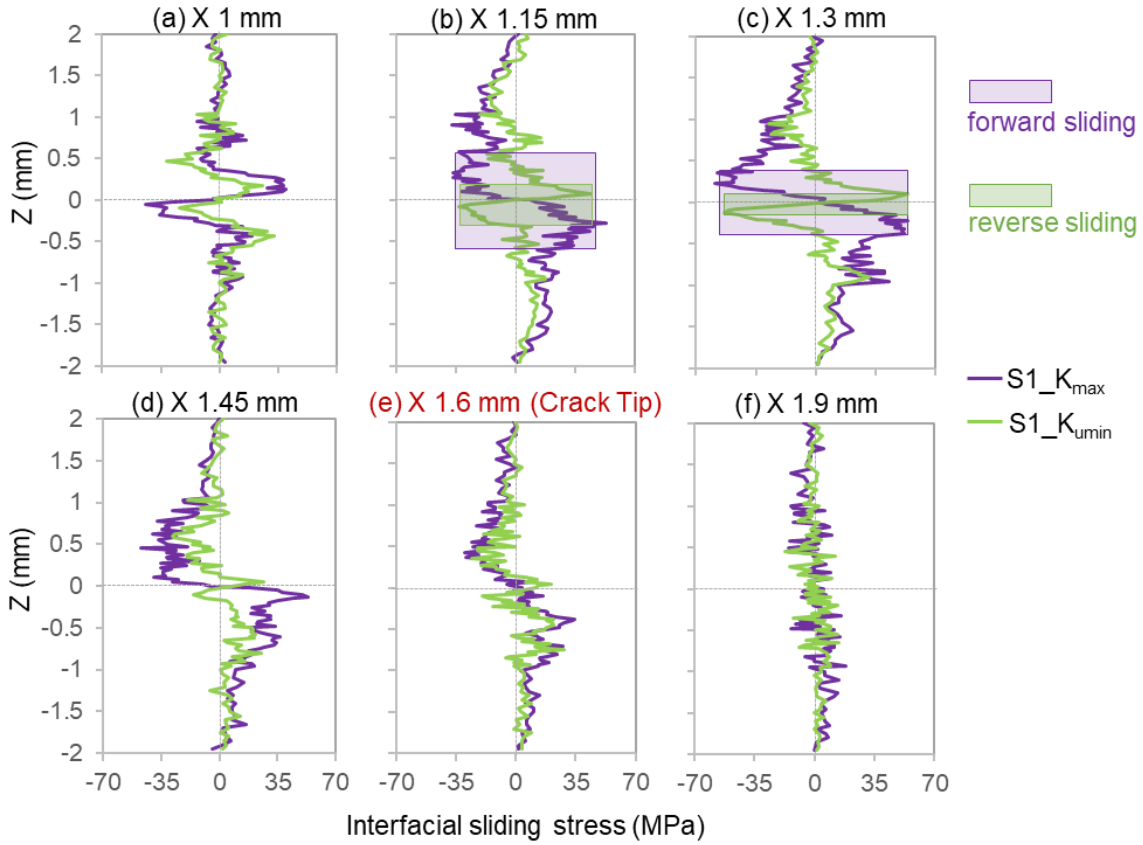
Fig. 8. Variation in interfacial sliding stress (inferred from the corresponding fibre strains in Fig. 7) along the fibres at different X positions for S1 in the peak loaded and unloaded states at 350 °C. The ISS profiles are shown at X positions of (a-d) 1, 1.15, 1.3, 1.45 (in the crack wake), (e) 1.6 (at the crack tip) and (f) 1.9 mm (ahead of crack tip) at K_{\max} and K_{\min} .

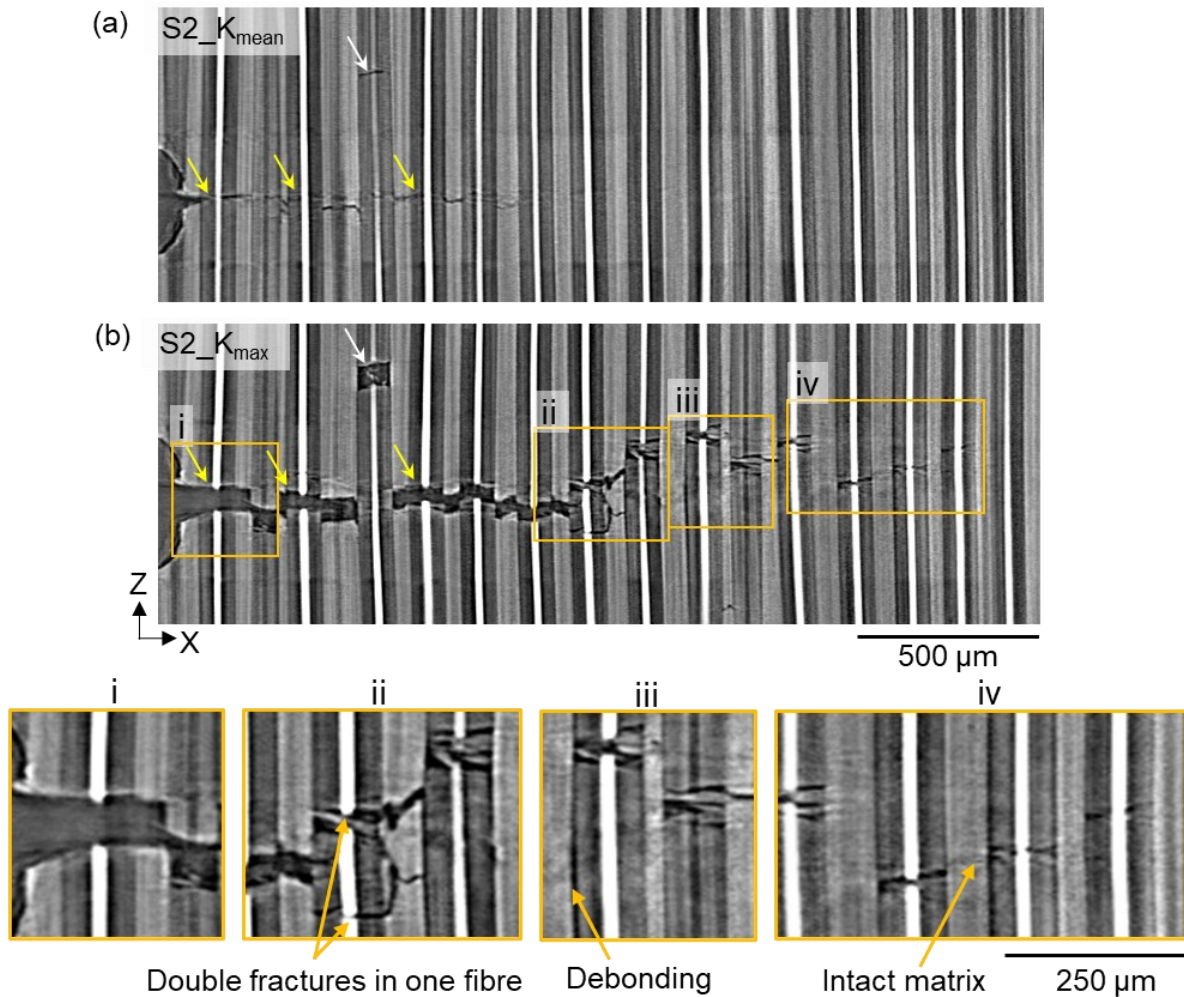
Fig. 9 X-ray CT virtual sections for S2 at 350 °C comparing damage a) before (at K_{mean} , 11.6 MPa $\sqrt{\text{m}}$) and b) after (at K_{max} , 19.0 MPa $\sqrt{\text{m}}$) a rapid burst of crack propagation. Yellow and white arrows indicate fibres that were damaged during the pre-fatigue. Inserts (i-iv) show magnified views of a range of different features marked in boxes in (b).

Fig. 9 shows a magnified virtual XZ section in S2 before (K_{mean}) and after (K_{\max}) rapid crack growth. It is worth noting that although many fibres in the fatigue crack wake remained intact therefore bridging the crack during the stable growth observed during the fatigue pre-cracking, a few fibre fractures are evident in the CT scan at K_{mean} . A number of broken fibres

can be seen in the longitudinal slice shown in Fig. 9(a) most of which lie very close to the crack plane (see yellow arrows). However, the relatively high fatigue ΔK_{ini} has also been sufficient to break one fibre (highlighted by the white arrow) distant from the crack plane ($\sim 350 \mu\text{m}$). It is clear by comparing Fig. 9(a) and (b) that as K_{max} was approached a burst of fibre fractures occurred leading to the rapid advance of the crack. Cotterill and Bowen [6] reported instantaneous rises in crack growth rate of up to two orders of magnitude (up to $\sim 10^{-4} \text{ mm/cycle}$ at $350 \text{ }^\circ\text{C}$), associated with one or a group of fibre fractures, during fatigue crack propagation in Ti-15-3/SCS6 composite at elevated temperatures ($200\text{-}500 \text{ }^\circ\text{C}$). The rapid crack growth observed here is even more pronounced causing the crack to advance by 1 mm instantaneously. It is clear that the fibre fractures have enabled the fatigue crack formed during the stable-growth stage to open (see Fig. 9)., In contrast to the fibres that fractured during pre-fatigue which show fractures normal to the applied load, as seen in Fig. 9(b) many of the fibres that fractured in the rapid burst exhibit several wedge/disc-shaped fractures, which have the same morphological characteristics as those observed in the static axial tensile failure of UD Ti-6Al-4V/SCS6 SiC fibre composites at room temperature [34] as shown in the magnified inserts (i and iii) in Fig. 9.

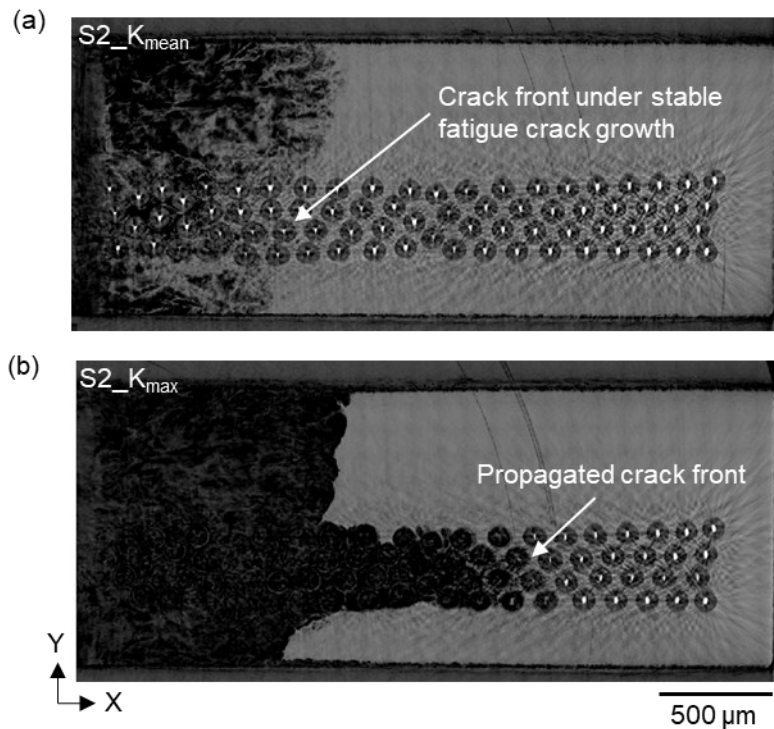
Fig. 10. X-ray CT virtual XY cross-sections of S2 at 350 °C comparing the fatigue crack a) at K_{mean} and b) after rapid crack growth (at K_{max}). The black regions (corresponding to air) indicate where the crack has propagated.

A stack of 201 XY sections centred at the notch-height ($z = 0$) in S2 were processed in MATLAB to obtain an image with the darkest pixel (with minimum grey value, which corresponds to crack/air) of all pixels in Z (i.e. having the same X and Y positions) plotted in a single XY slice image. (see Fig. 10) The projected XY sections show that the crack propagated predominantly in the fibre-reinforced region restrained somewhat by the tougher matrix-only cladding which may have also prevented catastrophic fracture of the entire specimen.

Fig. 14(a-b) shows the axial fibre elastic strain maps for S2 before and after rapid crack growth. Comparing the fibre strain map of S2 at K_{mean} (11.6 MPa $\sqrt{\text{m}}$) (see Fig. 14(a)) with that of S1 at K_{max} (16.5 MPa $\sqrt{\text{m}}$) after the same number of cycles (see Fig. 7(a)), where the damage states correspond to fatigue crack development during stable growth, the fibre strain map of S2 shows a larger wedge-shaped region characteristic of load redistribution as a result of the higher applied load. The effect of the rapid burst of fibre fractures is evident both in terms of the changes in fibre strain field between K_{mean} and K_{max} (see Fig. 14(a-b)) but also by comparison of the fields at K_{max} for S1 (see Fig. 7(a)) and S2 (see Fig. 14(b)). The fibre strains in the vicinity of the crack plane ($z = 0$ mm) have fallen to zero (white in Fig. 14(b)), confirming that the fractures evident in Fig. 11 (extending up to $x \approx 3.1$ mm) mean that the fibres were not supporting any load across the crack. The positions of fibre fractures (rendered brown) are generally found to match the regions with zero fibre strain (in white). Note that the white (low stress) region is larger in the rapid-growth zone than in the stable-growth zone, which can be attributed to the relatively larger scatter in the location of the fibre fractures away from the crack plane in this zone. Ahead of the crack tip, the maximum elastic fibre strain is about 0.50% which is similar to the maximum fibre strain measured in the bridging fibres in S1 (0.52%). In addition, the fibre strain falls sharply from tensile strain into compressive strain across the remaining un-cracked ligament ($3 < x < 4$ mm), which may be due to the bending component induced by crack opening on the remaining (~ 0.9 mm long) un-cracked ligament (shown at K_{max} and K_{umin} in Fig. 14(b)). The fact that the strain in the remaining intact fibres is not very high explains why the rapid crack growth and the large number of fibre fractures did not lead to rupture of the sample. This is due to the load borne by the un-cracked cladding in the wake of the propagated crack seen in Fig. 10(b).

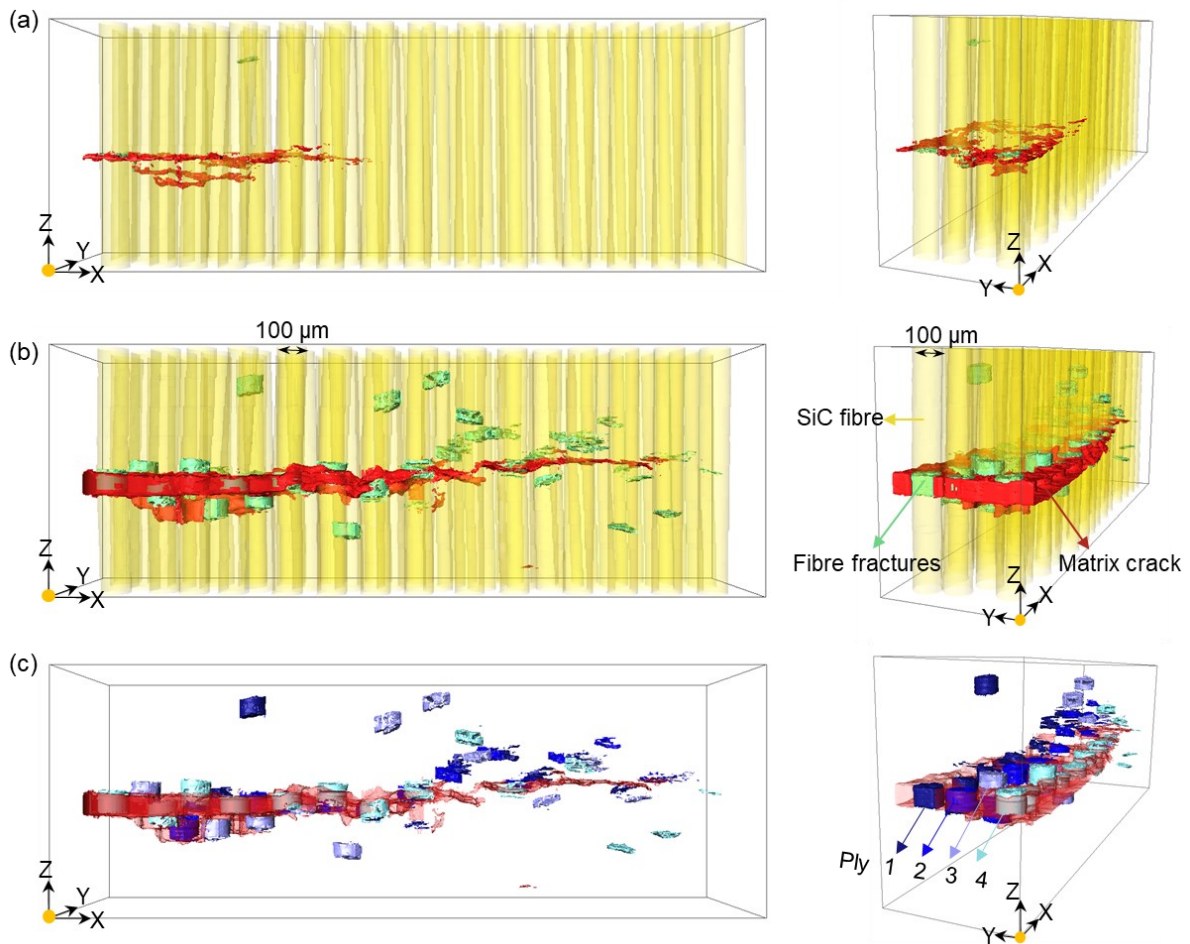
Fig. 11. 3D morphology of crack in S2 before (at K_{mean}) and after (at K_{max}) the period of rapid crack growth, showing the spatial distribution of the matrix crack and fibre fractures. Extracted and 3D volume rendered X-ray CT image of the crack (a) before and (b) after the period of rapid crack growth (the front on views (LHS) and perspective views (RHS) of the matrix crack (red), SiC fibres (yellow) and fibre fractures (green)), and (c) the fibre fractures are grouped in four plies (represented by different shades of blue) in S2 at K_{max} with the matrix crack rendered semi-transparent.

Fig. 11 and Fig. 12 show the 3D morphology and topography of the crack before and after the period of rapid growth. It is evident that compared with the region corresponding to stable fatigue growth, the region of rapid growth is somewhat less tortuous. Furthermore, while the fibre fractures in the stable-growth zone are located close to the matrix crack plane, those that have fractured ahead of the original crack position are distributed over a much larger distance extending further away from the matrix crack plane, which could be because they formed ahead of the matrix crack. This is corroborated by the presence of fibre fractures ahead of the crack-tip position (see the 3D rendering in Fig. 11b), which is typical of the static tensile failure of UD Ti/SiC fibre composite [34]. This means there is less fibre pull-out in the stable fatigue-growth zone (see Fig. 13(a)) than in the rapid-growth zone (see Fig. 13(b)) on the final fracture surface. In Fig. 11(c), the fibre fractures have been colour-coded based on their Y positions into four plies. Although the fibre arrangement in the four plies of fibres is

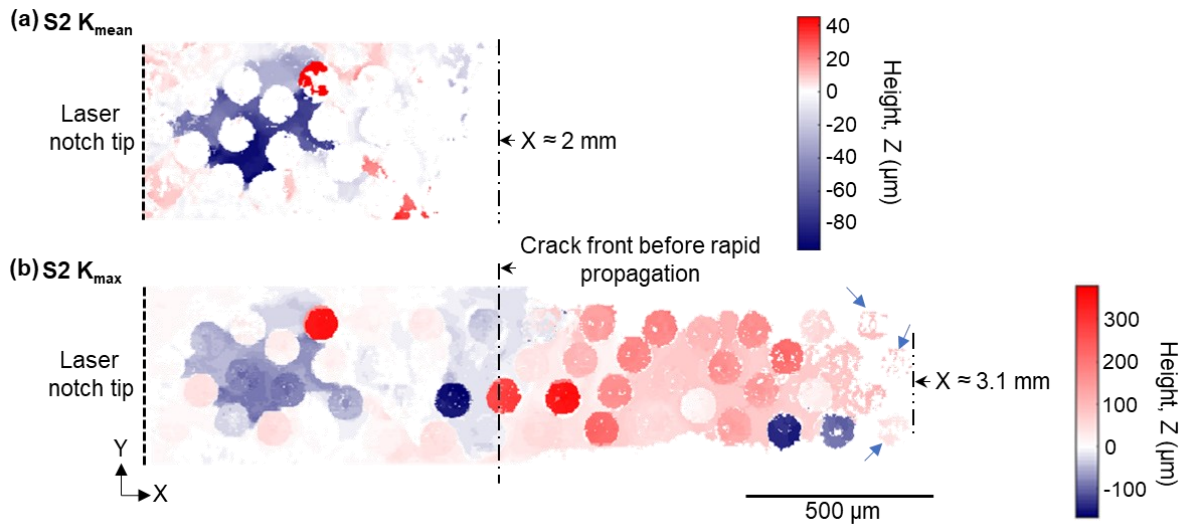
Fig. 12. The map of crack height showing crack deflection and the height of fibre fractures (a) before and (b) after the period of rapid crack growth. The height of the crack plane above and below $z = 0$ (the height of notch tip) was calculated based on the X-ray CT segmentation of S2 at K_{mean} and K_{max} .

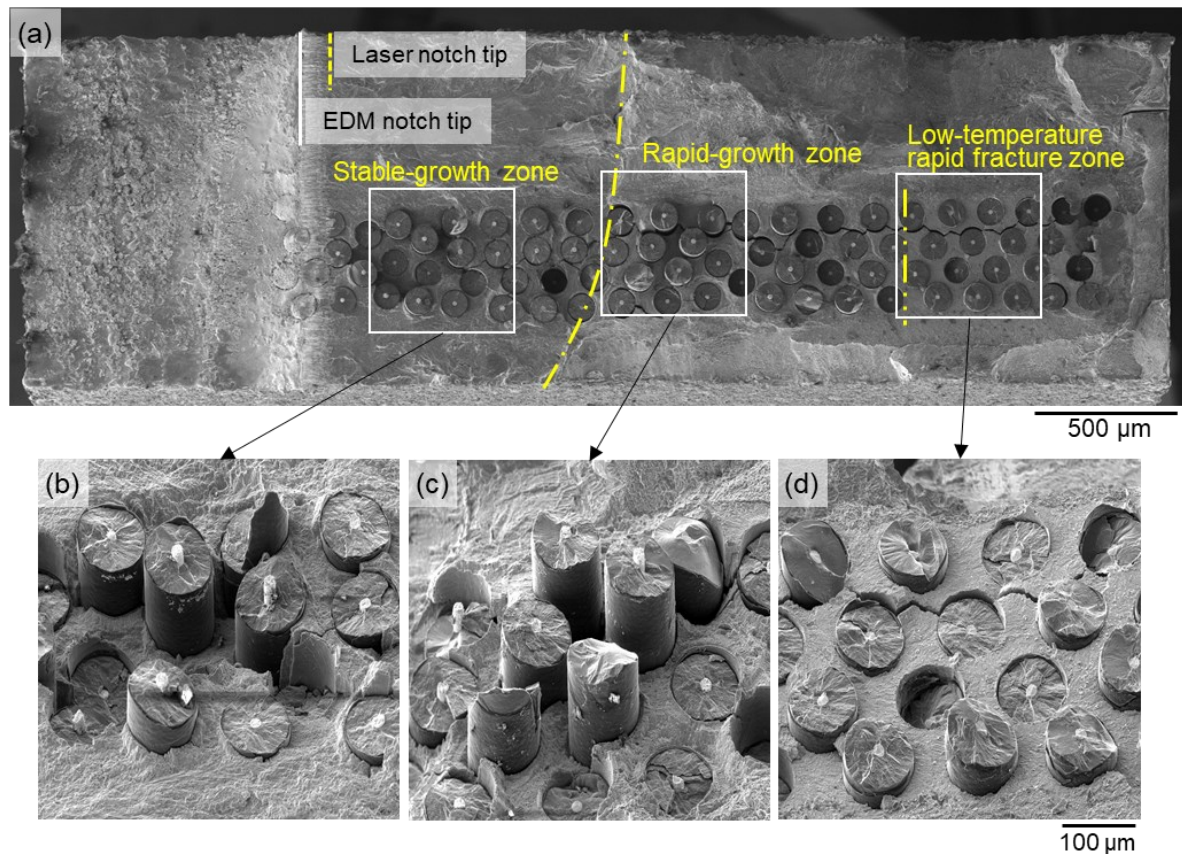
Fig. 13. The SEM images of the fracture surface of S2. (a) An overall micrograph and magnified views, showing (b) the stable fatigue crack growth zone and (c) the rapid crack growth zone developed at 350 °C, and (d) the zone that corresponds to the fast fracture in liquid nitrogen.

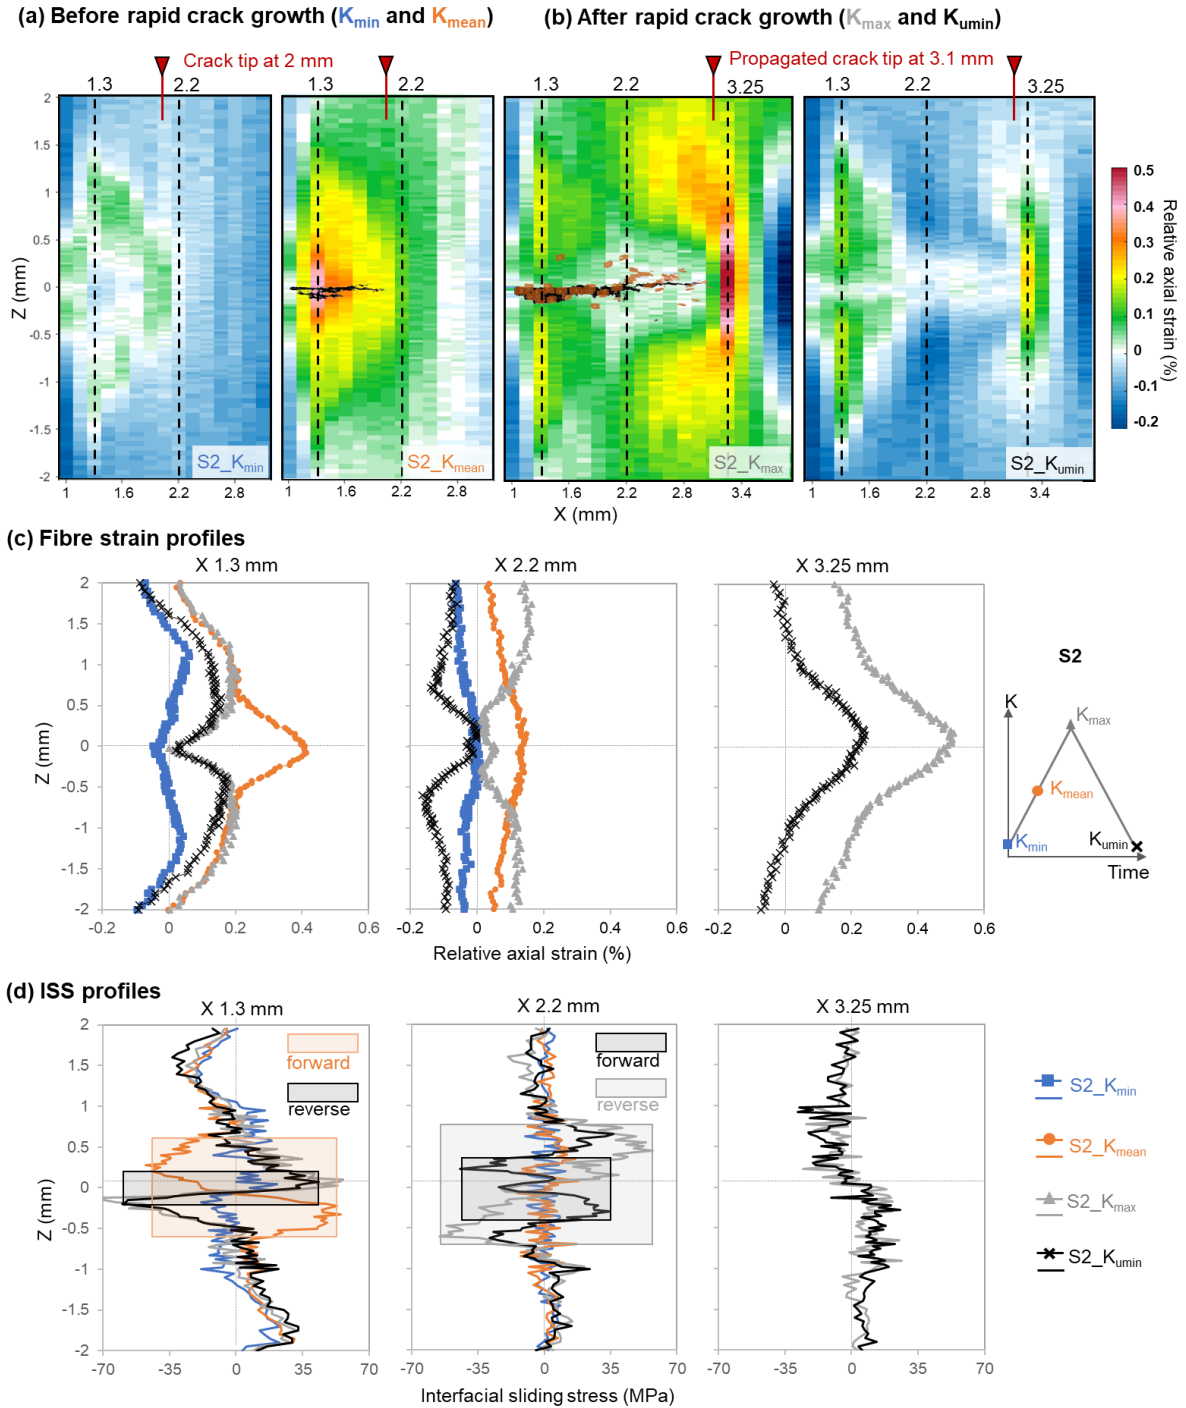
Fig. 14. Variation in relative axial fibre elastic strain distribution and interfacial sliding stress ahead of the notch in S2 at 350 °C. The fibre strain maps over a loading cycle, (a) before rapid crack growth at K_{min} and K_{mean} , and (b) after rapid crack growth at K_{max} and K_{umin} , with the extracted matrix crack (in black) and the fibre fractures (in brown) overlaid for K_{mean} and K_{max} . The dashed lines correspond to the X positions for (c) and (d). The crack tip is at $x \approx 2$ mm at K_{min} and K_{mean} , whereas at $x \approx 3.1$ mm at K_{max} and K_{umin} . (c) The fibre elastic strain profiles at X positions of 1.3, 2.2 and 3.25 mm. (d) The interfacial sliding stress (inferred from the corresponding fibre strains) along the fibres at the X positions in (c).

Further, the influence of load redistribution mechanisms upon fibre fracture is investigated via the line profiles of fibre strains and the ISS profiles (see Fig. 14(c-d)). Three characteristic regions have been analysed: 1) the region where the bridging fibres have fractured ($x = 1.3$ mm), 2) the region originally ahead of the crack containing dispersed fractured fibres ($x = 2.2$ mm) and 3) ahead of the final crack tip position ($x = 3.25$ mm). At $x = 1.3$ mm, the peak in the strain profile at $z = 0$ mm at K_{mean} clearly indicates the tensile load borne by the fibres bridging the crack. This falls to zero after rapid crack growth due to the resulting fibre fractures. The ISS profile at K_{mean} is indicative of forward sliding (fibre pull out) at a frictional shear stress of around 50 MPa as for S2 and a sliding length of around 600 μm either side of the crack plane. After fracture the fibres retract over a distance of around 200 μm which, as for the fibres at $x = 1$ mm in S1, then remains retracted as the load is cycled from K_{max} to K_{min} . Prior to the burst of rapid crack growth the crack tip is positioned at around 2 mm. Consequently the stress at $x = 2.2$ mm at K_{mean} is considerably below that at the crack tip (see Fig. 14(a)) and there is no evidence of frictional sliding along the fibres located there in common with the fibres just ahead of the crack for the low stress amplitude sample (S1). After fibre fracture at K_{max} the fibre stresses (at $z = 0$ mm) fall to zero and the fibres retract significantly (sliding over a length of ~ 700 μm) with a frictional sliding stress around 55 MPa. Then upon unloading the fibres are pushed out somewhat over a sliding length around 400 μm . For the fibres ahead of the propagated crack tip ($x = 3.25$ mm), the stress profile is very similar to that ahead of the crack for S1. There is no evidence of interfacial sliding because the shear stresses here at K_{max} are very low.
