Experimental study of rf pulsed heating

Cyclic thermal stresses produced by rf pulsed heating can be the limiting factor on the attainable reliable gradients for room temperature linear accelerators. This is especially true for structures that have complicated features for wakefield damping. These limits could be pushed higher by using special types of copper, copper alloys, or other conducting metals in constructing partial or complete accelerator structures. Here we present an experimental study aimed at determining the potential of these materials for tolerating cyclic thermal fatigue due to rf magnetic fields. A special cavity that has no electric field on the surface was employed in these studies. The cavity shape concentrates the magnetic field on one flat surface where the test material is placed. The materials tested in this study have included oxygen free electronic grade copper, copper zirconium, copper chromium, hot isostatically pressed copper, single crystal copper, electroplated copper, Glidcop®, copper silver, and silver plated copper. The samples were exposed to different machining and heat treatment processes prior to rf processing. Each sample was tested to a pea

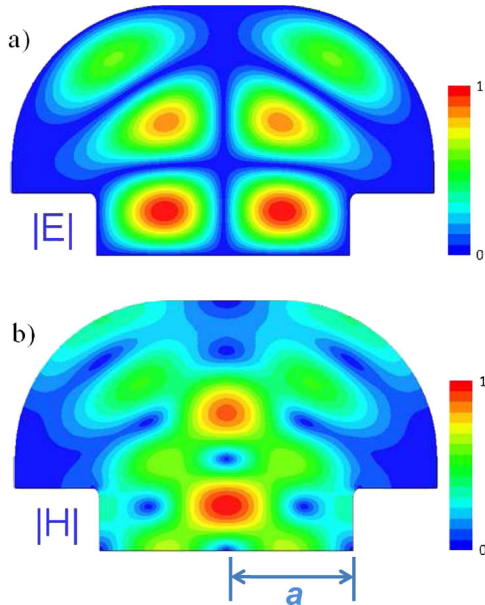
FIG. 1. Geometry of the pulsed heating test cavity and normalized color plots of the (a) E-field and (b) H-field patterns for the TE_{013} -like mode. The bottom edge is the face of the test sample.

The approach we took is to focus the magnetic field solely on the bottom plate, formed by the test sample. The geometry arrived at after some simulation effort is shown in Fig. 1, along with electric and magnetic field patterns. The mode utilized is TE_{013} -like, but the upper portion of the cavity flares out in a sort of mushroom shape, allowing the upper lobes of the mode to spread out over greater surface area. The cavity is approximately 4.88 cm high,

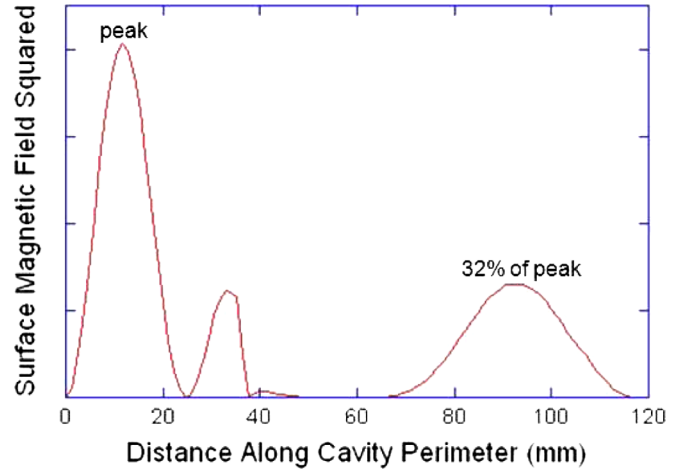
FIG. 2. Magnetic field profile (in arbitrary units) along the contour of the cavity wall, beginning at the center of the bottom face. The first peak, and by far the highest, is on the bottom face.

The square of the magnetic field profile along the cavity wall, proportional for a given conductivity to pulsed heating, is plotted in Fig. 2, starting at the axis on the bottom and going out and around to the top. The field reaches a peak on the bottom plate significantly higher than anywhere else. With the next highest surface fields, on the lower side and the curved area near the top, reaching only 56% of this, the off-sample pulsed heating is suppressed by better than a factor of 3. As noted, the surface electric field is everywhere zero.

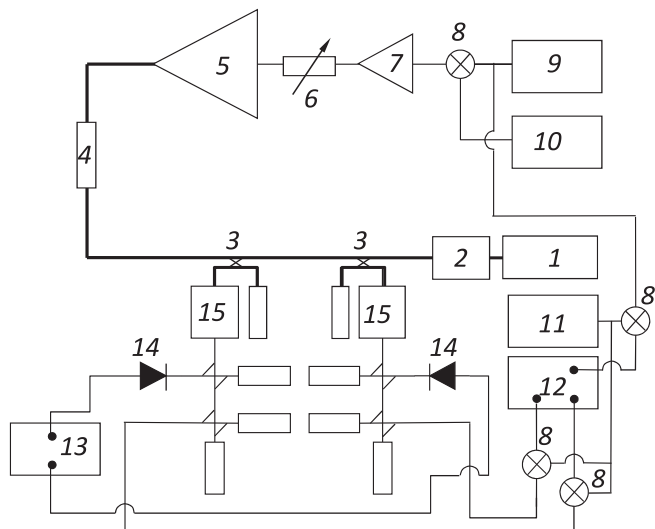
FIG. 3. Experimental setup schematic diagram: 1—pulse heating cavity, 2—mode converter creating TE_{01} mode, 3—high-power directional couplers, 4—high-power attenuator, 5—SLAC 50 MW klystron, 6—variable waveguide attenuator, 7—1.5 kW traveling wave tube amplifier, 8—mixer, 9—11.4 GHz synthesized signal generator, 10—arbitrary function generator, 11—local oscillator to drive mixers, 12—digital oscilloscope, 13—peak power meter, 14—power meter probes, 15—low pass filters. Not numbered: crossguide directional couplers that couple signal between low pass filter (15) and probes (14) and low-power rf loads which are connected to high-power directional couplers (4), and crossguide directional couplers.

The high-power tests are performed using a SLAC XL4 50 MW x-band klystron operating at 11.42 GHz [13]. Because there is no circulator available at this frequency and power level, we use a long stainless steel waveguide with an attenuation of about 4 dB to provide 8 dB round trip isolation between the klystron and the cavity. A pulse, very close in shape to a square pulse, is injected into the cavity. The reflection coefficient is then measured through a set of directional couplers.

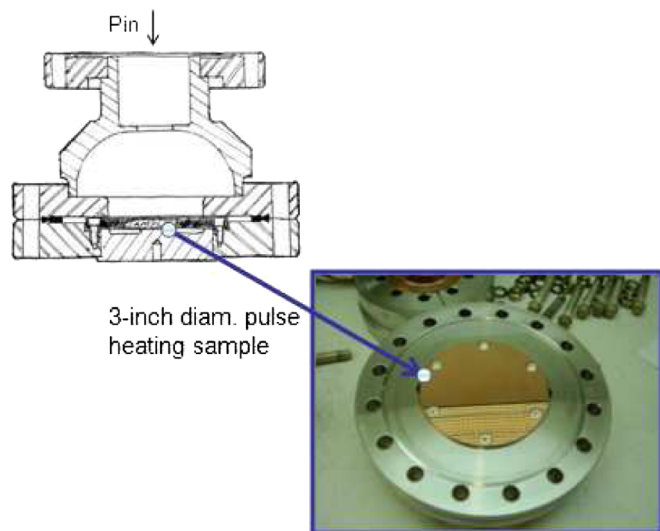
FIG. 4. The pulsed heating experiments are conducted using a TE_{01} cavity. The three-inch diameter samples are first mounted onto a cavity end cap (bottom right).

on the sample. Figure 4 shows the mechanical design of the cavity and a picture of the end plate that is attached to the cavity using a high-power vacuum flange. The three-inch diameter pulsed heating sample is mounted onto the cavity end plate. A photograph of the cavity assembly is shown in

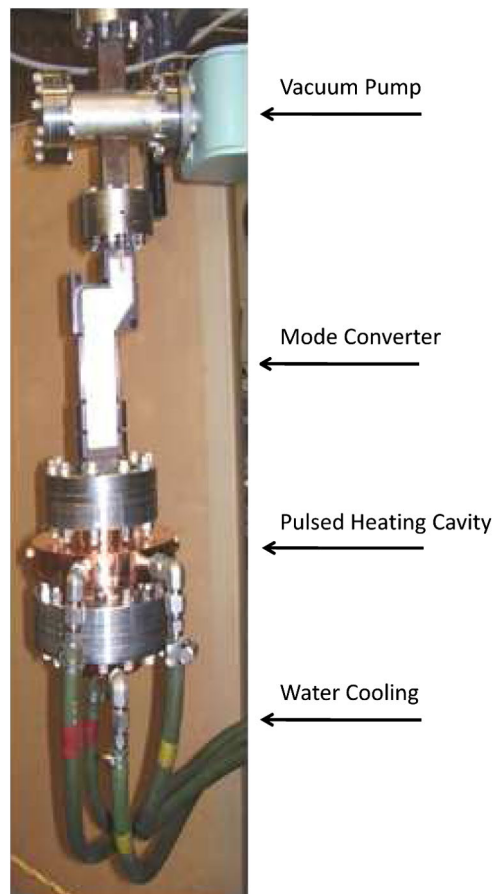
FIG. 5. The cavity has water cooling and is connected to the power source through a TE_{01} (WR90) to TE_{01} mode converter.

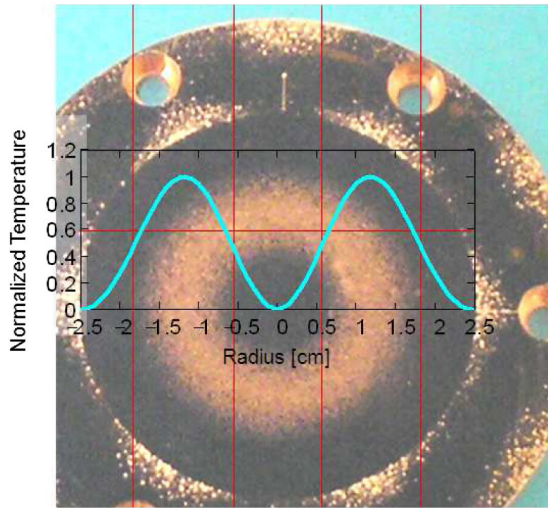
FIG. 6. Normalized pulsed heating temperature calculations superimposed on a copper pulsed heating sample.

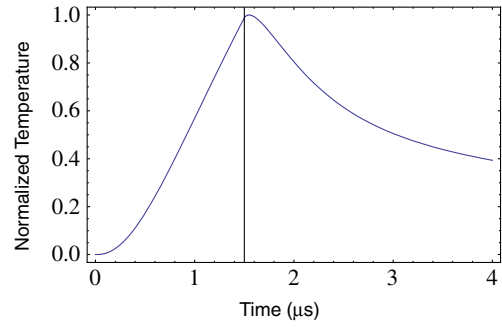
FIG. 7. Normalized temperature rise calculation on surface of test sample for a $1.5 \mu\text{s}$ rf pulse as a function of time. The temperature is normalized to its maximum value at a given point on the surface.

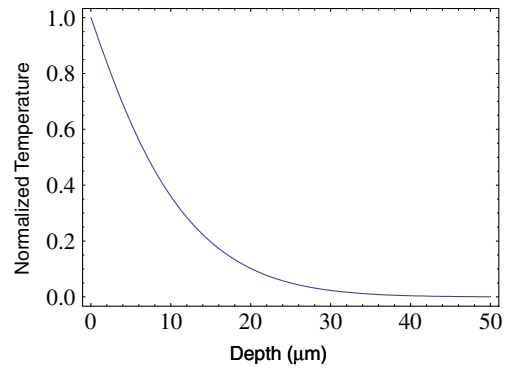
FIG. 8. Temperature profile at the maximum temperature point for a $1.5 \mu\text{s}$ rf pulse as a function of surface depth.

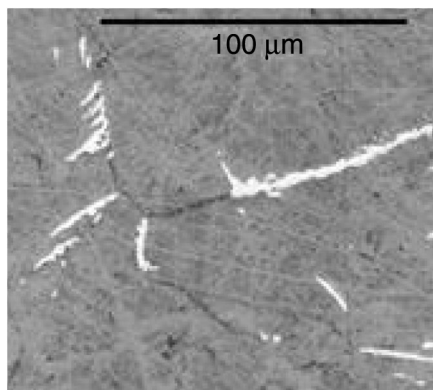
FIG. 9. Initial tests at a peak pulsed heating temperature of 70°C on OFE copper showed pulsed heating damage predominately followed grain boundaries.

Pulsed heating surface damage was already evident at this temperature and was predominate along grain boundaries like that shown in the scanning electron microscope (SEM) image of Fig. 9. The same copper sample was reinstalled into the cavity and retested at the same pulsed heating temperature (70°C) for an additional 4×10^6 rf pulses. The TE₀₁ pulsed heating ring was faintly visible after both of these runs and can be observed in the photographs of Fig. 10. An increase in the number of rf cycles during the 2nd run [Fig. 10(b)] showed many newly formed fatigue extrusions and propagation from fracture sites that were already initiated during the first run. Fatigue cracking results when a material is subjected to repeated cyclic stresses. Above a certain threshold, microscopic cracks will begin to form at the surface. SEM images showing a section of the pulsed heating ring after the first and second

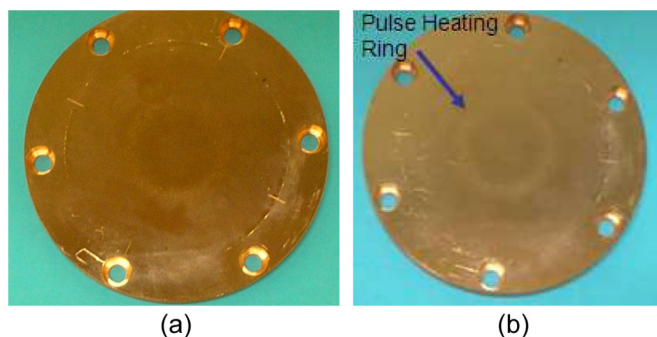
FIG. 10. Photograph showing copper pulsed heating sample with faintly visible TE₀₁ pulsed heating ring after testing to a pulsed heating temperature of (a) 70°C for 4×10^6 rf pulses and (b) a second 70°C run for an additional 4×10^6 rf pulses.

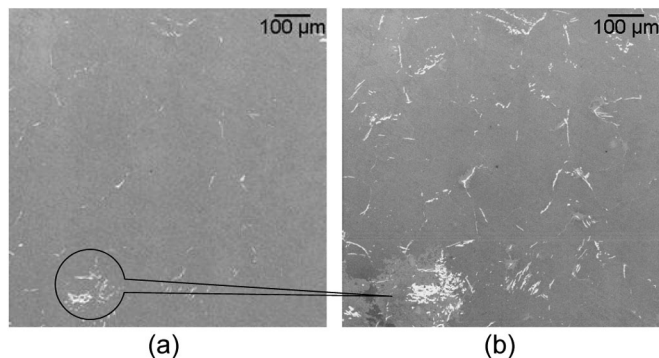
FIG. 11. SEM image of copper pulsed heating sample taken at the same location after (a) the first 70°C run and after (b) the second 70°C run.

70°C run are shown in Fig. 11. Both images were taken at the same location and at the same magnification to compare the level of surface damage between these two 70°C runs.

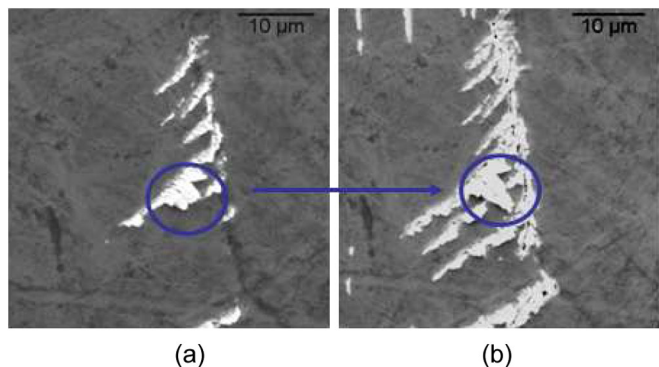
FIG. 12. SEM image after (a) first 70°C run and after (b) second 70°C run. Surface extrusions were more severe after extending the rf processing time.

The pulsed heating surface damage included both intergranular and transgranular fatigue cracks within the TE₀₁ pulsed heating ring. Transgranular fatigue cracks are a stochastic process that begins with dislocations that lead to slip lines and slip bands. Repetition of forward and reverse slip results in the initiation of a fatigue cracking which then propagates with an increase in the number of pulses and/or temperature. Intergranular fatigue cracks are microfractures that occur along grain boundaries. An SEM image with both types of fatigue cracks is shown in Fig. 12. The thermal fatigue stresses produced a noticeable slip band extrusion in this sample and in most of the samples tested in this study. After the extended run time at 70°C, the fatigue crack length and extrusions had increased. An example of the latter is encircled on the image in Fig. 12(b).

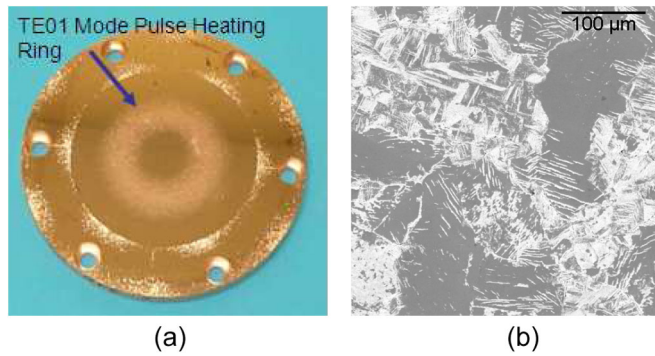
FIG. 13. Copper pulsed heating sample tested to 110°C showing (a) pulsed heating ring and a (b) SEM image showing a typical surface area within the pulsed heating ring at higher magnification.

A second copper sample was processed to a peak pulsed heating temperature of 110°C. A photograph of this sample is shown in Fig. 13(a). In this photograph there are two outer concentric rings visible beyond the pulsed heating

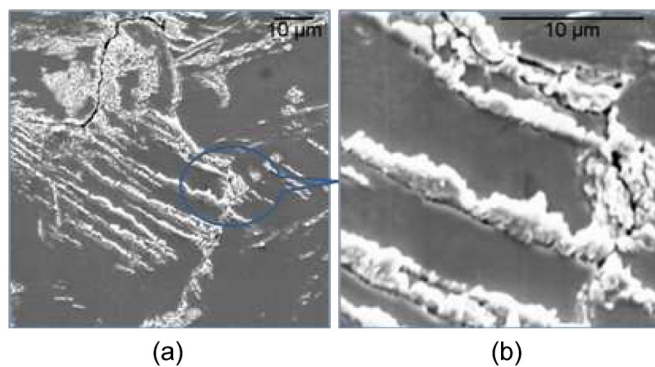
FIG. 14. SEM images showing an example of the surface damage observed on the copper pulsed heating sample tested to 110°C at (a) lower magnification and the same area at (b) higher magnification.

Like the first copper sample, intergranular and transgranular surface extrusions were evident. The surface damage observed at 110°C was significantly more severe compared to the first pulsed heating sample tested to 70°C. An image showing a typical damaged area on the surface within the pulsed heating ring is shown in Fig. 14(a) and at higher magnification in Fig. 14(b).

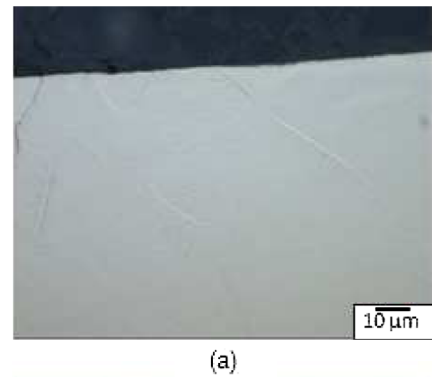
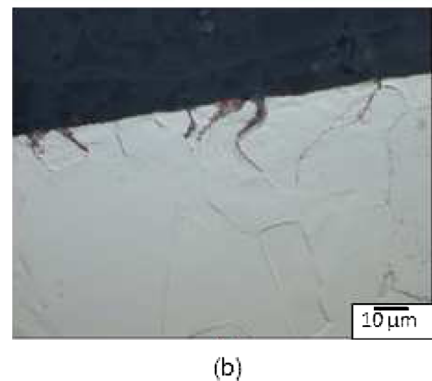
FIG. 15. Metallography of the copper sample tested to 110°C. Subsurface images showing (a) outside the pulsed heating ring and (b) within the pulsed heating ring. Grain boundary damage extended 20–40 μm below the surface.

ring is shown in Fig. 15(b). Grain boundary separation and damage was clearly evident forming channels that widened near the surface creating a funnel appearance. These areas are responsible for the intergranular extrusions discussed earlier. The channels extend from depths of 20–40 μm below the surface. The metallography results suggested only intergranular damage. Internal flaws, inclusions, and grain boundaries are sites where locally the crystal lattice is heavily disturbed. This may facilitate fatigue crack initiation and growth and be the reason why mainly intergranular fatigue cracks have been found.

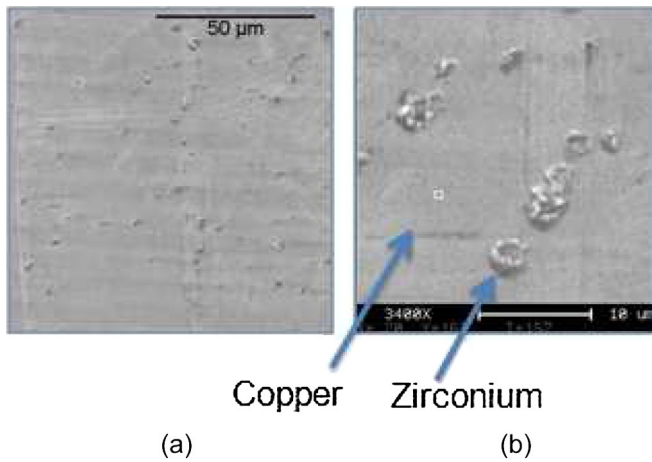
FIG. 16. SEM image of copper zirconium pulsed heating sample before rf test at (a) low magnification and a section of the same area at (b) higher magnification.

An SEM image of the CuZr pulsed heating sample taken prior to rf test is shown in Fig. 16. Chemically etching this material led to preferentially etching the softer copper base

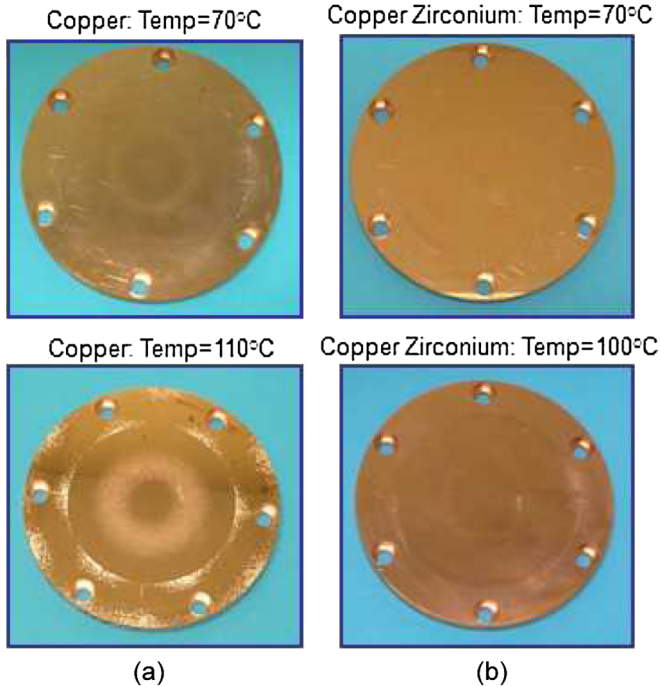
FIG. 17. Two copper pulsed heating samples tested to a pulsed heating temperature of (a) 70°C and 110°C and two CuZr samples tested to (b) 70°C and 110°C. The CuZr test samples had much less surface damage at a given pulsed heating temperature.

A photograph showing the two copper and two CuZr test samples after test is shown in Fig. 17. On the top row (left), a comparison of the copper sample tested to 70°C can be made with the CuZr sample (top row, right) tested to the

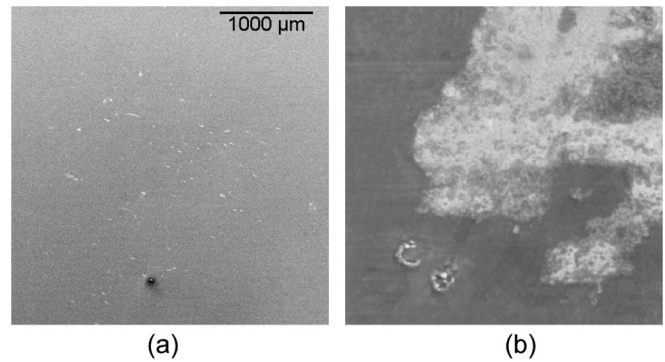
FIG. 18. SEM image taken inside the CuZr pulsed heating ring after rf testing to a pulsed heating temperature of 70°C showed minor surface damage.

One section of the pulsed heating ring on the CuZr sample tested to 70°C is shown in Fig. 18(a). The white areas in these images are areas where small amounts of surface melting and surface roughness have occurred. These microscopic specks collectively form the pulsed heating ring. A higher magnification image showing one of these small minimally impacted areas is shown in Fig. 18(b). It was not until reaching a peak pulsed heating temperature of 100°C [Fig. 17(b), bottom right, and Fig. 19] that the pulsed heating surface damage on the CuZr sample approached the level of damage observed at 70°C on the copper sample. At a pulsed heating temperature of 100°C, the intergranular and transgranular surface extrusions observed on the CuZr sample looked similar to

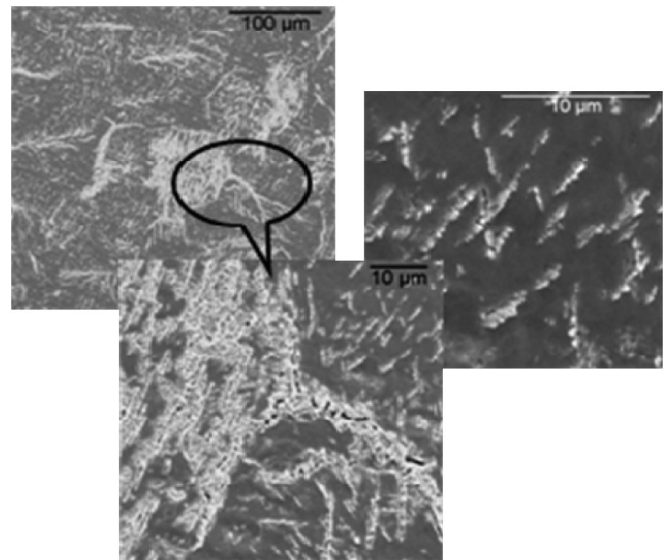
FIG. 19. SEM image taken inside the CuZr pulsed heating ring after rf testing to a peak pulsed heating temperature of 110°C.

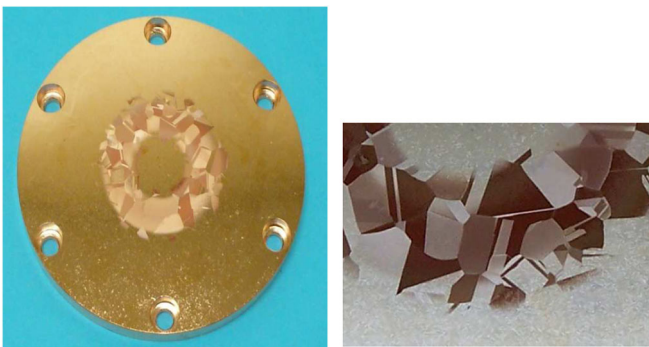
FIG. 20. Diamond-turned OFE copper with larger grains due to hydrogen firing at 1000°C . Testing to 110°C showed pulsed heating surface damage to be dependent on crystallographic orientation.

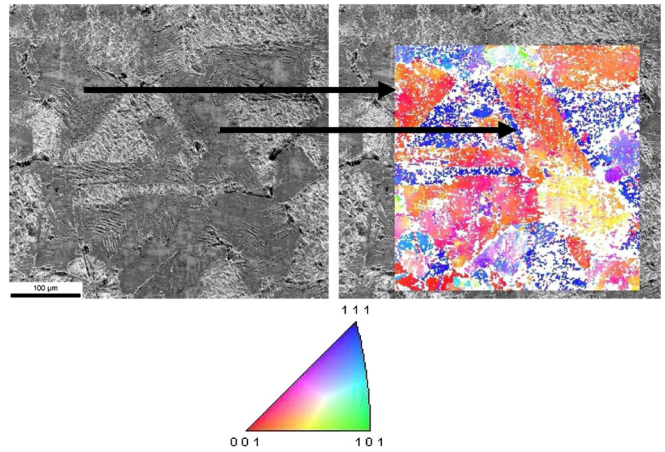
FIG. 21. EBSD image of a copper sample showing pulsed heating surface damage is dependent on crystallographic orientation.

The large grains on this sample provided an opportunity to examine individual grains. SEM analysis showed that some grains were impacted more than other grains within the same radial distance (i.e. same pulsed heating temperature) around the pulsed heating ring. It is shown in [19] that the surface degradation, arising from pulsed heating, is dependent on the crystallographic orientation of the grains with respect to the surface. One of the copper samples was analyzed using electron backscattered diffraction (EBSD). EBSD is a microstructural crystallographic technique used to examine the crystallographic orientation of a material using a scanning electron microscope equipped with a backscattered diffraction camera. An EBSD map showing a segment of the pulsed heating ring of a copper sample is shown in Fig. 21. The SEM images on the left and on the right are the same. The image on the right has a colored overlay on top of the SEM image that provides information on the crystallographic orientation. The out-of-plane orientation is determined by using the color legend that is situated below the SEM images. The arrows have been manually drawn in to point out that the darker regions, which have the least amount of surface damage, correspond to the color grid for a $[100]$ crystal orientation. The grain orientation with the most severe damage (lighter regions) corresponds to a $[111]$ grain orientation. The results of this study suggest that single crystal copper having a $[100]$ orientation should outperform polycrystalline copper under the same pulsed heating conditions. An experiment using $[100]$ single crystal copper was conducted as part of this study and will be discussed later in this paper.

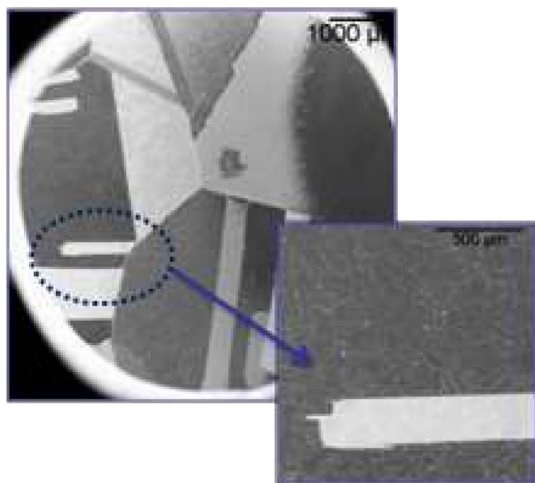
FIG. 22. Twin grains with significant pulsed heating damage surrounded by minimally impacted grains.

An SEM image showing a twin grain boundary with pulsed heating damage covering the entire surface area of the grain and bounded by a grain which had minimal surface damage is shown in Fig. 22. There were many twin grains on this sample that were observed to show

excessive damage compared to neighboring grains. Although EBSD has not been conducted on this sample, the previous EBSD results suggest that the darker, less damaged grains are likely to have a [100] crystal orientation.

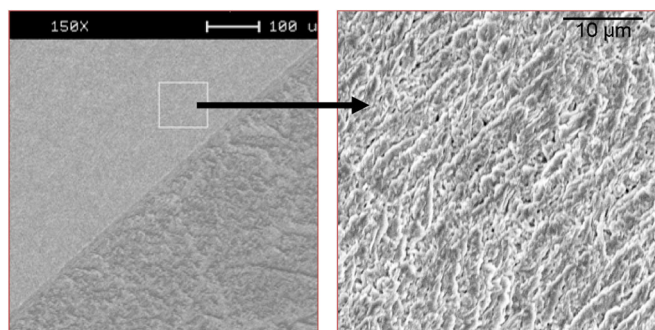
FIG. 23. Two neighboring grains on a copper pulsed heating sample that was tested to 110°C showing different types of pulsed heating damage (left image). The top left grain had damage that initiated with micropits and resulted in a matted appearance (right image).

Analysis on numerous grains has also revealed that not all grains are impacted topographically the same by pulsed heating. One example of this can be seen in Figs. 23 and 24. The SEM image on the left side of these figures shows two grains with the grain boundary running diagonally in the picture. The images on the right of Figs. 23 and 24 are higher magnification images of these two grains near the grain boundary. The pulsed heating damage on the grain shown on the right of Fig. 23 has a matted surface and the damage shown on the right of Fig. 24 has a weavelike pattern. The grain with the matted surface is created by extrusions occurring through submicron size pits that form on the face of the crystal. These micropits do not seem to be associated with slip bands as previously seen on the

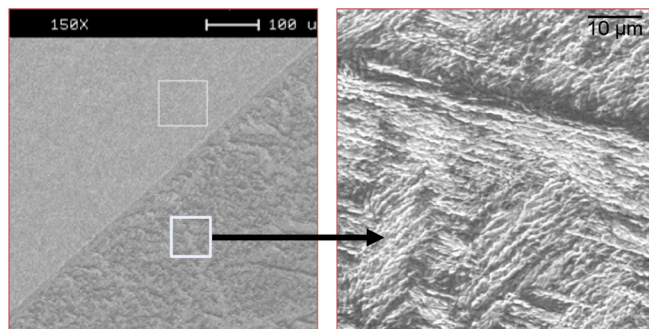
FIG. 24. The bottom right grain has a weavelike appearance that was initiated by intergranular and transgranular fractures.

other test samples and which are often times a precursor to transgranular cracking. The weave pattern is created by the combination of intergranular and transgranular microfractures. The crossing of transgranular cracks propagating perpendicular (or oblique) and parallel to grain boundaries creates the weave-pattern appearance that is observed on the grain of Fig. 24. The grain boundaries serve as a termination point for the propagation of these transgranular fractures. Earlier stages of both the micropits and weave-pattern fractures will be shown and discussed later in this paper.

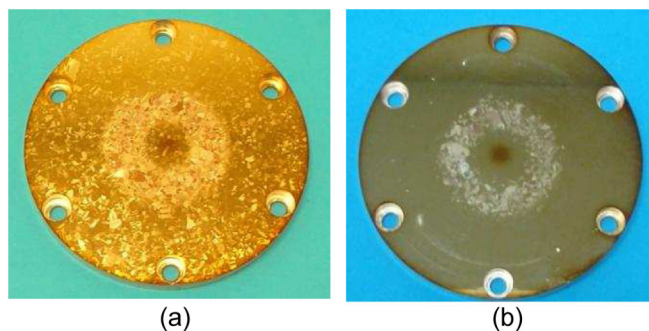
FIG. 25. Two HIP copper pulsed heating samples. One sample was (a) chemically etched and the other sample was (b) not etched.

went through a two-micron chemical etch prior to rf test. The etching process, besides removing undesirable protrusions and foreign particulates, removes a different amount of material from the grain boundaries due to a different chemical potential, when compared to the interior of grains, here resulting in a deepened grain boundary. This effect is used in metallography in order to reveal the material microstructure as shown for the sample in Fig. 25(a).

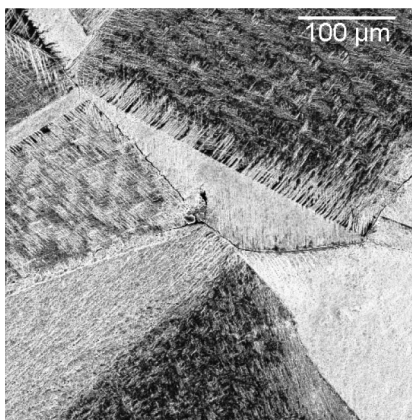
FIG. 26. High magnification SEM image of a HIP copper sample showing variations in the degree and type of pulsed heating surface damage on individual grains.

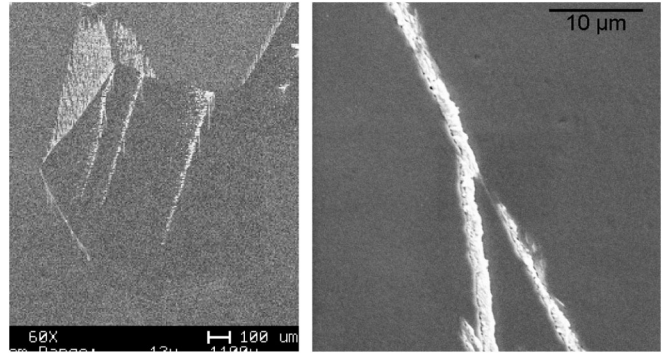
FIG. 27. SEM image showing the outer edge of the pulsed heating ring where grain boundaries are the first to be impacted.

An SEM image showing the outer edge of the pulsed heating ring on the HIP copper sample that was chemically etched is shown in Fig. 27. Because the temperature is lower on the outer edges of the pulsed heating ring, examining the outer edges can reveal the initial impact or onset of pulsed heating surface damage that occurs at lower temperatures. Grain boundaries were observed to be the first locations impacted by pulsed heating. They have a lower energy barrier and are regions where atoms have become misaligned and are susceptible to localized grain boundary defects and foreign particulates.

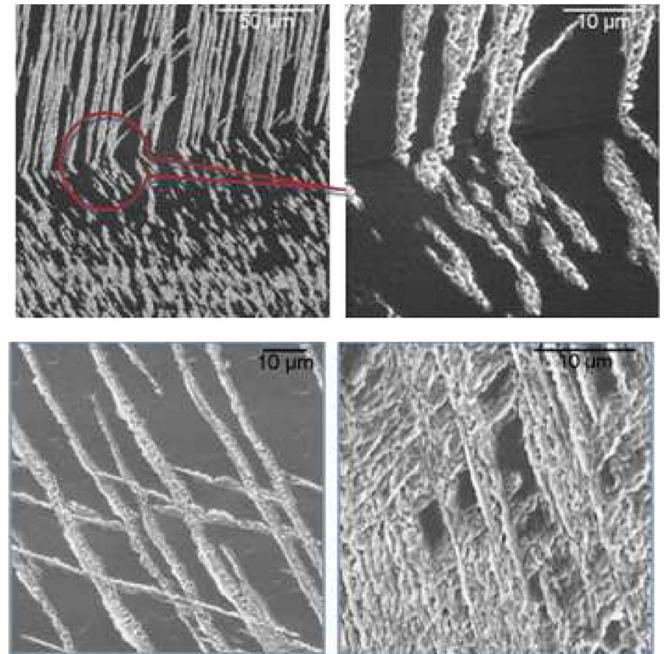
FIG. 28. Transgranular extrusions terminating along grain boundaries (top) and the resultant weavelike pattern (bottom) that is created when they are oriented in different directions.

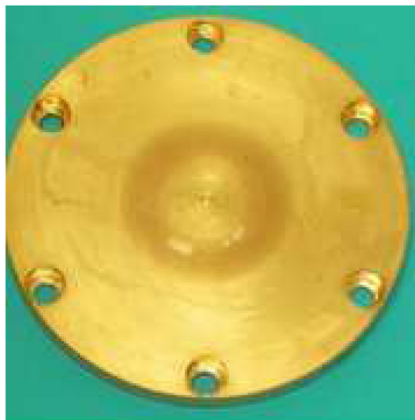
FIG. 29. Photograph of electrodeposited copper sample after processing up to a pulsed heating temperature of 110°C.

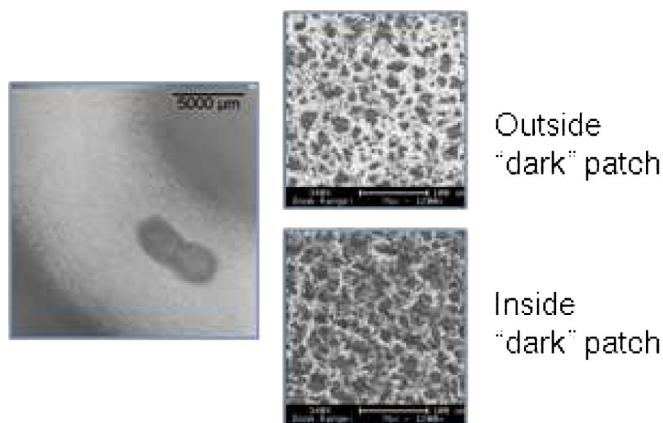
FIG. 30. Nonuniform pulsed heating surface damage. Dark elongated patchy areas were observed inside the pulsed heating ring. These were areas that had less surface damage relative to the rest of the pulsed heating ring.

The darker locations in the SEM images are areas that had less surface damage compared to the nearby surrounding regions. The top right image of Fig. 30 gives an

example of what the surface characteristically looked like within the pulsed heating ring. The bottom right image of Fig. 30 shows what the surface looked like inside the dark patchy area. The damage in both of these regions looks similar but the darker regions are spots on the surface that have been less impacted by pulsed heating. This is easier to see in the high magnification SEM images shown in Fig. 31. The different types of pulsed heating surface damage discussed so far have been due to the transgranular surface extrusions oriented in different directions and terminating on grain boundaries and the damage observed due to extrusions through micropits. In this sample, the pulsed heating damage followed the latter case. The formation of micropits is initiated near grain boundaries and as the pulsed heating temperature increases the number of pits increase and progressively develop further away from the grain boundaries until the remaining grain has been damaged. The micropit extrusions give a stringy or matted surface appearance that has been observed on many of the samples tested. It is speculated that the observed differences in types of pulsed heating damage may be due to a difference in crystallographic orientation.

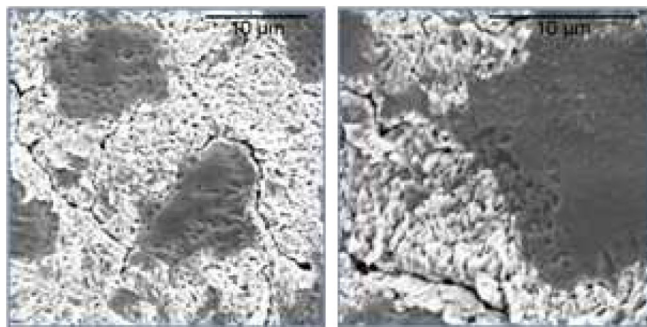
FIG. 31. High magnification SEM image of the electrodeposited copper sample taken after the test. These images show a region inside the dark patchy area.

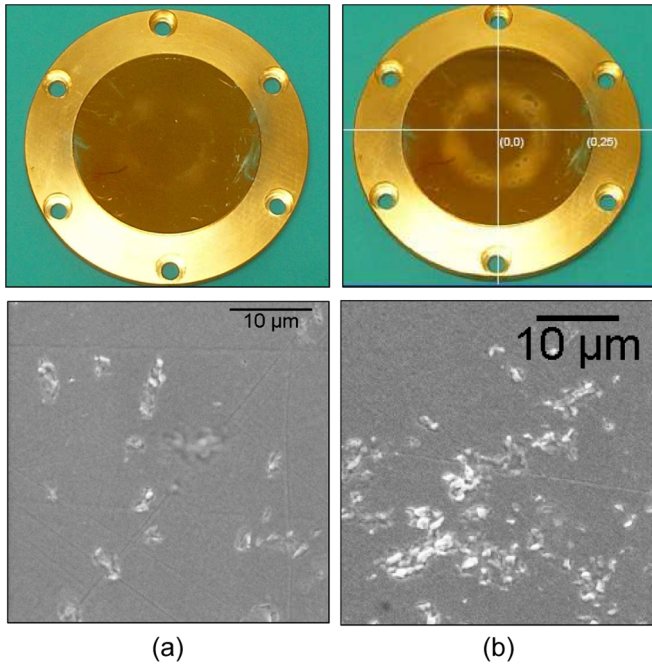
FIG. 32. Single crystal copper with [100] grain orientation after rf testing at a pulsed heating temperature of (a) 70°C and (b) 110°C.

day of operation and then temporarily removed from the cavity for a preliminary SEM inspection. The pulsed heating ring was already faintly visible. This can be seen in the top left photograph of Fig. 32. The SEM image in the bottom left shows a typical area within the pulsed heating ring after the initial 70°C test. The surface damage observed was minimal and appeared as small pits. There were no microfractures located on the surface as a result of this initial 70°C test run. The photograph in the top right of Fig. 32 is the same sample after reinstalling it into the cavity and continuing with the established test protocol. At 110°C there was a significant increase in surface damage and transgranular slip band extrusions (Fig. 33). The lengths of the extrusions and fractures were much smaller than in the previous samples tested and were typically

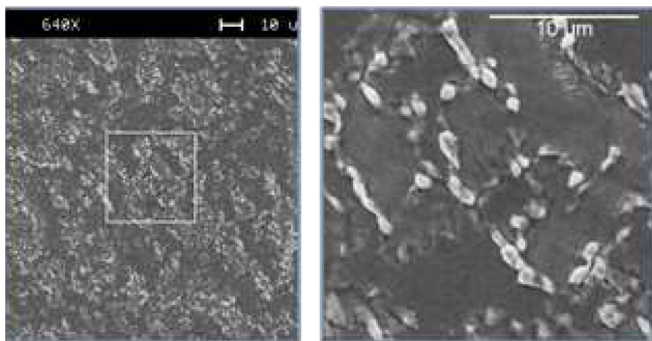
FIG. 33. At 110°C some areas on the single crystal copper showed evidence of microfractures and extrusions.

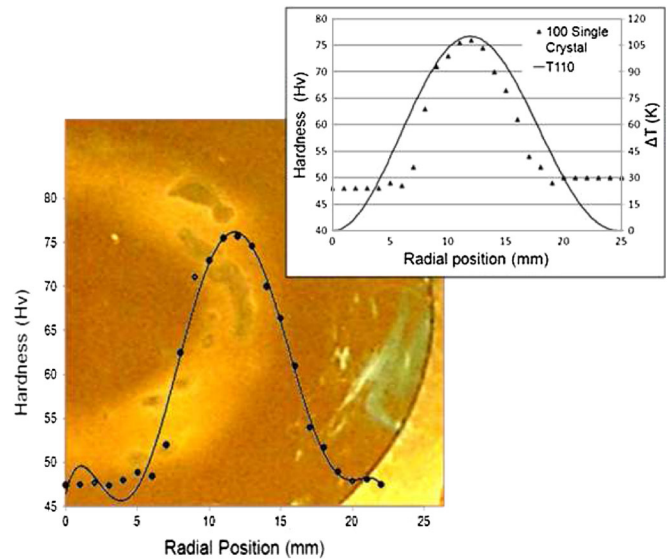
FIG. 34. Vickers hardness test results on [100] single crystal copper after the rf test showed work hardening occurred on the surface within the pulsed heating ring. Radial distribution of hardness and cyclic temperature rise shows that a threshold of approximately 60 K has to be overcome to initiate surface hardening.

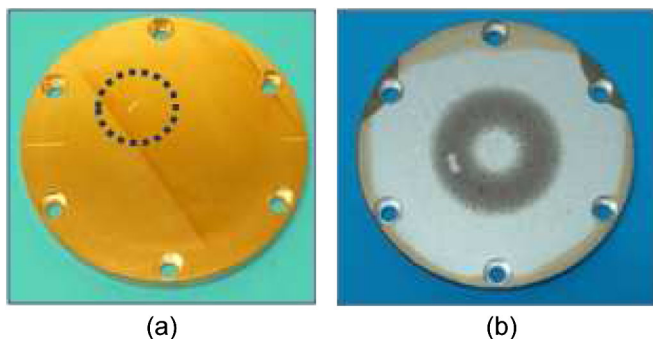
FIG. 35. Two copper chromium pulsed heating samples that were tested to a pulsed heating temperature of 110°C. (a) Nonheat treated sample had minimal surface damage and (b) heat treated sample that went through a 988°C vacuum braze cycle had significantly more pulsed heating surface damage than the nonheat treated sample.

pulsed heating sample. The pulsed heating ring on the softer heat treated CuCr sample is clearly evident in Fig. 35(b). It had significantly more pulsed heating surface damage than the one without the heat treatment. On the nonheat treated sample only a small patch of surface damage was visibly evident and is encircled in the photograph of Fig. 35(a). At higher magnification, a pulsed heating ring was observed but only transgranular extrusions were found. In Fig. 37(a), the large number of grain boundaries that were impacted can be seen in this lower magnification SEM image. The grain boundaries appear whiter than the surrounding surface area. The SEM image in Fig. 37(b) provides a closer view of one of these impacted grain boundaries. The grain boundary extrusions appear white in the image and the white specks that can be seen randomly scattered over the surface are the submicron size embedded chromium

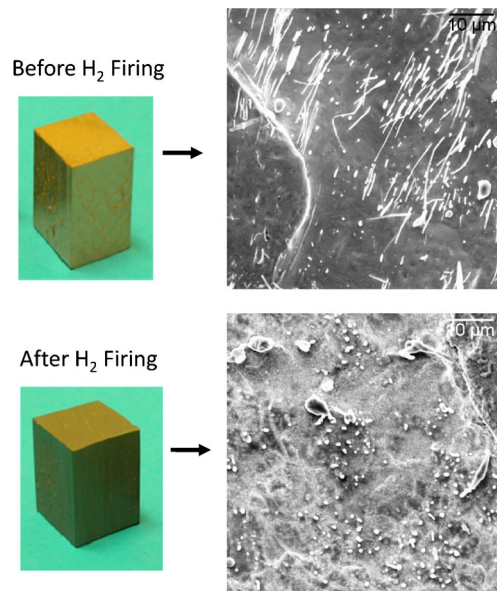
FIG. 36. Chromium copper test piece before (top) and after (bottom) dry hydrogen firing.

The photograph and SEM image at the top of Fig. 36 were taken prior to any heat treatment. The color of the test piece (top left) looked similar to copper and in the SEM image (top right) the dark areas are copper and the white areas are chromium particles. The geometry of the embedded chromium particles on the surface was typically either elongated or spherical before any heat treatment. After heat treatment, the elongated particles were no longer observed on the surface and surface analysis of the areas that were copper prior to heat treatment now showed much higher levels of chromium. After heat treatment the test piece was discolored and had a grayish tint which can be seen in the bottom photograph and SEM image of Fig. 36.

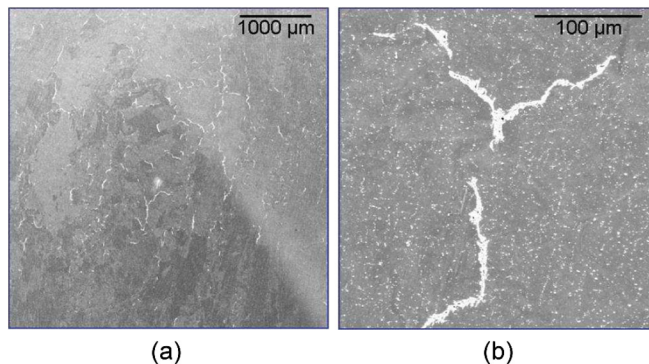
FIG. 37. SEM image of nonheat treated copper chromium sample. Grain boundaries were the locations primarily impacted on this sample.

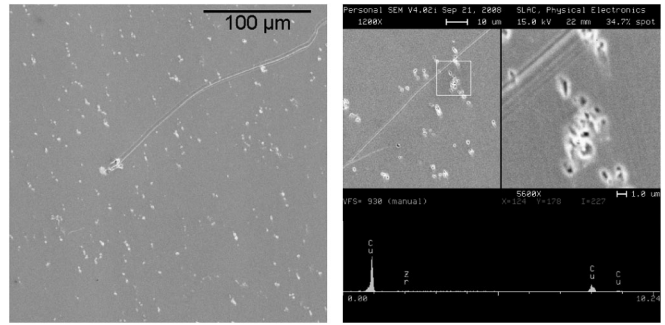
FIG. 39. Cold worked CuZr sample before test showing surface pits which are likely due to embedded zirconium particles ejected during the fabrication process.

SEM analysis of the cold worked CuZr sample prior to test showed that the surface had numerous pits on the surface (Fig. 39). These pits are most likely caused by embedded zirconium particles that were freed from the surface during the fabrication process. Remarkably, at a

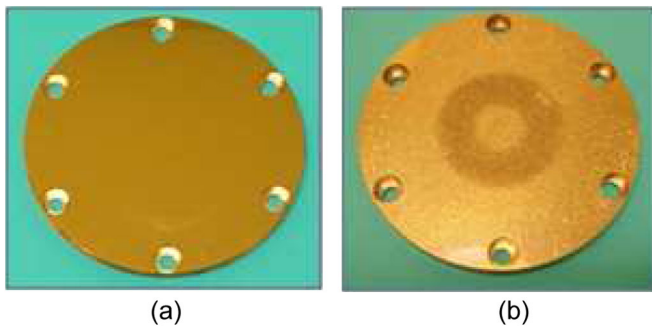
FIG. 38. (a) Cold worked copper zirconium and (b) annealed copper zirconium after rf testing. The harder material (cold worked) had significantly less pulsed heating surface damage compared to the softer annealed CuZr.

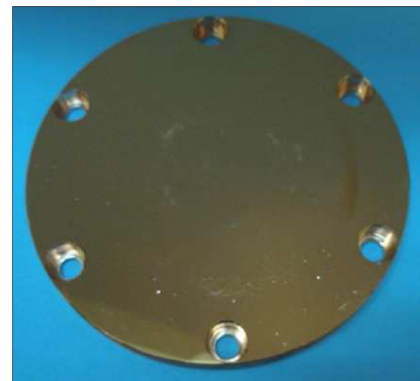
FIG. 40. Photograph of cold worked CuZr sample after testing to a pulsed heating temperature of approximately 150°C.

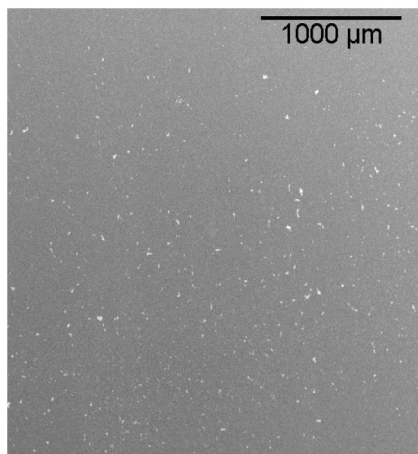
FIG. 41. SEM image showing one section of the pulsed heating ring on the cold worked CuZr sample after testing to approximately 150°C.

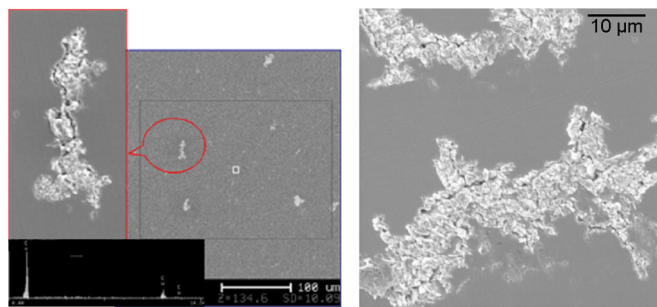
FIG. 42. SEM images showing areas of microscopic surface damage observed on CuZr sample that was tested to 150°C. Small fracture lines due to thermal fatigue are now evident.

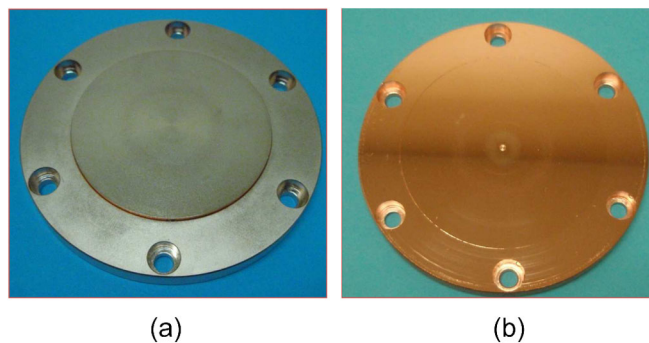
FIG. 43. A (a) SLAC and (b) KEK fabricated copper silver pulsed heating sample that were tested to 110°C. Neither of these samples was subjected to heat treatment.

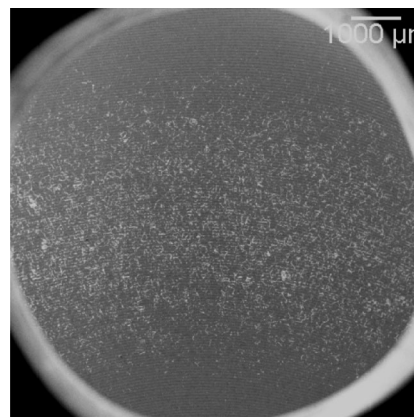
FIG. 44. Approximately one quadrant of the pulsed heating ring of the SLAC fabricated CuAg sample after rf testing.

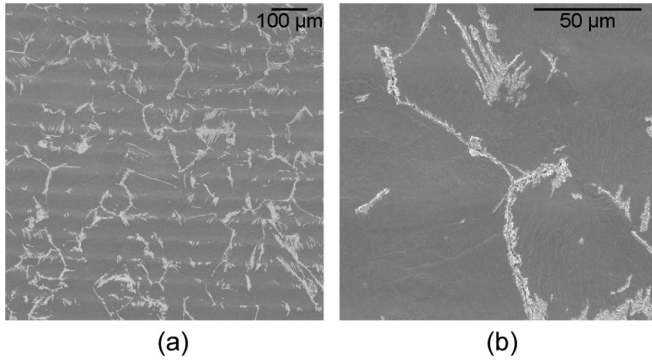
FIG. 45. High magnification image of the SLAC CuAg pulsed heating sample shown photographically in Fig. 43(a). Pulsed heating damage was dominate along grain boundaries.

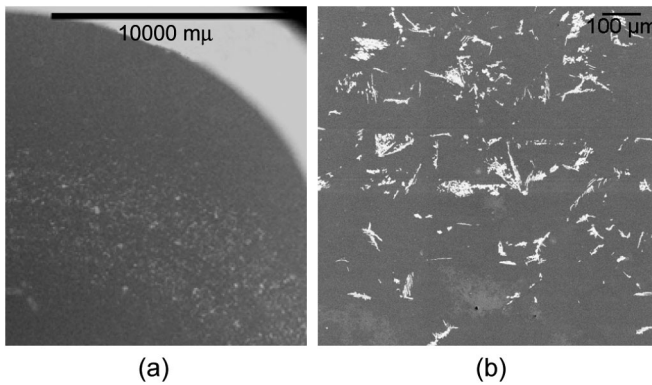
FIG. 46. Low magnification SEM image of KEK fabricated CuAg pulsed heating sample.

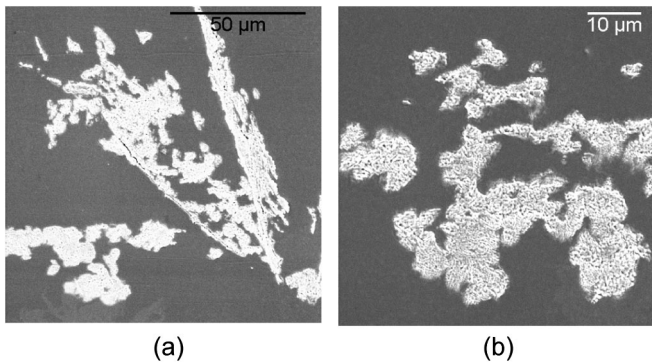
FIG. 47. High magnification image of KEK CuAg sample showing surface damage (a) along side fracture lines and (b) and on the crystal face.

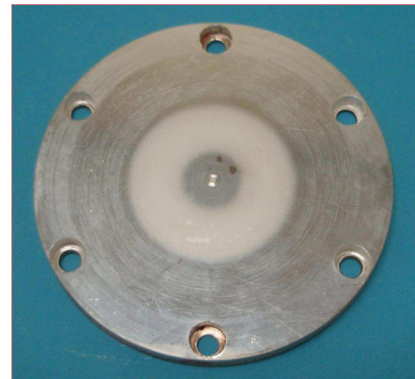
FIG. 48. Silver plated copper pulsed heating sample after rf testing.

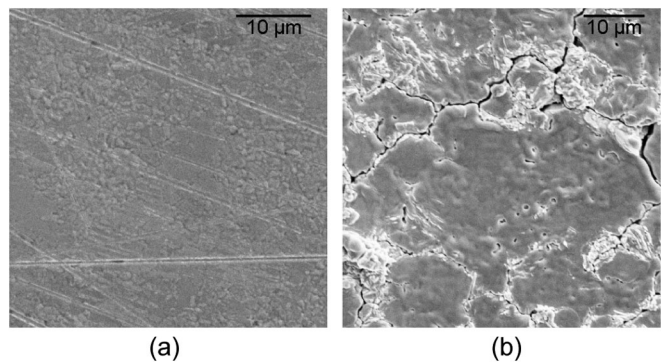
FIG. 49. Silver plated copper pulsed heating sample (a) before test and (b) after 110°C test (SEM image is taken at the outer edge of the pulsed heating ring).

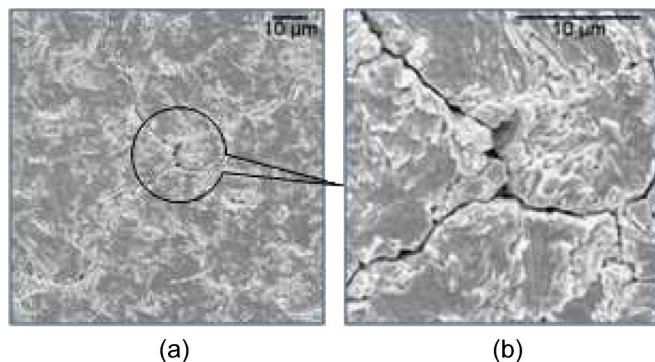
FIG. 50. SEM image taken in the center of the pulsed heating ring showing severe damage and cracking on the silver plating after the rf test.

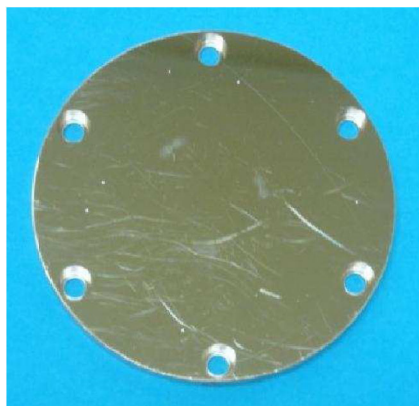
FIG. 51. Glidcop® pulsed heating sample after the 110°C test. The scratches on the surface occurred prior to testing the sample.

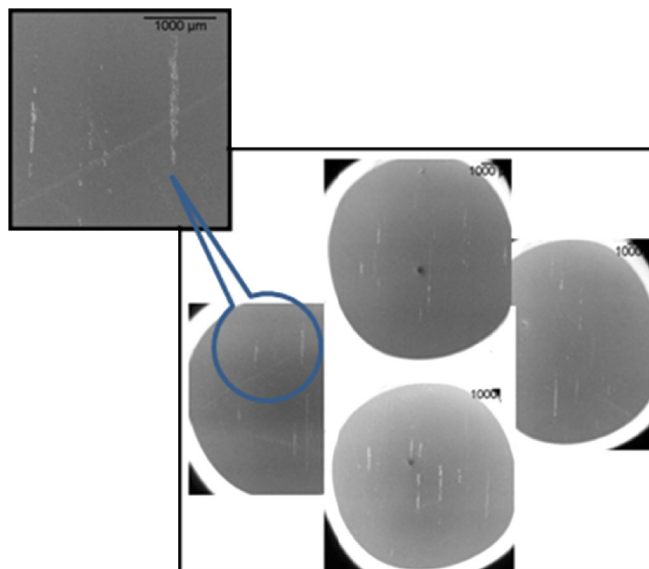
FIG. 52. Pulsed heating damage following straight lines and oriented in the same direction at various locations around the pulsed heating ring.

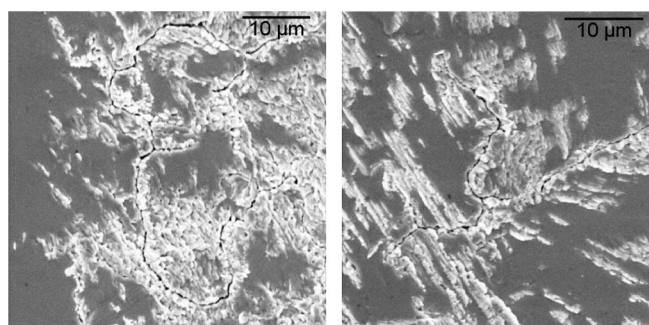
FIG. 53. Intergranular and transgranular surface fatigue extrusions observed within the Glidcop® pulsed heating striation lines.

A high magnification SEM image looking inside one of these narrow strips is shown in Fig. 53. The damage

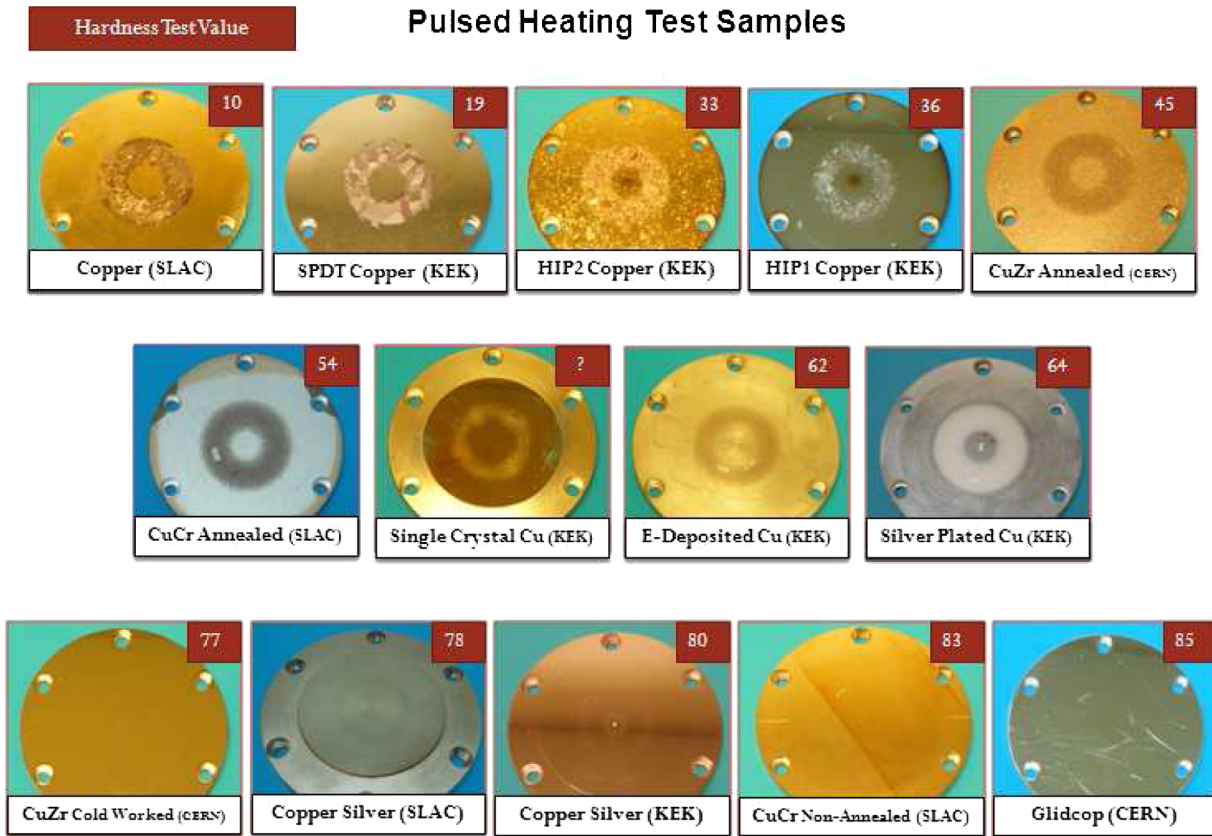
FIG. 54. Pulsed heating samples that have been tested to 110°C . They are listed in order of material hardness values with the softest materials in the top row and the harder materials in the bottom row (hardness values are located in the top right corner of each photograph).
