# RF-BREAKDOWN KICKS AT THE CTF3 TWO-BEAM TEST STAND

A. Palaia, M. Jacewicz, T. Muranaka, R. Ruber, V. Ziemann, Uppsala University, Uppsala, Sweden  
W. Farabolini, CEA/DSM/IRFU, Saclay, France

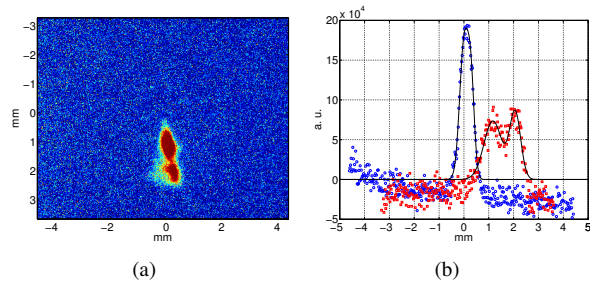
Figure 1: Example of a double beam spot detected for the same beam pulse in correspondence of a RF-breakdown in the accelerator structure. (a) The beam spot is measured on a scintillating YAG:Ce screen. (b) The centroid of the two beam spots can be calculated by means of a 2-Gaussian fit on both the horizontal and the vertical projections of the screen image.

Double spots were occasionally measured as shown in Fig. 1(a) which are explained as resulting from a change of the beam orbit during the pulse. Part of the pulse is kicked on the transverse plane, travels on a different orbit and hits the screen on a different point.

To verify that these double spots were not due to breakdown current hitting the screen, the measurement was repeated without the beam and this always led to a less bright, wider, and blurred image as shown in Fig. 2. It is worth noting that the gain of screen images in Fig. 2 is higher than the one normally used in presence of the beam (see for example Fig. 1(a)).

Most of the recorded images show a double beam spot, although it is not always as clear as the case shown in Fig. 1(a), because often the two spots are very close. Therefore, under the assumption that the beam is Gaussian, for each image we calculated the centre of the two beam spots by means of a 2-dimensional 2-Gaussian fit, as shown in Fig. 3. A 2-dimensional fit is preferred to separate fits of vertical and horizontal image profiles because it includes information on the correlation between the two dimensions. Nevertheless the initial guess of the fit parameters is calculated with a 2-Gaussian fit on the horizontal and vertical profiles of the screen image, separately (see Fig. 1(b)). When only one beam spot was measured on the screen - either because the beam was not kicked or because the kick was smaller than the screen resolution - the 2-Gaussian fit

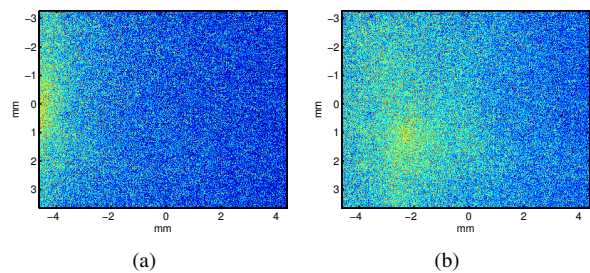
Figure 2: Example of breakdown current detected on a YAG:Ce imaging screen downstream of the accelerator structure.

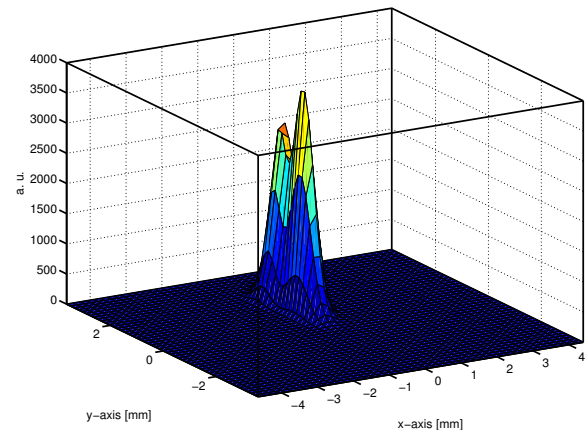
Figure 3: (a) Examples of 2-dimensional 2-Gaussian fit on the imaging screen data shown in Fig. 1(a).

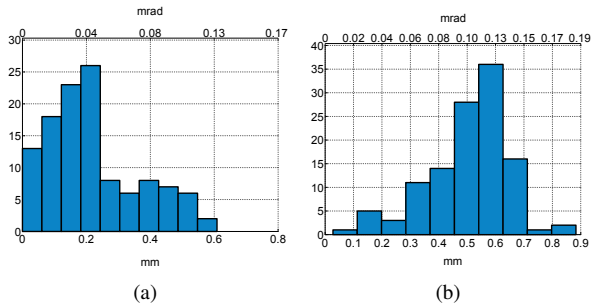
Figure 4: Distribution of horizontal and vertical kicks to the beam. The distribution of the horizontal distances and angles between the two beam spots is shown in (a) whereas the distribution of the vertical distances and angles between the two beam spots is shown in (b).

Given the distance  $d_{x,y}$  between the two beam spots detected on the screen and the distance  $L$  between the center of the accelerator structure and the same screen, we calculated the corresponding kick angle  $\phi_{x,y} \simeq d_{x,y}/L$  respectively on the horizontal and vertical planes, and the total kick angle  $\phi = \sqrt{d_x^2 + d_y^2}/L$  (see Fig. 4). It is worth noting that we switched off all quadrupoles in the beam line to have only a drift space.

We did not detect transverse kicks to the beam having a small or no vertical component, as shown in the compass plot in Fig. 5(b) and from the distribution in Fig. 4(a). Further studies are needed to explain that although the symmetry of the distribution suggests effects other than geometrical limitations. For instance, a misalignment of the accelerator structure with respect to the beam line would result in an asymmetric distribution.

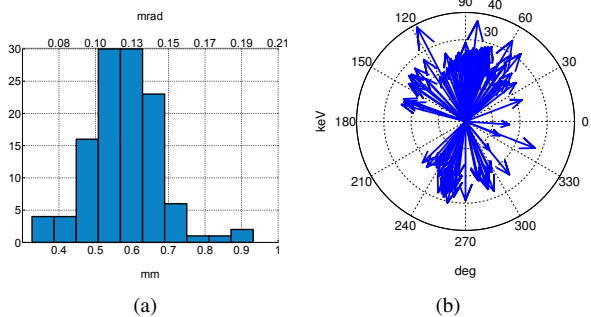
Figure 5: Distribution of transverse kicks to the beam. The distribution of the distances between the two beam spots is shown in 5(a) whereas the distribution of the corresponding transverse electric field in the accelerator structure accounting for such effect is shown in 5(b).

We also estimated the transverse electrical field  $\mathcal{E}$  accounting for the measured kick angle, given the beam energy plus half of the energy gained in the accelerator structure as we do not have any time information of where the breakdown happened along the beam pulse. The electrical field is then  $e\mathcal{E} \simeq E_{beam} \cdot \phi$  (see. Fig. 5(a)).

In Fig. 5(b) we present the measured kicks in a compass plot, where each arrow has a length corresponding to the transverse momentum transferred to the beam and a direction corresponding to the direction of the kick as it is measured on the screen.
