# TDI - PAST OBSERVATIONS AND IMPROVEMENTS FOR 2016

In Run 1, the LHC injection absorbers (TDIs) were affected by several anomalies including structural damage of the beam screens and elastic deformations of the jaws due to heating during fills. Other issues became apparent in 2015, like excessive vacuum spikes, which gave rise to several beam dumps, as well as quality issues affecting the hBN absorber blocks. This paper briefly summarizes past observations and issues like impedance, and describes the modifications which have been implemented in LS1 and the YETS 2015/2016. In addition, the expected implications and improvements for operation in 2016 are discussed.

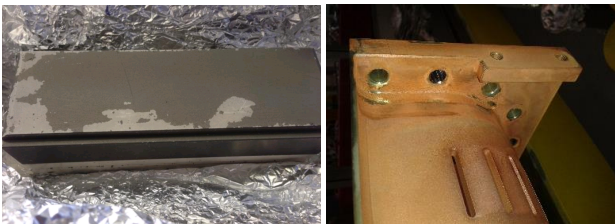
Figure 3: Issues with coatings in LS1: damaged Ti/NEG/Cu/NEG coating on hBN block due to hBN outgassing during bakeout (left) and discolored copper coating on beam screens due to Cl contamination (right). Photos courtesy of M. Taborelli and A. Perillo Marcone.

Owing to manufacturing difficulties and time constraints, some of the modifications originally foreseen for LS1 had to be discarded or delayed [12–14, 17]. This included a sandwich of new coatings on top of the Ti-coated hBN blocks, consisting of a  $2 \mu\text{m}$  Cu layer to reduce resistive heating and a  $1 \mu\text{m}$  NEG coating to reduce the secondary electron yield (SEY). The coating sandwich however peeled off after a bakeout cycle at  $300^\circ\text{C}$  as the strong outgassing of the hBN blocks damaged the NEG irreversibly [14, 17] (see Fig. 3). The NEG coating was therefore discarded and the implementation of the Cu coating was delayed to the YETS 2015/2016 (for 2015 operation, the hBN blocks were hence left with the  $5 \mu\text{m}$  Ti coating already present in Run 1). Likewise, the originally foreseen NEG coatings on the aluminium blocks, CuBe blocks and beam screens (in all cases for SEY reduction) could not be implemented due to the same reason. The aluminium blocks were instead coated with Ti, whereas the CuBe blocks were left uncoated. Suppressing the NEG coatings on the CuBe blocks and the screens was eventually considered justified as electron cloud-related effects were likely not the main cause of problems faced in Run 1 [17]. Issues were also encountered when applying a Cu plating on the beam screens owing to the geometry

which hindered a proper removal of Cl from the previous Ni plating process [13] (see Fig. 3). As a consequence, the Cu coating was removed from the screens and the screens were left uncoated. The impact on impedance was estimated to be acceptable [11].

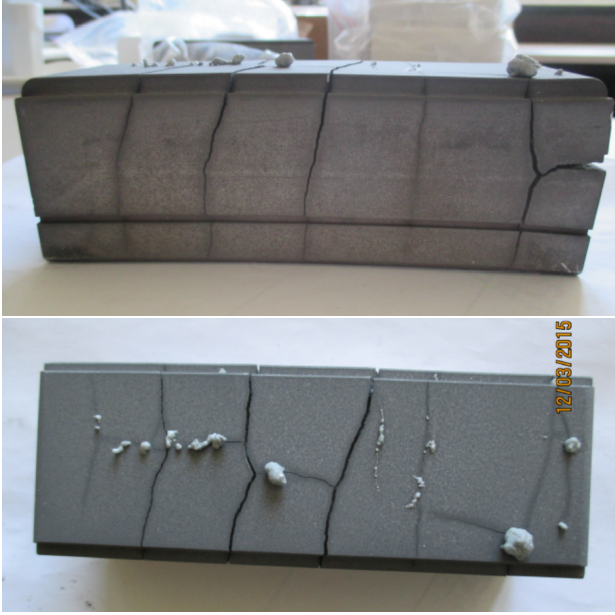
Figure 4: Cracked hBN blocks after thermal treatment in vacuum at 800°C. Material projections are visible on the block surface.

blocks for the spare TDIs [18]. To achieve a better cleanliness before coating, new procedures were applied involving a high-temperature bakeout cycle under vacuum. Previous treatments were carried out at lower temperature (400 °C in air and vacuum). About 20% of the blocks were found cracked after a thermal treatment at 800 °C, and about 50% failed after a cycle at 1000 °C (see Fig. 4). These findings were in contradiction to the material specifications of the manufacturer which state a maximum use temperature of 1150 °C in inert atmosphere. The faulty behaviour can likely be attributed to a non-conformity in the manufacturing process. Remains of unreacted binder material ( $\text{B}_2\text{O}_3$ ), with a melting point of around 450 °C, were found inside the blocks. No clear correlation with a single batch of blocks could be determined.

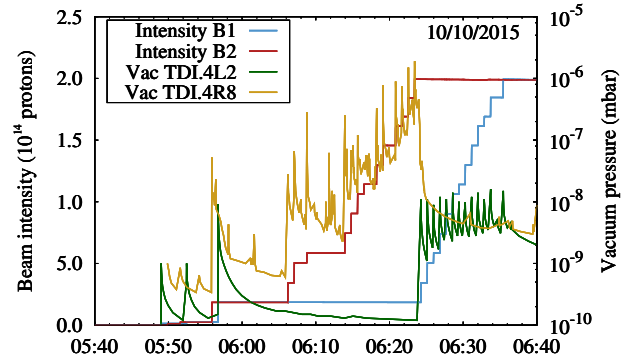
Figure 5: Typical vacuum pressure spikes in the TDIs (VGPB.4L2.231.X.PR and VGPB.4R8.231.X.PR) during injection for a regular physics fill in 2015. Spikes were orders of magnitude higher in the TDI.4R8 than in the TDI.4L2. The number of bunches per injection was 144.

In 2015, excessive vacuum spikes were observed in the TDI.4R8 during injections, typically resulting in a significant vacuum pressure build-up when filling for scrubbing or

for physics (see Fig. 5). The abnormal vacuum behaviour became apparent during the first scrubbing period in June, when the machine was filled for the first time with higher intensities after LS1, i.e. with several hundreds of bunches. No conditioning was observed throughout the year. The pressure build-up at injection became progressively worse in summer and autumn owing to the increasing number of bunches per fill, and hence the increasing number of injections. For many of the fills, the spikes reached a few  $10^{-6}$  mbar up to a few  $10^{-5}$  mbar for the last batches injected into Ring 2. Several times the beams were dumped and the vacuum valves next to the TDI closed as the pressure spikes exceeded the interlock limit on nearby vacuum gauges (at least 2 gauges need to exceed the interlock limit in order that the beams are dumped). To improve availability, the interlock limits were increased in several steps throughout the year, from initially  $2 \times 10^{-6}$  mbar to  $1 \times 10^{-5}$  mbar in early November. Spurious pressure spikes were also observed in between injections, as well as at flat top with the jaws being in parking position. The spikes at flat top were typically smaller than the ones at injection. To determine the cause of the abnormal vacuum behaviour, x-ray inspections of the TDI.4R8 were carried out in the first technical stop in 2015, however no obvious non-conformities were found [20]. Vacuum spikes occurred also in the TDI.4L2 (when injecting into Ring 1), however they typically remained below a few  $10^{-8}$  mbar (see Fig. 5). Apart from the spikes, the vacuum pressure of the TDI.4R8 did not show any anomalies. In particular, the baseline pressure in absence of beam was similar as in 2012 (few  $10^{-10}$  mbar).
