IONIZATION CHAMBERS AS BEAM LOSS MONITORS FOR ESS LINEAR ACCELERATOR

Abstract

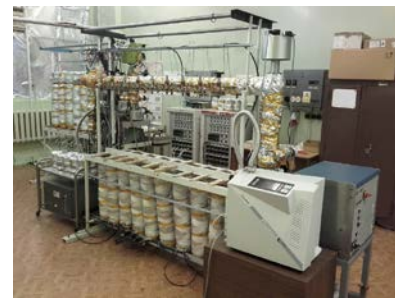
Figure 2: IHEP production stand.

The icBLM is very sturdy, offering a good radiation hardness. The consistent, long-term (20 years of operation) high quality of icBLM requires materials testing and various tests during and after production in IHEP, after reception at CERN and ESS. IHEP designed and built the UHV production stand [2], shown in figure 2.

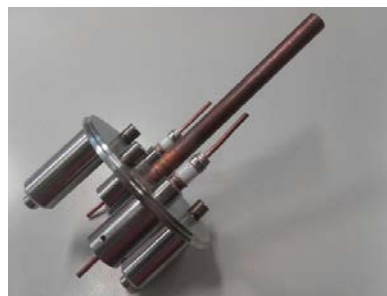
Figure 6: “Head” after welding.

The various tests were performed at IHEP before, during and after the production to verify the quality of chambers. All welds including heads are He leak tested (figure 6).

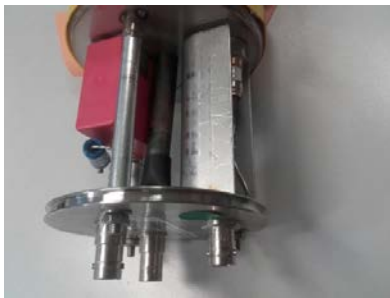
Figure 8: HV low pass filter.

To stabilize the high voltage a low pass filter, R=1 MOhm and C=0.047 μ F is mounted on the HV input (figure 8).

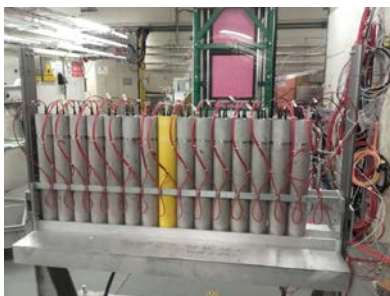
Figure 9: Test set-up at GIF++.

After transport of the monitors to CERN by lorry, reception and calibration tests were performed at CERN's gamma irradiation facility GIF++ (figure 9).

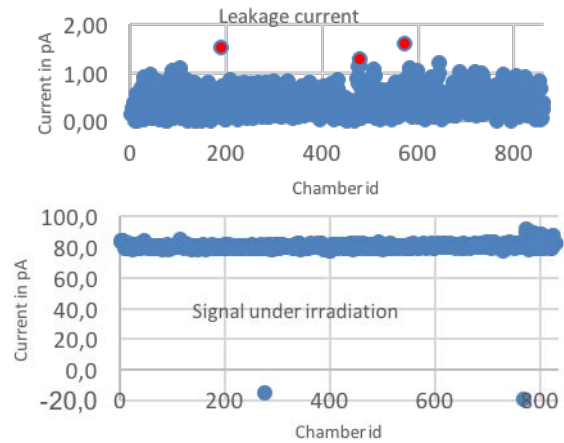
Figure 10: 830 icBLM tests results.

For each ic17 detector the tests consisted of leakage current and radioactive source induced signal measurements (figure 10). 14 tested monitors were placed in a special support at 2.8 m transverse to the flux of the radioactive source, the geometry leading to a difference in flux of +/- 5% between the 14 monitors. One ic08 moni-

tor is in the centre of the set-up as a reference during the measurements.

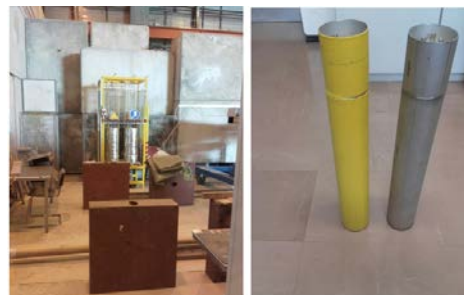
Figure 12: Insulation of icBLM.

After acceptance test at GIF++ each accepted detector was insulated and shipped to ESS and GSI (figure 12).

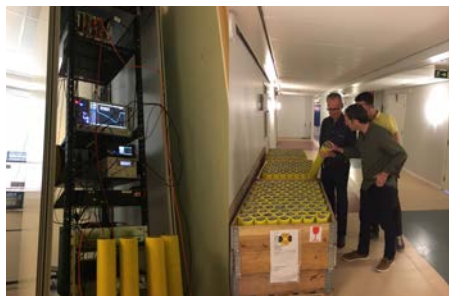
285 detectors were received at ESS in July 2017 and are now under reception and calibration tests (figure 13).

Figure 13: icBLM at ESS.
