STUDIES FOR MITIGATING FLASHOVER OF CERN-LHC DILUTION KICKER MAGNETS

A. Loebner, M. J. Barnes, W. Bartmann, C. Bracco, L. Ducimetière, V. Namora, V. Senaj
 CERN, Geneva, Switzerland

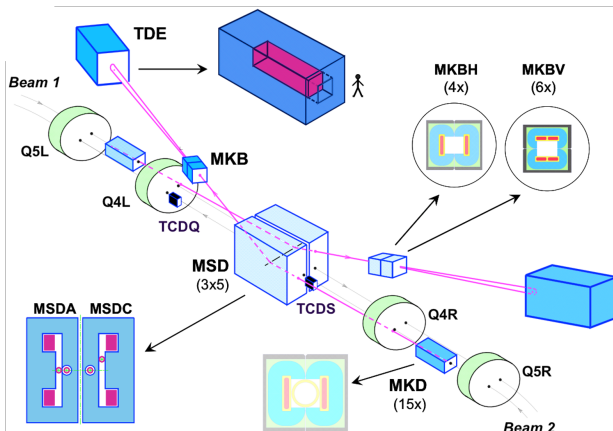
Figure 1: Schematic overview of the LHC extraction area.

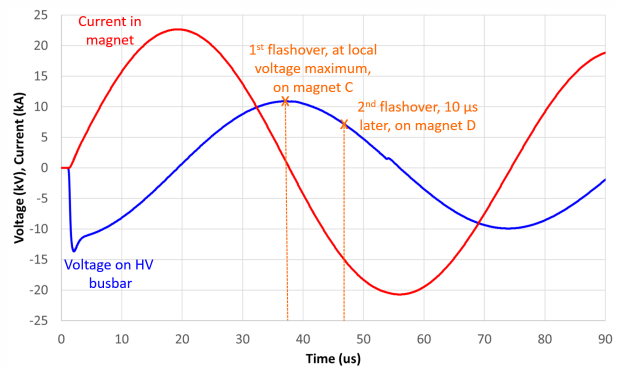
Figure 2: Simulated voltage on the MKBV busbars and current in the magnet coils for a nominal turn-on of the kicker. Times of the flashovers on July 14, 2018 are indicated [2].

The voltage at the busbars and the current in the magnet coil are not measured directly. Therefore, simulations with PSpice [4] were performed for a thorough understanding of the internal circuit behaviour [2]. Figure 2 shows the simulated voltage at the MKBV busbars as well as the current in the magnet coils during a nominal firing of the kicker. The flashover on magnet C occurred at $\sim 37 \mu\text{s}$, when the high voltage reached its local maximum of ~ 11 kV. A time of $10 \mu\text{s}$ later a flashover occurred on magnet D, which is in the common MKBV vacuum tank: the plasma from the first flashover probably propagated to the adjacent magnet in the tank, causing the second flashover.

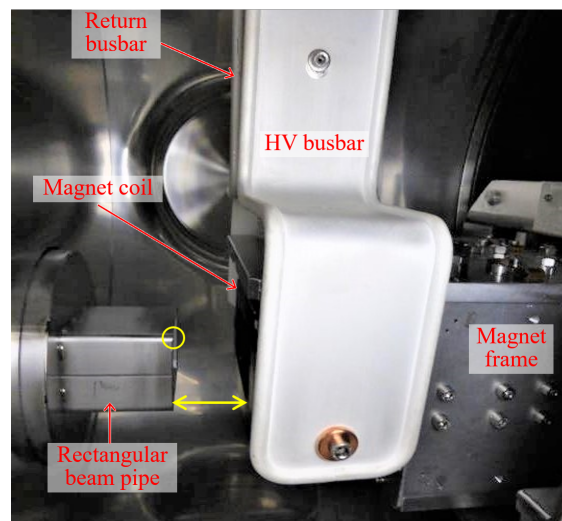
Figure 3: Photo of inside of one end of an MKBV tank.

The distance between the internal RBP and the magnet coil was designed to be ~ 35 mm, and is illustrated by the double-ended arrow on Fig. 3. As mentioned above, the purpose of this RBP was to limit plasma propagation between tanks in case of a flashover in one tank - thus reducing the probability of a breakdown in the adjacent tanks. The idea studied here was to extend the RBP towards the magnet coil, thus decreasing their separation, and further reducing the probability of plasma propagation between tanks. In addition, since electron cloud occurs inside the RBP, reducing the separation between it and the magnet coil, which itself is generally close to ground potential, helps to prevent electrons from being accelerated towards the HV busbar.

predictions could be compared. The regions studied include an HV feedthrough, magnet frame (Fig. 3), an unused ground connector and the rectangular beam pipe (RBP) installed at the entrance and exit of each tank (Fig. 3).

The magnet frame surrounds the sides of the magnet coil: the magnet frame is the nearest part, which is at ground potential, to the magnet coil (Fig. 3). The corners and edges of the frame are chamfered and blended to increase the curvature to avoid excessively high electric fields.

Since the flashover had occurred during beam extraction, suspicion focused on the area between the stainless steel RBP, at each end of the MKBV vacuum tank, and the HV busbar (Fig. 3). In the presence of the beam, which was the case for the flashover incident in 2018, there was probably electron cloud inside the RBP at each end of the tank. Electron cloud is generated in the vacuum chamber by photo-emission or beam-induced multipacting and subsequent electron accumulation during a bunch or bunch-train passage [8]. In addition, this effect leads to dynamic pressure rise [1].

The highest field on the RBP is on the corner nearest to the HV busbar, indicated by a circle on Fig. 3. The predicted electric fields on the corner were compared for different separations between the RBP and the magnet coil. The electric field is calculated along a straight line: the line touches the DAG coated end face of the magnet coil and the corner of the rectangular beam pipe where the highest field was found: the line then continues along the outside of the

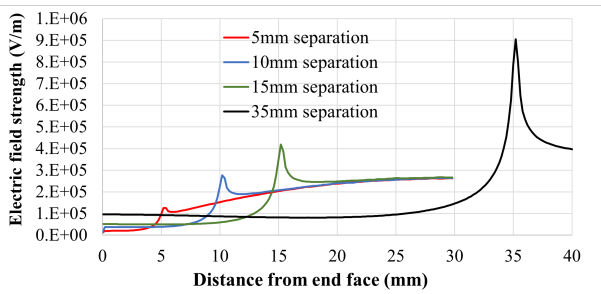
RBP. The electric field predictions for different separations between the RBP and the magnet coil are shown in Fig. 4, for 0 V on the DAG.

Figure 4: Electric fields along a straight line from the surface of the magnet coil (0 mm), to the corner of the RBP and then along the outside upper edge of the beam pipe: peak fields occur at the corner indicated with a circle in Fig. 3.

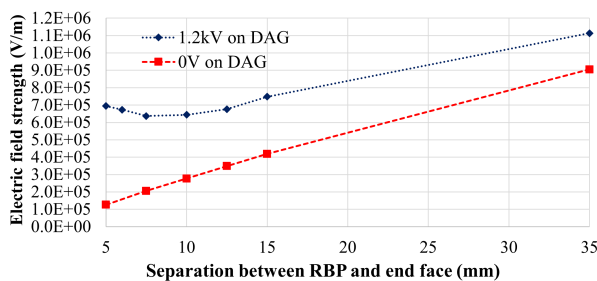
The simulations were rerun with 1.2 kV modelled on the DAG coating of the end face of the magnet coil. The peak value, on the upper corner of the RBP, are summarized in Fig. 5 for both 0 V and 1.2 kV on the DAG. With 0 V simulated on the DAG, the peak field on the corner of the RBP reduces monotonically when decreasing the separation to the end face of the coil: this also decreases the opportunity for a pressure wave to propagate between tanks due to a flashover outside the magnet. With a voltage of 1.2 kV modelled on the end-face of the DAG, the peak field is minimized for a separation of ~ 7.5 mm. It is considered unlikely that the resultant peak field of ~ 640 kV/m would result in a flashover: even assuming the presence of electron cloud in the RBP, the initial voltage transient on the DAG is negative (Fig. 6) and would thus repel, rather than attract, electrons.

Figure 5: Peak value of field on the corner of the RBP, versus separation between the coil and RBP, for 0 V and 1.2 kV on the DAG.

As mentioned above, a concern is that the beam creates electron cloud inside the RBP, and can thus cause flashovers between the beam pipes and HV busbars. The separation of the RBP and magnet coil will be reduced to ~ 7 mm, to significantly reduce the electric field on the corner of the RBP: in addition, to try and eliminate the formation of electron cloud, it is proposed to coat the interior of the RBP with amorphous carbon (a-C). a-C has a maximum SEY close to 1.0, while the maximum SEY of stainless steel is 2.25 [9].

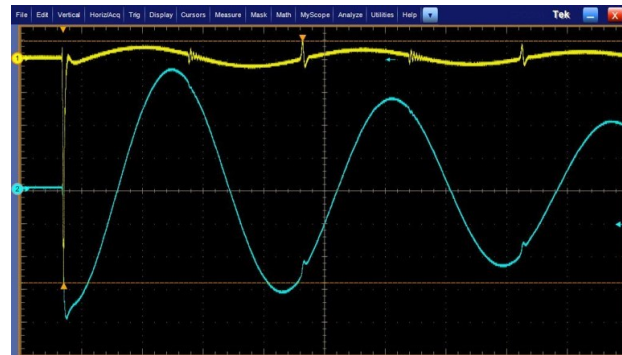
The voltage of the DAG on the end face of the coil, facing the RBP, was measured using a spring loaded probe, with a rounded contact to avoid scratching the surface coating, while the MKBV magnet was pulsed. A measurement with 1 kV on the generator is shown in Fig. 6. The transient voltage measured on the DAG (yellow waveform), with HV (blue waveform) applied to the busbar, has a width at half of the peak negative voltage of ~ 500 ns: as a result of parasitic capacitance between the coil and DAG, the peak and width are expected to be dependent upon the switching speed of the semiconductor switches. After the transient, the peak-peak voltage measured on the DAG is only $\sim 0.6\%$ of the generator voltage.

Figure 6: Measured voltages with generator at 1 kV: HV busbar (blue) 200 V/div, and DAG (yellow) 10 V/div. 20 μ s/div.
