**CERN/PS 2002-028 (RF)
CLIC Note 516**

**HIGH-GRADIENT BREAKDOWN IN NORMAL-CONDUCTING
RF CAVITIES**

W. Wuensch

8th European Particle Accelerator Conference, 3-7 June 2002, Paris, France

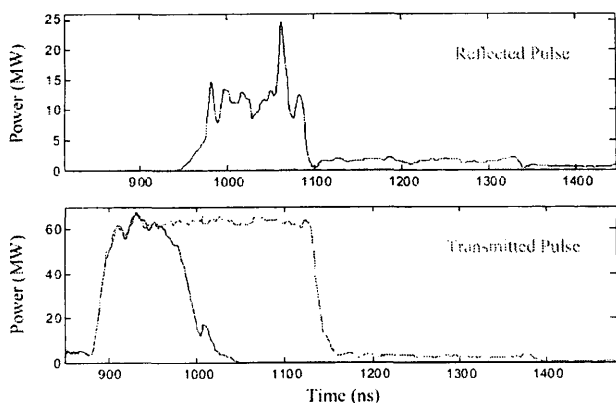
Figure 1: RF power pulse shapes during a breakdown at 11.4 GHz.

The high-power RF systems used for high-gradient testing are equipped with directional couplers before and after the structures so that the incident, transmitted and reflected power pulses can be measured. Examples of

such measurements taken during breakdown at 11 and 30 GHz are shown in Figures 1 and 2 respectively [7,8]. One common, and consequently important, feature that can be derived from these signals is that there is energy missing from the balance of incident, transmitted and reflected powers. Measured missing energies can be over 50% at both 11 and 30 GHz, corresponding to well over a Joule at 11 GHz and about a half a Joule at 30 GHz. Reflected power usually remains below a quarter of the input power. The time for the transmitted power to fall is of the order of 50 ns at 11 GHz and 10 ns at 30 GHz [9].

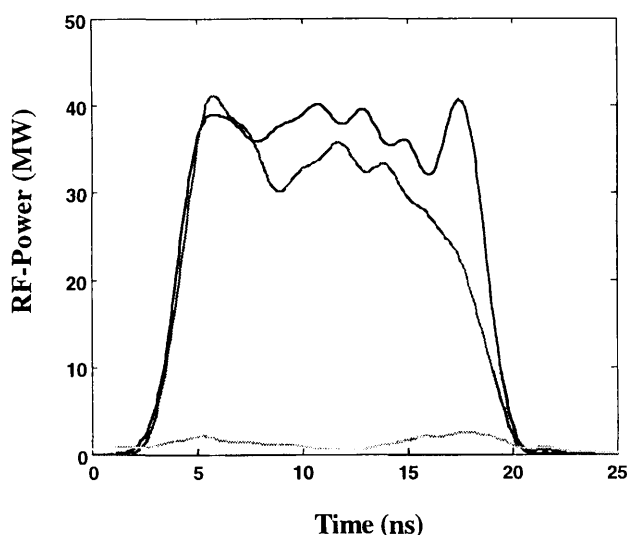
Figure 2: RF power pulse shapes during a breakdown at 30 GHz. The incident power is shown in blue (highest trace), transmitted power in red (middle trace) and reflected power in green (lowest trace).

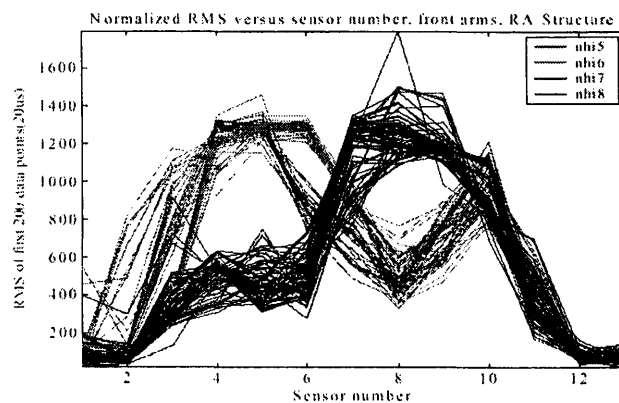
Figure 3: Output from an azimuthal array of acoustic sensors. The traces are produced over many breakdowns.

Acoustic waves are produced by the large powers deposited during breakdowns. Measurement with an array of piezoelectric sensors of the timing of acoustic waves allows the position of a breakdown to be localized within the structure. Figure 3 shows the output from an azimuthal array of acoustic sensors placed around an 11 GHz accelerating structure [10]. This data shows a sequence of breakdowns on either side of a symmetric input power coupler.

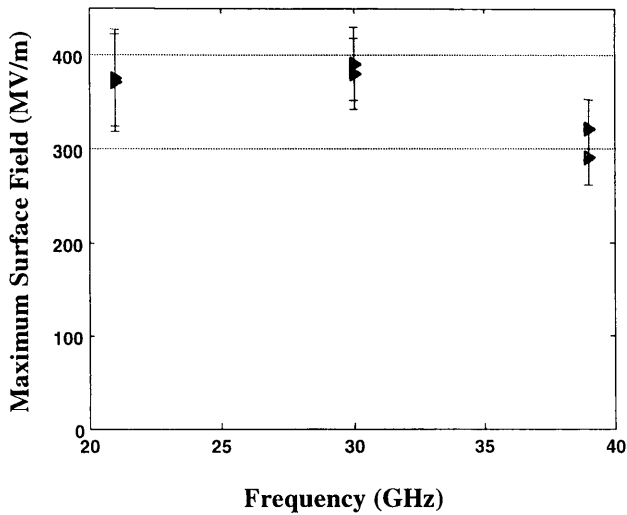
Figure 4: Final maximum surface electric field as a function of frequency achieved in six scaled single cell cavities.

Because of the importance of RF frequency on linear collider design, a dedicated experiment has been made to measure directly the frequency dependence of maximum achievable gradient. The experiment was made by testing six exactly-scaled single-cell standing-wave cavities resonant at 21, 30 and 39 GHz (two at each frequency). Each cavity was conditioned for 5×10^5 pulses. The astonishing result, shown in Figure 4, is that there is no discernible frequency dependence. In addition, one of the cavities was cooled to liquid nitrogen temperature and heated to 300 °C. The breakdown level was measured at:

Nearly all of the CLIC structures have conditioned to a maximum surface electric field in the range of 300 to 400 MV/m. These include two 11.4 GHz structures tested with 150 ns pulses [12,13], numerous 30 GHz structures [9] tested with 16 ns pulses and the standing wave cavities mentioned above. The only exceptions have 30 GHz travelling wave structures tested with 3-5 ns pulses, which attained a surface field of over 600 MV/m.

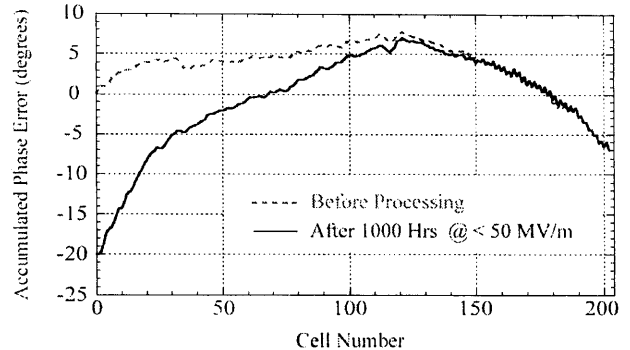
Figure 5: Phase error as a function of position introduced by conditioning an 11 GHz structure.

Damage to 11 GHz structures, which have been conditioned into the 50 to 70 MV/m range, has manifested itself by a change in the phase advance per cell. In early tests, accumulated phase advance errors of many tens of degrees over a structure length were observed. Phase shift error as a function of position inside the structure is shown in Figure 5. The phase error has been determined to be caused by the removal of up to 20 μm of material from the tip of the coupling irises.

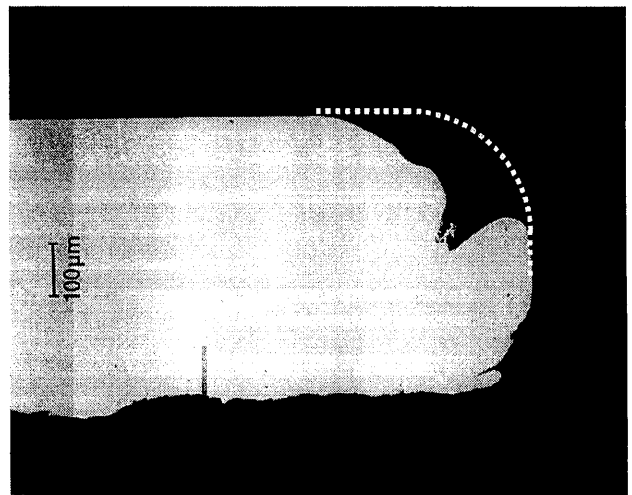
Figure 6: Cross section of coupling iris damaged by RF breakdown. The dotted line shows the original shape of the iris. The bottom of the iris was roughened when it was cut from the accelerating structure.

Damage to 30 GHz structures, here also operated in the range of 70 MV/m, has manifested itself through removal of cubic tenths of a millimetre of copper from the iris that separates the input coupler from the first cell. A picture of the cross section of a damaged iris is shown in Figure 6. The input coupler had only a single feed and consequently a highly asymmetric field profile. This produced a surface electric field with an over-voltage factor of 1.4 compared to the maximum surface field in the downstream iris. The damage occurred in the highest surface electric field

Evidence of damage caused by the impact of currents can be found in the notch in the coupler iris shown in Figure 6. Damage here appears to have been due to impact, rather than erosion of high-surface-field regions, because the damage has clearly propagated into a region of ever lower surface field. SEM photographs of the bottom of the notch show clear signs of melted copper and the surfaces opposite the damage are sprayed with copper droplets.

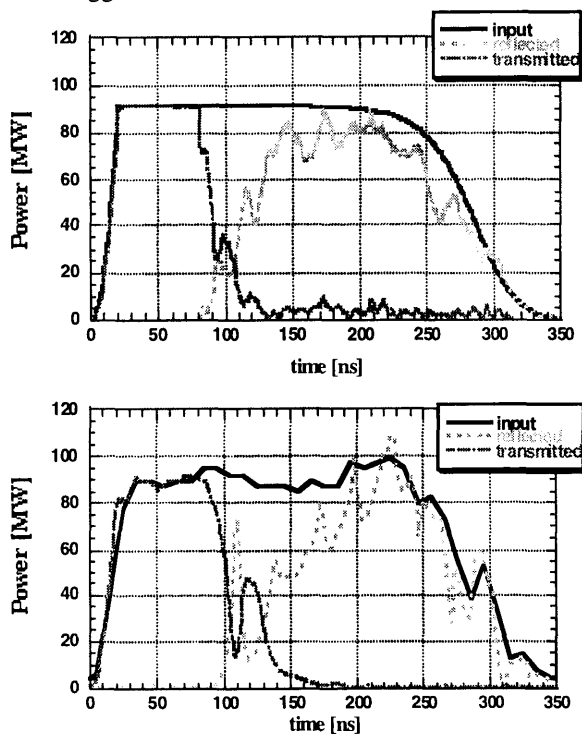
Figure 7: Measured RF signals from an 11 GHz waveguide breakdown is shown in the upper plot. Computed 11 GHz waveguide breakdown is shown in the lower plot.

Due to the complexity of RF breakdown and the difficulty of experimentally determining the validity of many of these arguments, it becomes quite desirable to be able to simulate breakdown. Although many arbitrary input parameters are still required, efforts to simulate breakdowns have started. An example of a measurement of breakdown in a waveguide at 11 GHz and a simulation are shown in Figure 7 [14].

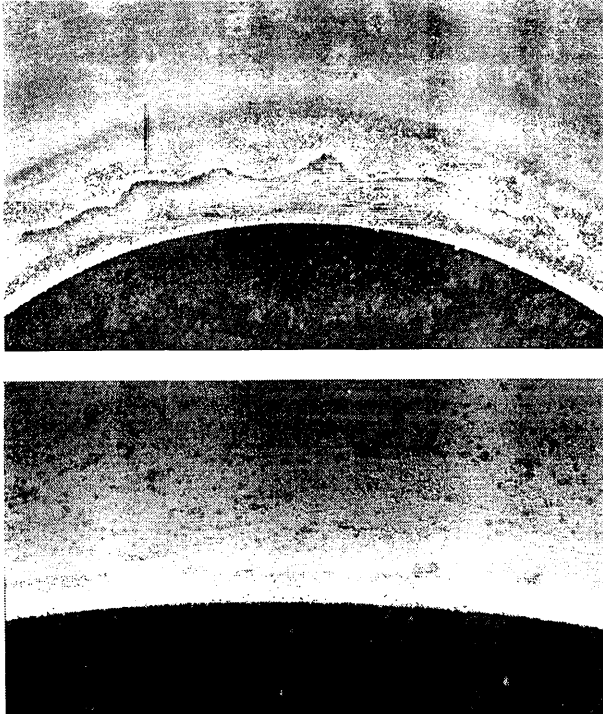
Figure 8: Direct comparison between the arc resistance of copper (upper) and tungsten (lower). The tungsten iris is shown with a higher magnification.

Based on the evidence that damage is caused by melting during the breakdown arc, the use of high melting point materials has been proposed as a way of avoiding damage. Tungsten is clearly a prime candidate since it has the highest melting point of any metal and a reasonable DC conductivity (only about a factor of three worse than copper). A test has been made to make a direct comparison at 30 GHz of the arc resistance of tungsten and copper by replacing the damaged iris shown in Figure 6 with irises made of tungsten and copper. Each iris in turn was clamped onto the end of a copper accelerating structure, conditioned to its maximum gradient and then run for 5×10^5 RF pulses. As shown in Figure 8, the clear result is that while the copper iris was severely damaged, the tungsten iris was not. The tungsten iris was also sprayed with copper removed from the downstream iris, which had a lower surface field than the tungsten iris (the coupler iris has a 40% over-voltage factor as mentioned in section 3). The structure with tungsten iris also went to a higher accelerating gradient, although the structure was finally limited in gradient by the (copper) output coupler. These results indicate that the surface-electric-field limit may also be a function of material, and that tungsten can support a higher field than copper.
