IMPROVING THE RELIABILITY OF THE 114 MHZ CAVITY (ESPECIALLY SHORTING SWITCH AND RF-WINDOW)

R. Hohbach

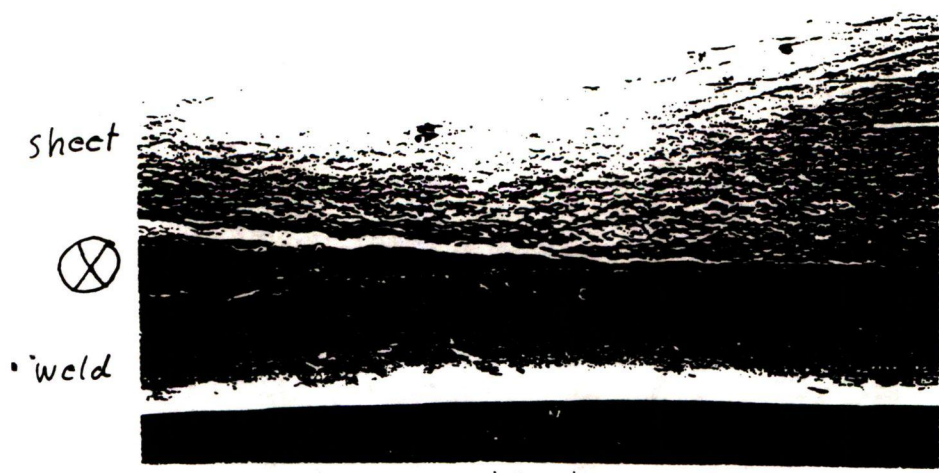
side view

cross-section of fold
(close to crack)

Fig 4 Bellows' end of life
(magnification 100x)

In the first version, with the vacuum outside, the bellows cracked in the middle of its length.
In the present version with vacuum inside (Fig. 3), it cracked close to its ends, at the inner welding (Fig. 4).

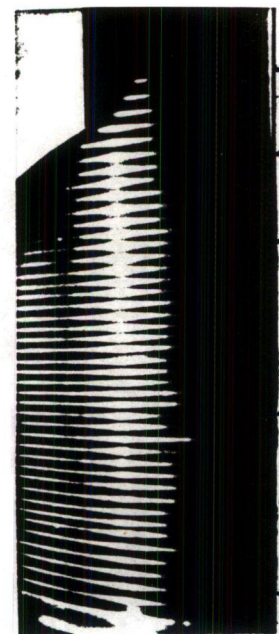
FIG. 5 Bellows deformed by side forces (approx. 1 : 1 scale)
Thin bellows (0.1 mm) in test set up, bending 12 deg.

compressed side
no vacuum

straight
no vacuum

extended side
no vacuum

all folds equally spaced

compressed side
vac. inside

straight
vac. inside

extended side
vac. inside

more extended | compressed | more extended

Observation on our new bellows-test-set-ups showed that the bellows moved angularly were deformed by side forces from the atmospheric pressure (differential pressure to vacuum) [3] (Fig. 5).

This opens the first and last folded sections much more leading to cracking, while in the middle they are more compressed (and less stressed).

So, the bellows crack because the stresses are not uniform along its length under vacuum.
