Derwentcote Forge, Derwentcote, County Durham

Archaeological Evaluation and Assessment of Results

Report reference: 74157.02

April 2012

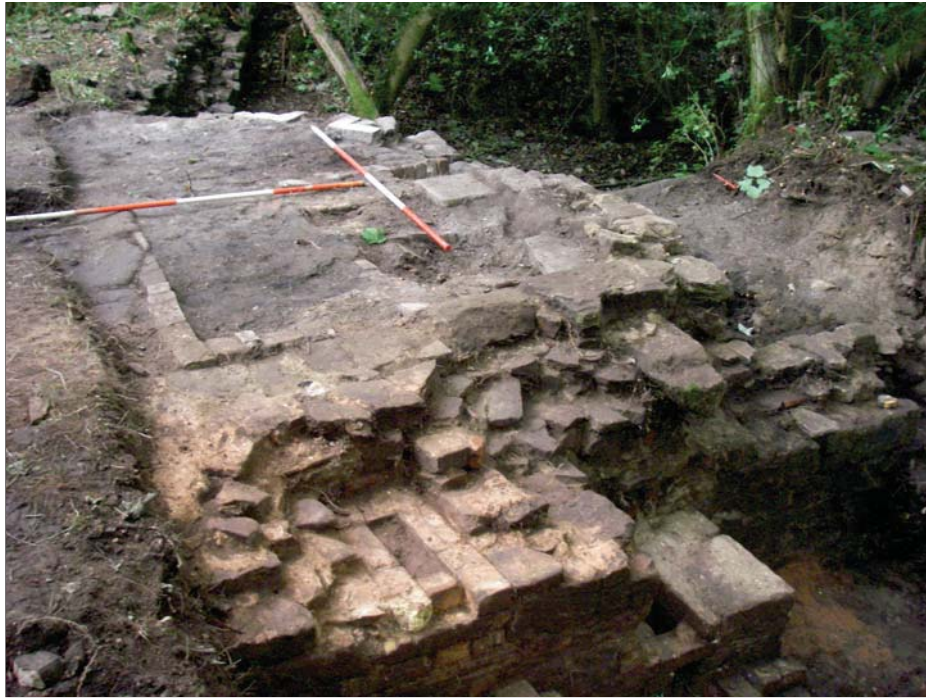
Plate 1: Trench 1 Area A, showing small forge north of crucible furnace (view from the south-west; scales = 2m)

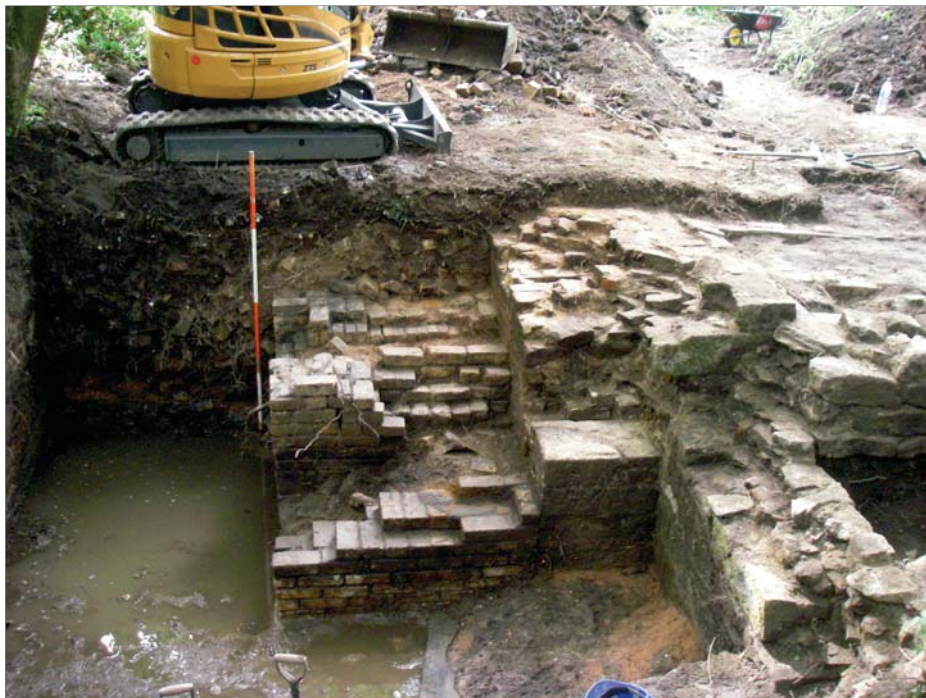
Plate 2: Trench 1, showing crucible furnace and demolition area over top (view from the east; scale = 2m)

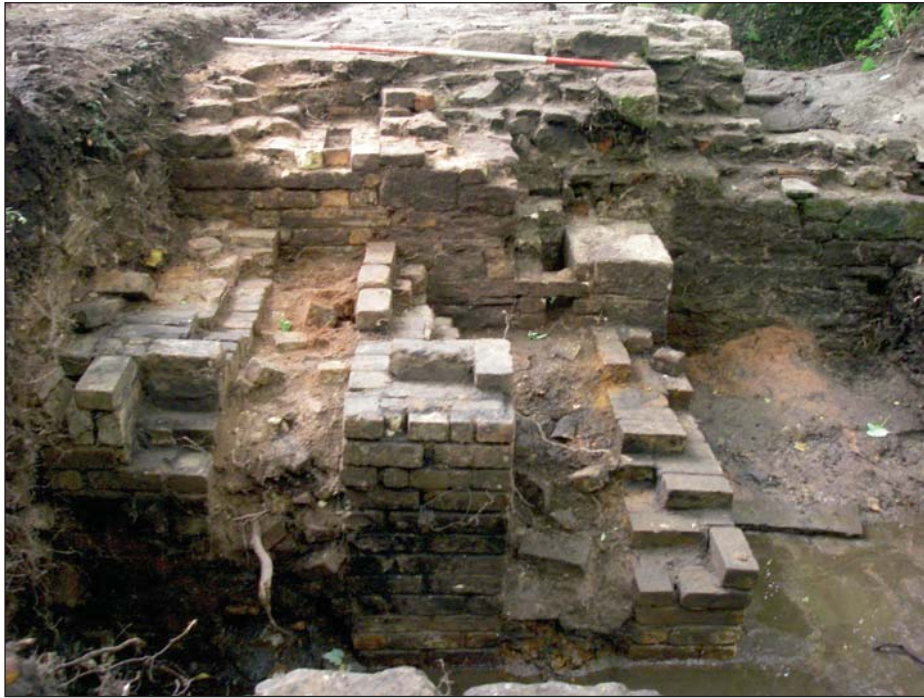
Plate 3: Trench 1 Area B, showing crucible furnace bays within cellar (view from the south; scale = 2m)

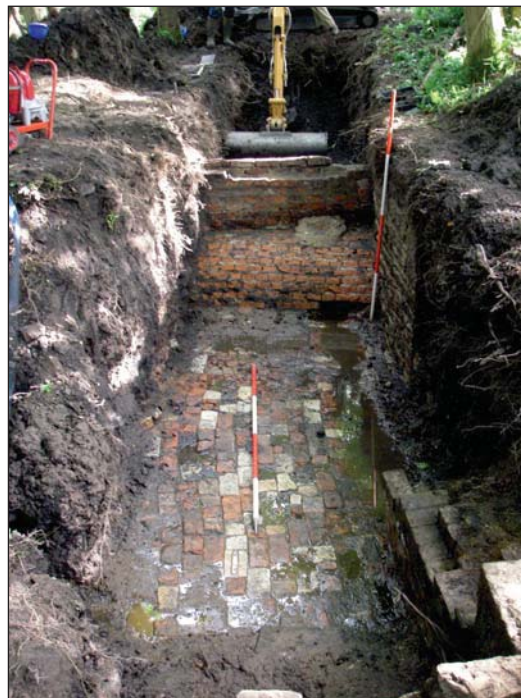
Plate 4: Trench 1 Area B, showing covered tailrace at south end of crucible furnace (view from the south; scales = 2m)

- 5.3.12 To the south, floor **1043** was built up against a 0.8m-wide double-skinned redbrick culvert (**1037**) which covered a leat / tailrace (**Figure 5: Plate 4**). A narrow redbrick wall (**1041**) defined the southern extent of the cellar, and abutted sandstone walls **1039** and **1038** (identical in construction to **1006** and **1009**), which formed an L-shape to the north, forming part of the cellar walls. The addition of the covering to the culvert and red brick walling suggests that the structure originally had a different function, and was possibly a foundation. The foundations were converted into a cellar and the crucible furnace added.

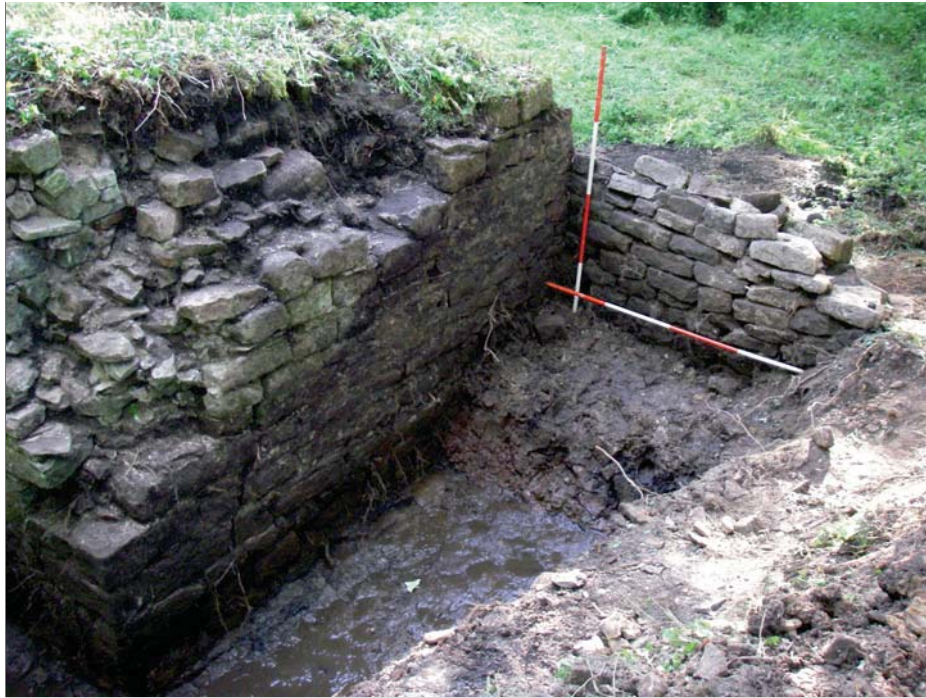
Plate 5: Trench 2, showing north-face of structure 2008, abutted by wall 2007 (right) (view from the north-east; scales = 2m)

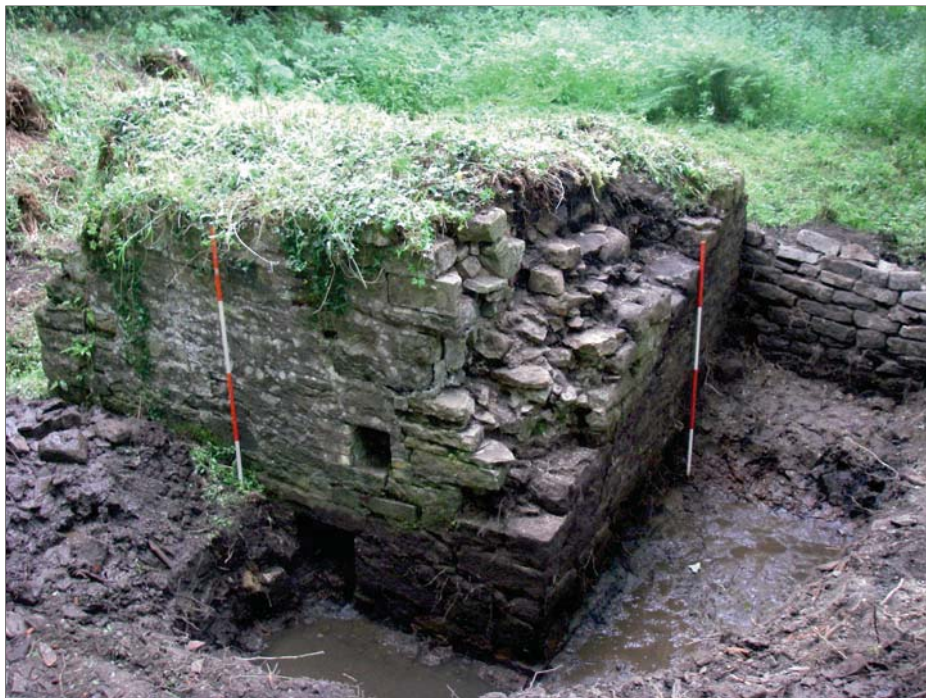
Plate 6: Trench 2, showing east-face of structure (view from the north-east; scales = 2m)

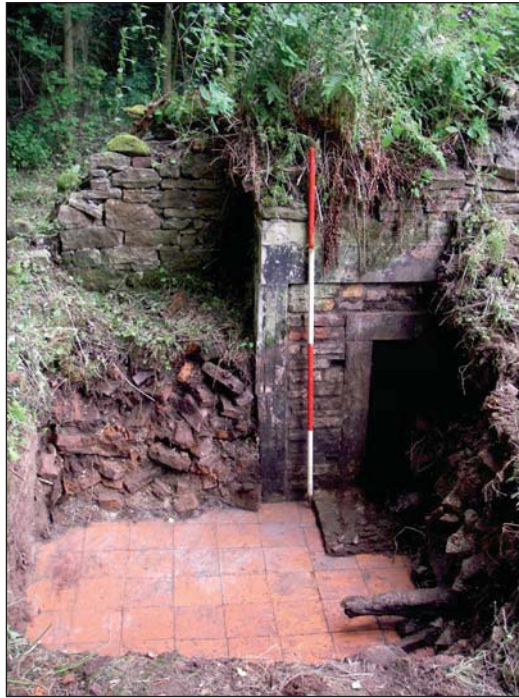
Plate 7: Trench 3, showing fireplace, floor and demolition deposits within workers' cottages (view from the east; scale = 2m)

- 5.3.23 Trench 3 was located within the workers' cottages (see below) and specifically targeted a chimney breast, believed to be the most stable area of the derelict cottages. The removal of humic and rubble-filled topsoil (**3001**) revealed a demolition layer (**3002**) that lay above rotting roof timbers (**3003**). The roof timbers were still nailed together and were made from softwood, possibly pine (Jacqui Huntley *pers. comm.*). The condition of the wood was poor and the decision not to take a sample for assessment was made by English Heritage's Regional Science Advisor (Jacqui Huntley) during a site visit.

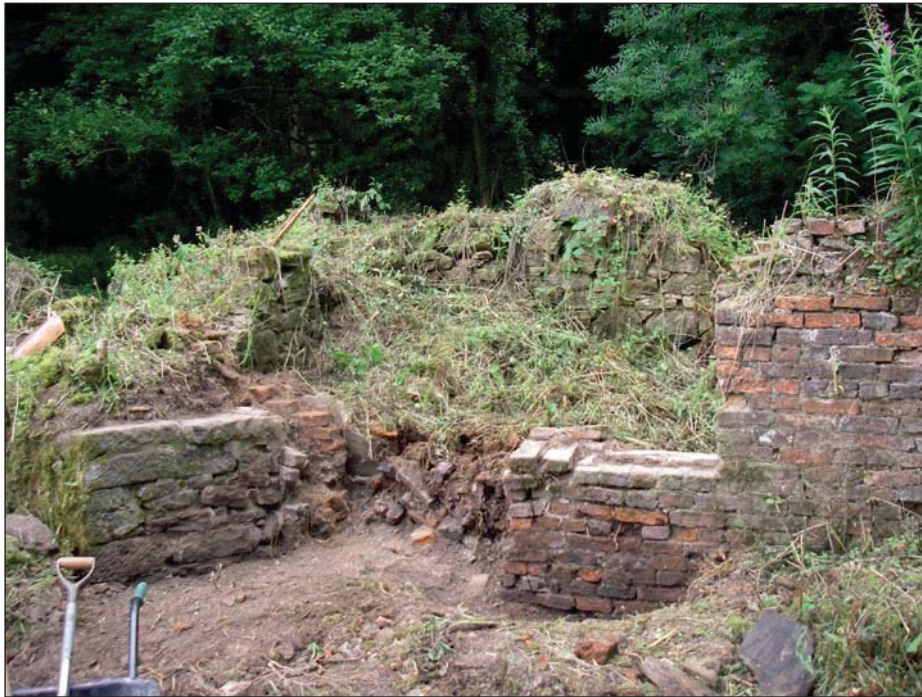
Plate 8: Trench 5, showing precarious nature of walls (view from the north-west; no scale)

- 5.3.26 Trench 5 was located along the northern edge of the workers' cottages (see below) and was excavated to assess the condition of the cottages as well as aiding their phasing. Excavation ceased once the precarious state of the walling was confirmed. The only layer to be removed was rubble (**5000**) deriving from the demolition / collapse of the cottages.

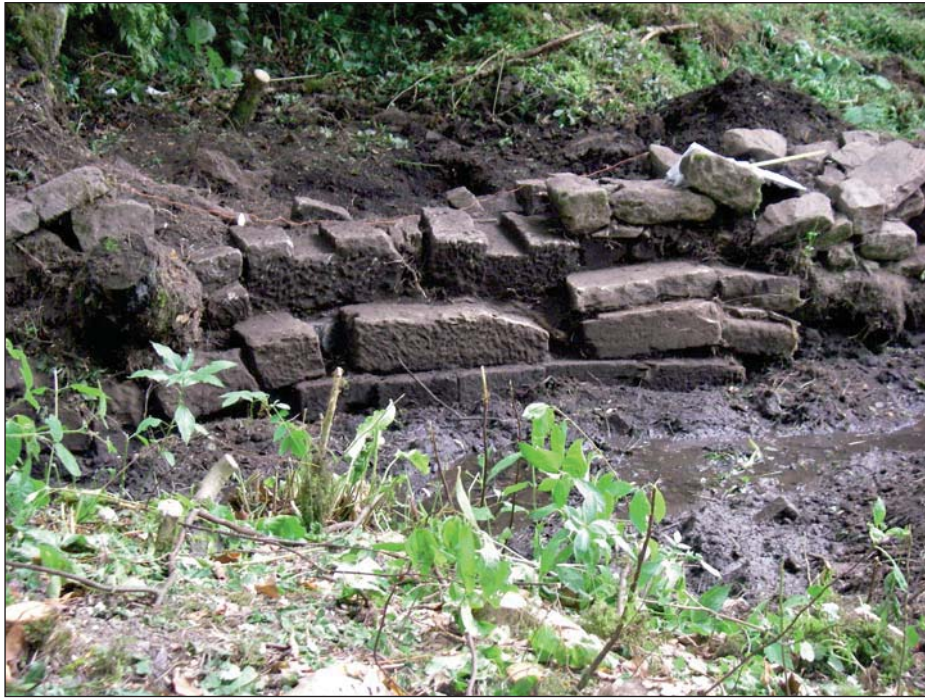
Plate 9: Trench 6, showing wheel-pit wall **6009** with waterwheel fixing points **6003** (view from the north-east; no scale)

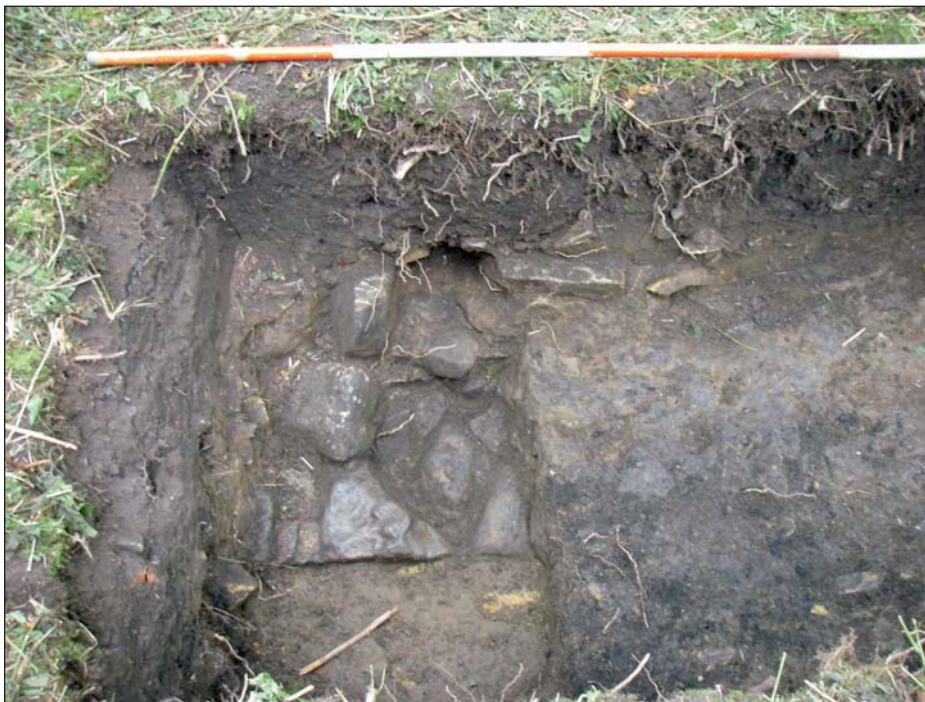
Plate 10: Trench 7, showing wall **7012** (view from the south-west; scale = 2m)
