# Fabrication, Tuning, Treatment and Testing of Two 3.5 Cell Photo-Injektor Cavities for the ELBE Linac

# FABRICATION, TUNING, TREATMENT AND TESTING OF TWO 3.5 CELL PHOTO-INJECTOR CAVITIES FOR THE ELBE LINAC

A. Arnold<sup>#</sup>, P. Murcek, J. Teichert, R. Xiang, HZDR, Dresden, Germany  
P. Kneisel, L. Turlington, M. Stirbet, G. Ereemeev, Jefferson Lab, Newport News, VA 23606

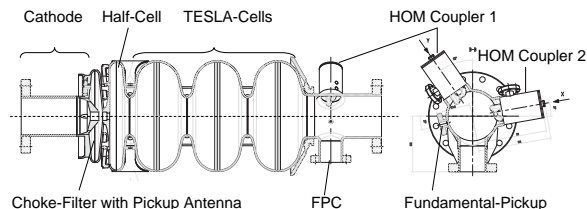
Figure 1: Cross-section of the modified 3.5 cell SRF-Gun cavity.

The injector cavity is shown in Figure 1. It consists of three cells with the TESLA cell shape and one velocity optimized half cell. The cathode insertion was designed for an easy exchange and precise positioning of Cs<sub>2</sub>Te

cathodes. Additionally, a resonant superconducting choke filter surrounding the cathode is needed to prevent RF leakage out of the cavity. Two TESLA type HOM dampers and one 10 kW CW input coupler, developed at HZDR are attached to complete the design.

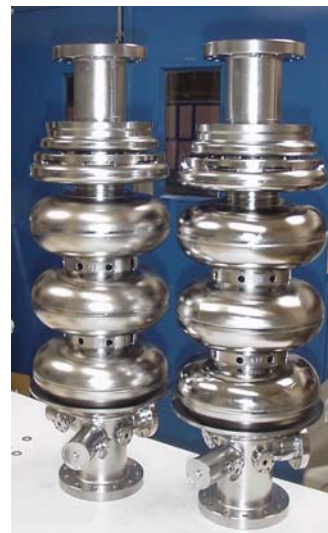
Figure 2: Both fabricated SRF-Gun cavities made from fine (left) and large grain material (right).

At the end of the fabrication process both cavities were off in frequency by 1-2 MHz and the field profile was strongly detuned. Main deviations occurred in the half-cell, which could be pre-tuned in the assembly only after softening the material by a 600 °C and 10 hrs heat treatment. Both finalized cavities are shown in Figure 2.

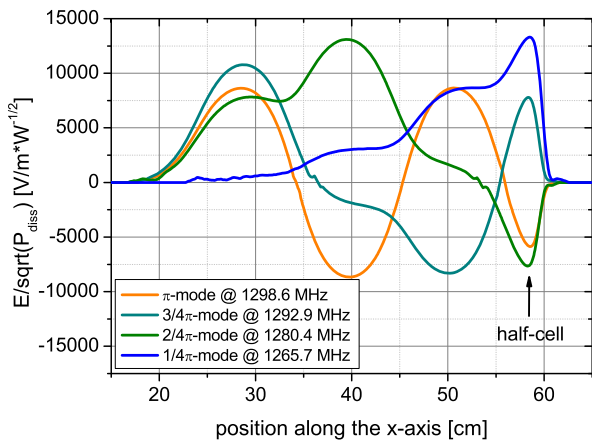
Figure 3: Measured field profiles and frequencies of all 4 passband modes, shown for the LG cavity after tuning.

- Measuring field profiles and frequencies of all four modes of the “as fabricated” cavities,
- Applying an algorithm to determine the amount of tuning for each cell to achieve the desired field and target frequency of the  $\pi$ -mode,
- Iterative tuning of each cell until the desired field profile and frequency is reached (see Figure 3),
- Tuning of the choke filter and both HOM filters to minimize the power transmission of the  $\pi$ -mode ( $Q_{ext} > 10^{12}$ ),
- Calibration of external Q-values of input coupler and both transmission probes,
- Identification of TE-modes for TE-mode focussing [2] using inductive coupling loop and bead-pulling.

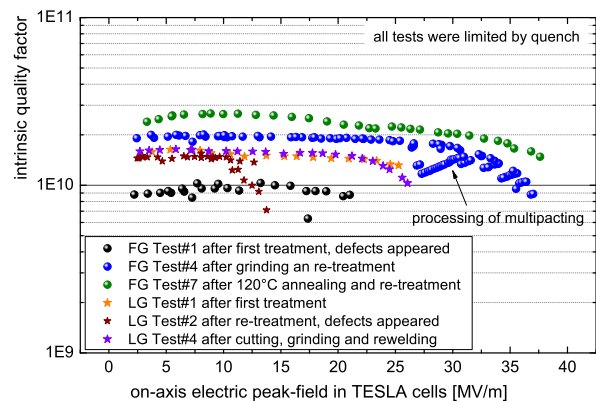
Figure 4: Summary of significant cold tests @ 2 K of both cavities.

(1:1:2 solution of HF:HNO<sub>3</sub>:H<sub>3</sub>PO<sub>4</sub>) in JLab’s production facility, followed by hot water rinsing, high pressure ultrapure water rinsing, drying in a class 10 clean room, assembly of auxiliary parts, attachment to the vertical test stand and evacuation. The cavity reached a vacuum of  $\sim 4 \times 10^{-8}$  mbar after 12 hrs and was subsequently cooled down to 2 K. In this test an electric peak field of  $E_{pk} \sim 25$  MV/m with a Q-value of  $1.3 \times 10^{10}$ , limited by a quench, was measured (Figure 4, LG Test#1). Since the frequency at 2 K was still too high, indicating that the material removal was less than anticipated, a second surface preparation and cold test was carried out. Much to our disappointment, the cavity degraded drastically (LG Test#2).

After 50  $\mu\text{m}$  of material removal by bcp and the same rinsing, drying and assembly procedures as before the cavity was retested with the results shown in Figure 4 (LG Test#4). The cavity performance could be restored but the field was limited by quench. The quench location was roughly detected by measuring the passband modes and in a following test using second sound detectors [6]. Both revealed a defect in the half self cell that could be clearly identified via optical inspection at the equator weld (Figure 6).

The polycrystalline cavity was subjected to the same surface treatment and assembly procedures as the large grain cavity. The performance in the first test was quite disappointing as shown in Figure 4 (FG Test#1). After the test the cavity inspection revealed not only a defect pattern similar to that shown in Figure 5, but also an

As shown in Figure 4 (FG Test#6) this approach was very successful. The cavity achieved much better performance which could be further improved up to  $E_{pk} \sim 38 \text{ MV/m}$  @  $Q_0 \sim 1.5 \times 10^{10}$  after applying 120°C annealing (FG Test#7). Nevertheless in both tests the cavity was limited by a quench that was localized by field measurement to be in the TESLA cell next to the coupling section.

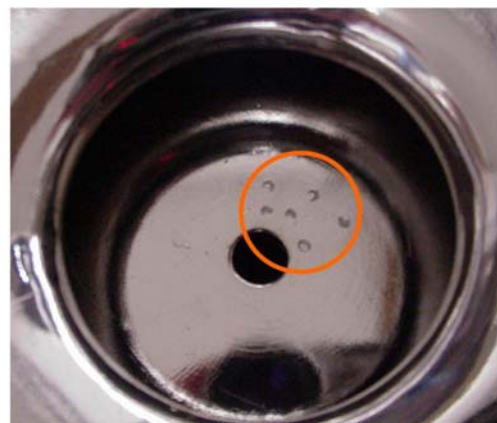
After disassembly of the cavity, a “strange” defect pattern on the endplate of the cathode cell as shown in Figure 5 was discovered; a similar pattern was also seen in the subsequent test with the FG cavity.

Figure 5: Photography of the defect pattern on endplate of the LG half-cell after re-treatment when defects appeared.

We could rule out mechanical damage from the high pressure rinse wand because the damage was outside the wand movement. Since in both cases these parts of the cavities were made from ingot niobium, we suspected defects/voids in the niobium from the melting process. Therefore another slice from the same ingot was subjected to the same depth of material removal as the

cavity in order to find material defects. Nothing showed up. Since the defects appeared in both cavities nearly at the same position and with a similar defect pattern, another idea is that the defects were produced during turning of both large grain endplates.

The idea of re-melting the defective areas with the electron beam welder had to be abandoned after some testing on samples, because the distance of the gun to the area of repair seemed to be too far and the alignment of the gun/beam was too uncertain. Additionally, it was not clear, if some foreign material was involved in the defect, which would be melted into the niobium. We therefore opted for cutting the cavity apart by wire EDM [electro discharge machining] at the equator of the first TESLA-cell next to the half-cell and mechanically removed the defects as good as possible by grinding. It turned out that the defects, which appeared to be very deep when observed through the full cavity were quite shallow.

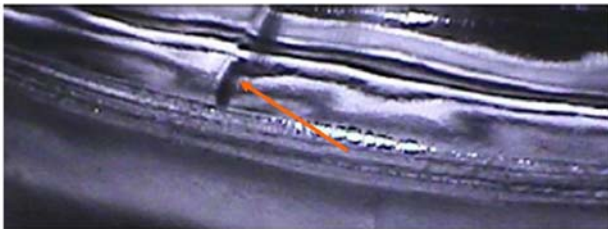
Figure 6: Suspected quench area in cathode cell of the LG cavity.

Unfortunately, this cell is very shallow and not accessible with our existing mechanical grinding tools. We will attempt to improve the cavity performance by additional chemical treatment (possibly locally first) and heat treatment.
