Aging Phenomena in the LHCb Outer Tracker

Tanja Haas, Physikalisches Institut Heidelberg on behalf of the LHCb Outer Tracker Group

11th Vienna Conference of Instrumentation Vienna, 19.-24.02.07

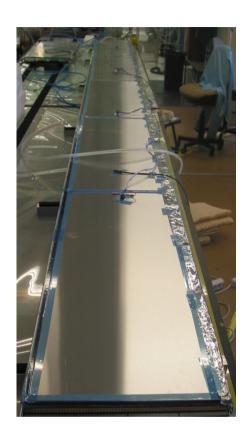
cover the module with thin aluminum plates

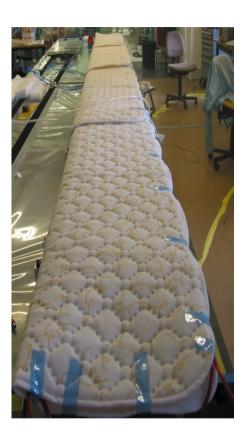
wrap the module in electric blankets

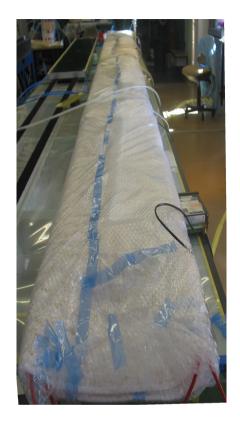
add insulation
