# Preparing the SPS Complex Alignment for Future LHC Runs

*P. Bestmann, P. Dewitte*, CERN, Geneva, Switzerland

Presented at: International Workshop on Accelerator Alignment, IWAA2014, 13-17 October 2014, IHEP, Beijing, P.R. China

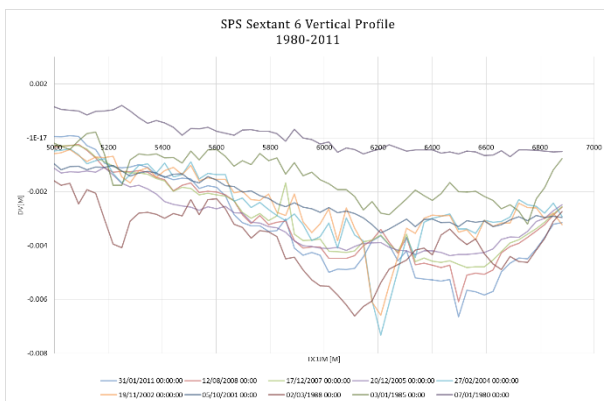
excursion of the vertical profile which was limiting aperture and performance of the machine. This excursion was built up slowly over 20 years and the yearly corrections have put all the magnet jacks to their end of range. The Figure 3 is showing the development in the last 30 years. Several corrections have already been done in the past but the ground keeps on moving. It was decided to fully correct this excursion during the LS1 and to shim the magnets in a way to get the jacks back to their centre position, even a bit lower to anticipate the future ground movements. A full sextant of the SPS was concerned including the extraction of the TI2 transfer line to the LHC. The vertical movements to smooth out the excursion were up to 3.5 mm plus another 10 mm shims to put the jacks back in their range. Movements of this amplitude cannot be done with the usual alignment equipment anymore. In addition all magnet interconnections were kept closed which makes this kind of activity even more delicate and needed the support of vacuum and transport teams.

Figure 3: 30 years of SPS Vertical profile in Sextant 6

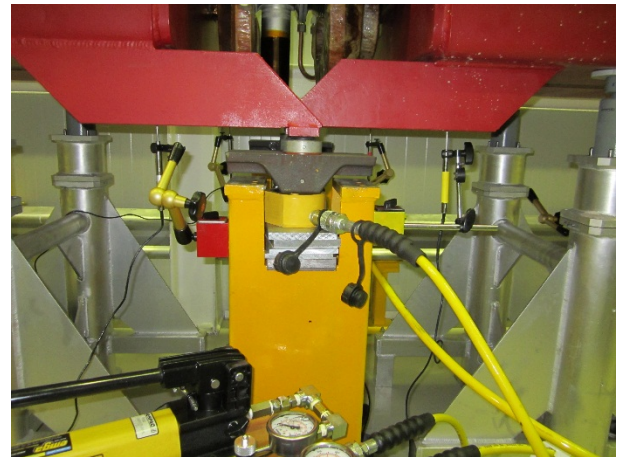
New handling equipment was designed and built to ensure that the interconnections between the magnets were not damaged during this operation. A two actuator hydraulic system with the possibility to balance the volume and pressure between the two actuators was used. During the lifting, the height and rotation of the magnets were controlled with LVDT gauges and digital readouts installed on the movable handling support structures. These support structures were needed to support the magnet during the exchange and shimming of the jacks.

Figure 4: Dipole interconnect handling equipment

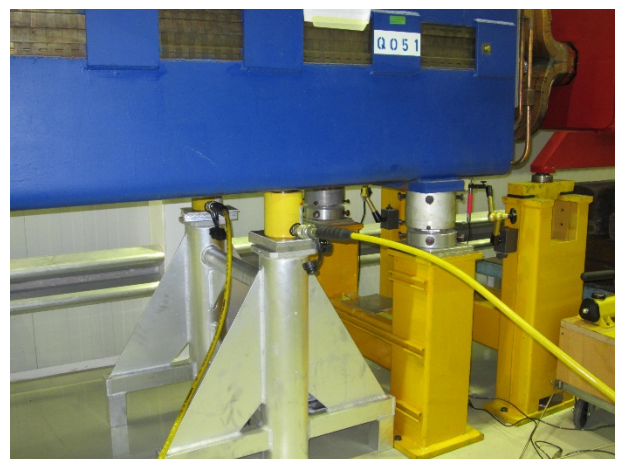
The quadrupoles are supported by three polyurethane jacks. The Polyurethane pieces inside the jacks degrade due to radiation influence. It was decided to exchange all the jacks instead of only re-centring and shimming them.

Figure 5: Quadrupole handling equipment

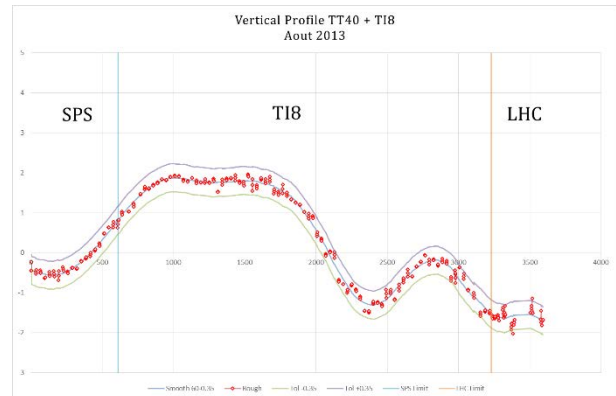
At first the roll angle of the quadrupoles were adjusted and then the levelling measurements using the Leica NA2 optical level were carried out. Due to the important slope of the transfer line, the levelling was done in two steps. During the first step, the reference points in the floor (GGPSOs) were measured in a double run with outward and return measurements from the SPS extraction down to the LHC deep reference in the long straight section 8. The difference of 0.56mm between the two deep references was compensated along the 1.4 km long transfer line. The second step was to measure the quadrupoles w.r.t. the new determined GGPSO reference points. A total of 30 quadrupoles have been realigned in vertical direction before the horizontal measurements could start. This is equal to 38 % as it was expected prior to LS1.

Figure 6: T18 vertical profile

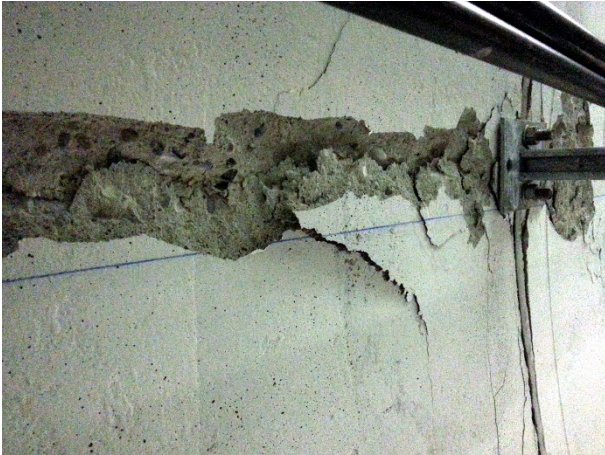
The transfer line TT10 is delivering the beam from the PS complex to the SPS complex. The tunnel has been constructed in 1972 and is, with a length of 850 m, one of the shorter transfer lines. Already in the past it showed some cracks at the level of the floor. This time the tunnel showed some serious cracks which are no longer a cosmetic, but a severe stability issue. In addition to the invert heave, the tunnel lining fails showing compression

cracks in the crown and tension/shear cracks in the shoulders.

Figure 7: TT10 compression crack on the tunnel crown

It was important to know if the tunnel still kept moving or if all the stress has been released with the cracks. Monitoring profiles have been installed in the concerned area and have been measured regularly using the Leica AT401. In addition, a Laser Scan was done right in the beginning to locate the cracks and to have a base for further analysis.

The profiles have been measured in time intervals ranging from 2 weeks at the beginning to 2 month at the end of the LS1. No significant movements have been observed. In order to reinforce the structure of the tunnel 22 reinforcement steel beams have been installed.

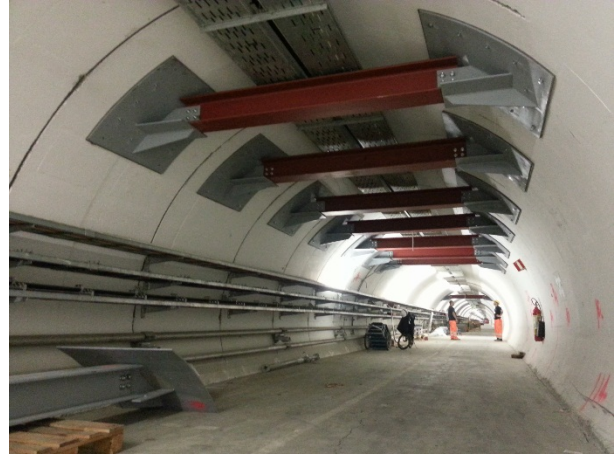
Figure 8: TT10 Tunnel reinforcements

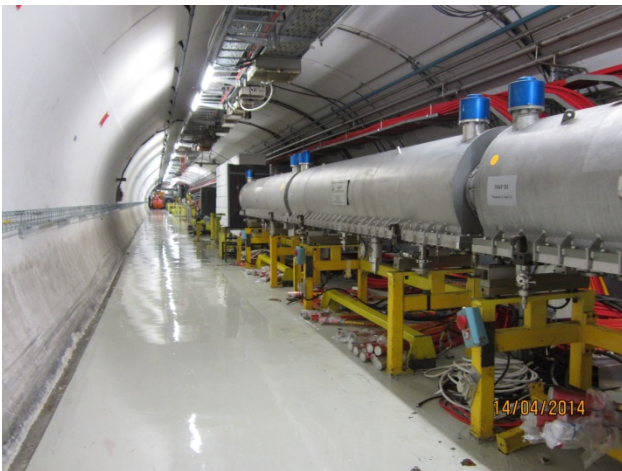
1. Establish a temporary external network and measure the position of the main equipment before removal
2. Aligning the 2 main quadrupole magnets after reinstallation using the external network as reference.
3. Aligning all secondary components using the quadrupole magnets as reference.

Figure 10: LSS 1 reinstallation

One year later, the reinstallation started. The ALARA committee decided to first install the less radioactive equipment and at the end to install the high radioactive equipments like the two beam dumps and the quadrupole magnet QDA 11910. The QFA 11810 quadrupoles magnet was the first magnet installed and it was aligned using direct optical levelling and AT 401 measurements with the external network as well as the QDA 11710 and QF 12010 still in place. All following elements have been aligned with usual alignment method: use of the adjacent quadrupole magnets as planimetric and altimetric references for all secondary elements.
