ATLAS ITk Pixel Pre-production Planar Sensor Characterisation for the HL-LHC Upgrade

In the ATLAS detector upgrade for the High-Luminosity LHC (HL-LHC), the current Inner Detector will be replaced with an all-silicon Inner Tracker (ITk), to operate under higher occupancy (instantaneous luminosity $7.5 \times 10^{34} \text{ cm}^{-2}\text{s}^{-1}$, which corresponds to about 200 inelastic pp collisions per bunch crossing) and radiation damage (particle fluence up to $2 \times 10^{16} \text{ n}_{\text{eq}}/\text{cm}^2$). The data taking is planned to start in 2029 and last for 10 years. The innermost part of the ITk will be equipped with pixel modules, consisting of pixel sensors and novel ASICs, implemented in 65 nm CMOS technology. The ITk project is currently in pre-production stage. To assure that specifications will be met during production, sensors and test structures from different vendors were sent to different sites for irradiation, hybridisation and follow-up testing. This paper presents the results of the characterisation of the pre-production planar sensor for ITk.

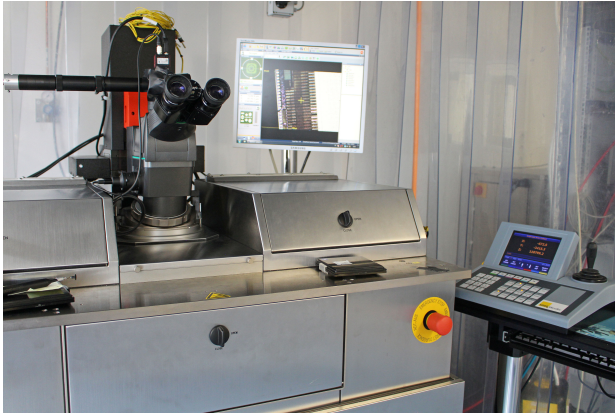
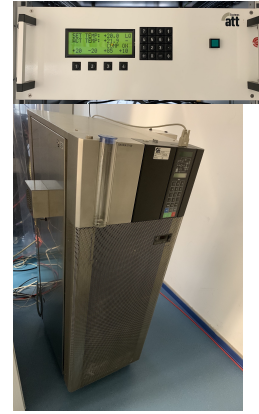
(a) Probe station: Süss PA300

(b) Chiller and controller: Huber Unistat 380

Figure 4: The probe station and the chiller. The probe station has inlets for connection to dry air for humidity control, and vacuum for fixing the sensor on the chuck. It also provides shielding from the ambient light. The temperature of the chuck is controlled by the chiller.

The testing was done at multiple sites including IJCLab, KEK, MPP, TU Dortmund, University of Göttingen, and Lancaster University. The testing setup used at Göttingen is presented here as an example. Various voltage sources and meters were used for different measurements, as shown in Table 4. Keithley6487 was used for CV measurements because Keithley2410 source meters were found to be incompatible with the CV setup. The sensors were put in a probe station for probing, and the temperature of the chuck in the probe station was controlled by a chiller, to reach the required temperature $20 \pm 1 \text{ }^\circ\text{C}$ for leakage current measurements on un-irradiated sensors, and $-25 \pm 1 \text{ }^\circ\text{C}$ on irradiated ones. The environmental monitoring is done by a PT1000 temperature sensor connected to the chuck via kapton tape, an NTC temperature sensor and a HIH4000 relative humidity sensor placed close to the chuck. Figure 4 shows photos of the probe station and the chiller.

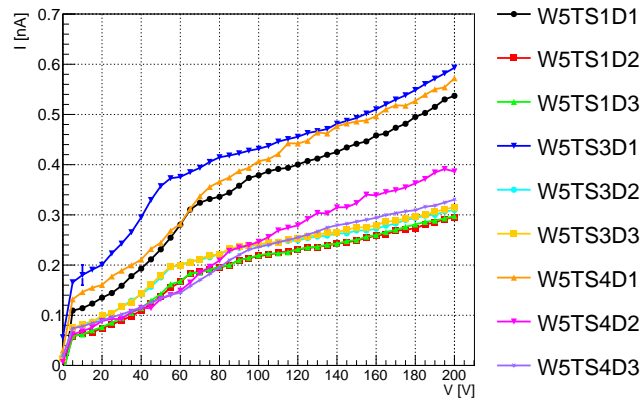
Figure 5: IV of nine un-irradiated HPK diodes from wafer 5. Diodes on three TS dies were tested, on each die there are three diodes, the diodes labelled D1 are of size $5 \times 10 \text{ mm}^2$, D2 and D3 are of size $5 \times 5 \text{ mm}^2$.

30 un-irradiated HPK diodes were tested in pre-production QA and 29 showed no breakdown, see Figure 5 for IV curves of nine diodes on wafer 5. These IV curves are from three TS dies, on each die there are one larger diode of size $5 \times 10 \text{ mm}^2$ (labelled D1), and two small diodes of size $5 \times 5 \text{ mm}^2$ (D2 and D3). Due to the size difference, D1s have almost double the leakage current of D2 and D3s. The leakage current level at $V_{\text{dep}} + 50 \text{ V}$ (which is about 120 V) are all well within the limit set in the specification, which amounts to 375 nA for D1s, and 188 nA for D2 and D3s. The scale of these limits is too large to be shown in the figure. Sensor tiles from HPK and Micron were also tested to ensure that the measurements made by the vendor can be reproduced. Testing results showed good agreement.

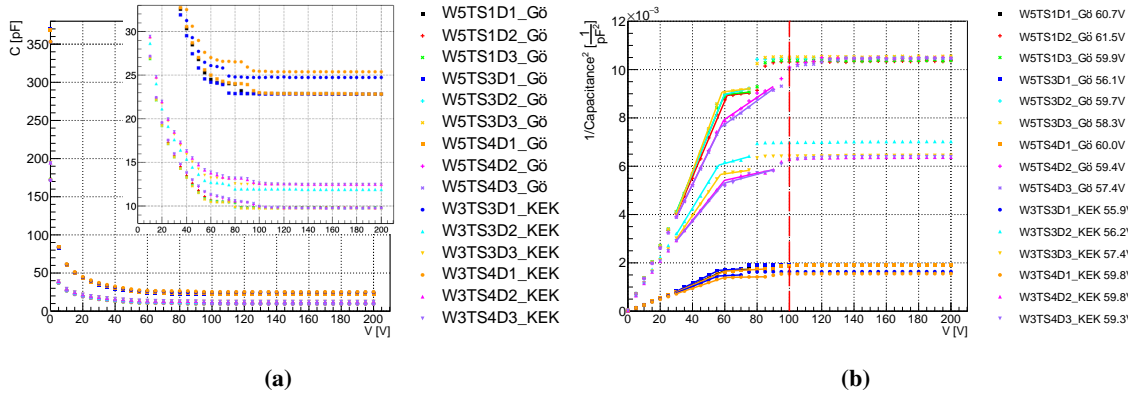
Figure 7: CV and $\frac{1}{C^2}$ of HPK diodes. The overlaid figure in (a) is a zoom-in of the lower C region. Diodes named D1 are larger ($5 \times 10 \text{ mm}^2$) than D2 and D3 (both $5 \times 5 \text{ mm}^2$). The results are from two different testing sites: Göttingen and KEK, each site tested dies from a different wafer. The full-depletion voltages V_{dep} written in the legend are the voltages correspond to the first intersection point (with lower V) of the fitted lines. The dashed red line indicates the limit on V_{dep} required by the specification.

Figure 7 shows the result of HPK diodes on dies from two different wafers, tested by two different testing sites. The capacitance decreases fast at low bias voltage, D1s have about double the capacitance of D2 and D3s due to the difference in size. There is a slight shift between the results for the same-sized diodes on dies from different wafers tested by different testing sites, which can be explained by differences between wafers and the testing setups. There are two kinks in the $\frac{1}{C^2}$ plot possibly due to edge effects: there are extra p^+ -doped rings outside the active area of the diodes, which causes further lateral depletion. Thus the first intersection point with lower V reflects better the V_{dep} needed to deplete the sensors across the whole thickness. The CV curves for Micron sensor tiles are shown in Figure 8, sensor tiles on wafer 0016 were tested without dicing. There is no edge effect observed on the sensor tiles, possibly due to their larger area compared to diodes, which makes the edge effect negligible.

The V_{dep} obtained from HPK diodes is 55 to 62 ± 5 V, the uncertainty is estimated by varying the data points that are included in the fit. V_{dep} for Micron sensors is 64 to 67 V for 150 μm and 43 to 45 V for 100 μm sensors. The results all meet specification, as indicated by the dashed red lines.

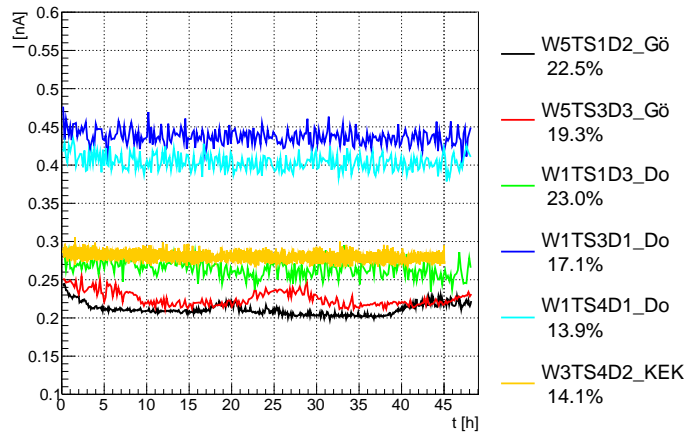
Figure 9: HPK It curves. The current is not corrected for temperature fluctuation. The curve for W5TS1D2 and W5TS3D3 shows periodic fluctuation, which is likely from environmental influence like ambient light. The fluctuations of all the curves are written in the legend and are within limit.

to be within 25 %. Figure 9 shows the result for HPK un-irradiated diodes, all measurements showed fluctuation within the limit.

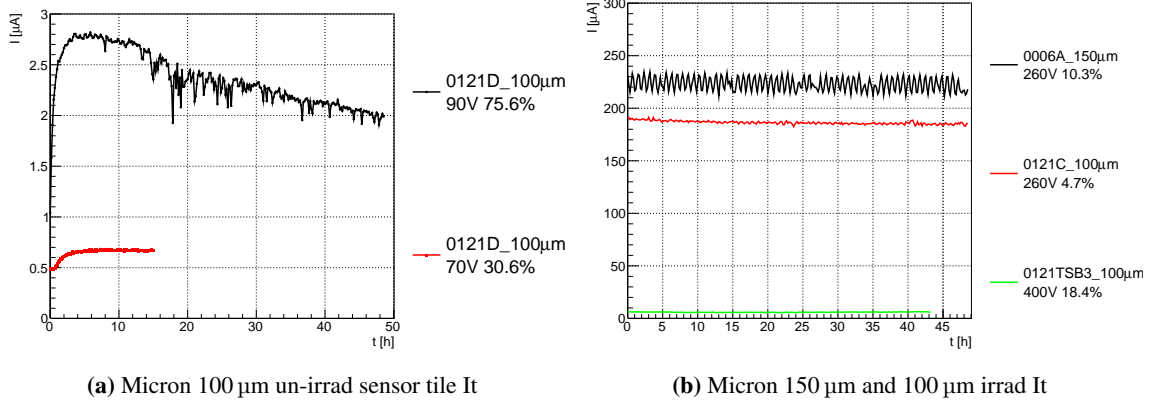
Figure 10: It curves for un-irradiated and irradiated Micron sensors. For un-irradiated 100 µm sensor tile 0121D (figure a), I increases fast and then decreases steadily w.r.t. time when biased at 90 V. A shorter curve was obtained at 70 V, in this case I still increases but no obvious decrease is observed. The fluctuation, as written in the legend, is out of specification in both cases. Two sensor tiles irradiated with 5×10^{15} n_{eq}/cm² fluence (0006A and 0121C) and one diode irradiated with 2×10^{15} n_{eq}/cm² (0121TSB3) were tested after irradiation (figure b), and the problem with un-irradiated sensor tile is no longer visible. The wavy fluctuation in 0006A is due to temperature fluctuation of the chiller.

However, un-irradiated Micron sensor tiles showed unstable behaviour, as shown in Figure 10a. The 100 μm sensor tile named 0121D was tested at two different bias voltages (90 V and 70 V) at 20 °C chiller T. When biased at 90 V, the It curve shows fast increase then decrease, while a shorter measurement at 70 V showed only increase and no obvious decrease. The fluctuations for both curves are higher than the required limit. The result of 150 μm only decreases and is also over the limit (figure omitted for simplicity).

This effect is gone after irradiation, as shown in figure 10b on measurements done on two sensor tiles irradiated with $5 \times 10^{15} \text{ n}_{eq}/\text{cm}^2$ fluence and a diode irradiated with $2 \times 10^{15} \text{ n}_{eq}/\text{cm}^2$. The fluctuations are small despite the measurement of 0006A having suffered from fluctuating chiller T, and having biased the diode 0121TSB3 at a very high voltage (400 V). It is suspected that the

change of leakage current in un-irradiated sensor tiles is due to a surface effect.

The vendor suggested baking the sensors (125 °C for 16 hours, and flush the sensor for 2 to 3 h with dry N₂ if the sensor has been staying in an environment with relative humidity >50 % before baking) to eliminate this effect. This suggestion is consistent with the practice in the strip detector community (150 °C for 15 hours with no special environment). Follow up testing will be done to investigate this.

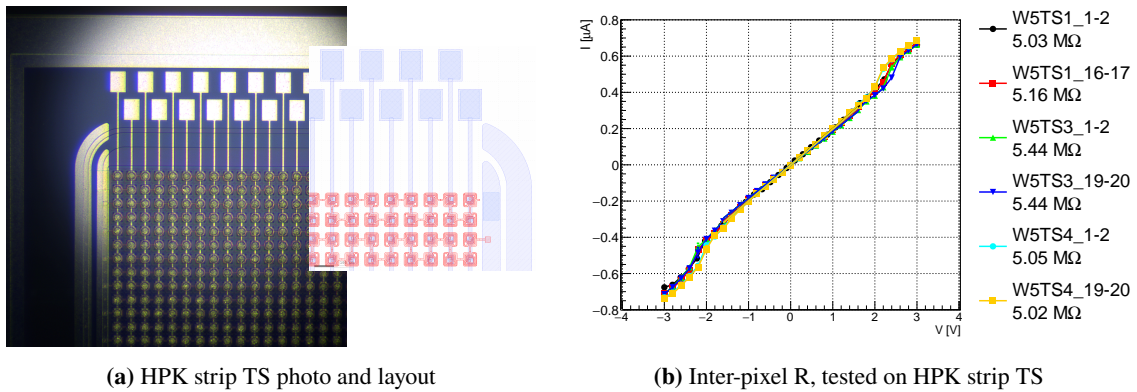
Figure 11: HPK strip test structure and testing results. Detail of the poly-Si bias rail is shown in red on the TS layout, half of the pixels on the neighbouring strips are connected by them. Two pairs of strips on each of the three TS on wafer 5 were tested, the indices of the strips are indicated in the legend, e.g. 1-2 being the first two strips next to the edge of the TS. Result shows that $R \sim 5 \text{ M}\Omega$ independent of the location of the strip.

Inter-pixel resistance was measured to test the inter-pixel isolation. The measurements were done on the HPK strip TS, a photo and the wafer map is shown in Figure 11a. The TS consists of pixels connected together, forming strips. There are 40 connected pixels per strip, and 40 strips in total on one TS. For HPK strip TS, there are pads at both ends of each strip for probing.

The measurements were done by placing two probe needles on the neighbouring strips and applying voltage. Probing the pads on the same or different ends of two strips made no visible difference.

The current vs voltage was measured in a small voltage range around 0 V. When applying voltage across the two strips, the 40 pixels are connected in parallel. Since 20 of the pixels are connected by poly-Si bias rail which results in much smaller resistance, the current from the other pixels are considered negligible. This means R can be obtained by dividing the measured current by 20 and plotting it against the voltage. After fitting a straight line to the linear part, Ohm's law gives that R is inverse the slope. The results show that $R \sim 5 \text{ M}\Omega$ (Figure 11b), which meets the requirement. The TS were not biased in these measurements, giving a more conservative measurement of R [5]. The measurement of Micron strip TS is ongoing.
