BRAZING OF NIOBIUM TO STAINLESS STEEL FOR UHV APPLICATIONS
IN SUPERCONDUCTING CAVITIES

J.P. Bacher, E. Chiaveri and B. Trincat

ABSTRACT

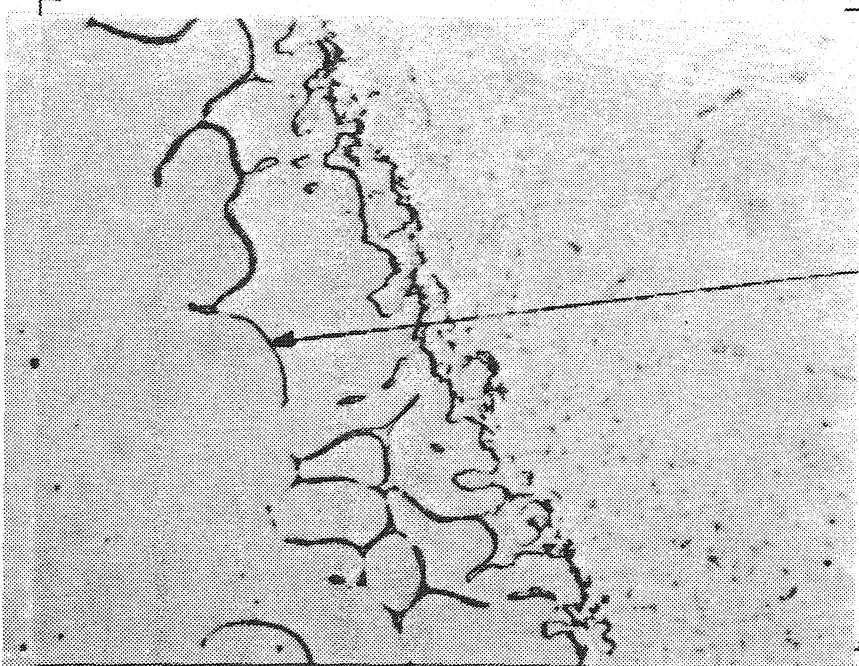
Fig.8

Metallographic section showing copper diffusion in the stainless steel grain boundaries.

- The study of the diffusion shows in every case a strong development of the copper in the stainless steel grain boundaries (short-circuits).

It has not been possible to distinguish a difference between the 3 components. The most affected zones are those neighbouring the grooves housing the copper wire (fig. 8). The segregation of impurities in the grain boundaries has not been noted. On the niobium sleeve side, the diffusion is very small and the analysis through energy dispersive X-ray analysis confirms the presence of an iron rich film (compound) at the niobium-stainless steel interface (fig. 9).
