# The ATLAS SCT Optoelectronics and the Associated Electrical Services

Keywords: LHC; ATLAS; SCT; Optoelectronics; Data transmission; ASICs.

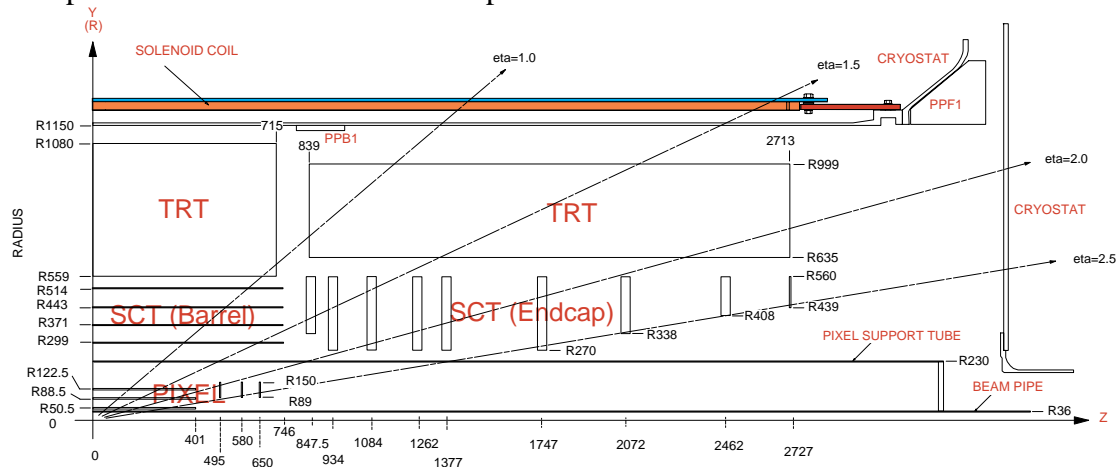
**Figure 1 Cross section of the ATLAS Inner Detector showing a quarter of the barrel and half of one of the two endcap regions and the location of the fibre optic and electrical patch panels PPB1 and PPF1. The PPF0 patch panels are located at the edges of each of the 18 Endcap disks.**

The locations of the optical and electrical patch panels are shown in Figure 1.

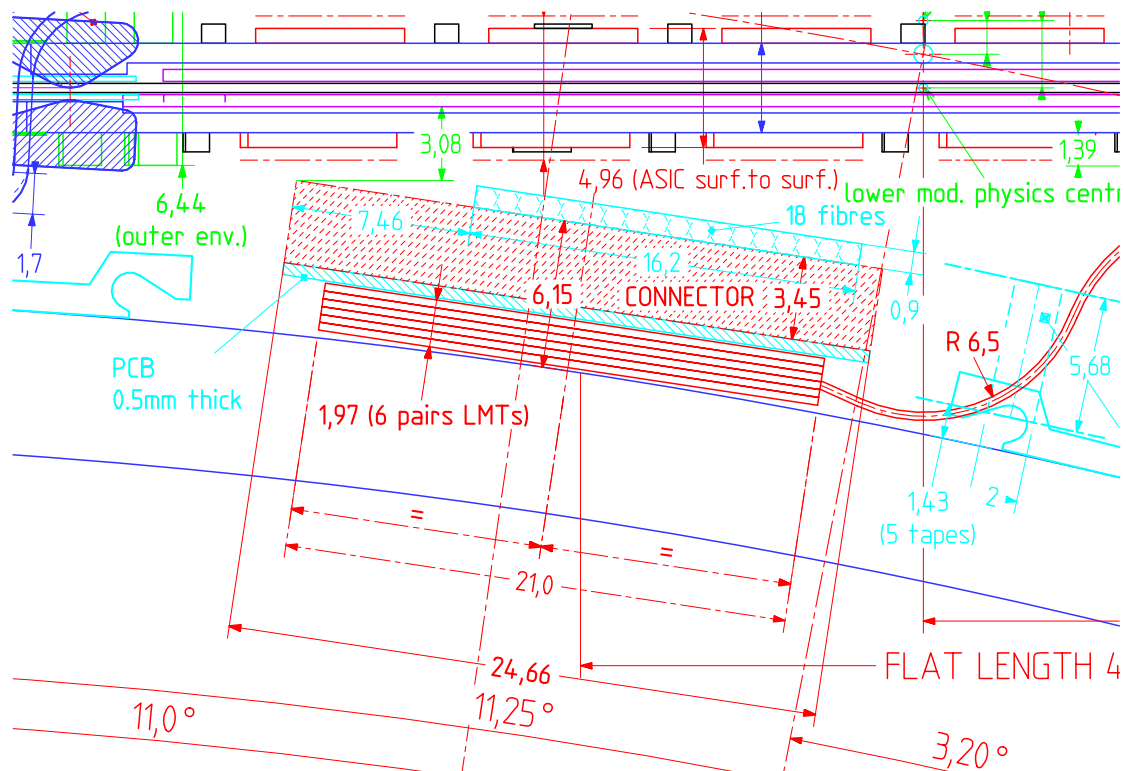
**Figure 4. Build up of stack of 6 pairs of LMTs at the end of the barrel showing the clearance to the SCT module.**

The SCT modules are mounted on carbon fibre brackets which are rigidly attached to the carbon fibre barrels. The optoelectronics components are mounted on the opto-flex cables, which are also attached to the carbon fibre brackets. The space envelope for the optoelectronics has a height of 1.6 mm and this provides a vertical clearance to the neighbouring module of 1.39 mm. This clearance is critical to avoid damage to exposed wire bonds on the modules. Therefore the thicknesses were measured at several stages during the assembly of the opto-package and opto-flex circuit. As a final check, after the assembly of the optical and electrical services to the barrel, mechanical “envelope” modules were mounted on each location to verify the clearances. The clearances at the end of the barrel are also tight, as can be seen in Figure 4 (extracted from [13]). Allowing for all the tolerances, the minimum clearance was calculated to be 1.8 mm. Therefore, the thickness of the Low Mass Tapes (LMTs) (see section 4.7) and the total height of the stacks of 6 double LMTs were checked during the assembly.

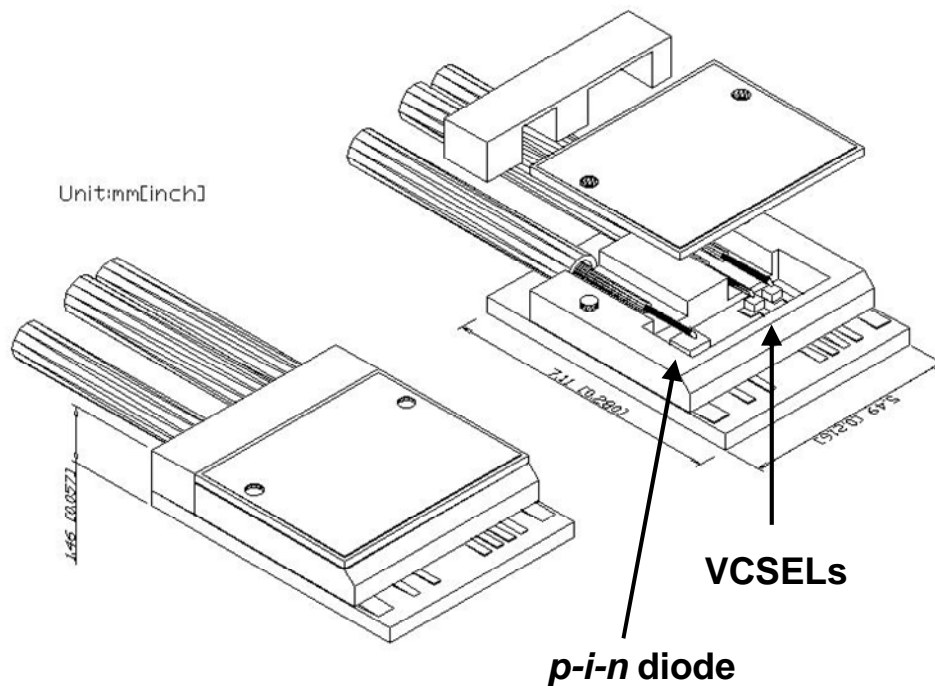
**Figure 5. The barrel opto-package. The dimensions are in mm (inches).**

The VCSELs and Si *p-i-n* diodes are mounted on the small PCBs and wire bonded to tracks on the PCB. The fibres are located in v-grooves on the plastic build-up component. Active alignment is used to ensure that the optimal fibre positions relative to the VCSELs are achieved and a UV curing glue<sup>14</sup> was used to fix the fibres in place. The cover is designed to protect the active components and the clamp at the back of the package ensures that the fibres are well strain relieved. The overall height of the package is only 1.46 mm, which is within the allowed space envelope. Extensive tests were performed to ensure that there was no significant optical or electrical cross talk between the VCSELs and the Si *p-i-n* diodes.

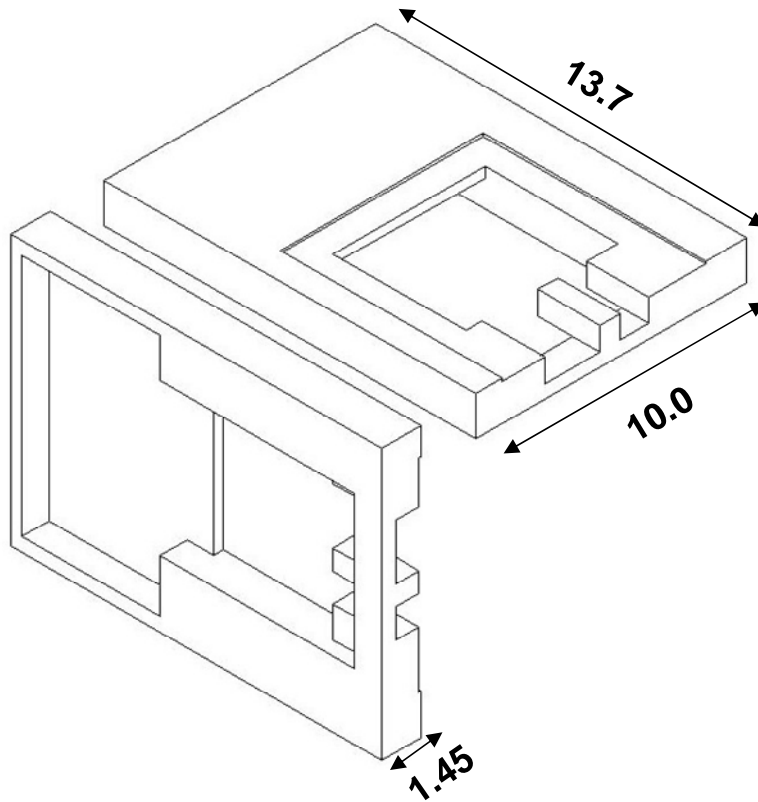
**Figure 6. Two 3D views of the plastic cover for the barrel opto-package. The opto-package fits in the hole and aluminium foil is glued over the top of the opto-package. The two VCSEL fibres fit in the wider groove at the back of the cover and the one Si *p-i-n* fibre fits in the narrow groove. The back of the cover fits over the opto-ASICs. The dimensions are in mm.**

Any small amount of light leakage can lead to significant excess noise in the silicon detectors because silicon has a high quantum efficiency for radiation at 850 nm. The effect was observed during the first system test of the SCT[16] before suitable precautions had been taken to minimise light leakage. Therefore the fibres were placed inside 900  $\mu\text{m}$  diameter black furcation tubing<sup>15</sup> in order to minimise light leakage from the fibres to the silicon detectors. In order to minimise the light leakage from the opto-package itself, custom plastic parts were manufactured. The parts were produced using plastic injection moulding and carbon fibre loaded PEEK<sup>16</sup> was used which is known to be radiation hard. This material is black and strongly absorbs infra-red radiation. In order not to significantly reduce the vertical clearance, the top of the cover is made using 25  $\mu\text{m}$  thick aluminium foil (which also prevents the transmission of infra-red radiation). A drawing of the cover is shown in Figure 6.

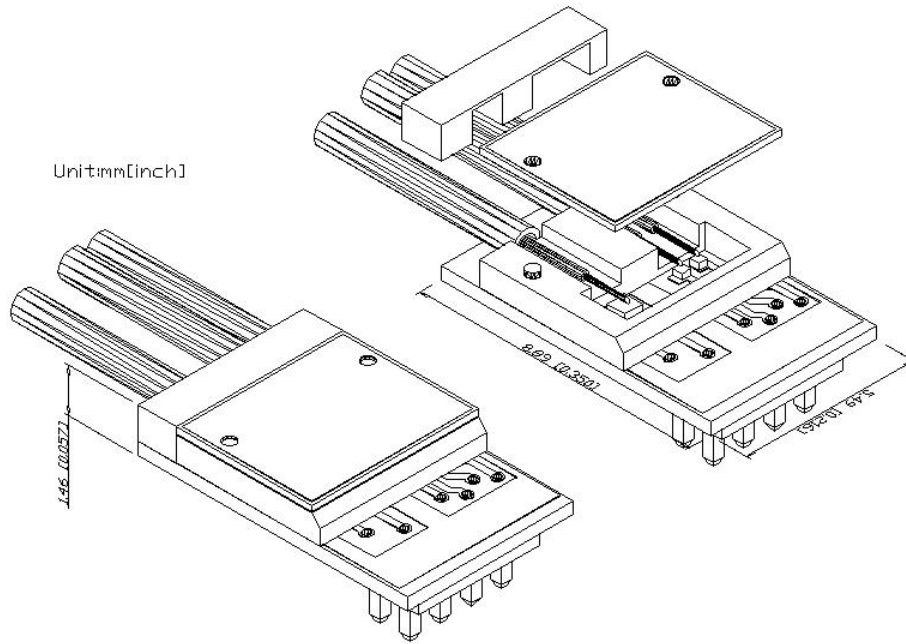
**Figure 7. Endcap opto-package showing the pins of the electrical connector.**

The endcap readout used a similar opto-package to the barrel. However for the endcap an electrical connection was required to the module. Therefore, the endcap opto-package contained an 8 way 1mm pitch electrical connector<sup>17</sup> which was used to connect the opto-package to the endcap module, as shown in Figure 7. In order to minimise light leakage, custom plastic covers were manufactured. For the endcap there was more vertical clearance but considerably less lateral clearance than for the barrel. Therefore a different opto cover had to be designed. The design is shown in Figure 8. These covers were also produced with plastic injection moulding using carbon loaded PEEK. A photograph of an endcap module showing an inserted opto plug-in is given in Figure 9.

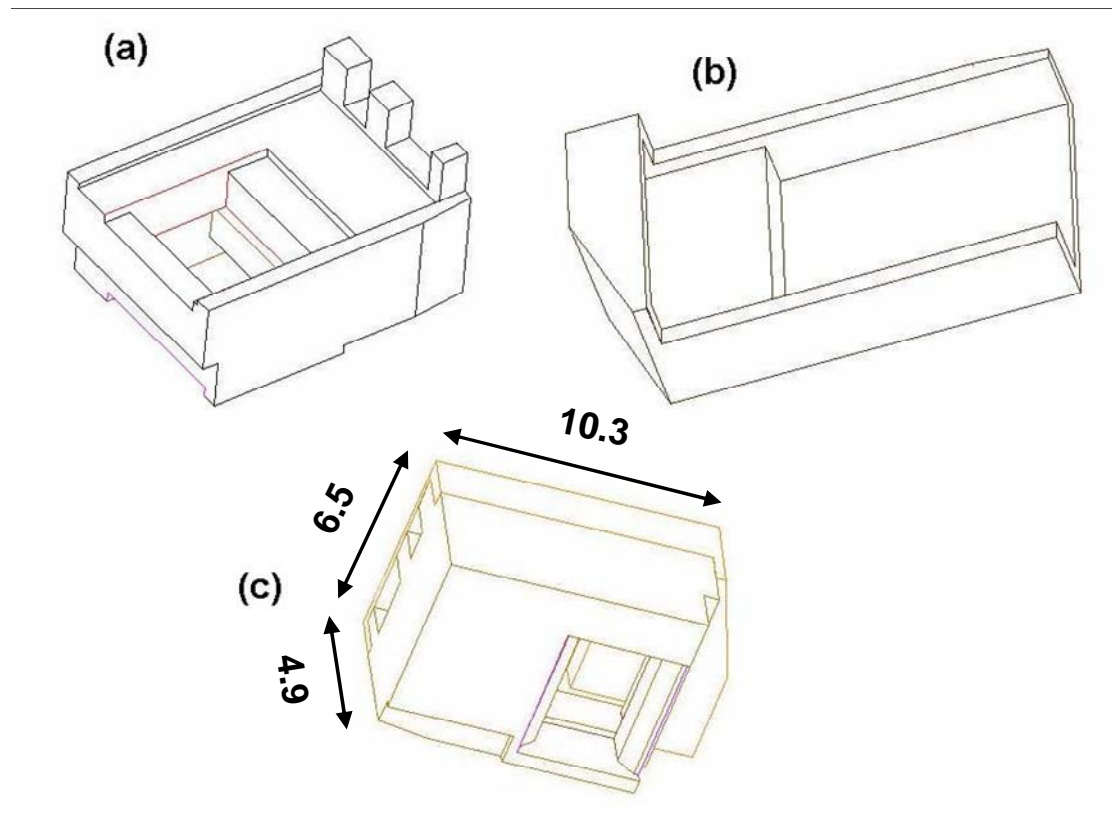
**Figure 8. Endcap Opto cover, (a) base, (b) lid and (c) assembled base and lid. The dimensions are in mm.**

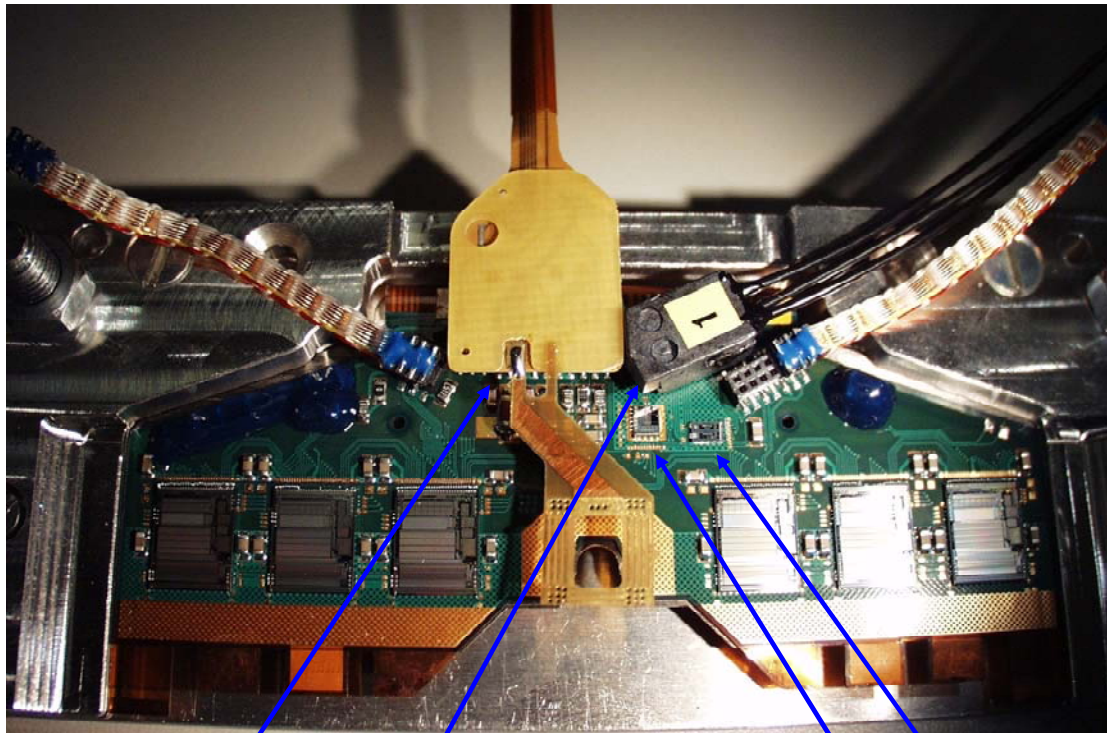
**Power tape connector    Opto-plug in and cover    DORIC4A VDC**

**Figure 9. Photograph of part of an endcap module, showing the location of the opto plug-in.**

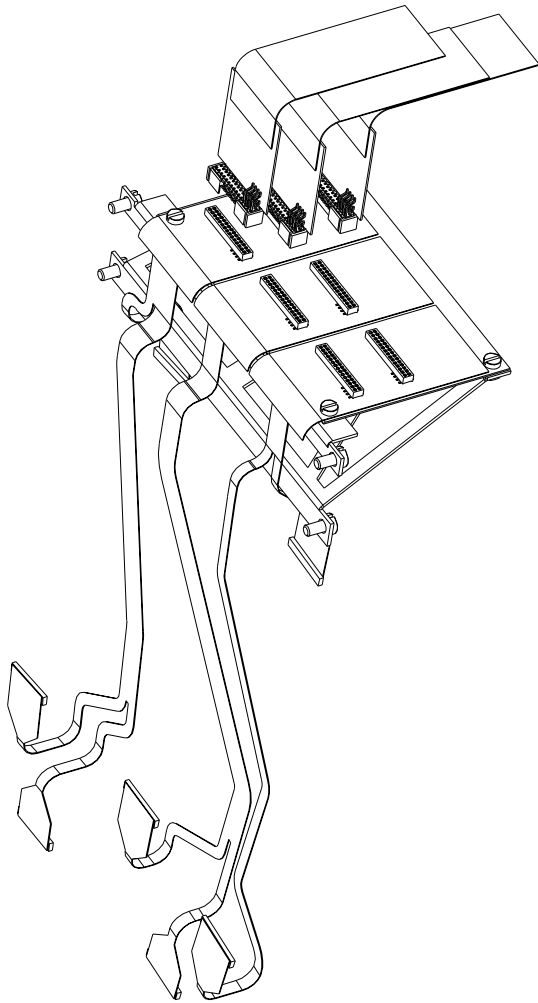
**Figure 11. 3-D model used for the tape layout as well as a section of a disk equipped with tapes and other services.**

The endcap flex circuits supply analogue and digital power and detector bias to the modules as well as other low current lines (see section 2.2). The constraints are to minimise voltage drop on the high current lines, with minimal additional material, as well as to provide 500 V isolation for the detector bias line. In order to minimise the material, each of the 33 modules in a quadrant is supplied by an individual circuit, grouped in tapes of up to 3 circuits each. There are up to 12 such tapes per quadrant of each disc in the endcap.

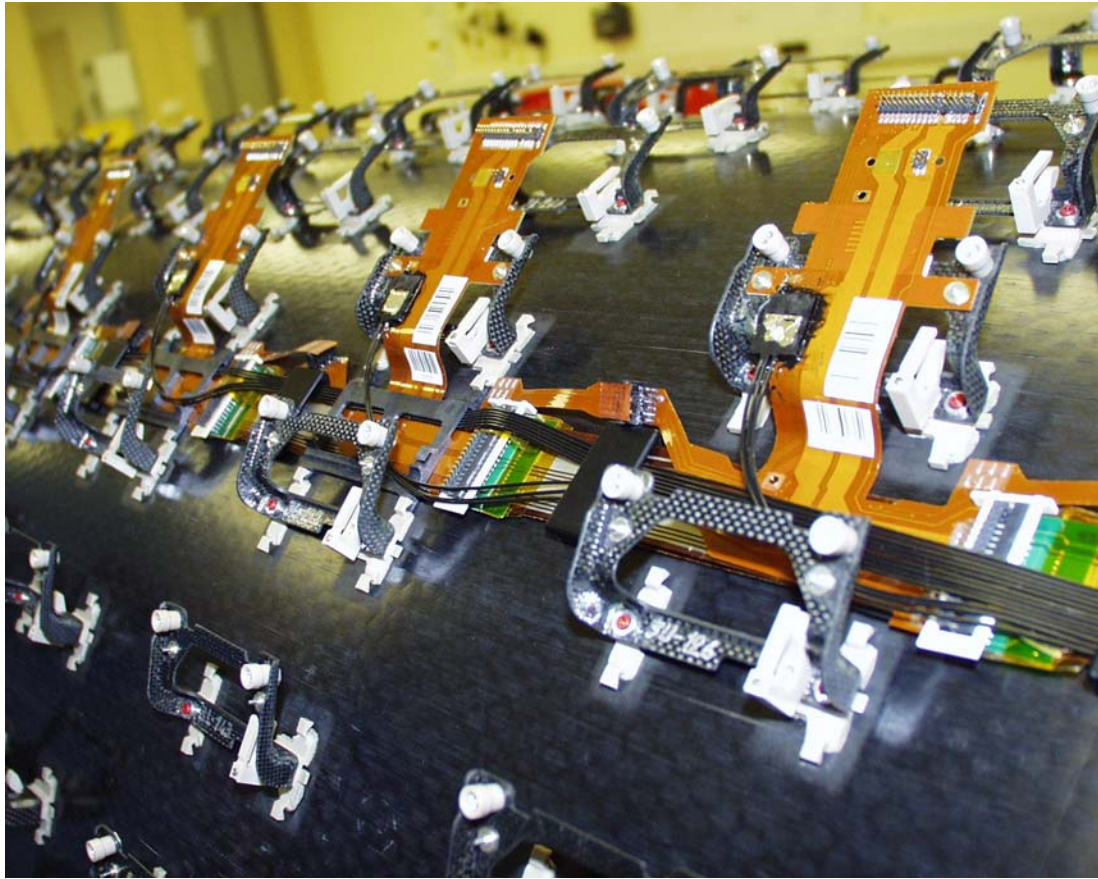
**Figure 12. Photograph of part of a barrel harness after mounting onto a barrel. Four opto-flex circuits (out of six on the harness) and the associated fibres are visible.**

The arrangement of the opto-flex on the smallest of the 4 SCT barrels (called barrel 3) is shown in Figure 3 (extracted from [13]), (see also the photograph of opto-flexes mounted on the barrel in Figure 12).

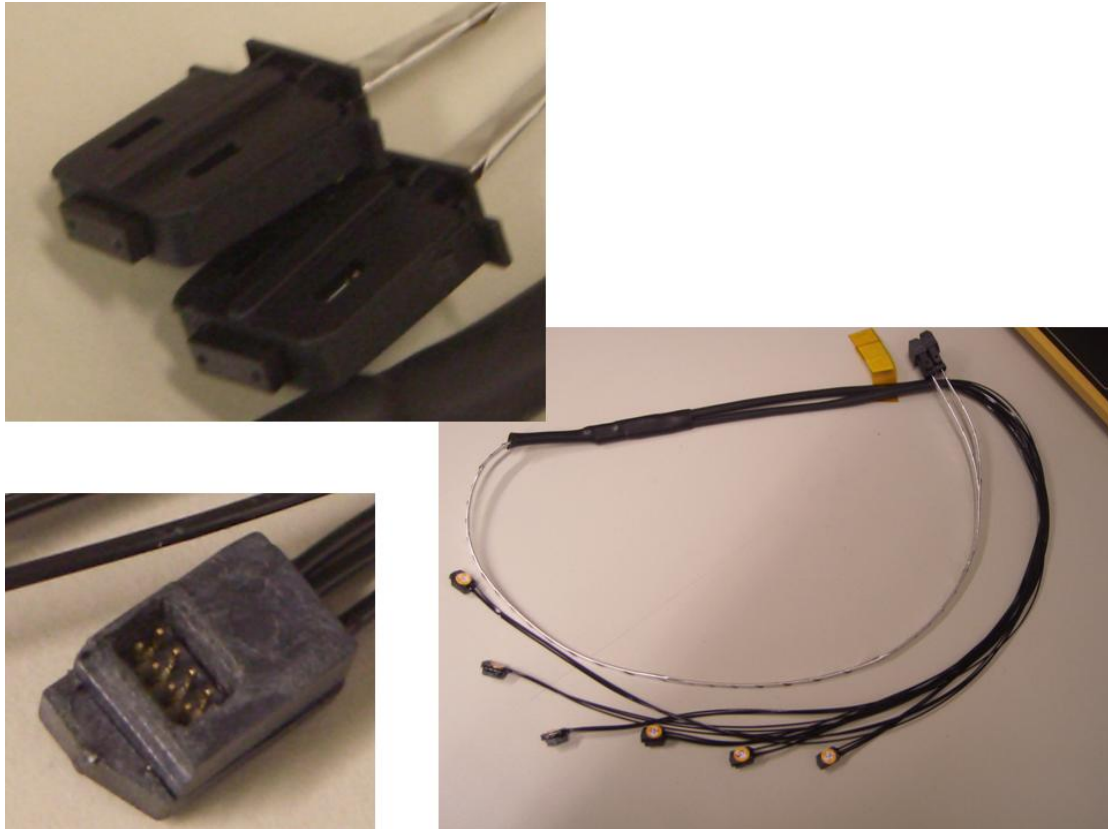
**Figure 13. Endcap fibre harness. The harness consists of 6 opto-packages and two fibre ribbons, terminated in MT connectors inside Infineon<sup>30</sup> SMC housings. The two inserts show the electrical connector inside the opto cover and the end of the harness with two Infineon SMC housings.**

For the endcap fibre harnesses a slightly more modular scheme was used. The fibre harness was assembled separately from the electrical harness. Each endcap fibre harness consisted of between 4 and 6 endcap opto-packages (see section 4.2). The data and TTC fibres were separately ribbonised and fusion spliced to 12 way fibre ribbons. The individual fibres were protected by the same furcation tubing as used for the barrel harnesses (see section 4.8.1). Since the lengths of fibre ribbons are positioned very close to the SCT modules, it was necessary to prevent light leakage from the fibres reaching the modules. This was done by wrapping the fibre ribbons in aluminium foil. A total of 354 endcap fibre harnesses were required. The endcap SCT only required 7 flavours of fibre harness which simplified production (compared to the barrel harnesses) and allowed 20% spares for each flavour to be produced. A photograph of an endcap fibre harness is shown in Figure 13. A photograph of part of an endcap disk after the fibre harness, kapton flex circuits and cooling pipes have been mounted is shown in Figure 14. At this stage of the assembly the modularity of the system is lost as the kapton flex circuits and the endcap fibre harnesses are trapped under the cooling pipes and can not be easily replaced.

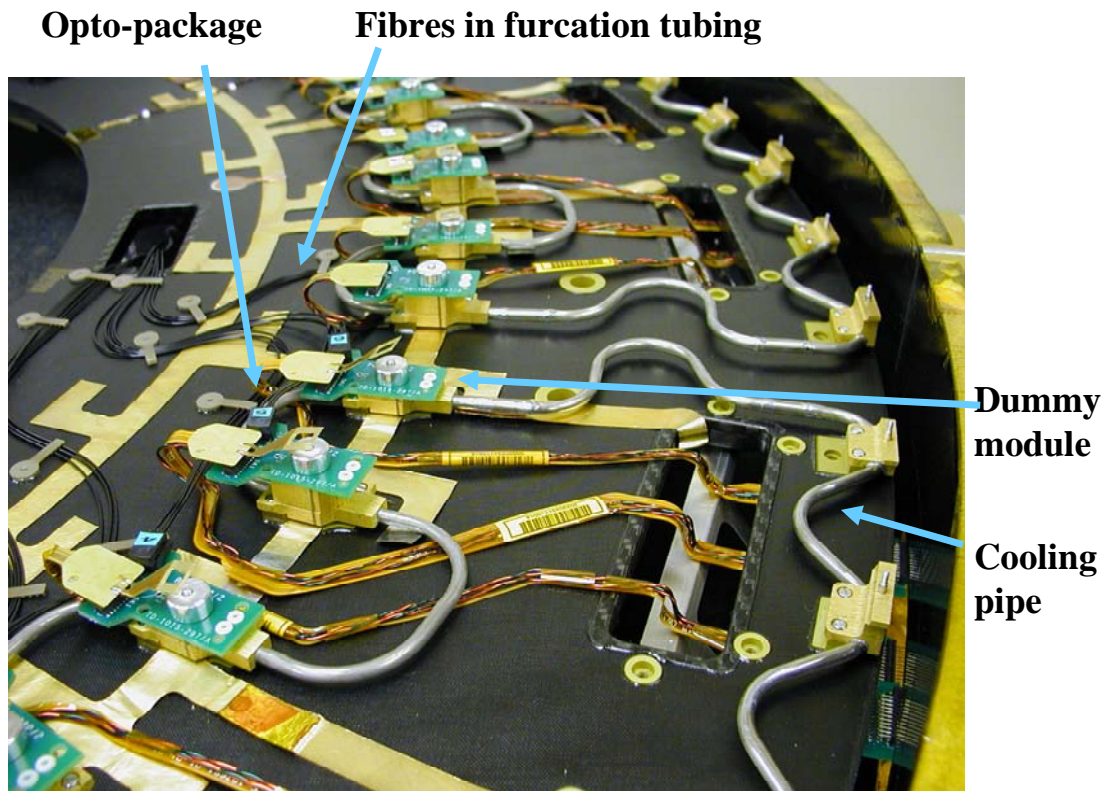
**Figure 14. Photograph showing part of an endcap disk after endcap fibre harnesses, kapton flex circuits and cooling pipes have been mounted. Dummy modules are mounted on the cooling blocks to allow the electrical flex circuits and the opto-packages to be tested.**

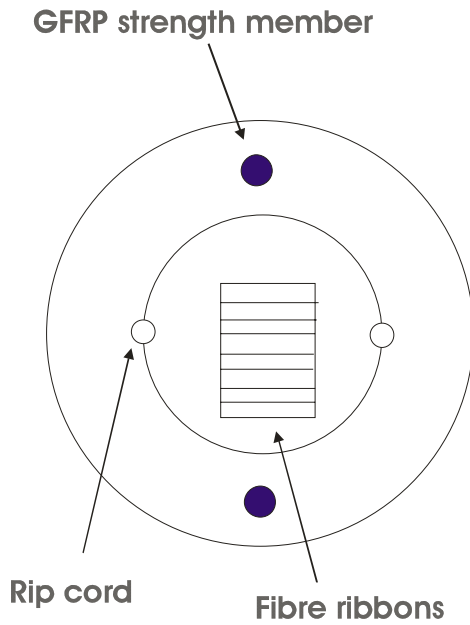
**Figure 15. Fibre protective cable (not to scale).**

<sup>36</sup> The orientation of the ribbons with respect to the GFRP rods shown in Figure 15 is that used during the assembly of the cable. The ribbons are loose inside the cable and will tend to orientate themselves to minimise the strain when the cable is bent.

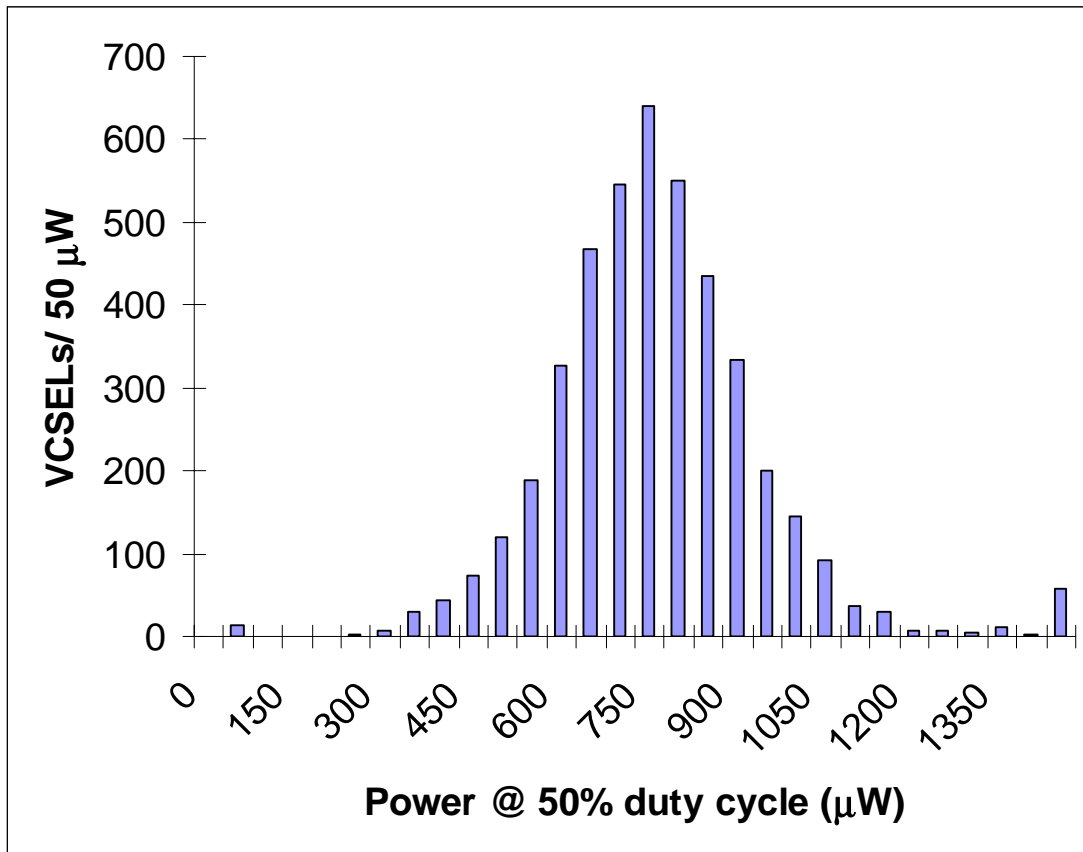
**Figure 16. Distribution of measured fibre couple light output from the VCSELs on barrel harnesses. The data give the measured optical power and are not corrected for the 50% duty cycle. The entries in the overflow bin are mainly due to a malfunction of the test system.**

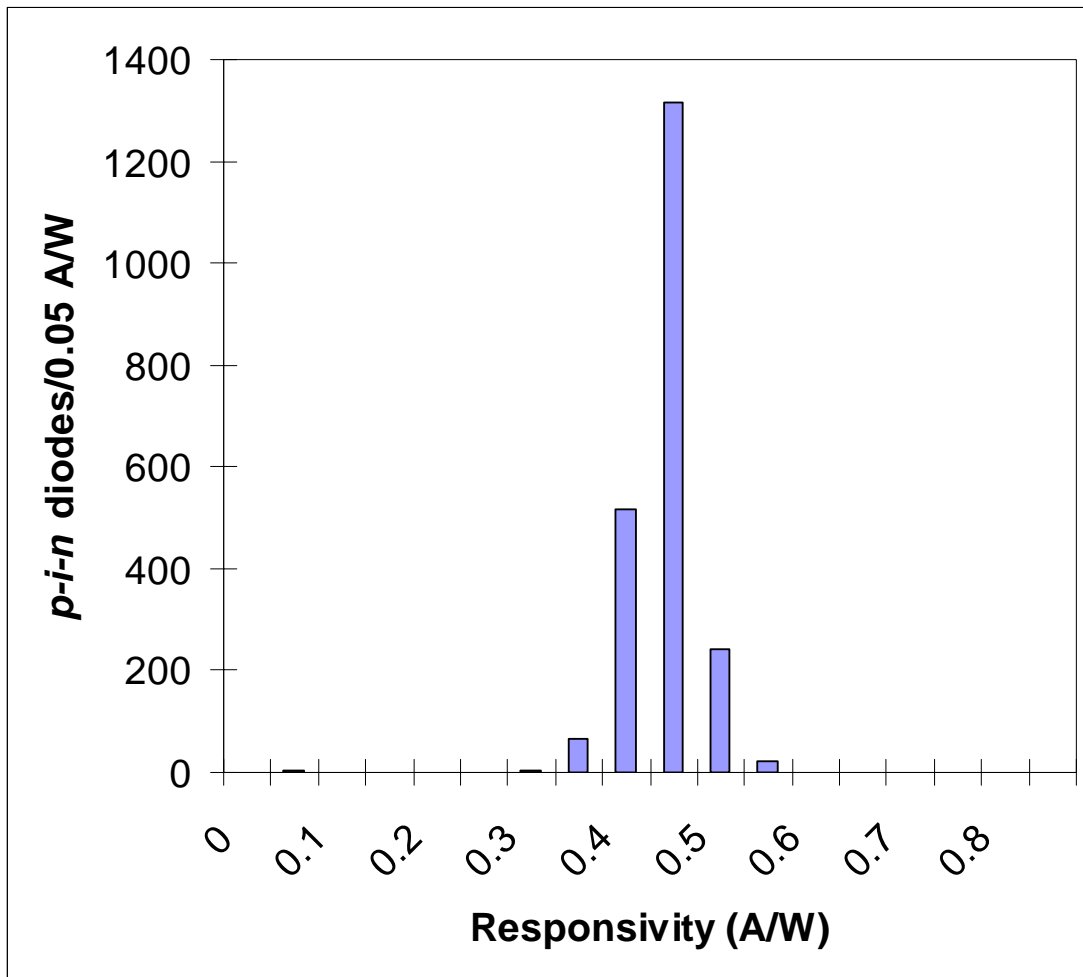
**Figure 17. Distribution of the measured Si *p-i-n* diode responsivities.**

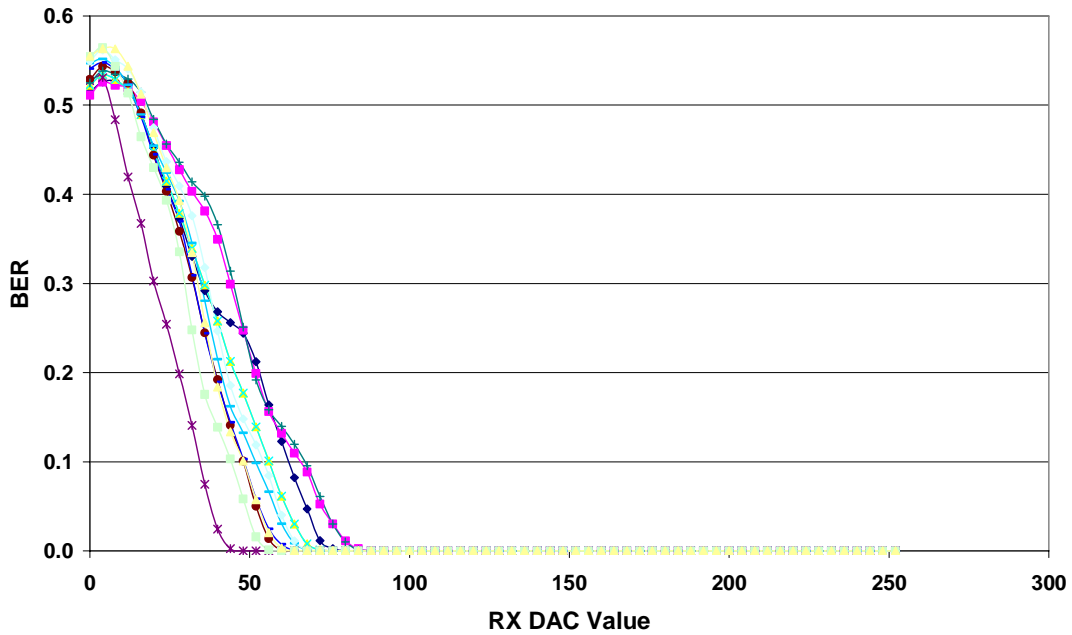
**Figure 18. RX threshold scans for one barrel harness. The 12 curves show the BER as a function of RX DAC value for the 12 data links on this harness.**

The digital performance of the data links was first tested by performing BER measurements as a function of the DAC (Digital-to-Analogue Conversion) values which set the thresholds for the DRX-12 receiver ASIC. This scan was done very quickly with only 32 kbits of data at each scan point. This crude measurement gives an upper (RXmax) and lower (RXmin) limit for the DAC setting for which no bit errors were detected. An example of these scans for one barrel harness is shown in Figure 18. For all 12 data links the VCSELs were sufficiently bright that no bit errors were detected with the highest value that could be set for the 8 bit DAC. The width of the working region was defined as the difference between RXmax and RXmin and the optimal setting was selected to be the average of RXmax and RXmin. The distribution of this width is shown in Figure 19 and shows some spread which is correlated with the brightness of the VCSEL. The very low values, correspond to channels with low output power VCSELs. The working margin is typically well above the minimum required value of 100 counts, which should make it simple to set a working RX DAC value in the final system. With the DAC set to this optimal value, the BER was measured for 10 minutes with the requirement that there should be no bit errors.

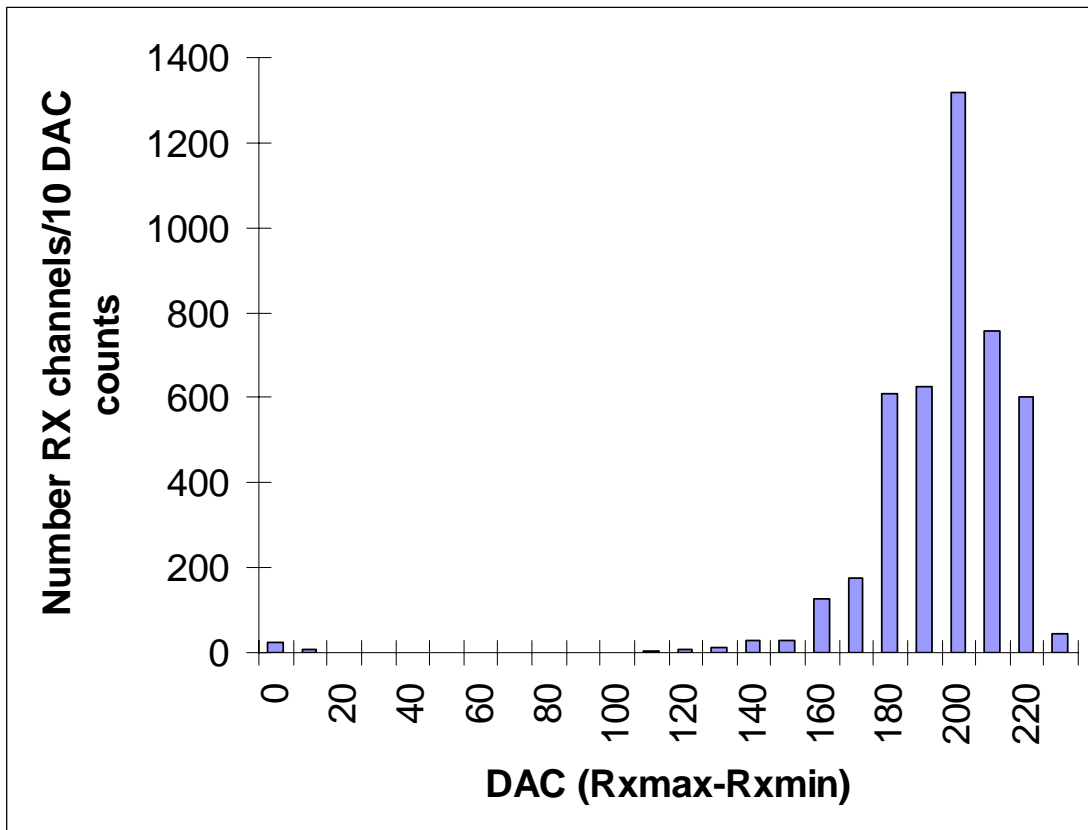
**Figure 19. Distribution of RX DAC working margin, defined as  $RX_{max}-RX_{min}$ .**

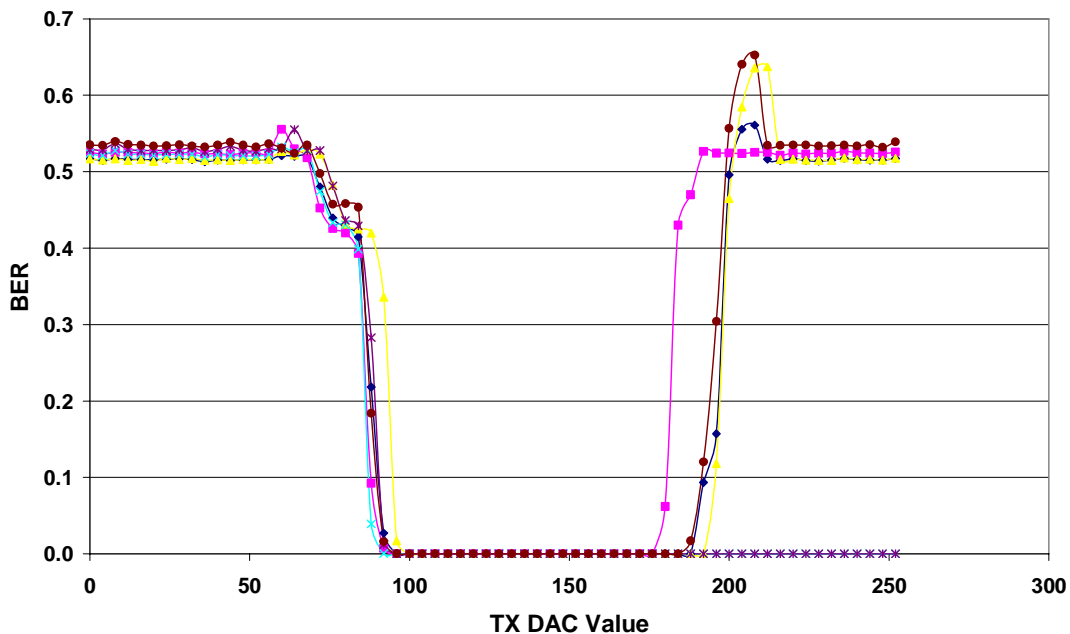
**Figure 20. TX threshold scans for one barrel harness. The 6 curves show the BER as function of TX DAC value for the 6 TTC links on one harness.**

The digital performance of the TTC links was measured in a similar way. A quick BER scan was performed for the TTC links as the value of the DAC which controlled the drive current to the VCSELs was changed. An example of these scans for one

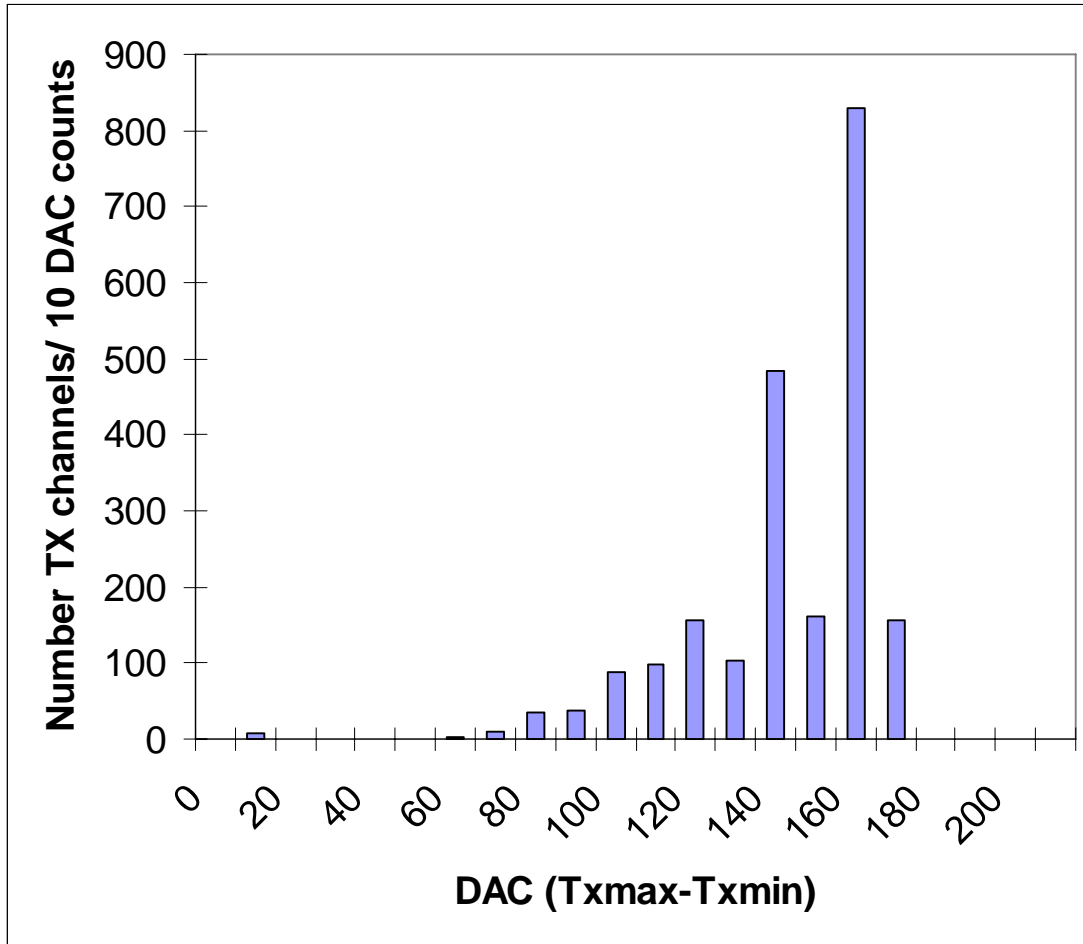
**Figure 21. Distribution of TX DAC working margin, defined as TXmax-Txmin.**

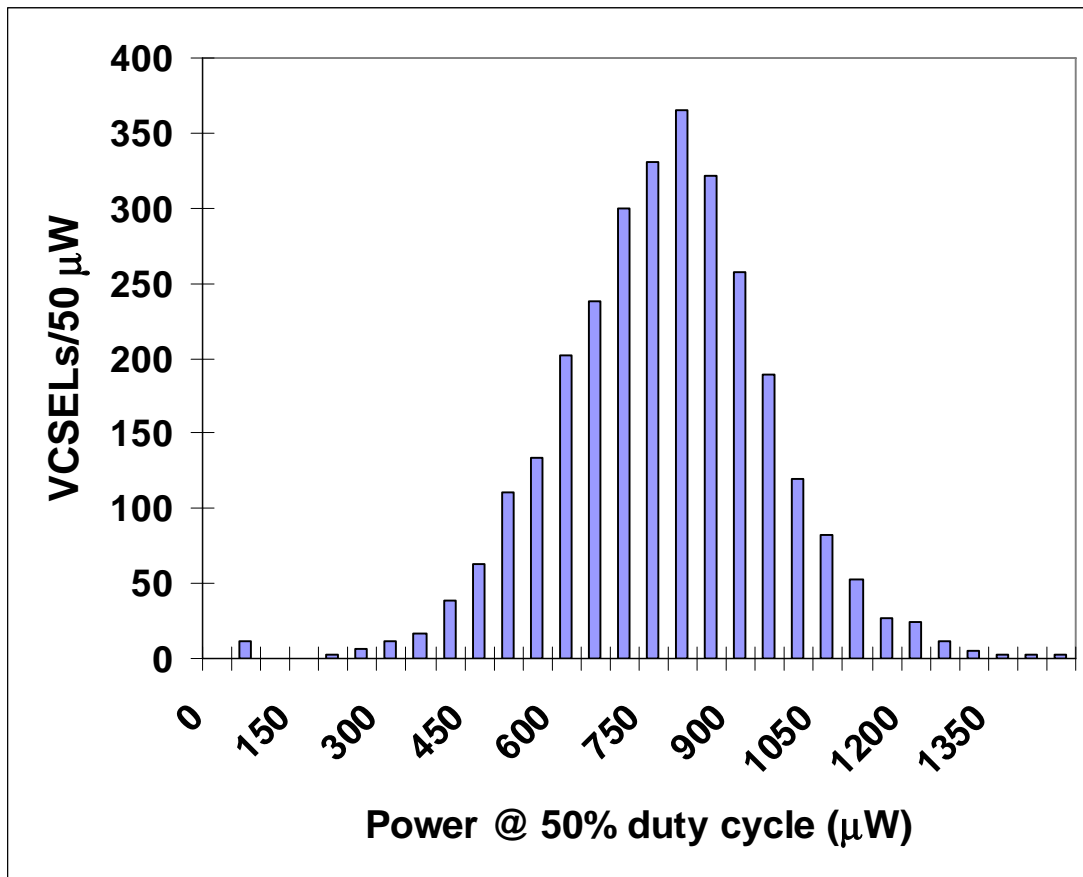
**Figure 22. Distribution of measured fibre coupled optical power from the VCSELs on a sample of endcap fibre harnesses measured at RAL. The data are not corrected for the 50% duty cycle.**

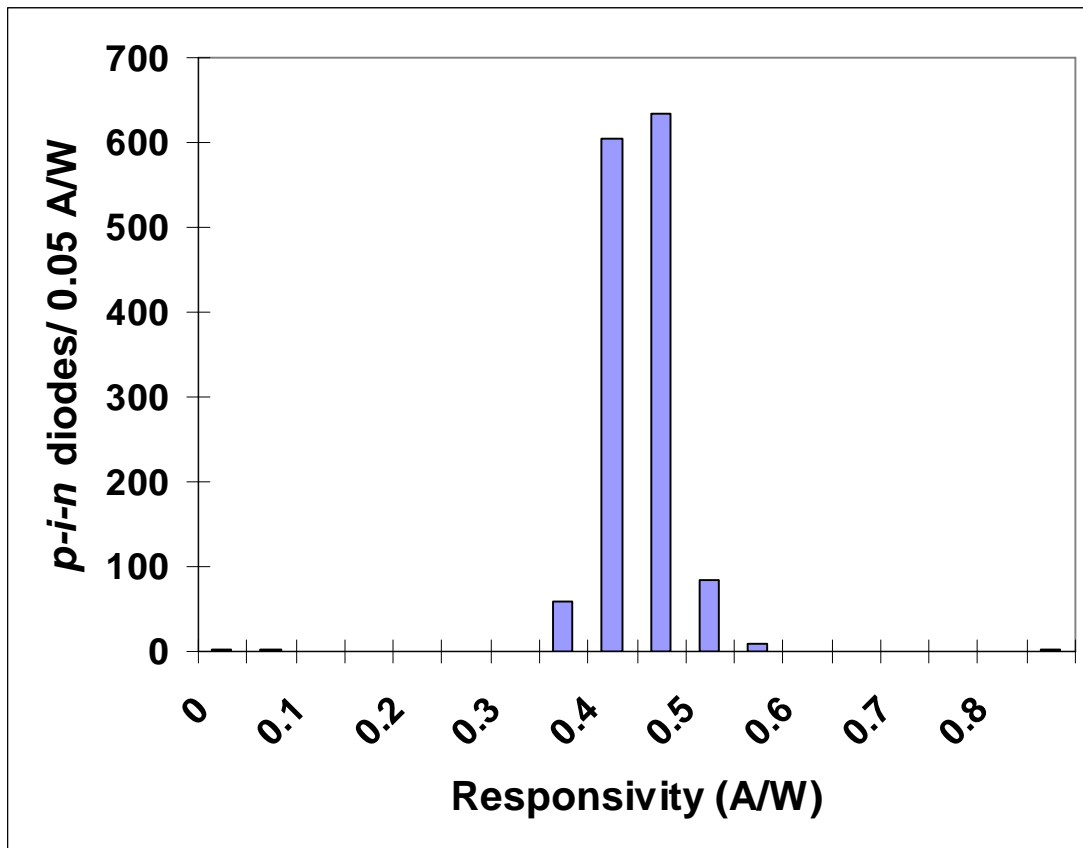
**Figure 23. Distribution of Si *p-i-n* diode responsivities for the endcap opto-packages measured at RAL.**

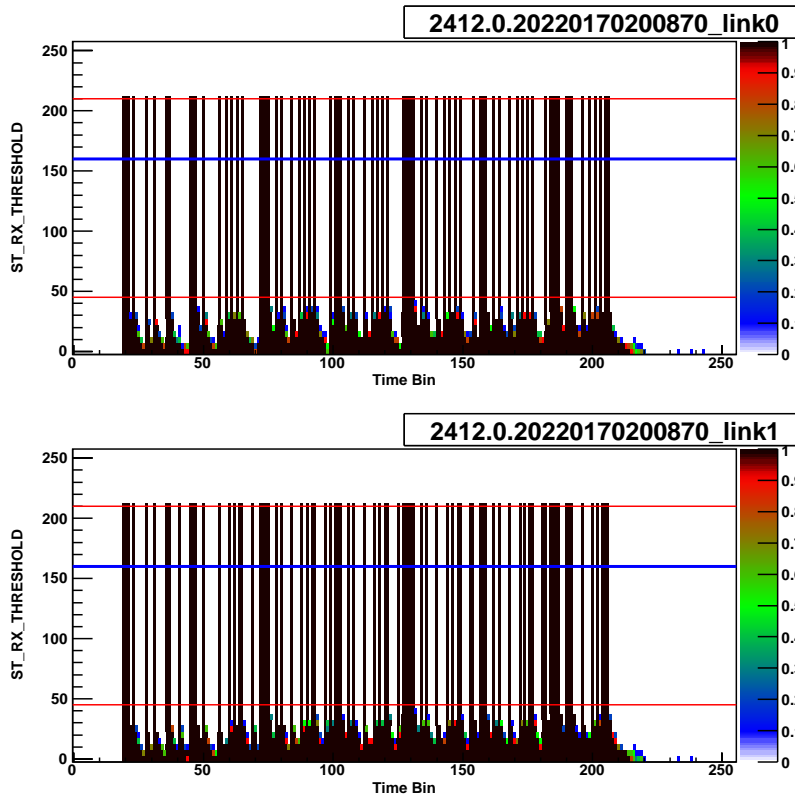
**Figure 24. Example of RX DAC scan for a module. The thin red lines show the computed values of RXmin and RXmax and the thick blue line shows the resulting value for RX(optimal) (see text for definitions).**

<sup>46</sup> In subsequent running it was found that more stable operation could be obtained by setting the RX threshold to be  $RX(\text{optimal}) = 0.75 \cdot RX_{\text{max}} + 0.25 \cdot RX_{\text{min}}$ .

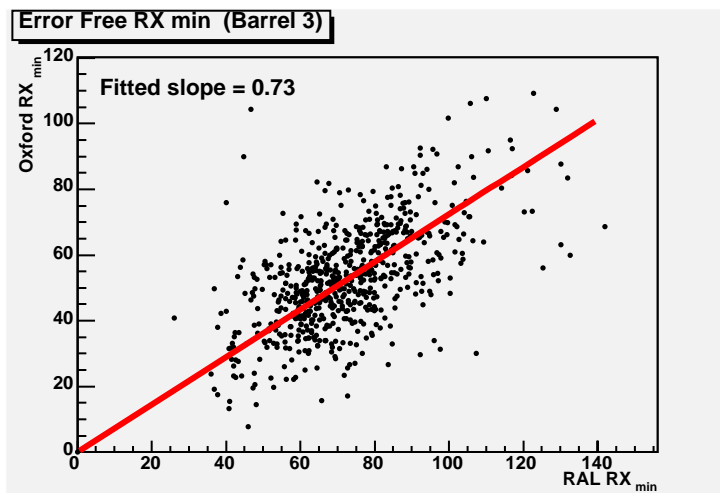
**Figure 25. Correlation of RXmin values from the RAL reception tests and the Oxford on-barrel tests. The data are for modules from barrel 3.**

the comparison is shown in Figure 25 and shows a very strong correlation as expected. The slope is less than one because the values of RXmin determined at Oxford was based on only 10 triggers, whereas the corresponding value determined at RAL was based on 32768 triggers. The stability of the optical links was analysed by comparing the RXmin values from two different tests of the links on B3 and the resulting distribution is shown in Figure 26. From this distribution most of the data links showed very little change and the RMS of the distribution of changes was 12 counts. However some links did show much larger changes. It was checked that the reason some channels show very large changes was due to them being run at different VCSEL currents.

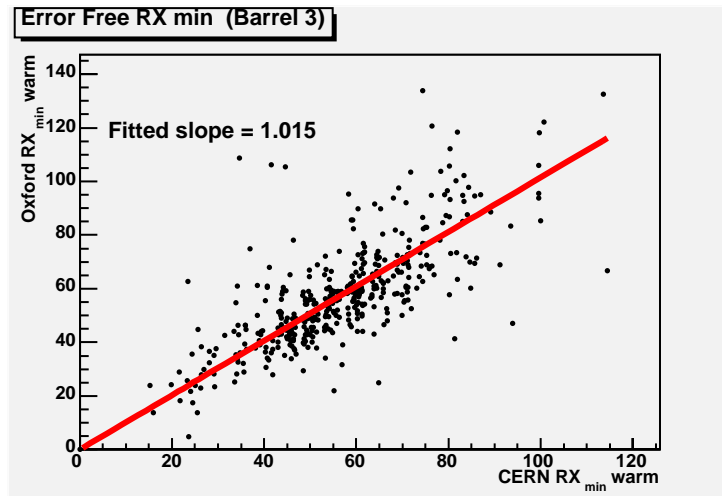
**Figure 26. Correlation of RXmin values from measurements performed at Oxford and CERN. The data are for modules from barrel 3. Different conditions were used for the cooling system in these two measurements, which resulted in small temperature differences.**

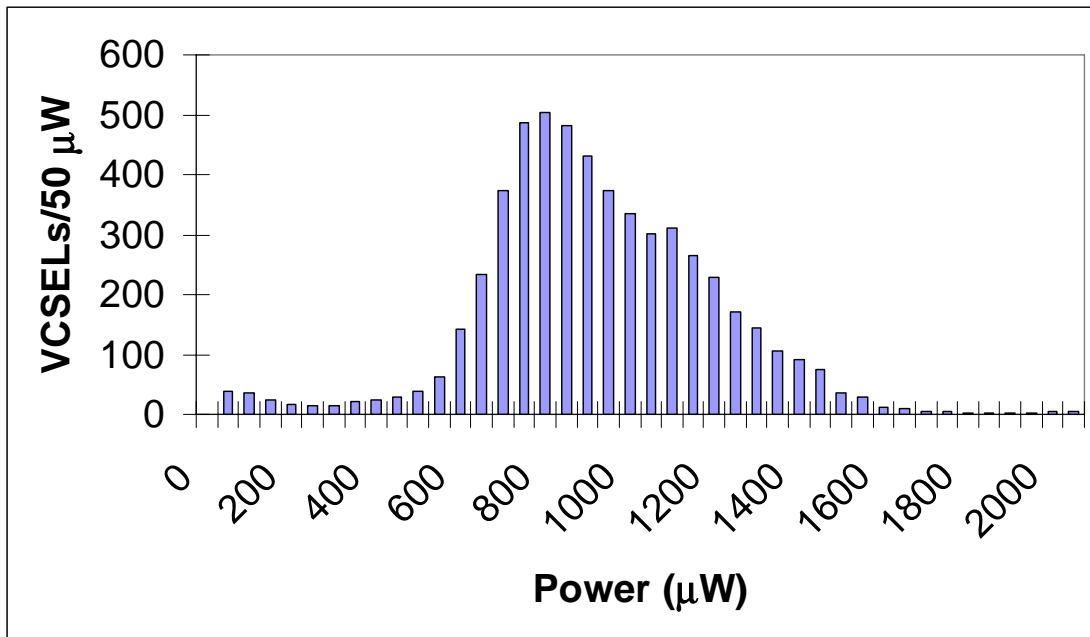
**Figure 27. Distribution of fibre coupled optical power for the VCSELs on TX plug-in PCBs. The data corresponds to the average power and is not corrected for the 50% duty cycle. The drive current was 10 mA.**

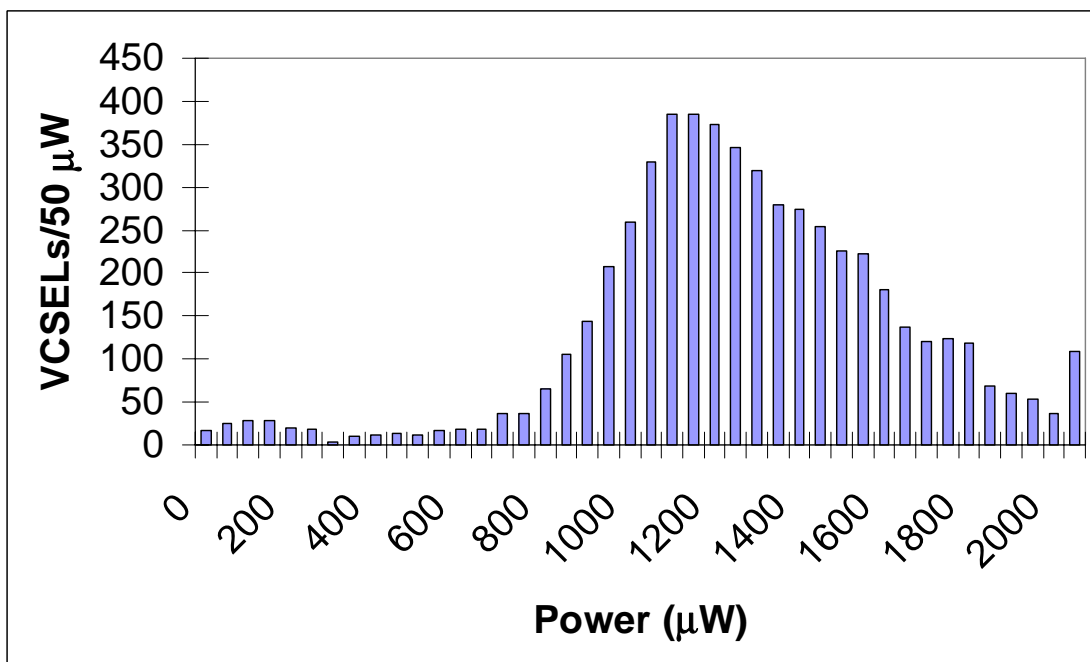
**Figure 28. Distribution of fibre coupled optical power for the VCSELs on TX plug-in PCBs. The data corresponds to the average power and is not corrected for the 50% duty cycle. The drive current was 15 mA.**

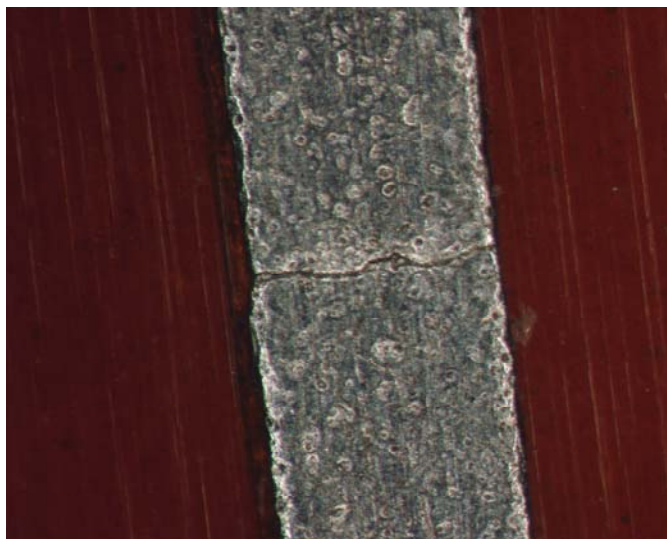
**Figure 29. Crack on an HV line of an Al/kapton LMT.**

A very serious problem with cracks was found for the LMTs. There were no problems with the basic Al/kapton tapes, but it turned out that the ends of the tapes were very fragile. The ends were electro-plated with a thin layer of Ni to allow a layer of Pb/Sn solder to be electro-plated (see section 4.7). The tapes were then soldered to PCBs. A typical example of a crack in a 500  $\mu\text{m}$  wide trace is shown in the photograph in Figure 29. The crack is not straight and is believed to follow the grain boundaries. In order to simplify the production of LMTs, they were made in bins of length so that tapes from a given bin could be cut back to the required length. Therefore a longer length of plating region was required, which meant that the fragile plated region was exposed and could be damaged by bending. For the barrel LMTs a low rate of these cracks was found. The numbers of failures due to cracks in LMTs found at the different QA stages for the 4 barrels are summarised in Table 14. The higher rate of failures found for barrel 3 harnesses was probably due to the extra re-work required to fix the solder connection problems (see section 8.1).

In order to avoid lengthy delays to the schedule, it was decided to try to do in-situ repairs for these failures. In the case of failures of one of the voltage sense lines, the sense line was short circuited to the relevant signal line on the PPB1 PCB. This creates a small error in the voltage sensing, which can be corrected for in the software that controls the power supplies. Failures due to a crack in one of the two VCSEL supply voltage lines were fixed by shorting the two control voltages for the two VCSELs on the opto-flex cable. In the cases of failures on other lines, a short length of wire was used to make an electrical connection over the crack in the LMT.
