# The ATLAS SCT Optoelectronics and the Associated Electrical Services

Keywords: LHC; ATLAS; SCT; Optoelectronics; Data transmission; ASICs.

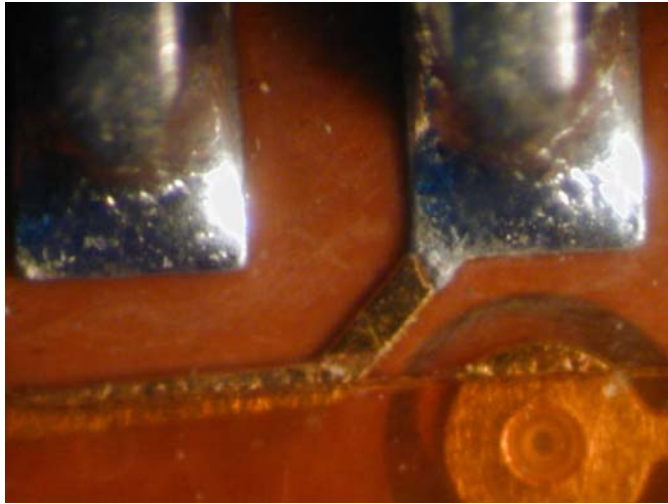
**Figure 30. Photograph of a crack on a copper/kapton opto-flex circuit.**

Some problems with cracks were found in the barrel kapton opto-flex circuits. An example of a crack is shown in Figure 30.

The cracks tended to occur because the layouts were not optimised for robustness. This happened because there was insufficient time for the detailed optimisation of the layout. The cost in time and money of remaking all these circuits was prohibitive. It turned out to be possible to use ceramic stiffeners behind the connectors as a work around for this problem. Also special tools were designed to allow the test PCBs to be mated and de-mated without stressing the fragile region of the flex. However if there had been fewer flavours of flex circuits to design, it would have been possible to optimise them to avoid these problems.

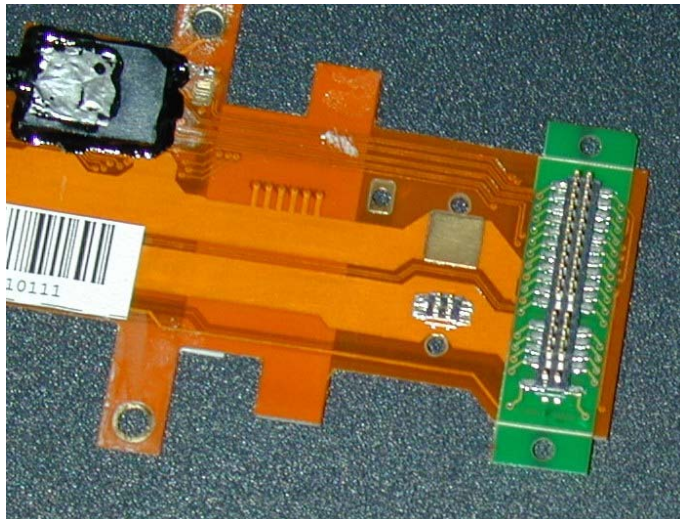
**Figure 31. Photograph of part of barrel opto-flex circuit showing the tPCB to displace the location of the electrical connector to the module.**

There was a mistake in the geometry for the layout of the flex circuits for two of the four barrels. The result was that there was a lateral error of 2.8 mm in the location of the connectors for the module. This was only discovered after nearly all the harnesses had been assembled. This required connectors to be removed from the flex circuits and special translation PCBs (tPCBs) added to the flex circuits as shown in Figure 31. These problems could have been avoided if a simpler design had been used.

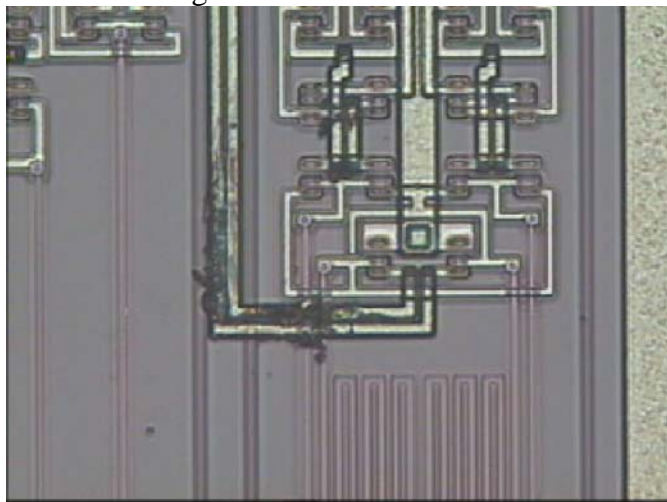
**Figure 32. Microscope photograph of a part of a DORIC4A ASIC, showing clear evidence of ESD.**

The VCSELs, PIN diodes and ASICs are well known to be sensitive to Electro Static Discharge (ESD). Therefore, standard precautions against ESD were implemented at all stages. The first ESD problems found were with the DORIC4A ASICs which were wafer tested before being assembled onto the flex circuits. The low yield of the DORIC4As after this assembly was eventually traced to ESD. A classic example of ESD damage on an ASIC is shown in the photograph in Figure 32. All the assembled opto-flex circuits were discarded, the ESD precautions improved and this problem was not seen again.

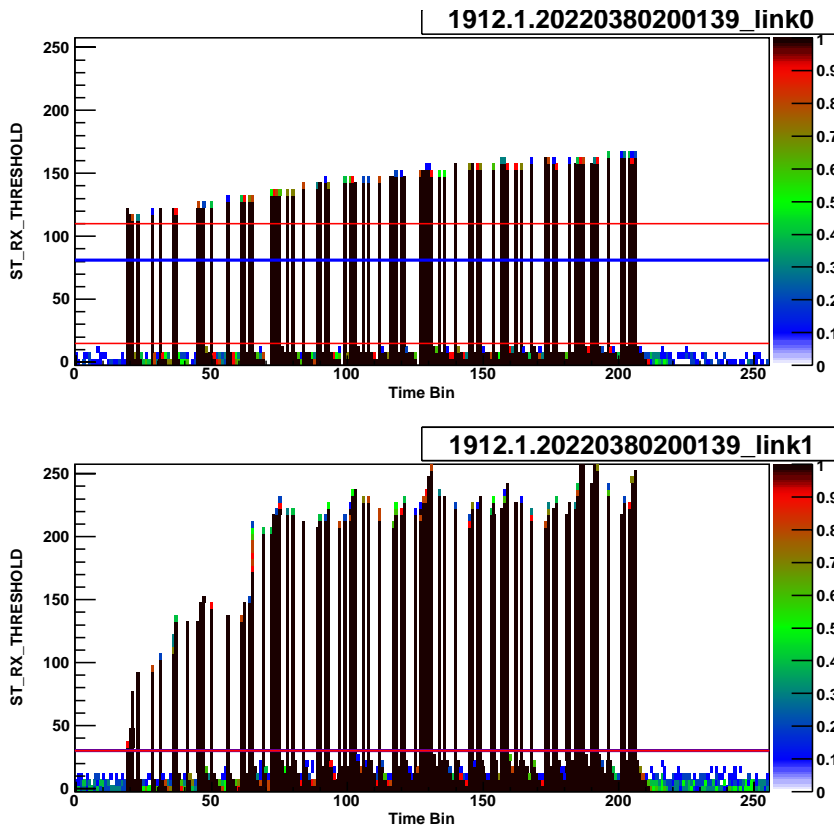
**Figure 33** BER scans of RX DAC threshold for the two VCSEL data links of a module on barrel 3. The lower plot shows the most extreme case of a slow turn on VCSEL found (for the barrels) and the upper plot shows a normal channel. The thin red horizontal lines show the value of RXmin and RXmax and the thick blue horizontal line shows the value of RXoptimal. For the lower plot, there is no visible separation between the values of RXmin and RXmax.

Apart from the clearly dead VCSELs, a few were found to have a slow turn on. An extreme example of this is shown in the BER scan in Figure 33, which should be compared with a similar scan for a module with two good VCSEL channels in Figure 24. It is clear that the light output is increasing significantly at the start of the burst of data. This effect was not seen in any of the previous QA because the tests were either DC or used pseudo-random bit streams which did not have a long gap between data. For this extreme case of this slow turn on, it was not possible to find any setting of the RX DAC for which this VCSEL channel could be used. Therefore the data from this side of the module will be readout using the other VCSEL channel on the module.
