AN INQUIRY INTO
the **Death** of **Ten Tannery Workers**
at the **Common Effluent Treatment Plant**
in **Ranipet** Tamil Nadu
on **January 31, 2015**

A Fact-finding Report by Cividep India

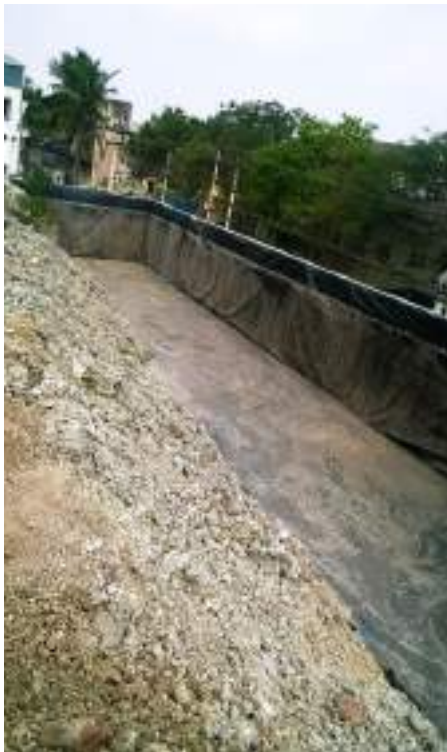
Solid sludge storage tank that broke-15ft high x 100 ft wide x 800mts long (L shaped)

By design, the SLF tank is supposed to store only solid rejects. It was built six months ago around an existing SLF tank that had reached capacity. The new tank was 800 feet long (L-Shaped), 100 feet wide and had 15 foot high walls. The CETP's failure to ensure scientific design and construction, and slack supervision of the effluent management process are likely to be the immediate reasons for the mishap.

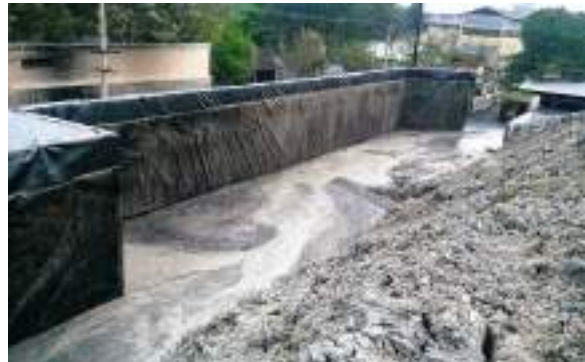
View of the broken wall that could not withstand weight of liquid. Chemical reactions increased pressure.

The wall breached when it could no longer sustain the pressure of the volatile liquid slurry. The TMMK, trade unions, local media sources, engineers at the CETP and workers have alleged that the thickness of the wall was only 9 inches, whereas regulation requires it to be built in a tapering manner with a broad base. Moreover the tank lacked a strong

foundation, and the walls were not supported by pillars. Steel rods with a diameter of 22 mm to 26 mm and with anti-corrosion properties are supposed to be used in its construction. However, rods of only 6 mm or 9 mm diameter were used.

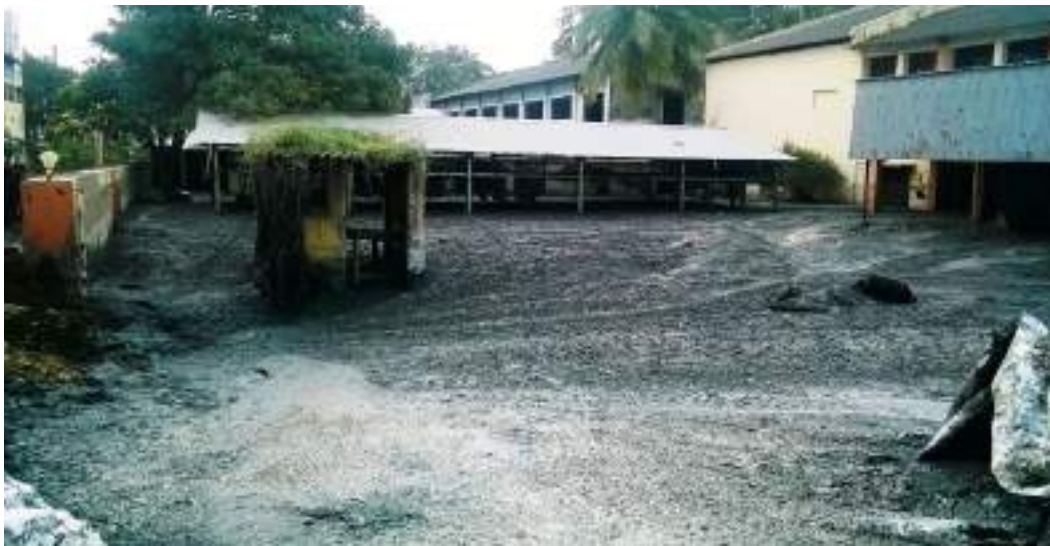
Security room and place (leather storage shed cum accomodation). 10 workers were sleeping and drowned in the sludge at 12.50am on Saturday.

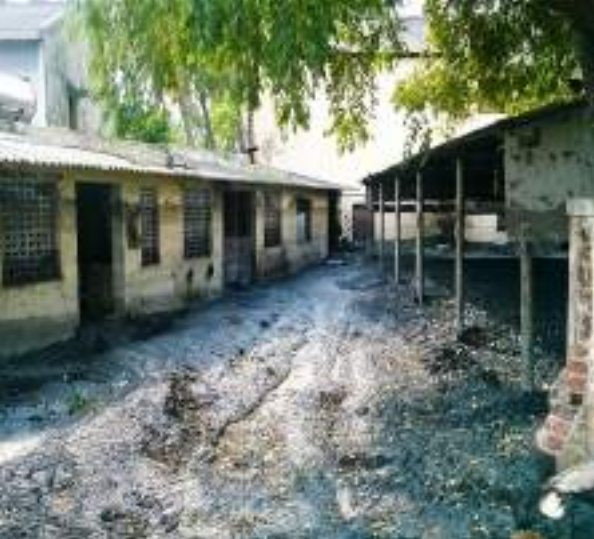
W.B Workers were sleeping in the room (on left) in leather drying shed (on right). Slurry was 8 ft high, marks can be seen.

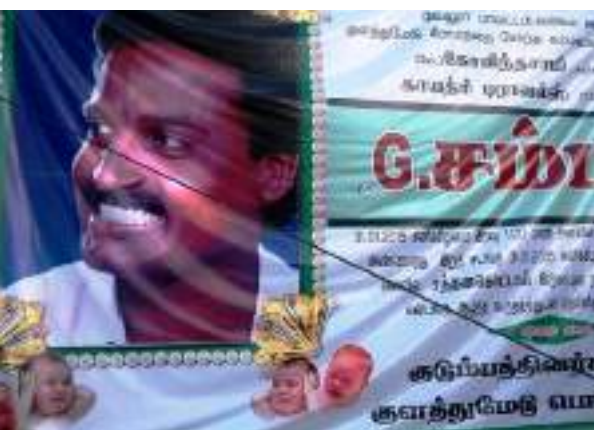
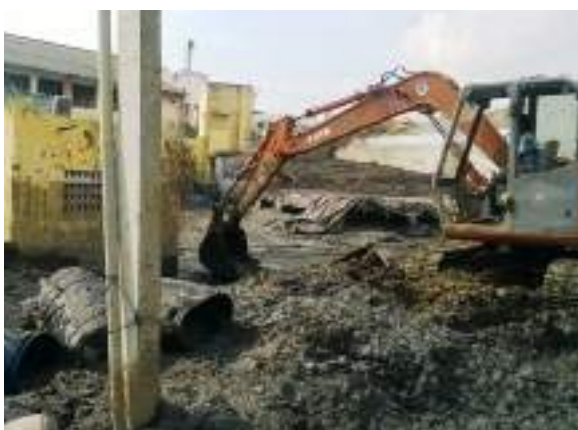
Security Room where Sampath, a security guard from Kannamangalam in Arcot District died. He worked at Arkay Leathers next to CETP. Has three children. One child is suffering from cancer.

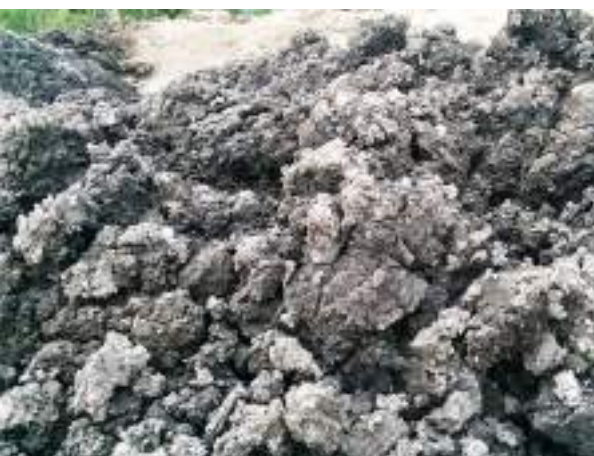
Tank was constructed to store solid sludge containing less chemical contents

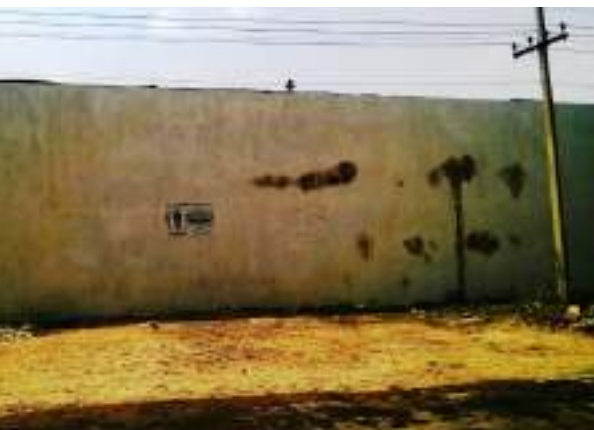
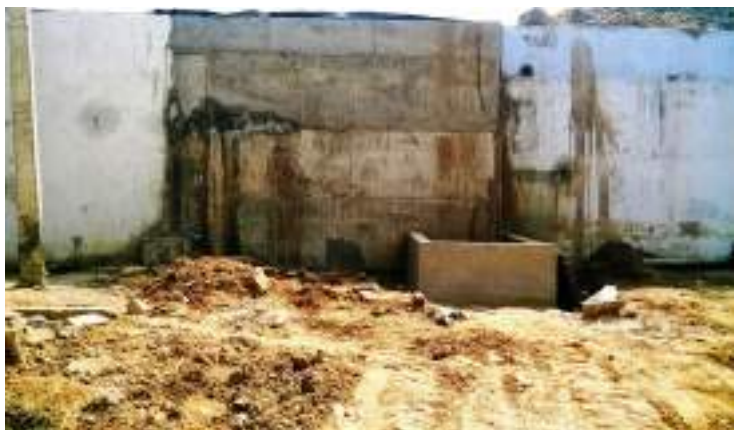
View of the patch works. Tank is six months old-Suffered frequent leaks-Walls patched and small tanks built to collect the leaking effluents.

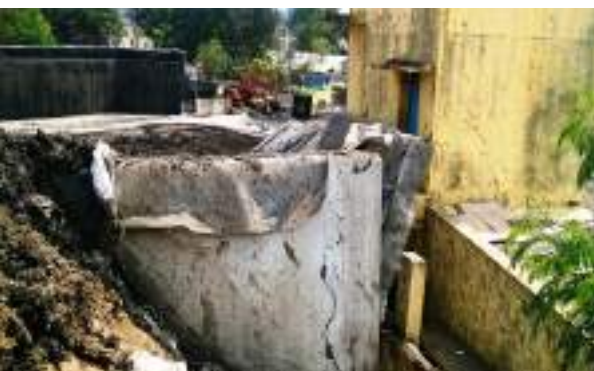
Broken wall-Thinner than the required thickness. Rs. 3.5 crores was sanctioned, but only Rs. 1.25 crore was spent for construction.

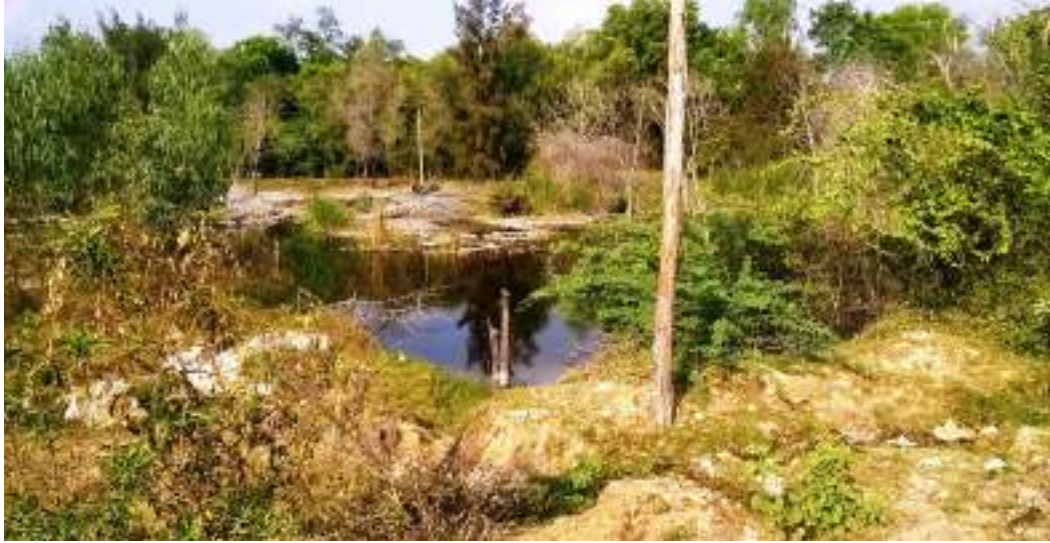
Effluent from CEPT flowing amidst green and thick vegetation.

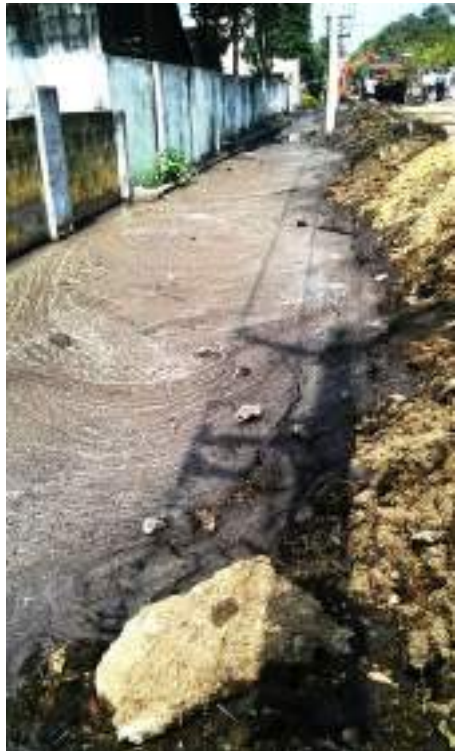
Sludge flowing into the drains

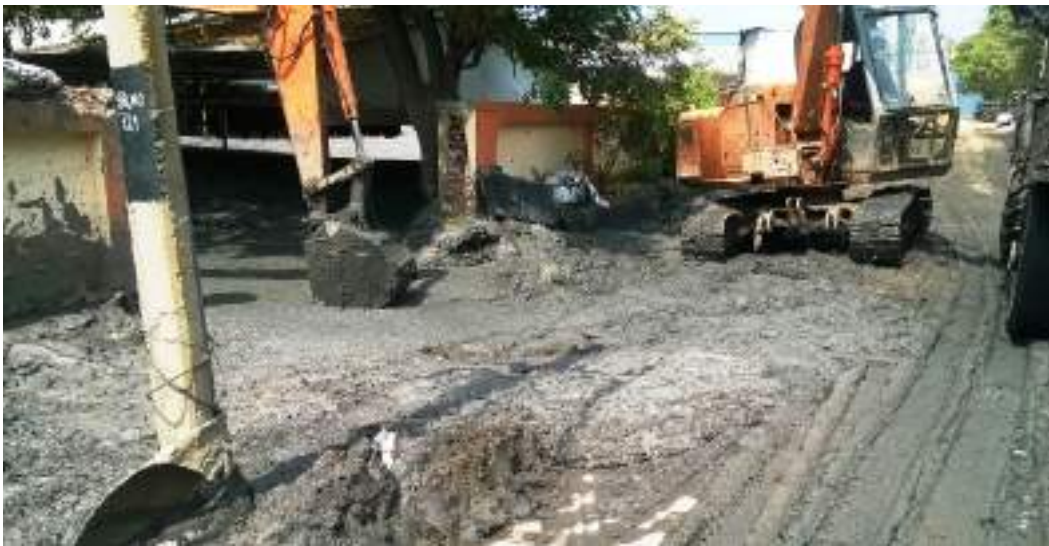
JCBs clearing the sludge-3rd day after the tragedy
