WHAT IN EARTH IS GOING ON?
BALANCING RISK, REWARD, REGULATION AND REALITY

20th Symposium of the New Zealand Geotechnical Society

Napier 2017

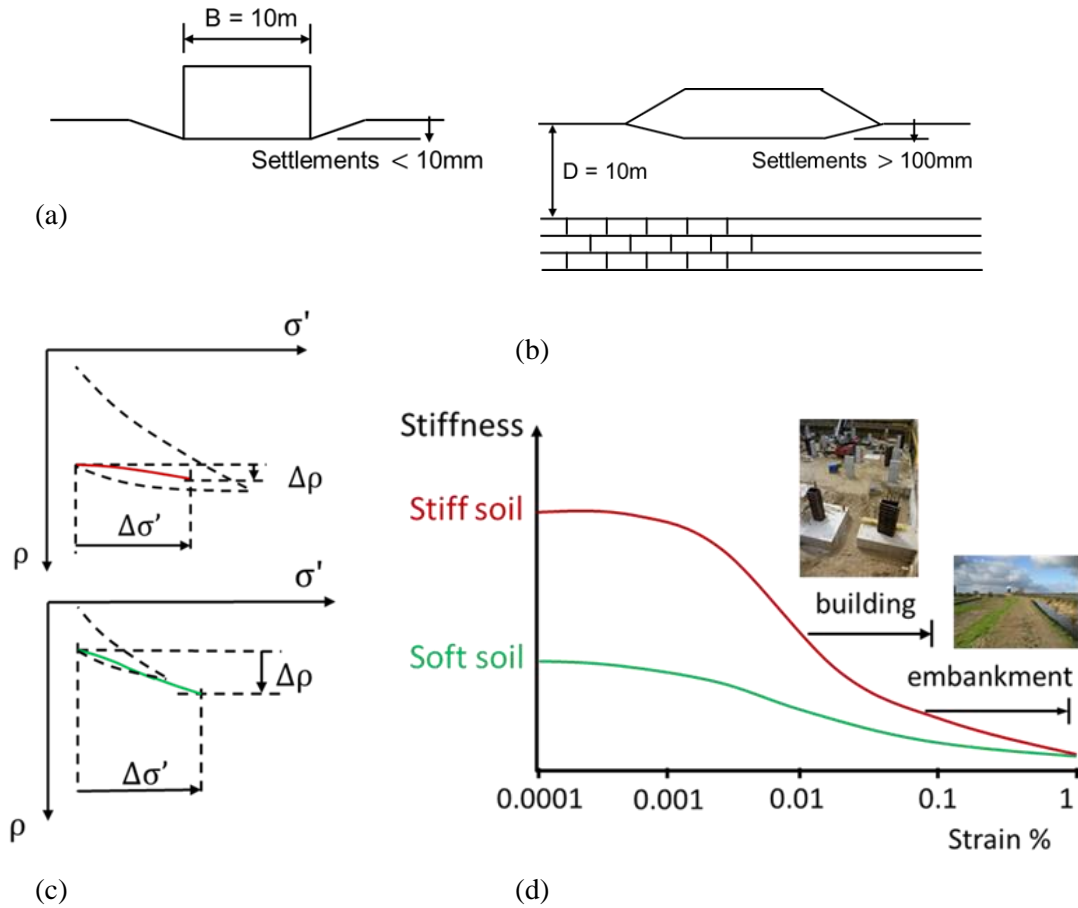
The strains resulting from the same loading $\Delta\sigma'$ are illustrated in Fig 9(c) and the corresponding stiffness decay curves are illustrated in Fig 9(d). The initial state of the soft soil is close to the normal consolidation line so the embankment loading moves the state from lightly overconsolidated to normally consolidated. The initial state of the stiff soil is far from the normal consolidation line and the state remains overconsolidated throughout the foundation loading.

Figure 9: Settlement of structures on stiff and soft soil

Buildings and embankments apply similar bearing pressures, typically 100 to 200kPa. An embankment can tolerate relatively large settlements of 100mm or more and can be built on soft soil. If the depth of soft soil is 10m the strains are of the order of 1%. Most buildings can tolerate only relatively small settlements of the order of 10mm and for a foundation 10m wide the mean strains are of the order of 0.1%. Shallow foundations can only be built on stiff soil so buildings on soft soil are most often on piled foundations.

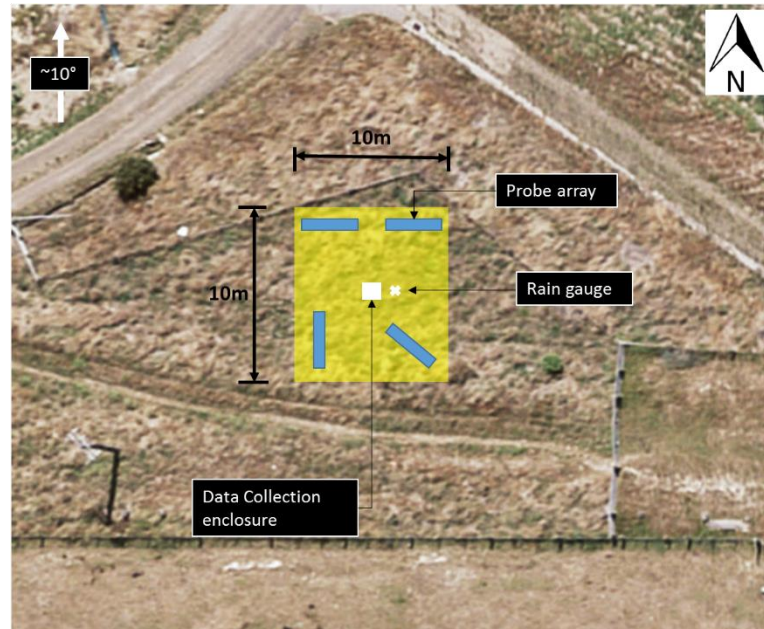
Figure 3: Field monitoring site at Takamatua showing the location of the *in situ* instrument arrays. Site slopes towards the north.

Data will be collected using a Campbell Scientific CR1000 data logger. Sensors will be installed in four arrays across the site (Figure 3). In each array there will be three CS-616 and three MPS-6 sensors. These sensors will be installed at three varying depths to capture progression of the wetting front during and after rainfall events. The data logger and rain gauge will be installed at the centre of the site.

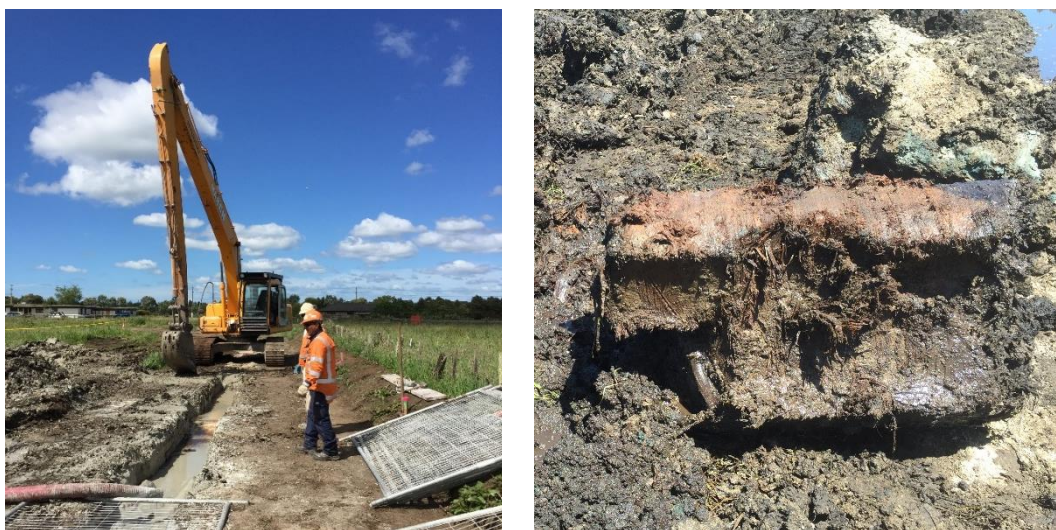
Figure 7: Slurry wall installation and obstruction removal

The primary issue on the site was the extensive buried timber obstructions typically encountered between 2m and 4m depth. These tree trunks were in some cases up to 2m in diameter and several metres in length. From a design perspective it was not acceptable to leave these obstructions encapsulated in the slurry wall as future excavation or degradation would compromise the integrity of the slurry cut off wall. Following a probing exercise, it was possible to re-align the wall around some of the obstructions where the site delineation and development extents permitted. Where this was not possible coring was carried out to cut and remove the obstruction; using light weight plant given the low bearing capacity crust / working platform.

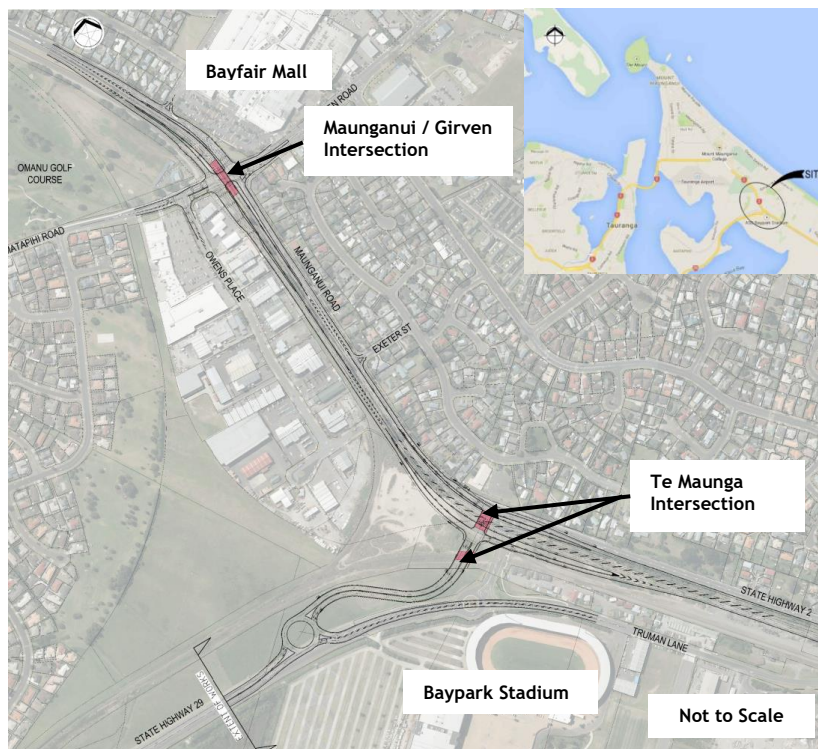
Figure 1: Project layout plan

The project layout is shown in Figure 1. The project features a 3 span flyover at the Maunganui/Girven intersection and 2 single span bridges at the Te Maunga intersection, with significant lengths of MSE type approach embankment. The estimated project cost is \$100m.

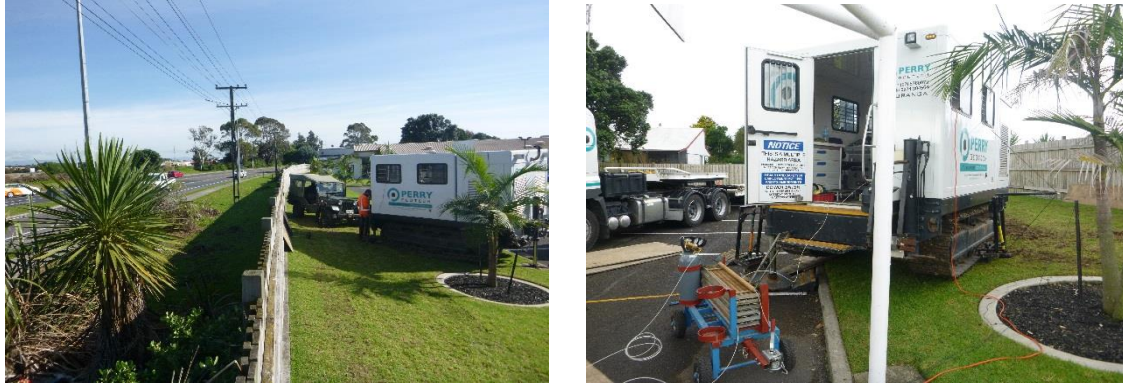
Figure 3: sCPT / sDMT field testing

The approach followed, for obtaining good quality data with the sCPTs, was to establish suitable controls during data acquisition. The V_s data was captured using specialist software (SC3-DAC Pro™) that allowed field checking of the data during acquisition. For example, the operator was able to check the signal to noise ratio as the data was acquired and assess the quality of the data ‘on the fly’. If poor quality data was acquired then the test could be repeated at that depth, until an acceptable data quality was achieved, before advancing the CPT probe further. Another control put in place was to observe potential sources of interference during testing, e.g. from heavy vehicles on the highway or trains passing nearby. Testing could be halted, repeated or rescheduled if necessary.

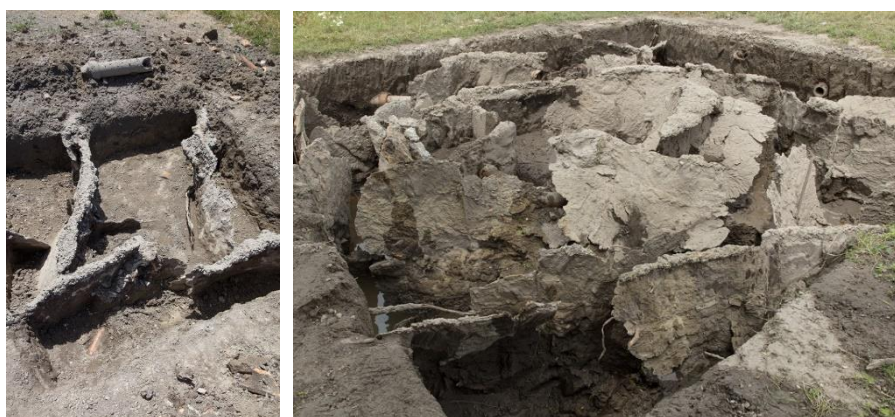
Figure 1. Hand-exhumed resin veins (left) and hydro-exhumed resin veins (right).

The low viscosity resin is injected at controlled pressures and penetrates the soil mass along pre-existing planes of weakness or through fracturing of the soil mass. The resin also permeates the soil mass to a limited extent depending on the porosity of the soil. The resin mix chemically reacts soon after injection (at controllable 'rise' times). The material expands rapidly to many times its original volume and changes from a fluid form to an (inert) solid one. Depending on soil density, confinement pressure, and the resin material selected, the expansion volume can be in the order of 5 – 15 times the injected volume (or more if required). The looser the soil, the greater the expansion for a given resin mix. The expansion of the injected material results in compaction of the adjacent soils, due to new material being introduced into a relatively constant soil volume. The resin injection process has been observed to result in a 'veining' of material distributed through the soil mass as dykes, sills or networks of sheets or plates, typically tens of millimetres thick (refer to Figure 1).

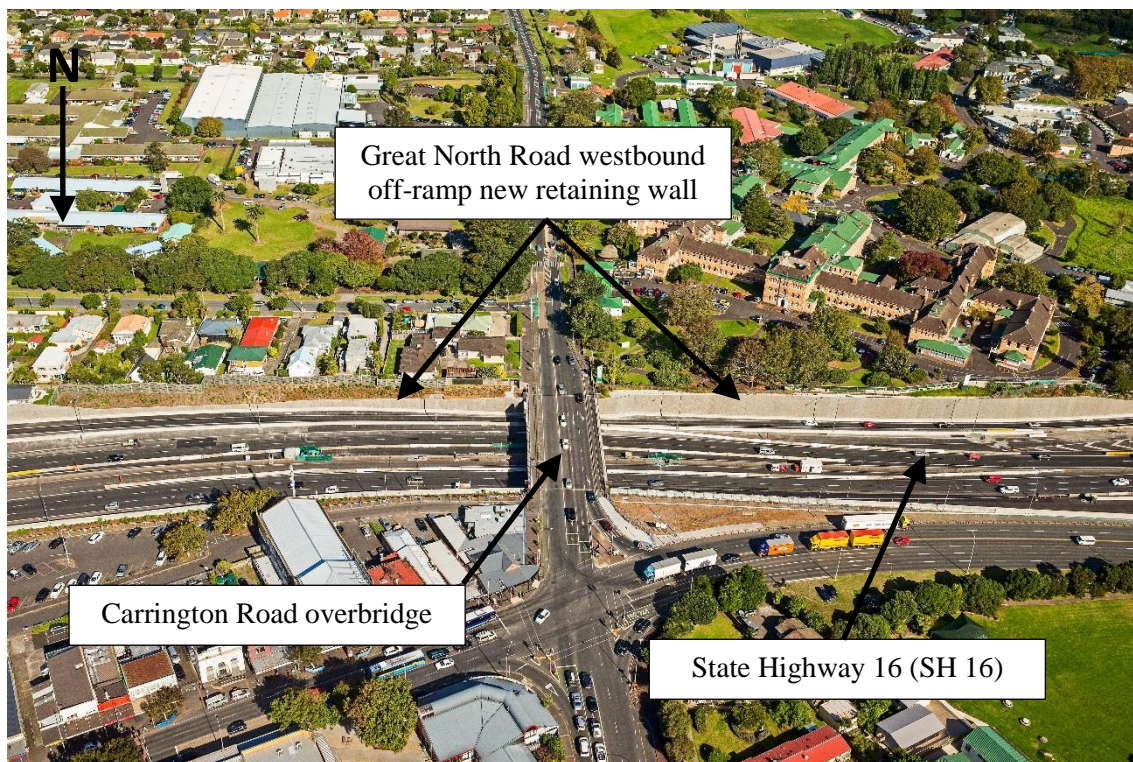
Figure 1: Aerial view of the Great North Road westbound off-ramp new retaining wall

- 1) Cantilevered reinforced concrete bored pile wall structure, which forms about twenty percent of the retaining wall, mainly within the eastern section.
- 2) Carrington Road overbridge retention, which is a retention system provided by the existing Carrington Road bridge south abutment columns.
- 3) Soil nail wall, which makes up the majority of the retaining wall and the focus of this paper.

Figure 1 below shows the aerial view of the completed retaining wall.

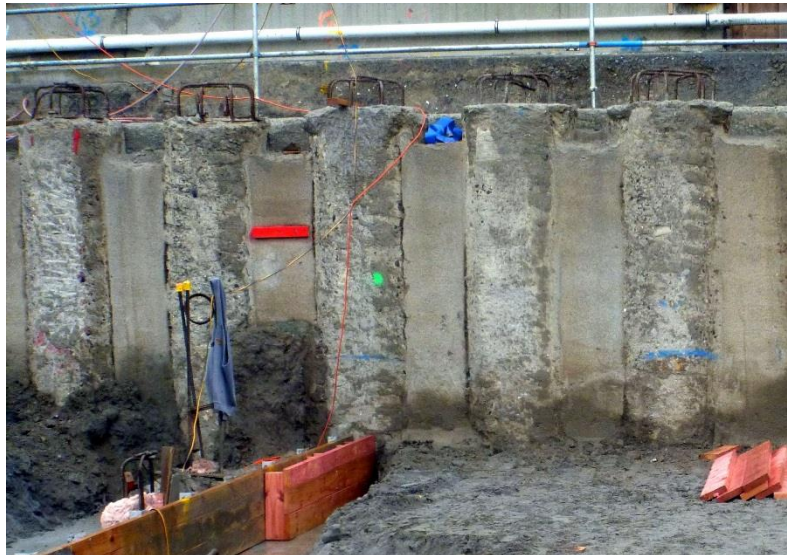
Figure 5. Hard and soft piles following basement excavation

At the Wellington waterfront site the ground improvement was constructed with secant CFA piles. Using hit one and miss one approach at the perimeter wall the unreinforced "soft" piles were formed first using lower strength concrete. The remaining piles were standard reinforced concrete "hard" piles constructed to overlap the "soft" pile by minimum 20% on both sides. The face of the piles following excavation is presented in Figure 5. The perimeter CFA piles created both a cut-off wall and a temporary basement retaining wall.

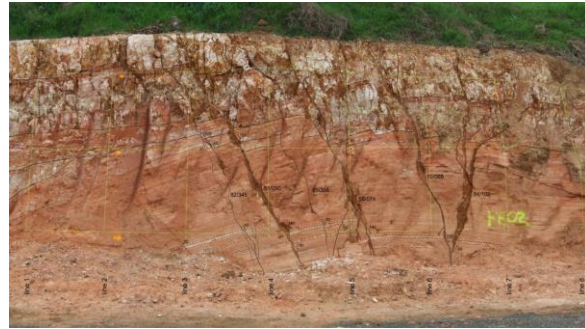
Figure 3. Exposed fault trace near Rototuna, Hamilton City.

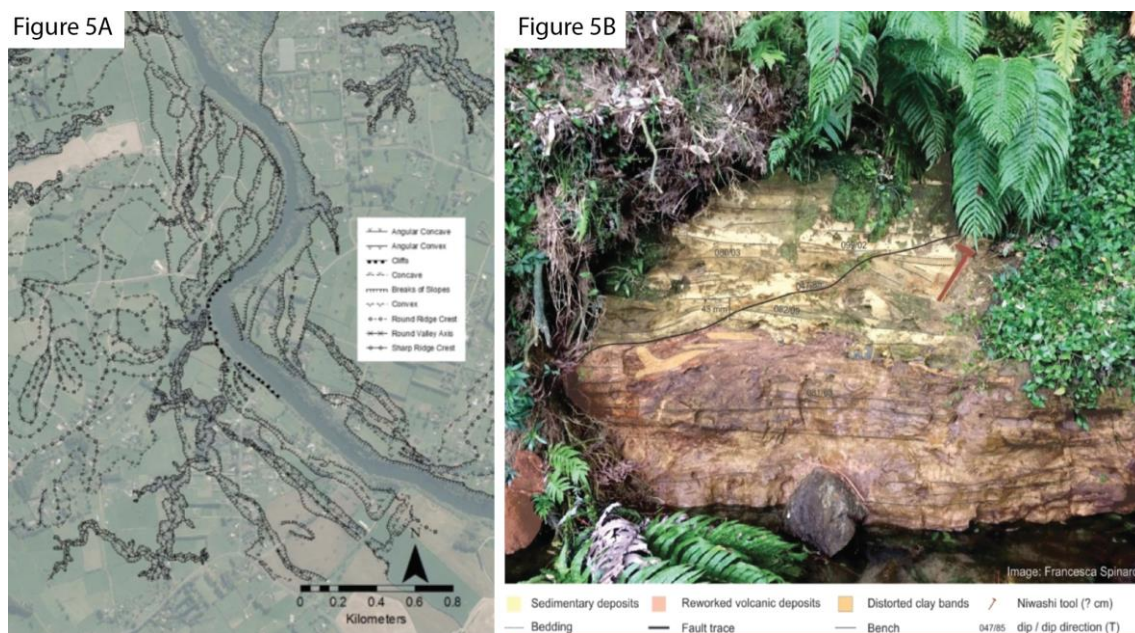
Figure 5. (A) Geomorphic map of Stubbs Road area (location A). (B) Annotated image of small exposed fault in riverbanks near Stubbs Road. Map courtesy Mike Cummins.

One measurable fault alignment was observable on the western bank of the river at 37°49'39.0"S, 175°19'35.2"E, as shown in Figure 5B. This fault offset shallow-dipping sedimentary beds at the base of the sequence, and was marked by ductile deformation of a pale yellow clay layer, together with ironstaining on the fault surface. Measured apparent vertical offset at this site was 43 mm and fault orientation was 85/047 (dip/dip direction, °T).

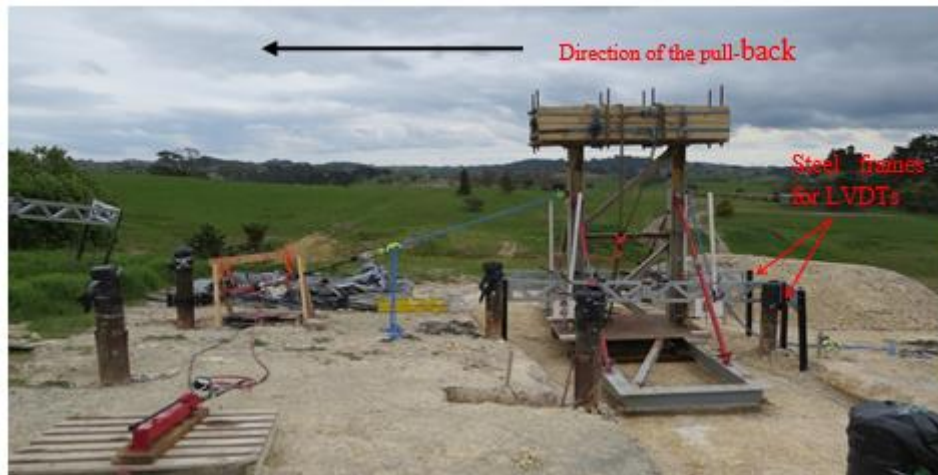
Figure 3: Experimental set-up assembled on site for snap-back test

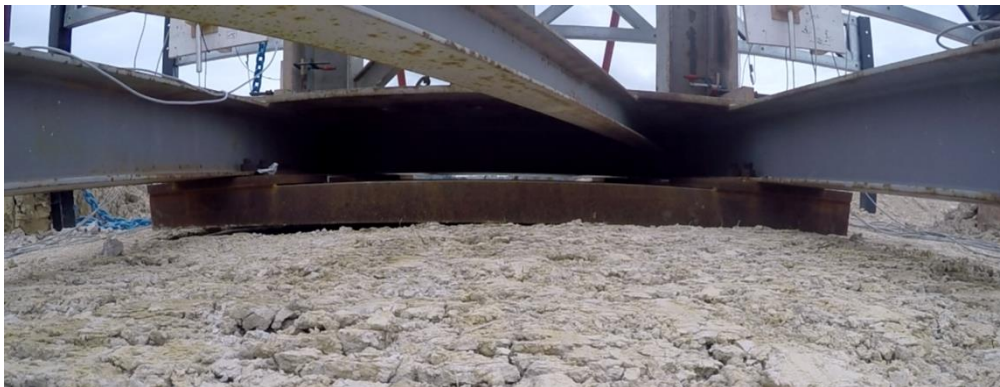
Figure 5: Partial detachment of the footing with the underlying soil

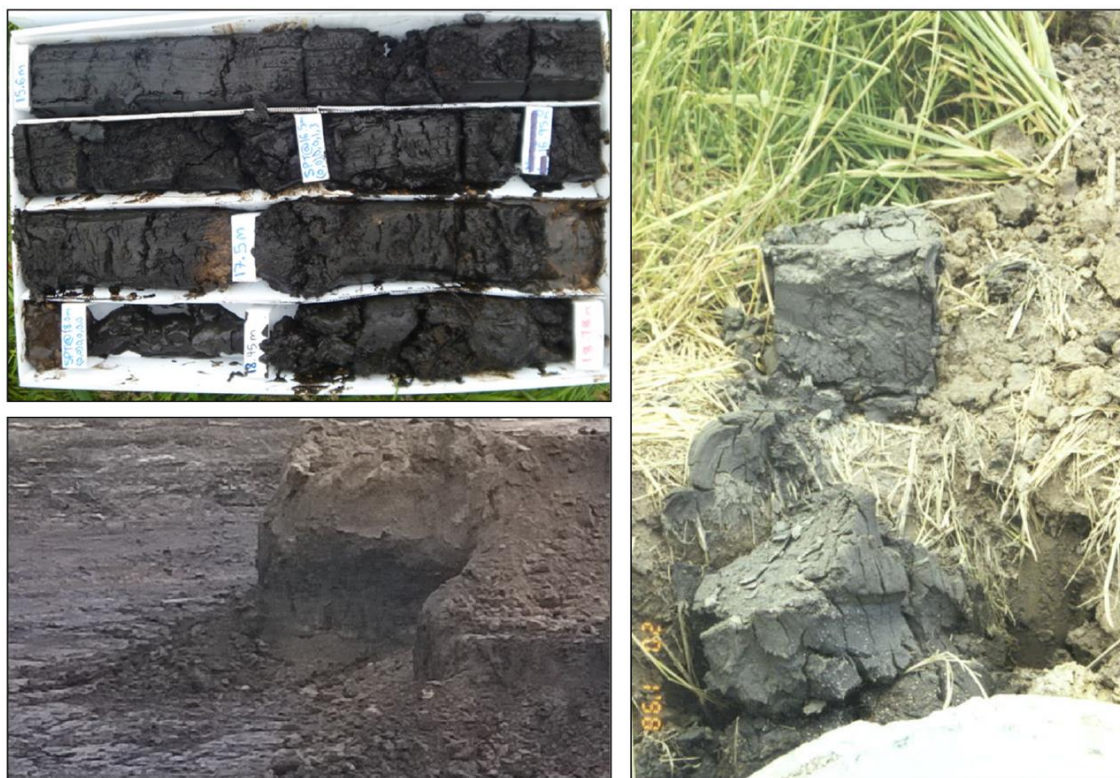
Figure 1: Examples of potential acid sulphate soils

water to form sulphides. This occurs in anaerobic aquatic environments and most frequently in warm, calm, marine environments which are high in organic matter (Macdonald, et al., 2002). Typical examples are shown in Figure 1. These conditions predominantly occur in areas similar to wave-protected mangroves, saltmarshes, outer barrier tidal lakes, and backswamps. The sulphides produced by the reducing bacteria form insoluble fine grained metal sulphides (commonly pyrite) that precipitate out of solution.

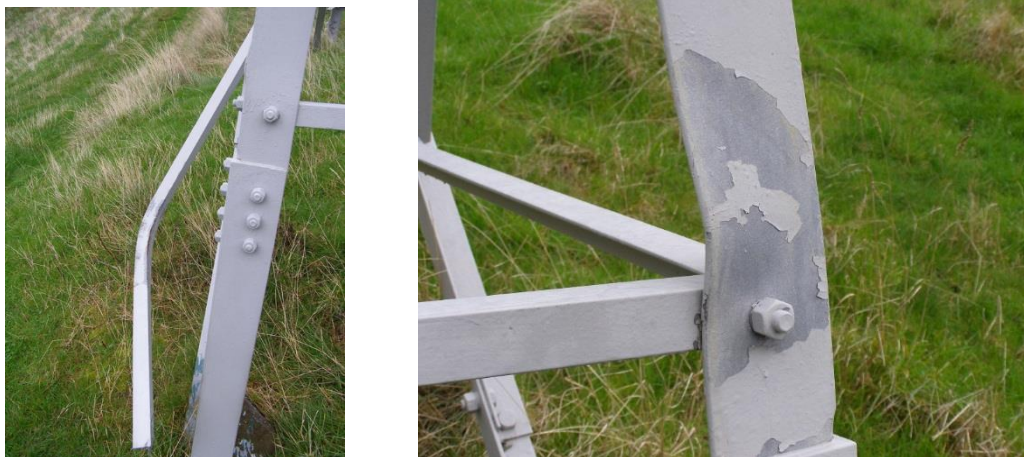
Figure 2: Examples of rock damage to pylon

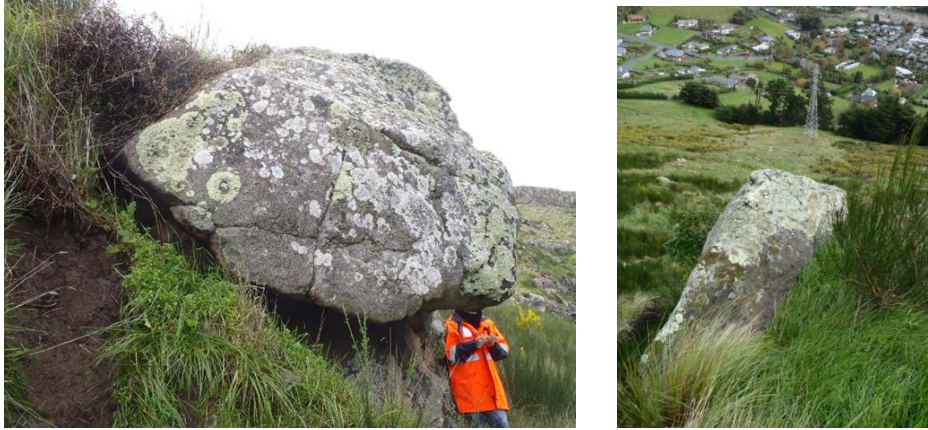
Figure 3: Precarious source rocks identified during walkover

Field mapping, see Figures 3 to 5, identified two types of potential rockfall boulders:

1. Boulders formed by defects in the bluffs (i.e. not yet released);
2. Boulders that had previously released from a bluff onto the slope below and were now supported by soil.

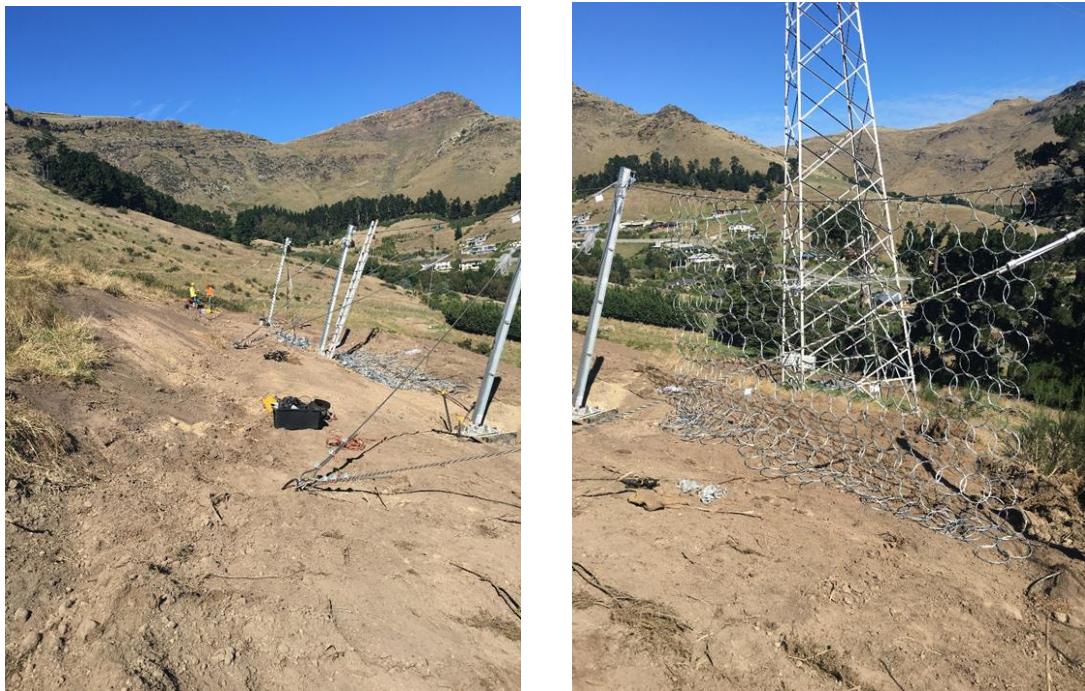
Figure 7: Construction

The rockfall protection fence was constructed by Solutions 2 Access Ltd with a rockfall protection fence provided by Geofabrics. Figure 7 shows the site during construction. Figure 8 shows the completed fence.

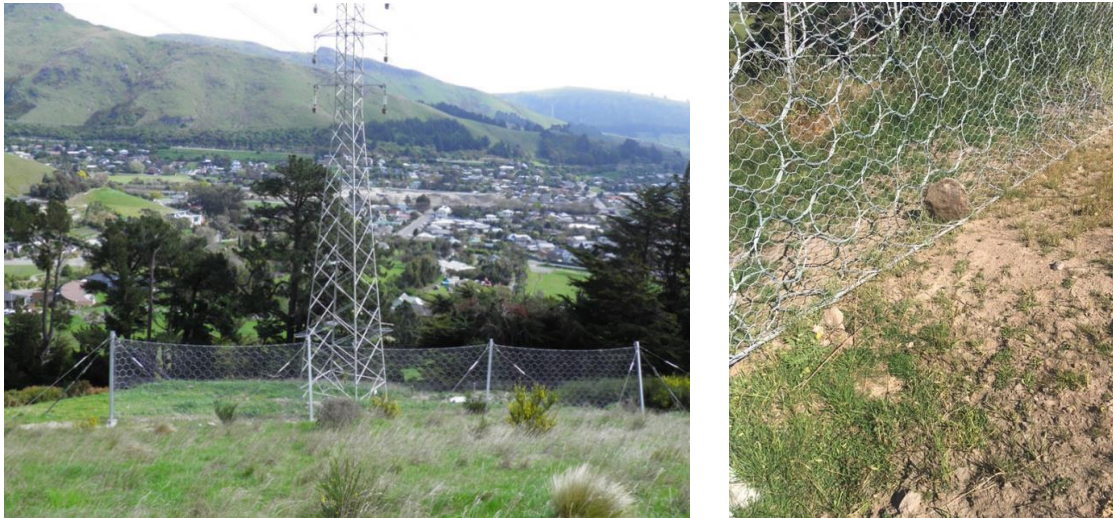
Figure 8: Completed fence

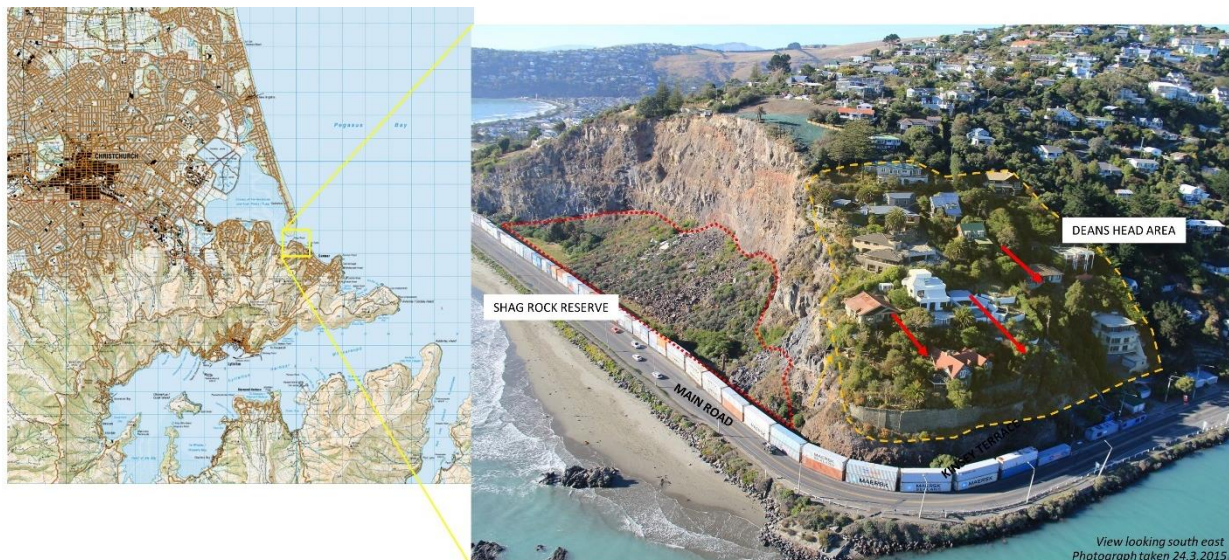
Figure 1: Deans Head and Shag Rock Reserve site areas in relation to Main Road. Indicative movement direction shown in red arrows (LINZ, 2011 and Aurecon, 2015).

Following the Canterbury earthquakes, GNS Science (Massey et al., 2014) identified numerous mass movement areas in the Port Hills. Identified as a Class I mass movement area, the Deans Head area extends approximately 8,300m² in size and contained an estimated 53,300m³ of soil (loess) material that could be mobilised as an earth/debris flow likely to have debris runouts which could cause damage to critical infrastructure, lead to loss or disruption of services and/or loss of life. Based on recorded surface movements and slope displacements across the site area, the landslide direction has been modelled in a northwest direction in relation to the site with trigger mechanisms rain related. Located on a steep sloping hillside, Deans Head has an average slope angle between 25° to 30°. Deans Head and Shag Rock Reserve site locations are presented in Figure 1 including the Deans Head indicative landslide direction.

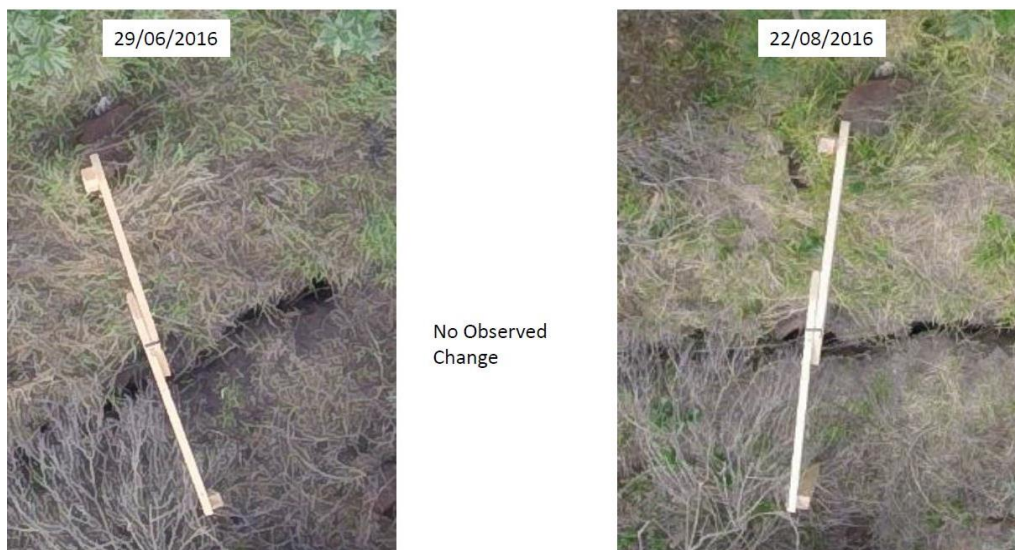
Figure 2: Comparison from UAV images of tell-tale monitoring at Shag Rock Reserve (Aurecon, 2016a).

We developed this visual monitoring to incorporate the simple technique of cliff edge tell-tales or extensometers. During cliff face scaling works, abseil teams installed wooden stakes positioned horizontally across significant ground cracks, see Figure 2. These tell-tales could then be observed periodically using UAVs to visually compare imagery and detect ground movement. This technique reduced personnel accessing close to the cliff edge. Combining UAV technology and tell-tale monitoring simplified work streams and increased monitoring frequency in hazardous locations.

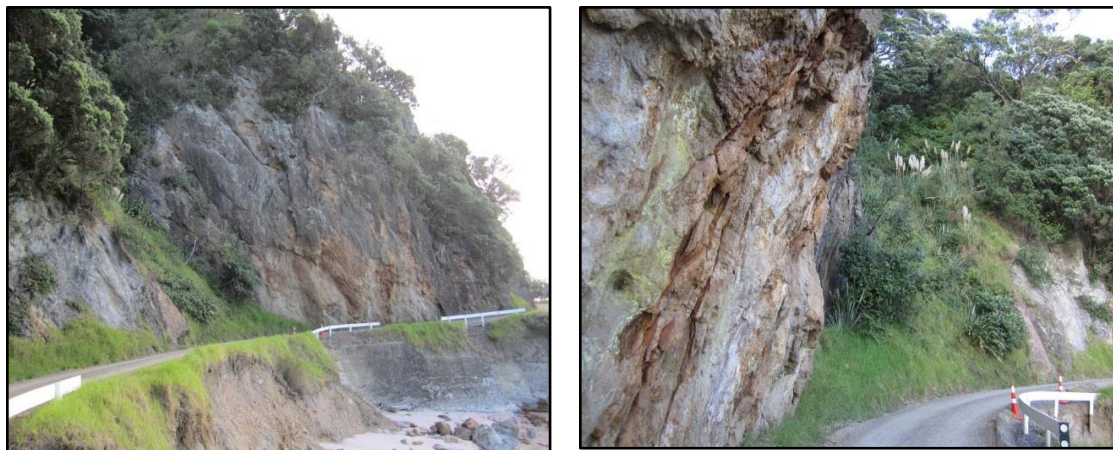
Figure 2: Views of Bluff Road section of concern showing overhang, fracturing and weathering/alteration

The section of road of concern has had a history of rockfalls coupled with coastal erosion which necessitated regular clearance and maintenance of the road. Following erosion and rockfalls associated with cyclone Wilma in early 2011 Thames Coromandel District Council (TCDC) set in train regular inspections and monitoring of the road and rock face.

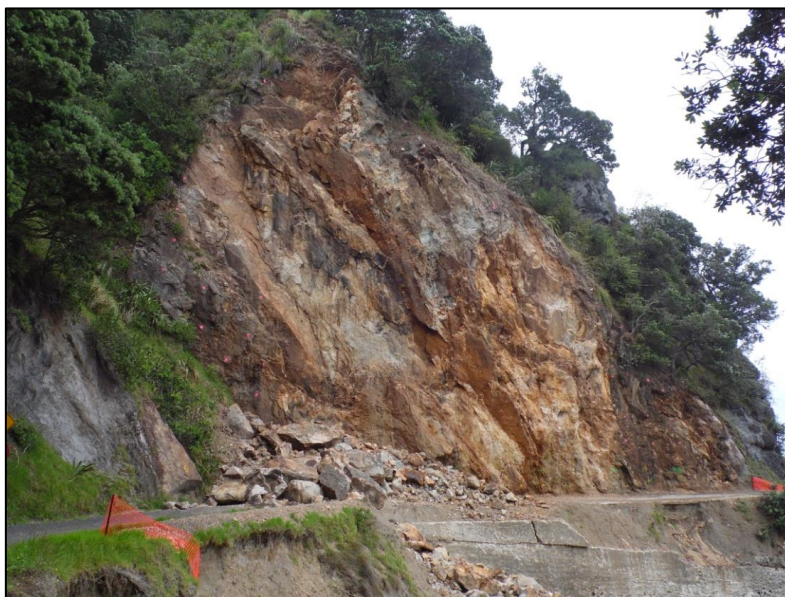
A significant rock-fall occurred after heavy rain on the 25th of December (Figure 4). It is unclear if this was also related in part to the effects of the work, such as blasting and stress relief opening fractures.

Figure 4: Rockfall of 25 December 2015.

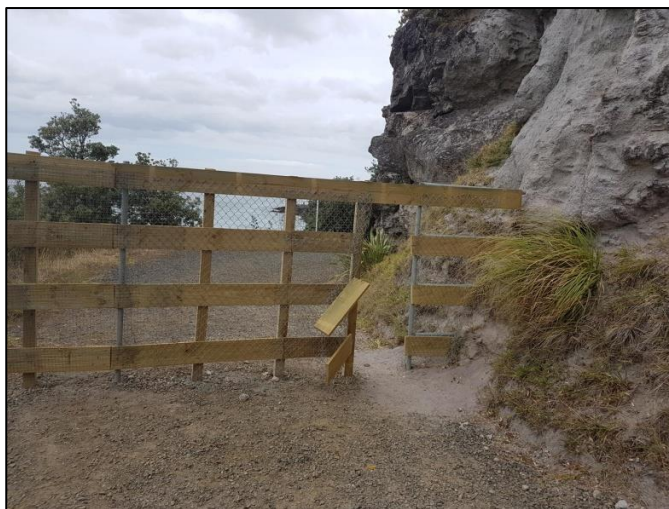
Figure 5: Vandalised fencing

However, over the next year the fences and barriers were repeatedly cut and broken down by members of the public seeking to use the road as a short cut between the two communities and to popular fishing and diving marks (Figure 5 and 6).

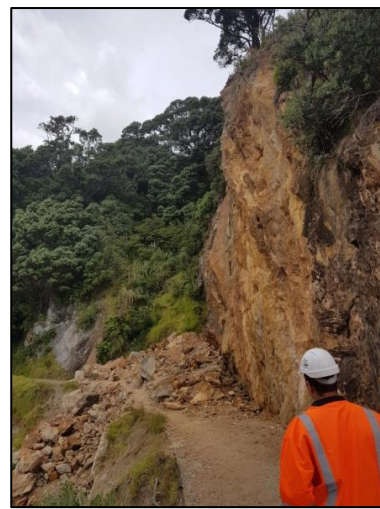
Figure 6: Footpath past debris

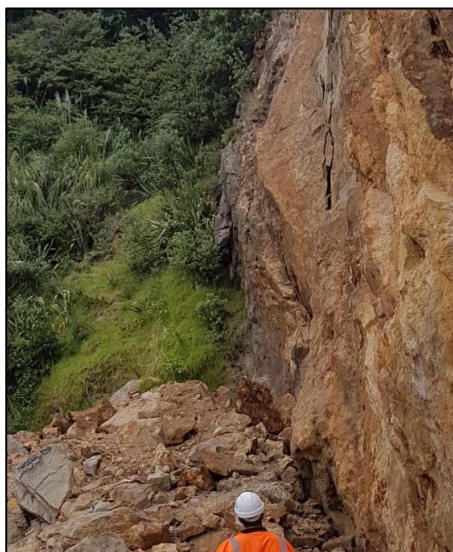
Figure 7: Open fractures above path

This was despite clearly hazardous conditions, as exhibited by wide open fractures, isolated fallen blocks (Figure 7 and 8), signage / barriers and warnings in the press.

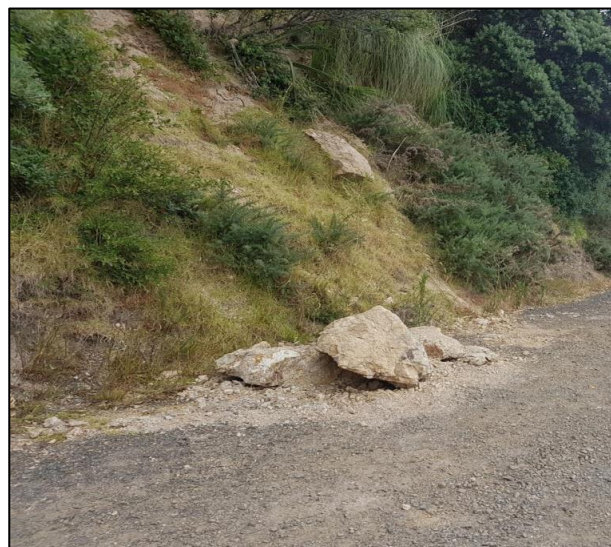
Figure 8: Fallen blocks on footpath

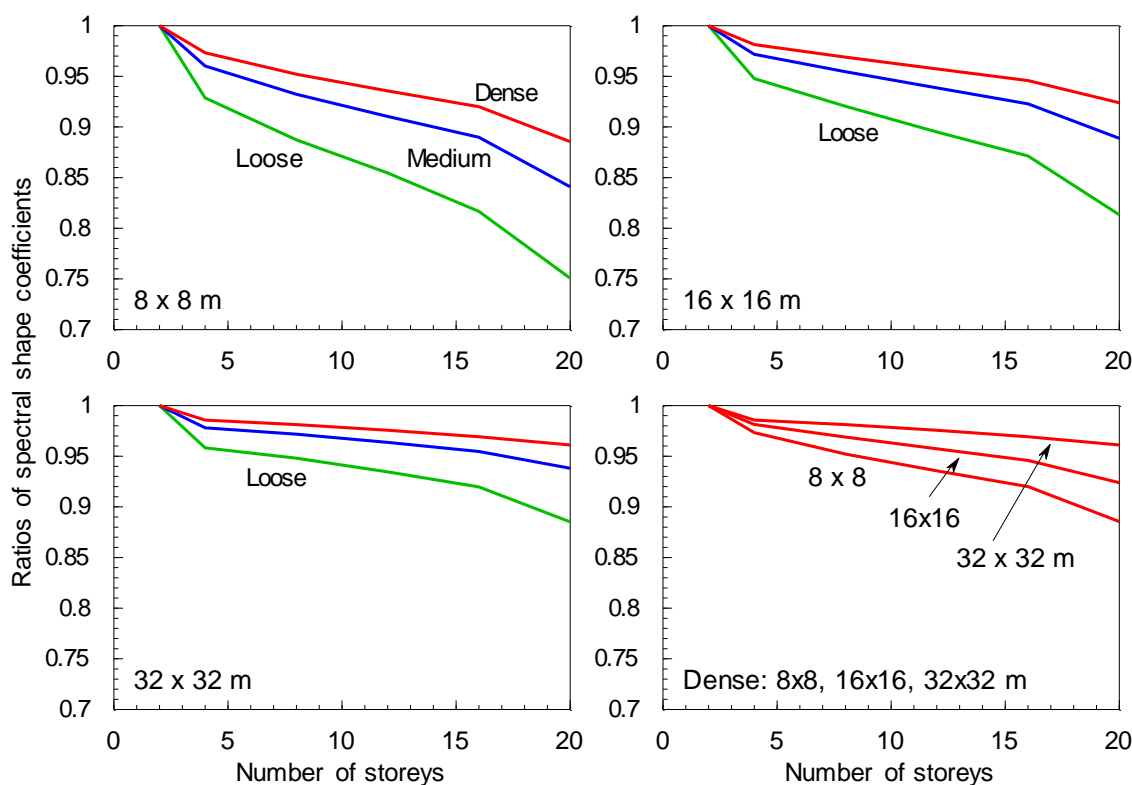
Figure 5: SSI induced reduction in the spectral shape coefficient, expressed as a ratio spectral shape coefficients from NZS1170.5 shallow site condition, for the various building configurations and ground conditions

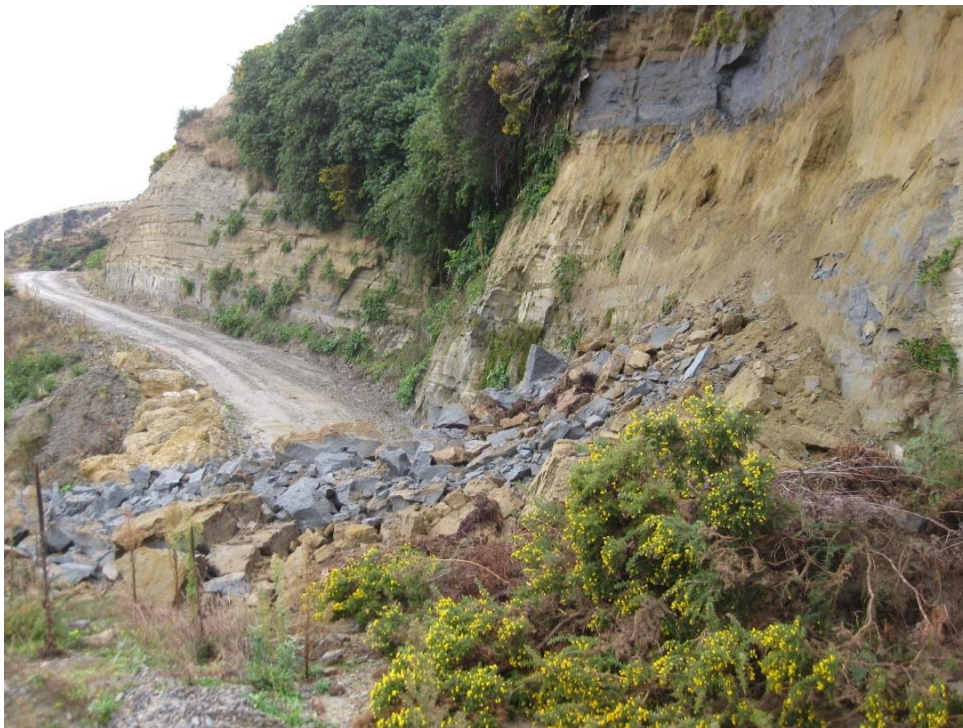
Figure 3: Slip in 2010, debris extending over the access road

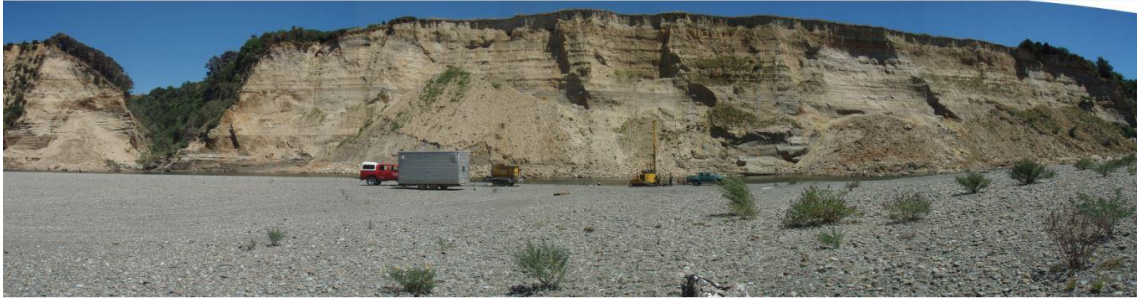
Figure 2: Composite of photographs taken from the opposite true right northern river bank during 2008 feasibility study

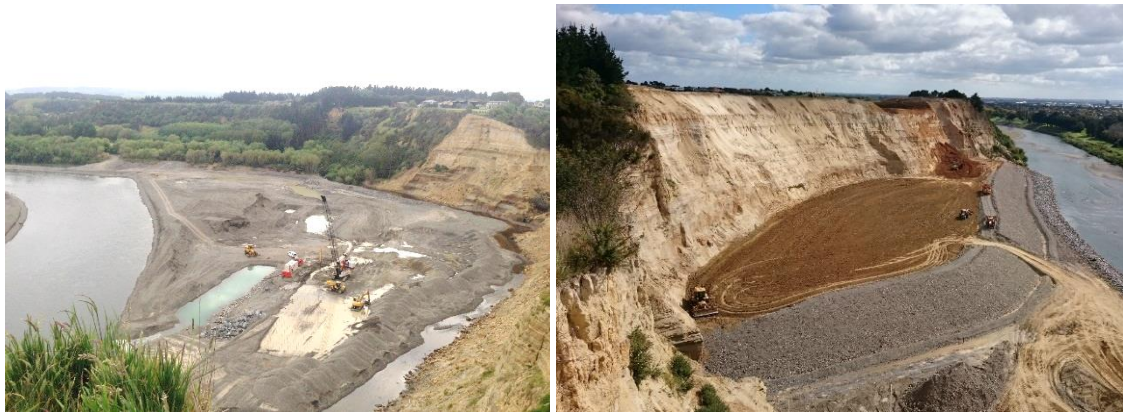
Figure 6: Looking south towards stone column installation, (9 December 2014)

Figure 7: Looking north towards later filling operations (20 April 2016)

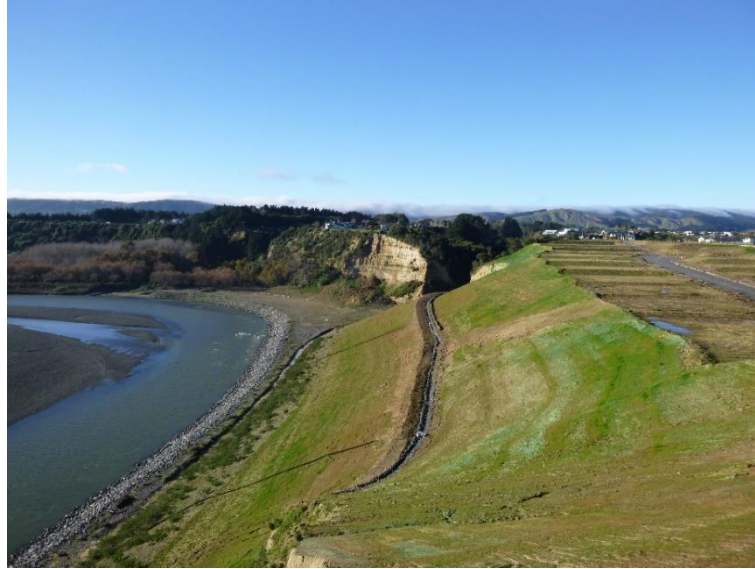
Figure 9: Photograph of completed realignment and cliff stabilisation works

Shallow-seated slumps were observed to occur on these steep cliff slopes where concentrations of surface water occurred. Surface collector drains were installed at the intermediate bench with a piped outlet to the cliff base (Figures 4 and 9). The reshaped slope is proposed to be vegetated to minimise surface water infiltration in the long term and also bind the surficial soils, reducing the risk of rill erosion on the face. To monitor the performance of the fill slope, a series of survey points were set up that are subject to ongoing monitoring for horizontal and vertical movement. To date the slope’s overall performance is within expectations (Figure 9).

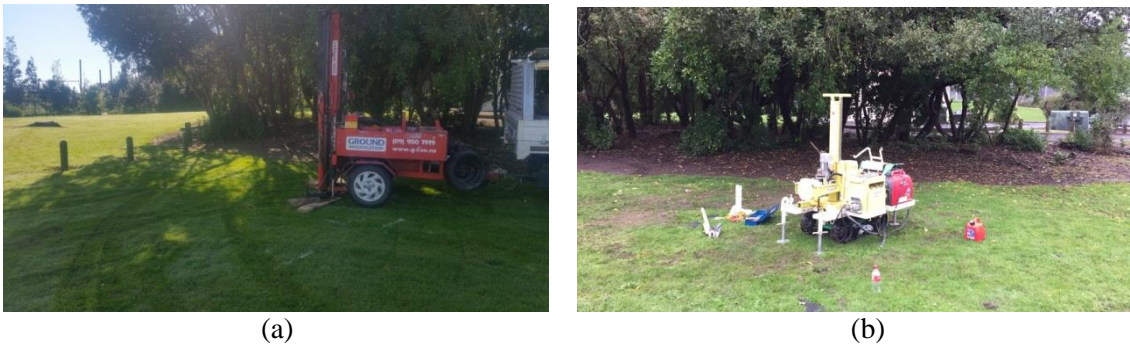
Figure 2: Field testing at Target site #1: (a) CPT and sCPT; and (b) SDS test.

speed of penetration, depth of penetration and friction on the rod. An important parameter derived was the specific energy of penetration, E_s , representing the sum of the contribution of the torque and applied load for every load step normalised by the volume of penetration (Mirjafari et al. 2016). At site #1, $E_s < 25 \text{ N-mm/mm}^3$ up to a depth of 10m, below which stiff layer with $E_s < 50 \text{ N-mm/mm}^3$ existed.

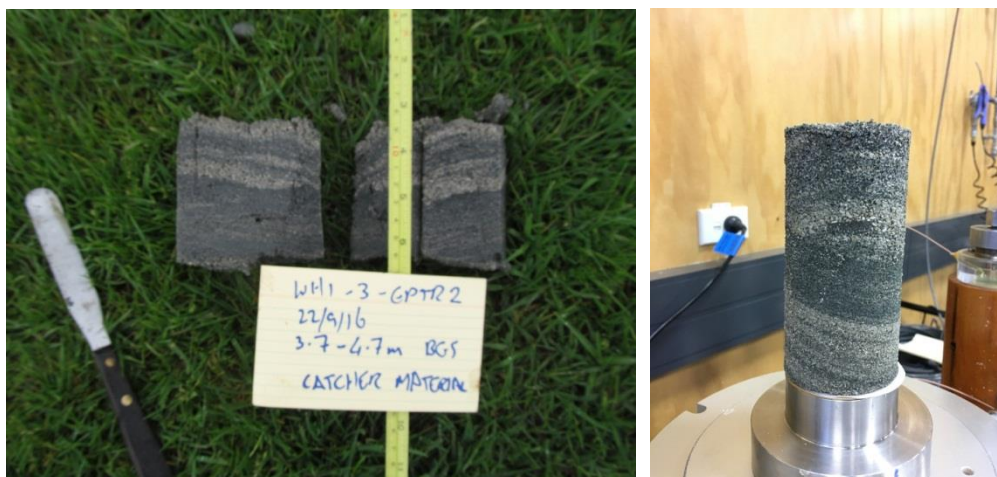
Figure 7: Samples of soils taken at site #1. White-coloured layers are pumiceous, while dark-coloured ones are hard-grained sands.

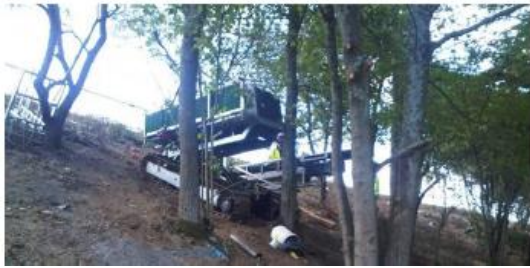
(a) self-climbing rig to install electrodes

Therefore, to accurately model the EO consolidation, the laboratory apparatus should be designed to accommodate the electrodes vertically in the testing cell (Figure 1b). However, in case of slope stability the electrodes are installed in horizontal alignment as shown in Figure 2. In addition, a self-climbing rig can be used to install electrodes on the slopes with no deforestation, as shown in Figure 2a. In such a case, the metallic electrodes can also be maintained in place to confine the soil and provide further improvement after EO treatment. Therefore, to accurately model the EO slope stability application in the laboratory, the electrodes should be installed in horizontal direction, as shown in Figure 3.

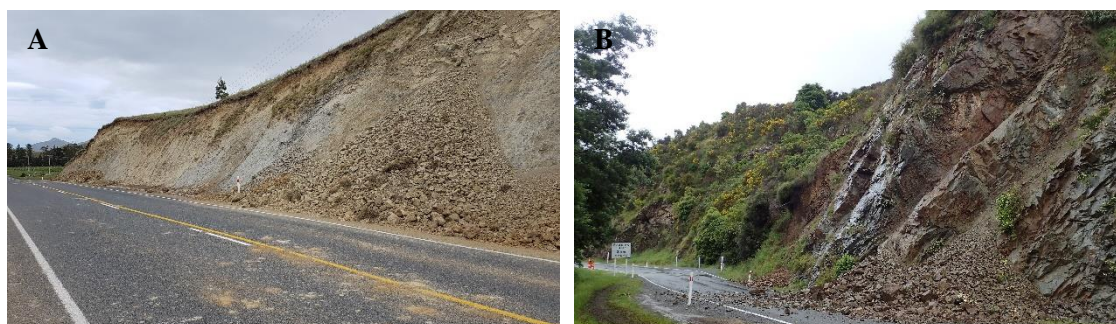
Figure 4. Examples of cut slope failures along SH1. (A) Failure of low height cutting in weak Tertiary siltstone, with accumulation of debris over the lower part of the slope. (B) Failure of cutting in indurated greywacke bedrock with encroachment of debris onto the road.

Failure of cuttings was dominated by shallow translational sliding and wedge failures in the upper half of the cuttings, particularly in the Ward to Clarence area. This was likely due to topographical amplification of ground shaking and the presence of more dilated soil and rock masses in the upper parts of the cuts. Run-out from the failures of the upper half of the slope covered the lower half of the cuttings and encroached into the road depending on the height of these cuttings (Figure 4).

Given the limited height of these cuttings, the slip debris generally affected the shoulder and one half of the road, and where it affected both lanes, they were able to be partially cleared quickly to create at least one lane access.

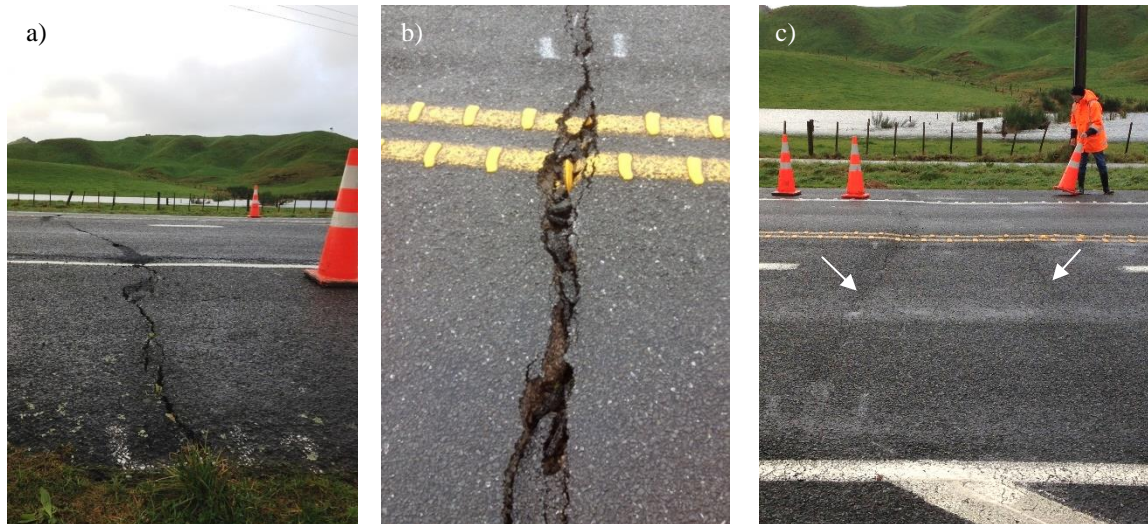
Figure 1: Observed damage to the road. a) North crack; b) Detail of the north crack; c) South cracks, as indicated by the arrows.

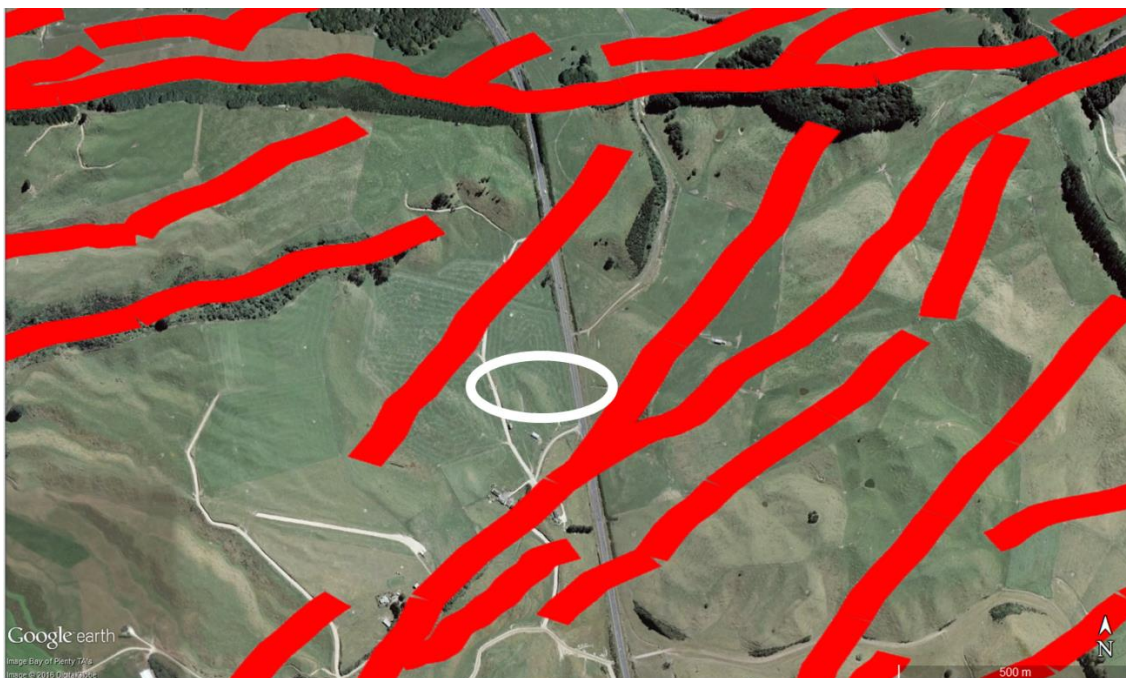
Figure 4: Active faults in the Tumunui area (New Zealand Active Faults Database, 2016). White ellipse indicates section of road affected by tomos.

Although a number of active faults are present in the wider Rotorua region associated with the Taupo Rift Zone, in the Tumunui area in particular, no active faults are known to exist, as indicated in Figure 4 (New Zealand Active Faults Database, 2016). In addition, whilst the vast majority of the active faults in the region are NE-SW oriented, in Tumunui the orientation of the gully on the east side of the road and the recently developed tomos is closer to E-W. Therefore it is considered unlikely that the piping process affecting SH5 is associated with active faults.
