WHAT IN EARTH IS GOING ON?
BALANCING RISK, REWARD, REGULATION AND REALITY

20th Symposium of the New Zealand Geotechnical Society

Napier 2017

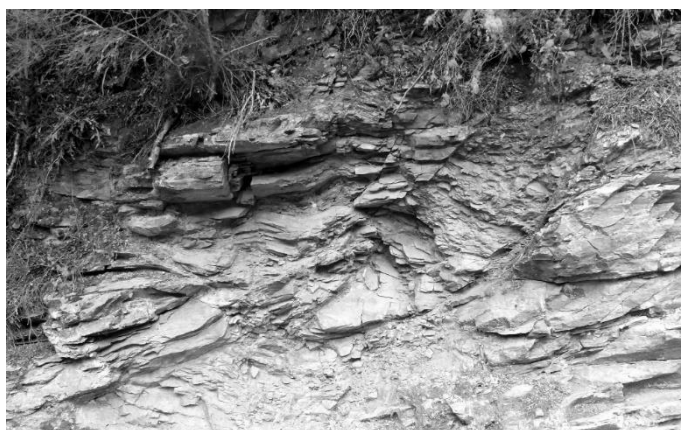
Figure 1: Micro-folds within shear zones in Haast Schist at No.4 Dam

On the left abutment of the dam, the schist is of good quality, moderately weathered, moderately strong with quartz segregations up to 50 mm thick, though typically less than 20 mm. Foliation attitude on the left abutment dips 20 to 30 degrees to east to north-east. By contrast, the right abutment is highly disturbed with numerous shear zones present, varying in character but with distinctly fissile rock mass sheared to fine to coarse, platy, angular gravel. Foliation orientation within shear zones is variable though broadly parallel to sub-parallel with the orientation of the McNamara Fault, with micro-folds (Figure 1) evident within some zones. The disturbed nature of bedrock on the right abutment is attributed to the proximity of the McNamara Fault which was mapped (MacFarlane 1986) as passing approximately 200 m to the south of the dam. Recently a new track has been cut on the river right of the No.4 reservoir, which exposes the fault. The zone of deformation is approximately 70 m in width at this location (consistent with the earlier DSIR report), highly disturbed, with a lack of distinct fabric. Material in the fault zone is predominantly extremely weak and when logged as a soil material is assessed to be moderately dense, light greyish brown sandy angular gravel. There are zones (up to 2 m diameter) of dark bluish-grey, highly plastic silty clay within localised pockets within the overall fault zone. Shear and crushed zones were noted up to 300 m on either side of the 70 m wide fault zone, including on the right abutment of the No.4 Dam. The fault appears to be high angle and downthrown on the southern side, indicative of a reverse thrust fault.

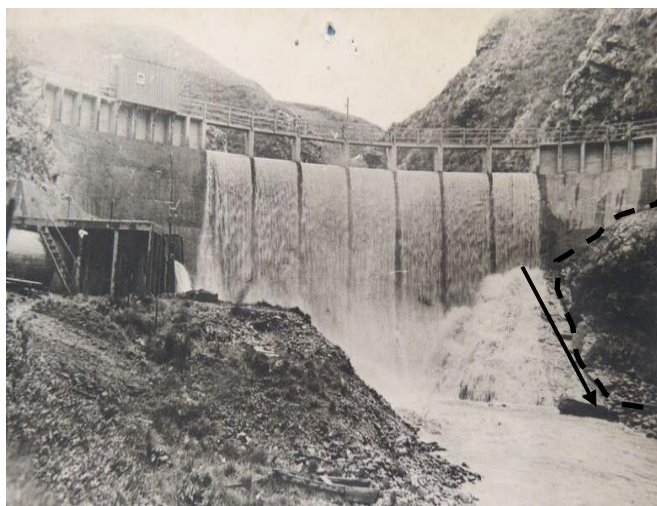
Figure 4a: Historical photo of No.2 Dam, showing potential slide block, arrow indicates foliation plane and dashed line indicates potential block of instability (date unknown).

A potential sliding failure mechanism was identified for the left abutment of the No.2 Dam. Historical photos of No.2 dam shows there does not appear to have been movement on this abutment since completion of construction (Figure 4a), however, it is noted that since raising the dam, water does now flow over the left abutment during dam overtopping events (Figure 4b). FEA analysis should assess the risk of block failure in this location and any impact this might have on abutment and dam stability.

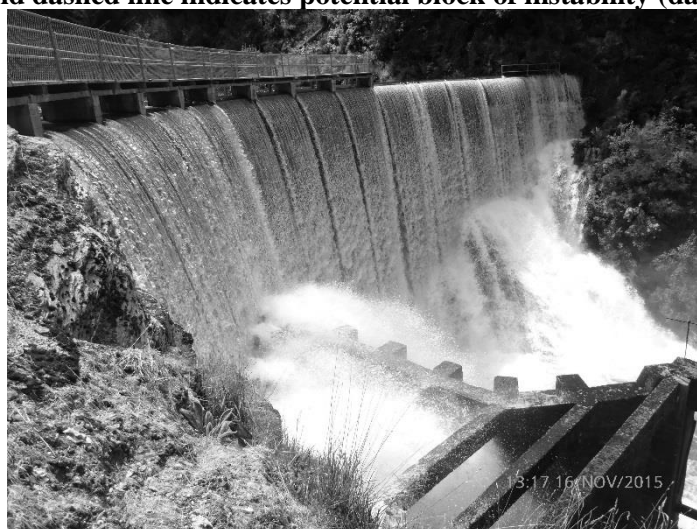
Figure 4b: Present day overtopping event at No.2 Dam (taken from downstream of right abutment, November 2015).

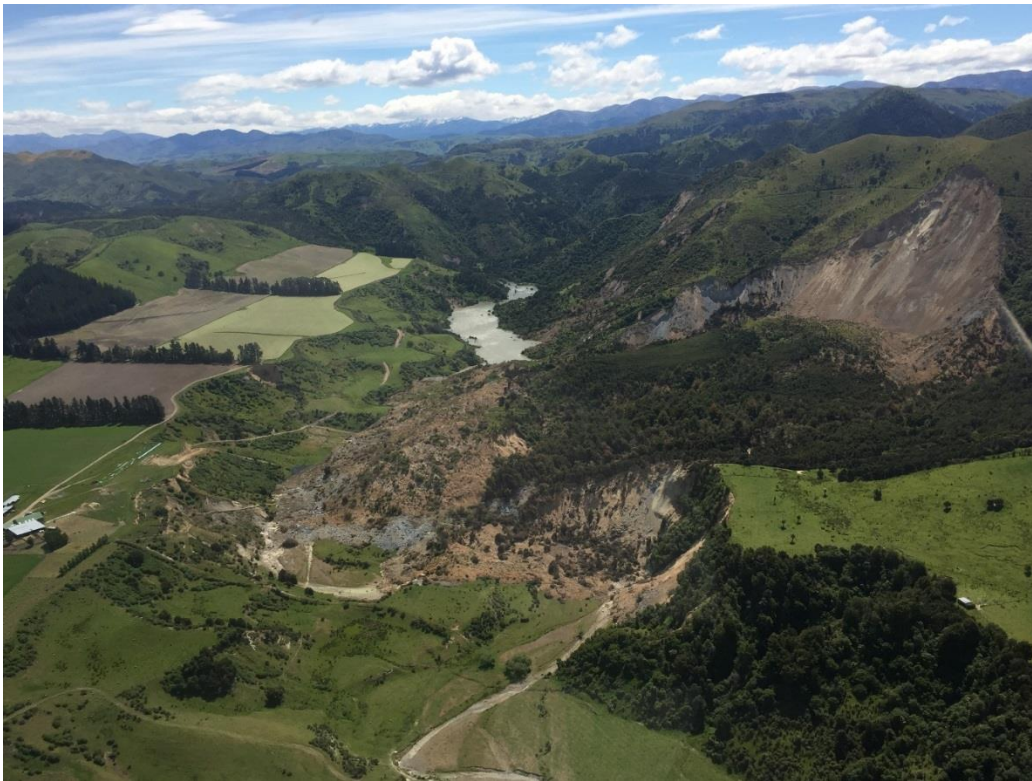
Figure 2: Landslide dam on the Leader River shortly after the earthquake. The landslide is a slump/block slide in a siltstone and is typical of the large landslides in weak Neogene rocks. The dam overtopped and partially breached in February 2017 (Photo credit: Environment Canterbury).

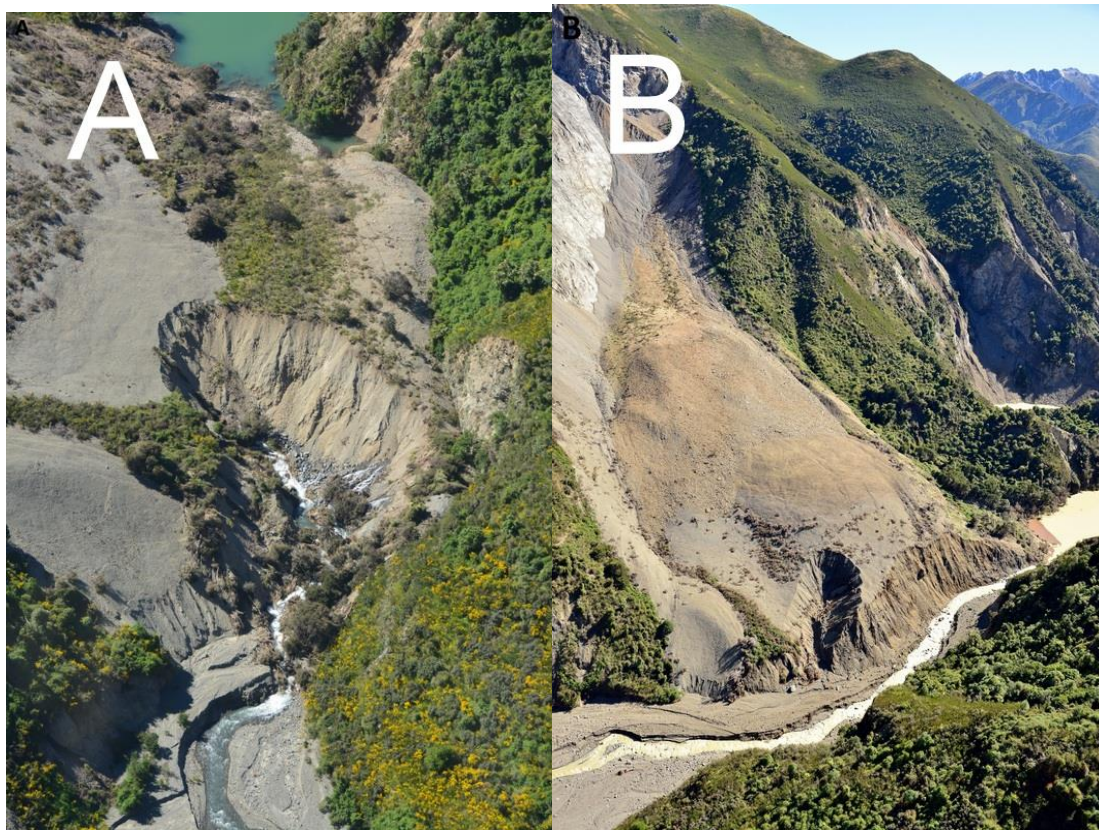
Figure 3: The greywacke-derived landslide dam in the upper reaches of the Conway River in the Seaward Kaikoura Ranges. This large dam developed flows through the permeable material of the dam under normal flow conditions (Photo 3A: J. Mitchell, 22/11/2016). On the 6 April 2017, 100-150 mm of rain fell in 24-hours and as a consequence this dam overtopped and breached, removing the landslide barrier and potential hazard. (Photo 3B: D. Townsend, 7/4/2017).

apparent (Figure 3). The source material for these landslides is Torlesse Greywacke which typically forms disrupted rock slides because of the closely jointed and fractured nature of the source rock mass. The resulting debris can be described as an angular gravel and is highly permeable. As a result, the large greywacke-derived landslide dams developed flows through the permeable material forming the dam under normal flow conditions. On the 6 April 2017, ex-Tropical Cyclone Debbie passed over the area dumping 100-150 mm of rain in 24-hours for the first time since the earthquake. As a consequence of this rainfall several of the greywacke dams finally overtopped and breached, effectively removing the landslide barrier and potential hazard.

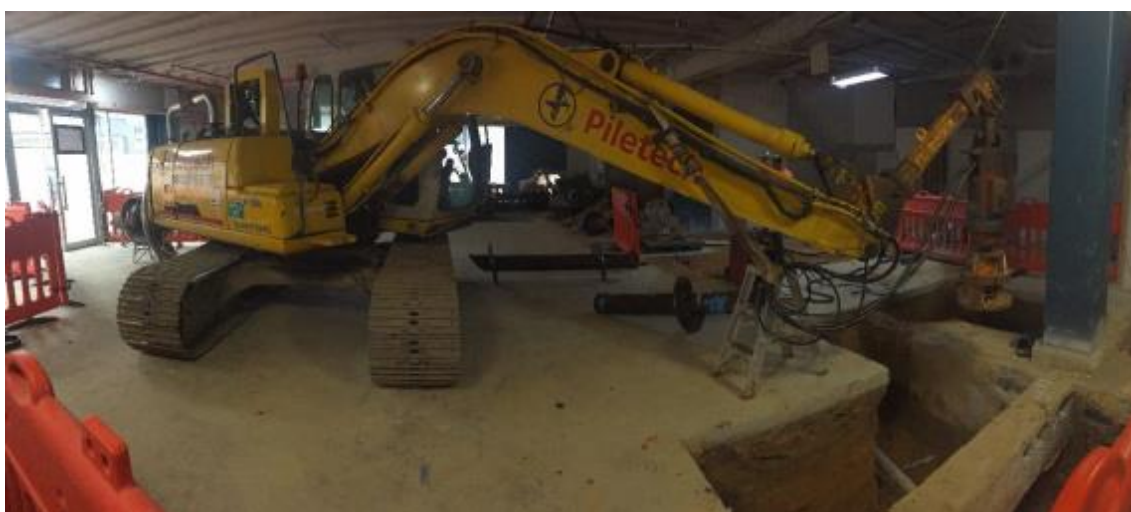
Figure 6: Stage 1 installation of screw piles (Lavin et al, 2016)

Initial screw piling began in late 2016 (Figure 6) with the raft foundation adjacent to the shear wall completed in June 2017. It is anticipated that construction of the foundations will be completed by the end of August 2017.

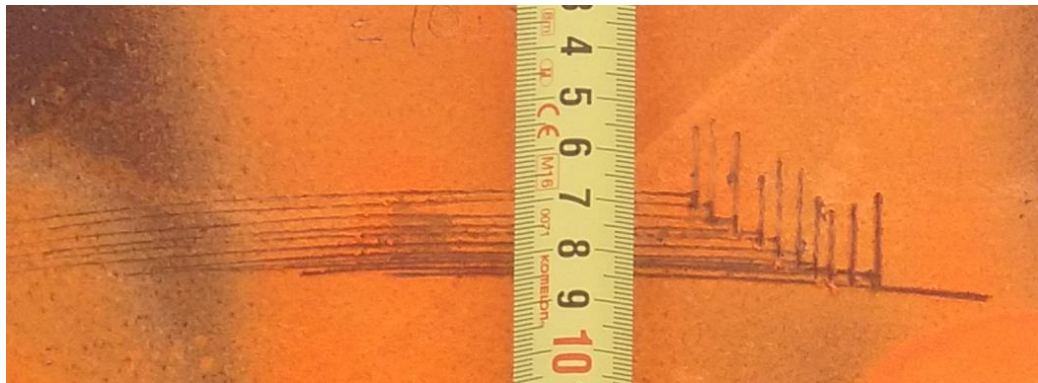
Figure 3: Example of manual set card on steel pile

Traditionally, the only method to record the temporary compression, was by means of a manual set card, in which a pencil or chalk is physically held by person to the pile (or to a paper attached to the pile) during pile driving. Often an inclined spirit level is used to provide a more or less stable reference level. The result can then be measured. This method is commonly applied for 10 impact blows, and results are subsequently averaged. Figure 3 shows an example of a manual set card.

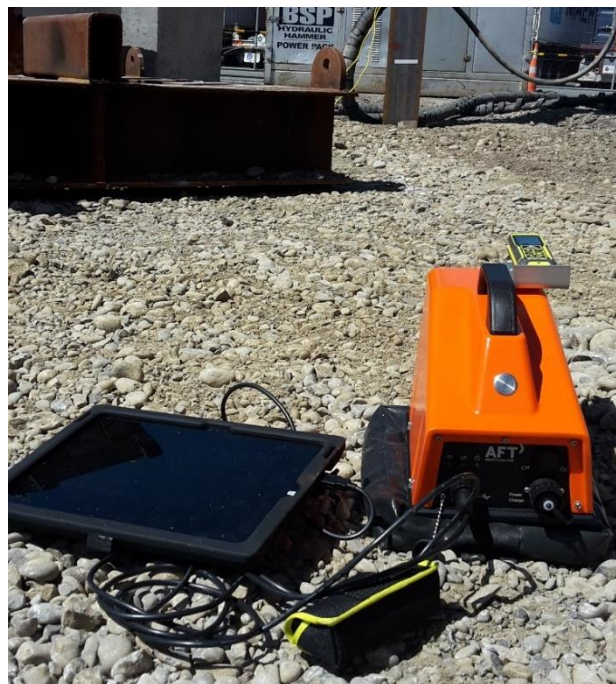
Figure 4: PDM set up outside exclusion zone

BPC used the PDM (Model G2) to replace manual set cards on all piles of this project. The main reason to use the PDM on this project was the obvious benefit to occupational safety. The device enabled the site engineer to measure set and temporary compression, whilst being well outside the exclusion zone (see Figure 4).

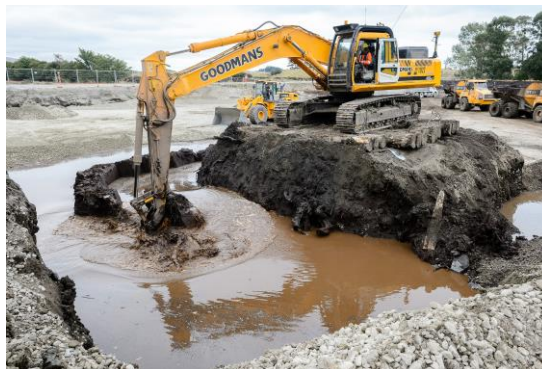
Figure 2 Excavate and replace at the Paetawa Bridge Site.

At the Paetawa Drain Bridge, near the northern end of the project, site investigation had identified organic deposits extending down to 5m below the water table. A design was developed that involved excavating the peat and its replacement with compacted sand fill, followed by vibro-compaction of any low density areas. De-watering was not used due to the extensive peat deposits and large area of replacement and high water table. Figure 2 illustrates the typical working conditions.

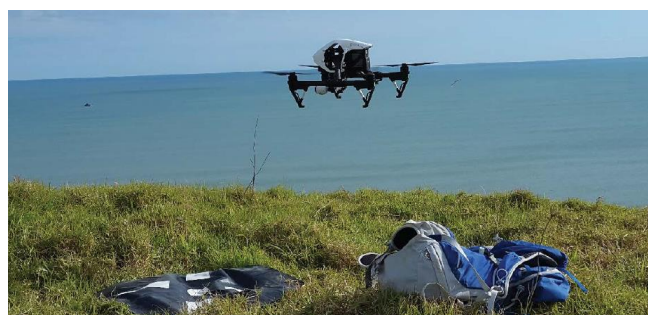
Figure 2: DJI Inspire 1 UAV taking off near a black and white GCP (Ohuka Landslide).

A Dà-Jiāng Innovations (DJI) Inspire 1 drone (Figure 2) equipped with a Zenmuse X3 camera was used to acquire datasets of 200-300 overlapping aerial photographs at each landslide. Up to 20 ground control points (GCP's; plastic mats and man-made features) were geo-located with a real-time kinematic global positioning system (RTK-GPS).

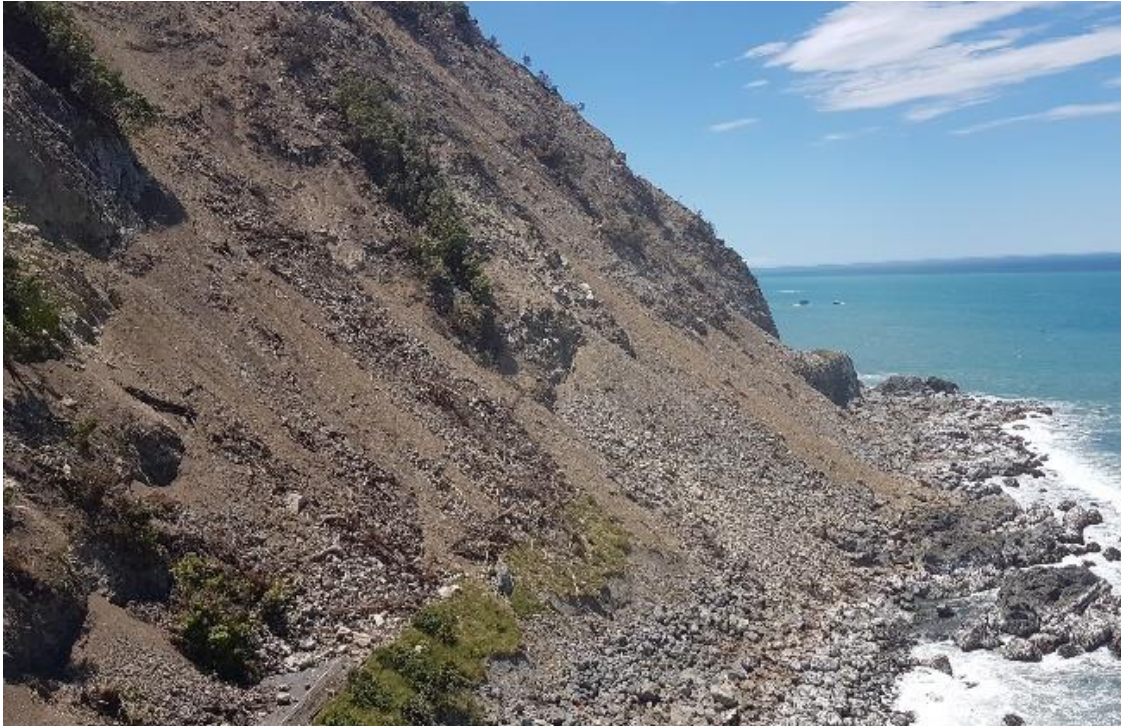
Figure 1: Landsliding on State Highway 1 from 2016 M7.8 Kaikoura Earthquake

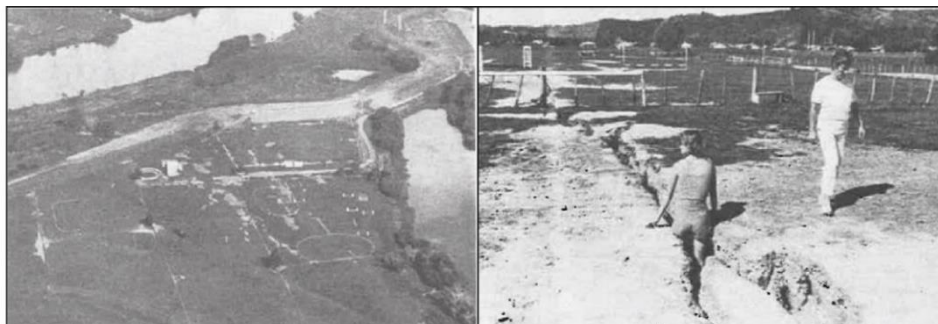
Figure 3: Historical photographs outlining the occurrence of liquefaction in Whakatane following the 1987 Edgecumbe earthquake (Collated from Christensen (1995)).

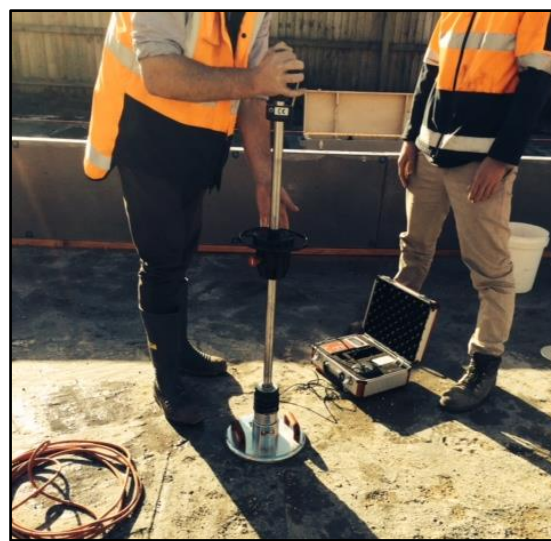
Figure 2: LWD equipment in use on PIC Raft shallow ground improvement
