Terrestrial Laser Scanning and Settled Techniques: a Support to Detect Pathologies and Safety Conditions of Timber Structures

Clara Bertolini-Cestari^{1, a}, Filiberto Chiabrando^{1, b}, Stefano Invernizzi^{2, c},
Tanja Marzi^{1, d} and Antonia Spanò^{1, e}

Keywords: Cultural Heritage, Wood dome, Structural assessment, Digital Photogrammetry, Laser survey, Orthophoto.

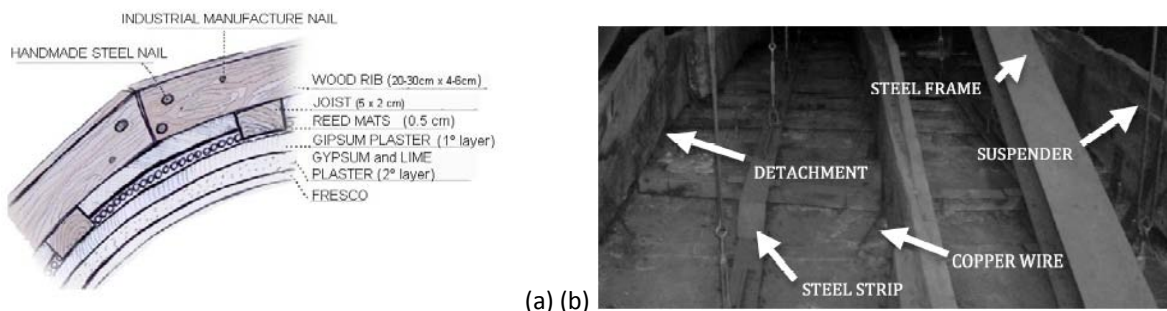
Figure 1: Scheme of "camorcanna" layers [5] (a), extrados of the Hall of Honor (b) of the Valentino Castle.

The principal structure is the above wood rib frame (Fig. 1a) that rules the curved shape of the dome. Each rib is obtained joining together two or more shaped planks with steel nails. The wood planks are 3 – 6 cm thick, 20 – 40 cm wide, and usually 2 – 3 m long. The rib spacing is around 0.7 m. The ribs are connected with steel nails to the underlying orthogonal wood joists. Joist section is 5 cm wide and 2 cm height. The joist spacing is around 25 cm. The continuous reed mat is hanging on the joists, and realizes the surface for the subsequent layers of plaster and stucco for the frescoes.

recently the roof structure was renewed and a steel frame structure was placed above the dome, and connected, with vertical suspender cables, to iron strips that were screwed to the little wood carpentry. (Fig. 1b) Nowadays, a survey revealed that the suspender cables above the vault in the region close to the abutments have lost their tension. This may indicate an increase of the vault deformation; therefore a structural assessment of the dome is mandatory.

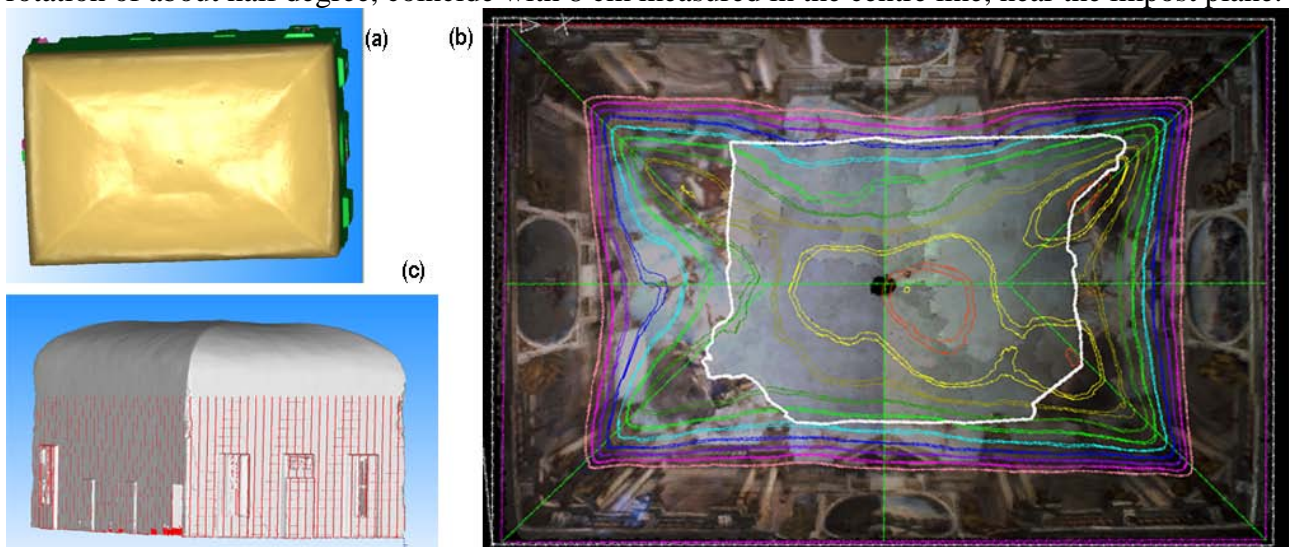
Figure 2: A nadiral view of the mesh model of dome for visual control of subsidence (a); the final orthophoto of the dome intrados, obtained by a mosaic of projected photograms with the superimposition of the section profiles and the signs of prior restorations (b) Total mesh model and sections profiles on walls.(c)

For the clear pavilion surface of the Hall of Honor, which is decorated by rich frescos and not by plastic ornamental elements, we performed the laser survey acquisition using a phase based scanner (LEICA HDS6100 [7]) The points model, after processes that fulfilled the complete cleaning and optimization of surface accuracy, describes the only interesting surfaces: floor, walls and vault. From laser model a large number of revealing profiles belonging to multiple section planes have been detected with the aim of analyzing the curves trends and spotting the anomalies and subsidence of the vault. Some irregularities are visually observable in the mesh model. (Fig 2a)

Furthermore the points model have been used to derive a Digital Elevation Model (DEM) useful for the orthophoto generation. In fact, the metric image texturing has been faced by a digital photogrammetry project; 8 images organized in two stripes have been acquired by self calibrated camera (Canon EOS 1Ds), then they have been oriented using a bundle adjustment process and projected using the DEM. In this way we obtained the complete removal of the huge chandelier encumbrance. The final orthophoto enable to detect the exact location and extension of restoration signs on vault frescos. The surface contours of the vault are computed with an equidistance of 5 cm and pertain horizontal planes: they present an high level of geometrical aberration. The location of height anomalies obtained from the laser model, and the shape of the frescos abruption outlined in the orthophoto, are in good agreement; it is observable because results are reported to the same reference system (Fig. 2b).

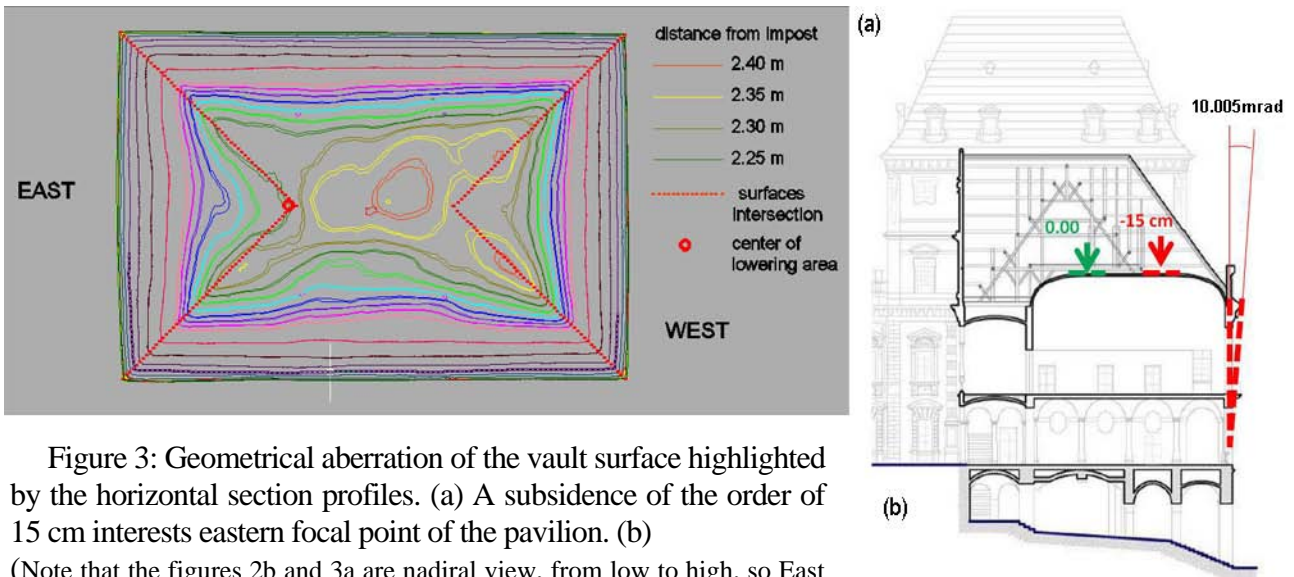
Figure 3: Geometrical aberration of the vault surface highlighted by the horizontal section profiles. (a) A subsidence of the order of 15 cm interests eastern focal point of the pavilion. (b) (Note that the figures 2b and 3a are nadiral view, from low to high, so East is in the left and west is on the right).

We can estimate the greater loss of the original geometrical shape in the subsiding area near eastern point of intersection of the cylinders of pavilion (red spot in Fig. 3a). Adding to the XXth restorations, this asymmetric subsidence may be related to a general rotation of eastern perimeter wall, that we observed and measured by means of the section profiles on walls (Fig. 2c and 3b). The rotation of about half degree, coincide with 8 cm measured in the centre line, near the impost plane.

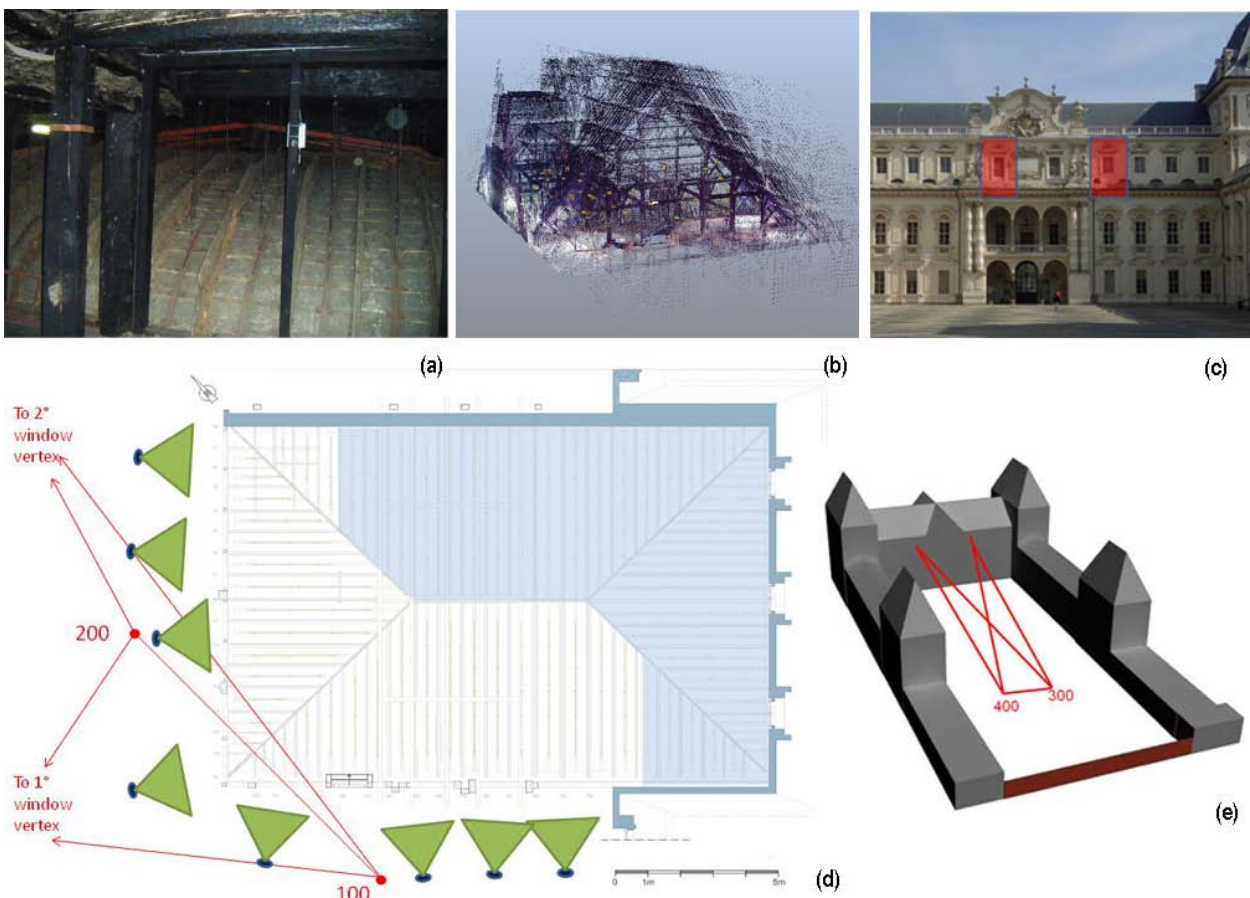
Figure 4: A view of the extrados with the wooden planking over it (a); a view of the registered points cloud (b); the position of windows enabling topographical intersections (c); a plan of the extrados with the scheme of scan positions and topographical measured directions (in red) on vertices located on attic floor (n° 100 and 200) and near the windows (d), the scheme of topographical intersections connecting the vertices in the attic, with the ones in the honor court(e).

The laser survey of vault extrados has been more complex than the lower, because of the encumbrances of the roof carpentry and since a wooden planking is placed over the vault (Fig. 4a)

Moreover the northern side is unreachable for the presence of a bearing wall, and obviously the curvature makes the measurable portion very reduced (in the Fig. 4d, the light blue points out the unmeasurable portion of the vault).

8 scans have been acquired (green triangle in Fig. 4d) and they have been registered with the support of about 25 plane targets, measured by topographical method. For the estrados survey we used the Focus 3D scanner (Faro Cam2) with portable and handy characteristics. The range of scan distances is variable from 0.6 to 120 m for reflective surfaces (> 90%), the error in linear distances is equal to ± 2 mm at 10 m and 25 m for reflectivity of 10% and 90%. [8] The results of registration are excellent (about half a centimeter for each residual) and obviously the cloud cleaning had to be totally manually managed in order to remove carpentry. Even the topographical measures performed with the aim to connect lower and upper models had been hard-working. Many portions of the castle have been surveyed by topographical, photogrammetrical and by TLS method, so a georeferenced topographical network (UTM WGS84 system) stands near the castle. [9]

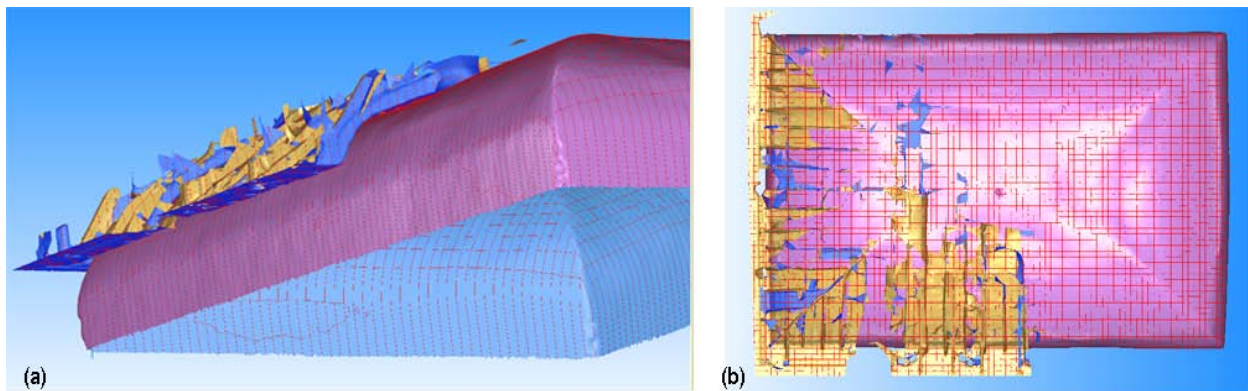
Figure 5: Two views of the combination of the upper and lower mesh models for the determination of the thickness of the vault. (a) (b).

Thickness and Profile Analysis. By means of the combined study of the extrados and intrados laser models (Fig. 5), it is possible to obtain an extensive mapping of the dome thickness and a precise analysis of local deformations. The analysis of section profiles, set in the horizontal or vertical planes and compared with the hypothetical original bending arcs, has enabled the chance to ascertain several localized deformation of the vault, in the order of some centimeters, that must be considered in the structural assessment of the vault. (A study on geometrical scheme of dome generation has been performed and we recognized that the hypothetical original bending arcs are very close to the constructive principles concerning the “*Cherche r’alongée*” recommended by P. Delorme in his essay: “*Le Premier Tome de l’Architecture*”. [10])

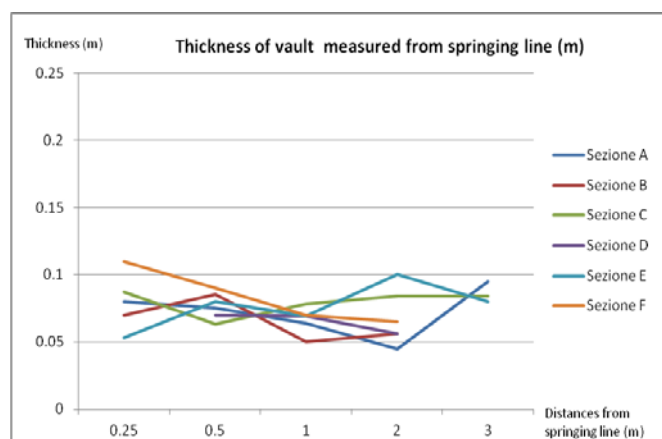
Figure 6: The thickness has been measured along some radiuses, interpolating arcs derived from Delorme geometrical scheme. Some sample vertical sections (A, B, C, D, E, F, about 1.5 m distant from each other) have been located in the measurable portion of

upper model, and they have been inspected and measured.

The maximum thickness is 0.22 m at the springing line. At the range distance between 0.5 m to 1m in plan from the walls, the average thickness decreases and becomes rather equal to 0.10 m. At the reins the thickness is minimum, and rather equal to only 0.06 m. In the central part of the dome the thickness is about 0.11 m, probably due to restorations and material additions. (Fig. 6-7)

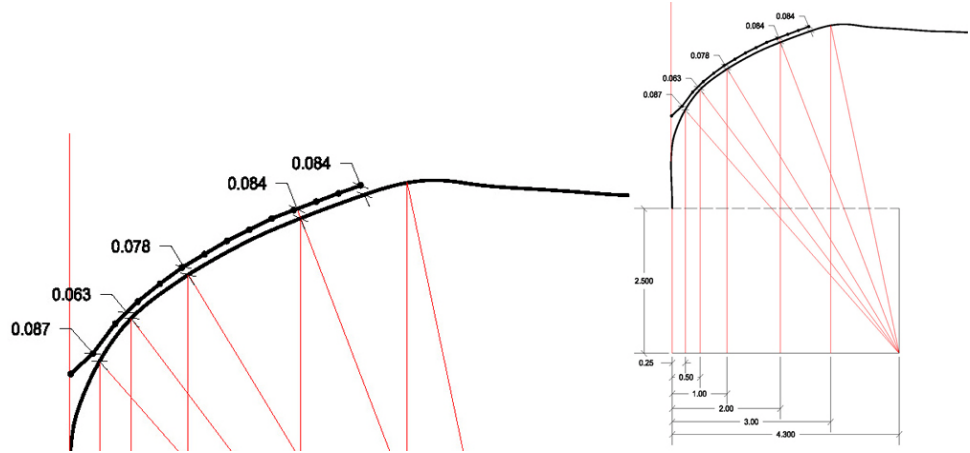
Figure 7: A sample section derived with the aim to examine the thickness of the vault.

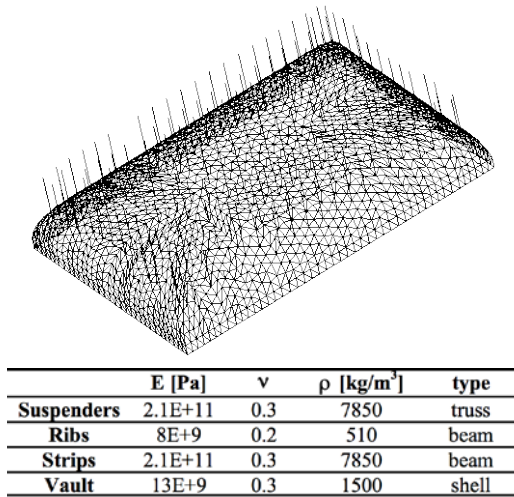
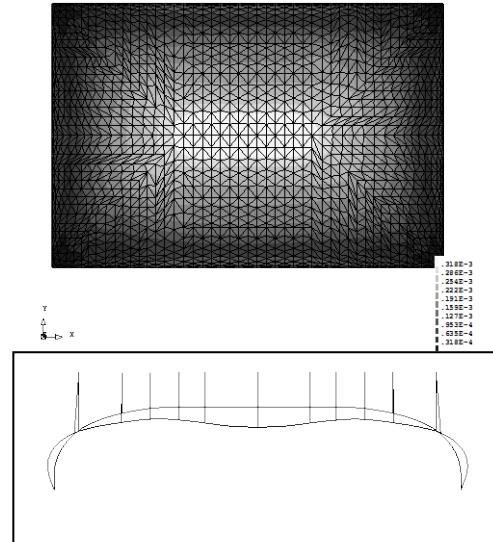
Figure 8: Mesh of the model (*above*); mechanical parameters of the model (*below*).

Figure 9: Contour plot of vertical displacements (*above*); transverse section with vertical displacements (*below*).

The shell represents the behaviour of the plaster, of the reed mat and of the wood joists in a single equivalent layer. The linear analysis has been carried out with the finite element program DIANA [11]. The overall mesh of the model is shown in Fig. 8a, while the table in Fig. 8b reports the basic mechanical assumption. The model is subjected to the only action of dead load due to gravity. At the present stage, the nonlinear behaviour of the materials has not been considered yet. Therefore, the model can provide only preliminary information about the structural behaviour of the dome. Nevertheless, the obtained deformed shape, shown in figure 9, is in agreement with the anomalies measured by the laser-scanning survey. In particular, the annular region around the big chandelier appears to be the most prone to displacements. On the other side, the suspenders, which are located in the outer region of the vault, are not elongated at all. This corresponds well with the evidence of the survey, which reveals that many of them have actually lost their tension (Fig. 10).

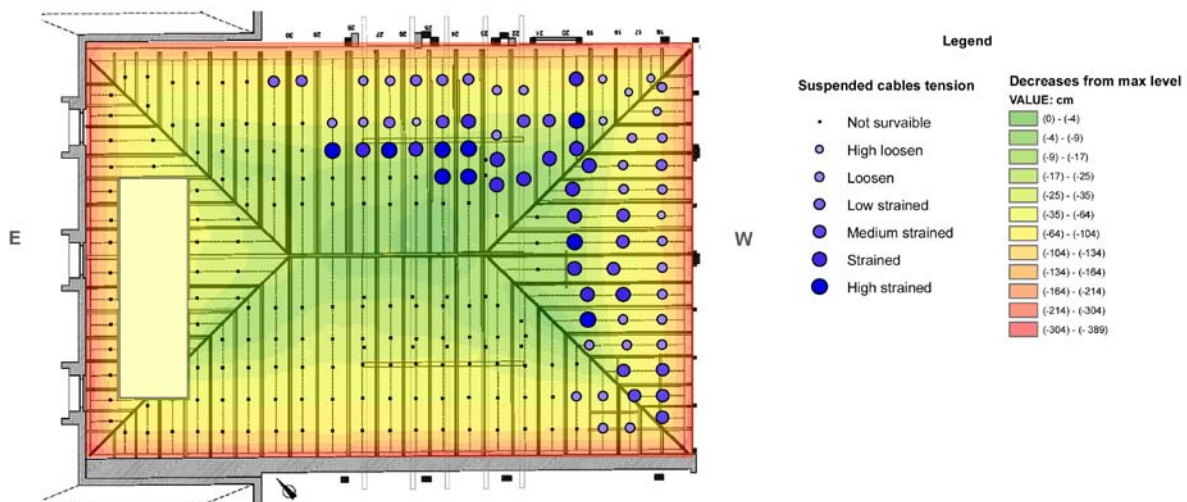
Figure 10: The survey representation of the state of tension in the suspenders is metrically referenced to the intrados Dem by GIS tools. The nadiral view is from low to high.
