Factual Report on Hong Kong Rainfall and Landslides in 2020

GEO Report No. 351

**Geotechnical Engineering Office
Civil Engineering and Development Department
The Government of the Hong Kong
Special Administrative Region**

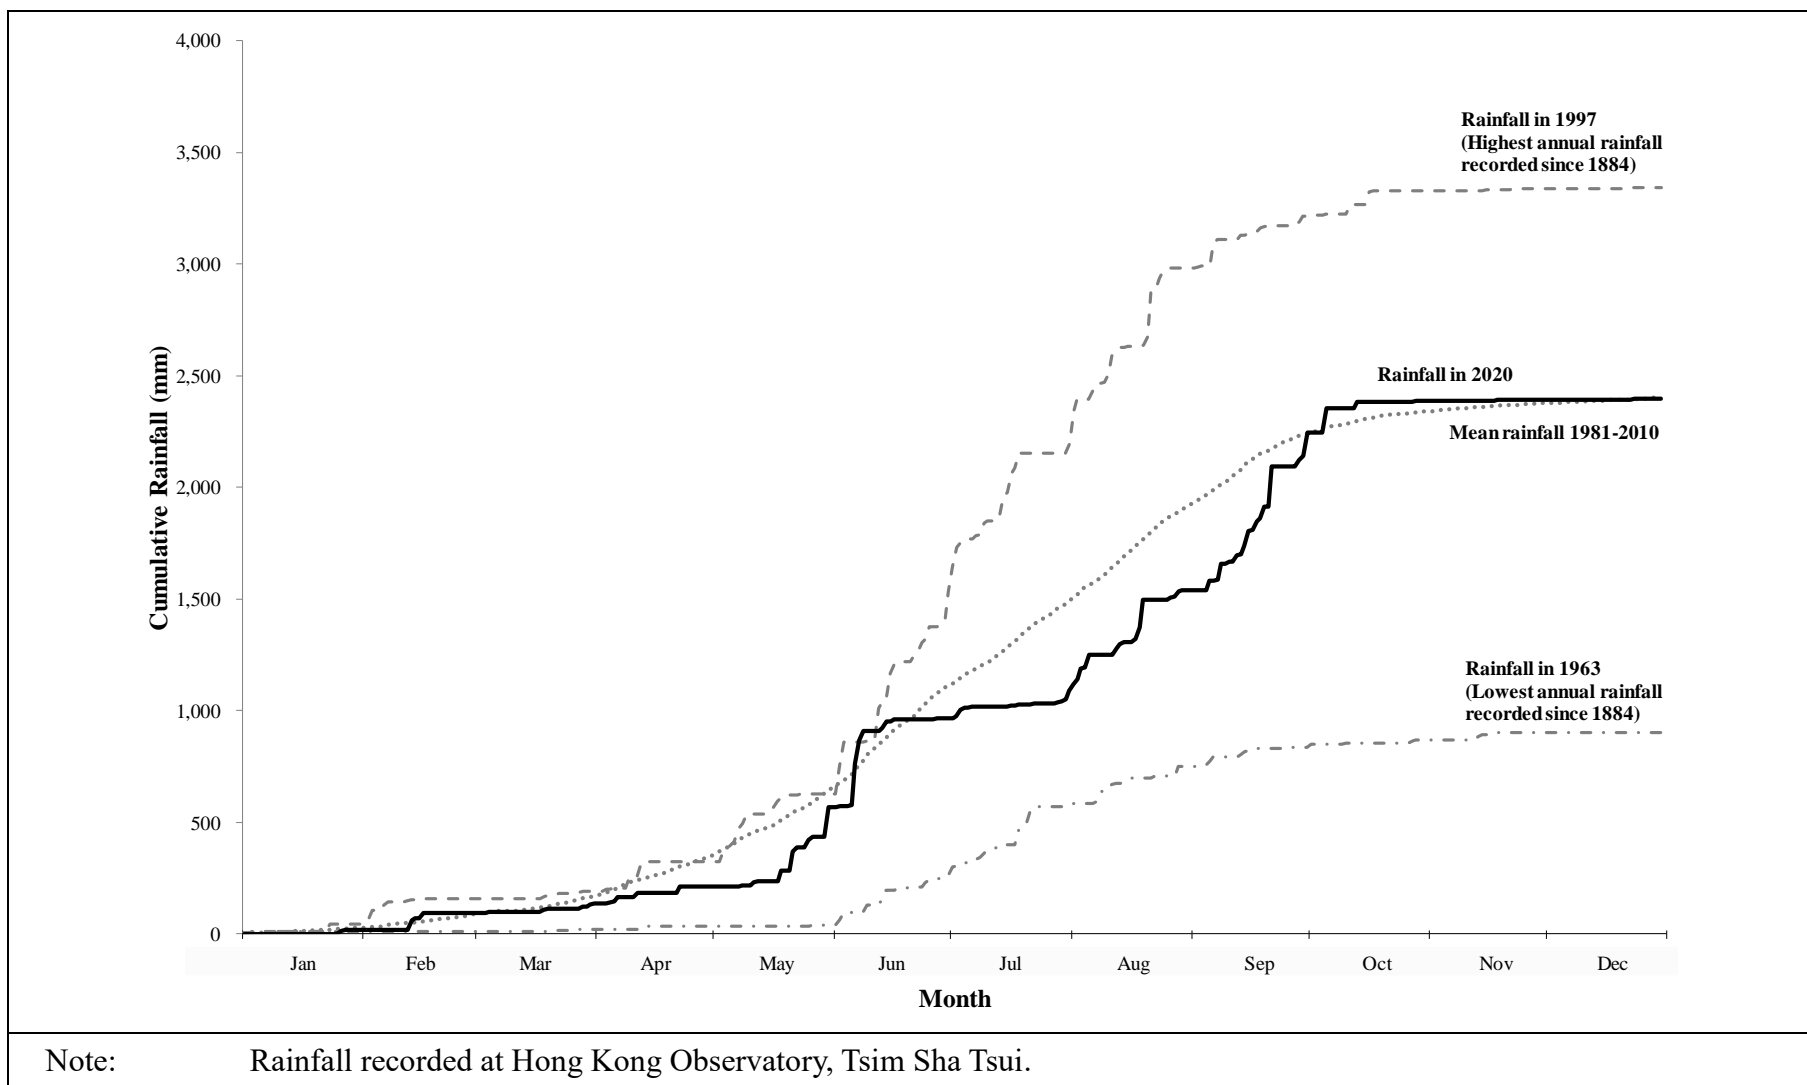
Figure 2.2 Cumulative Rainfall for 2020 at the Hong Kong Observatory and Its Recorded Highest, Mean and Lowest Cumulative Rainfalls

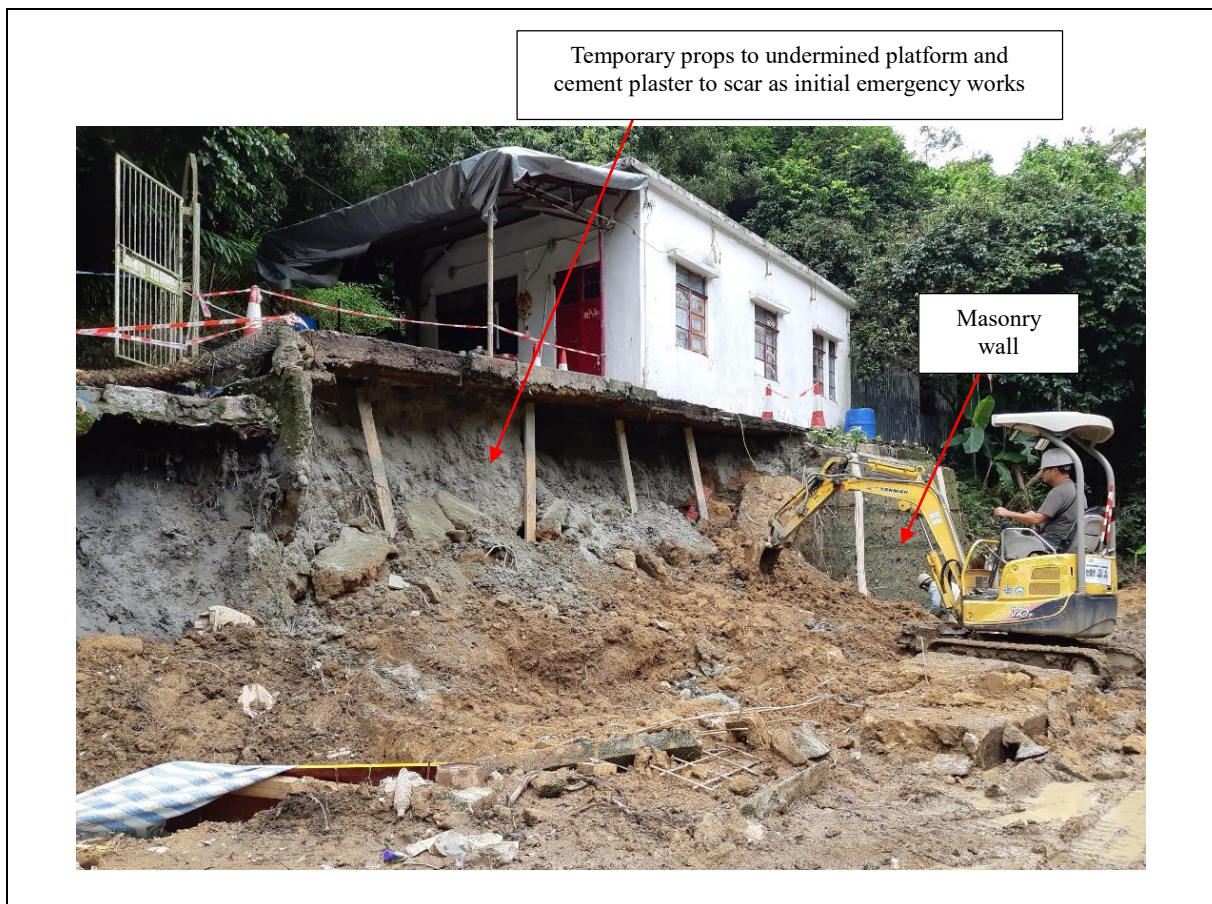
At about 4:00 a.m. on 6 June 2020 when Black Rainstorm Warning was in effect, a landslide occurred on a retaining wall (Feature No. 10SW-A/R9) located to the south of No. 5 Tung Hang Mei, Mui Wo (Figure 4.1). The landslide involved the failure of the masonry wall and the fill materials behind it (volume of about 12 m³). The failed wall portion was about 3 m high. At the wall crest, the paved platform was partially undermined and the one-storey squatter dwelling was temporarily evacuated. No casualty was reported as a result of the landslide.

Figure 4.1 View of the 6 June 2020 Landslide on a Retaining Wall at South of No. 5 Tung Hang Mei, Mui Wo (Incident No. 2020/06/2637)

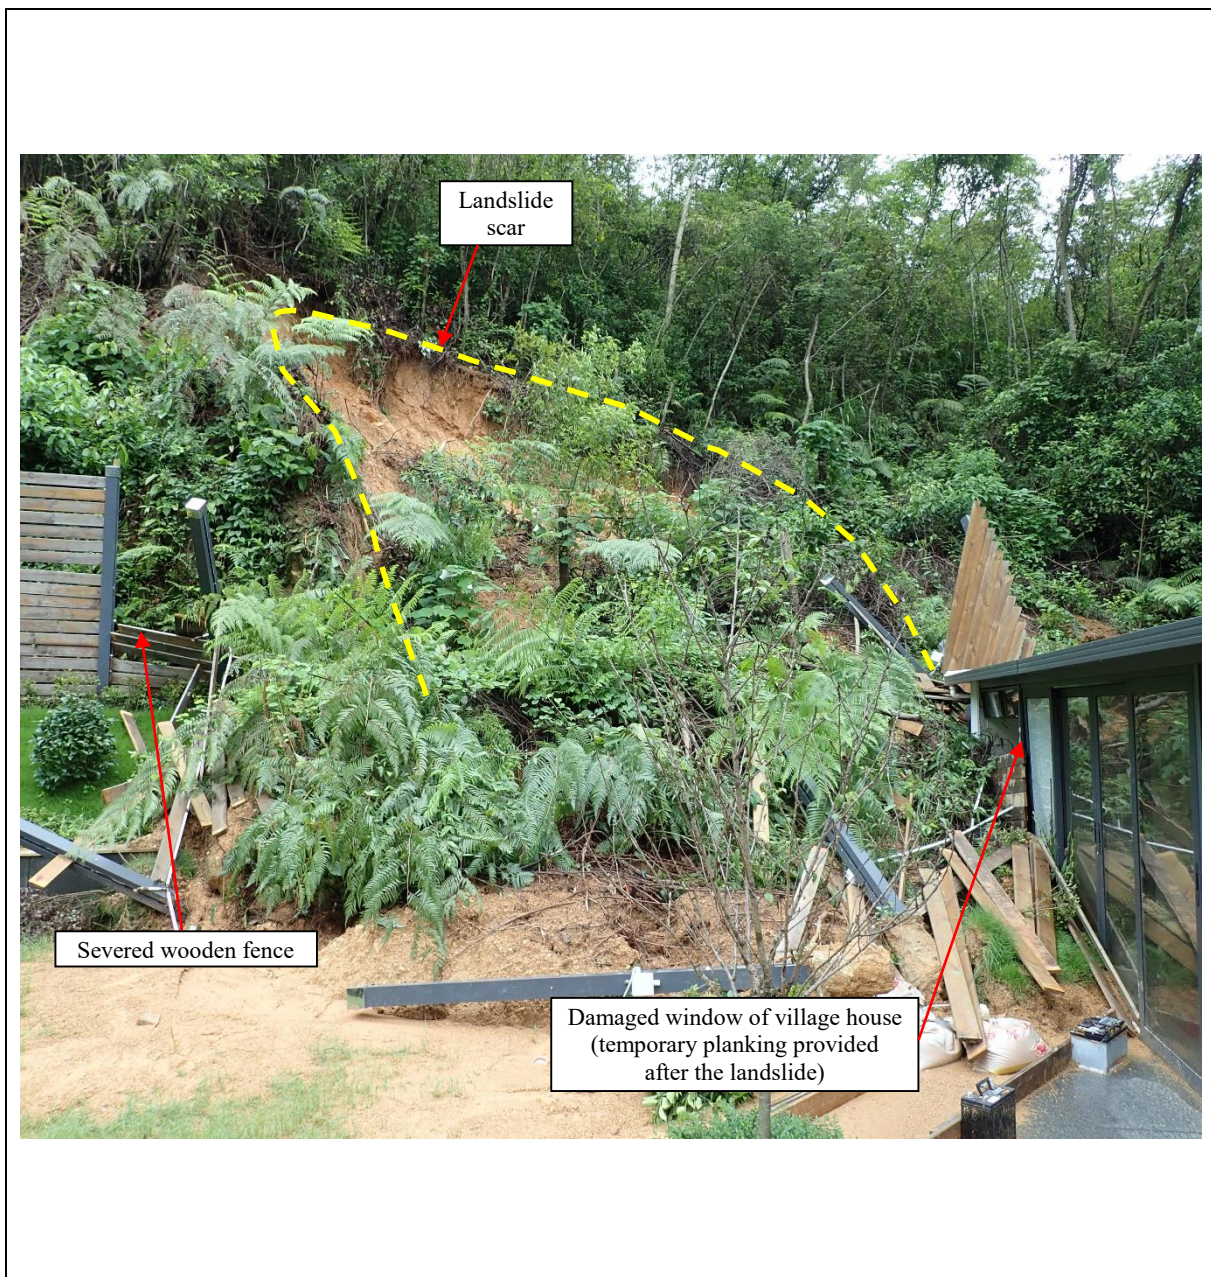
At about 7:00 a.m. on 7 June 2020 when Landslip Warning and Amber Rainstorm Warning were in effect, a landslide with an estimated failure volume of about 100 m³ occurred on the natural hillside behind house No. 292 Lung Mei Village, Tai Po (Figure 4.2). Debris from the open hillslope failure impacted on the village house causing damage of a window, a wooden fence and the backyard garden. The footpath at the toe of slope was temporarily closed. No casualty was reported as a result of the landslide.

Figure 4.2 View of the 7 June 2020 Landslide on the Natural Hillside behind House No. 292, Lung Mei Village, Tai Po (Incident No. 2020/06/2663)

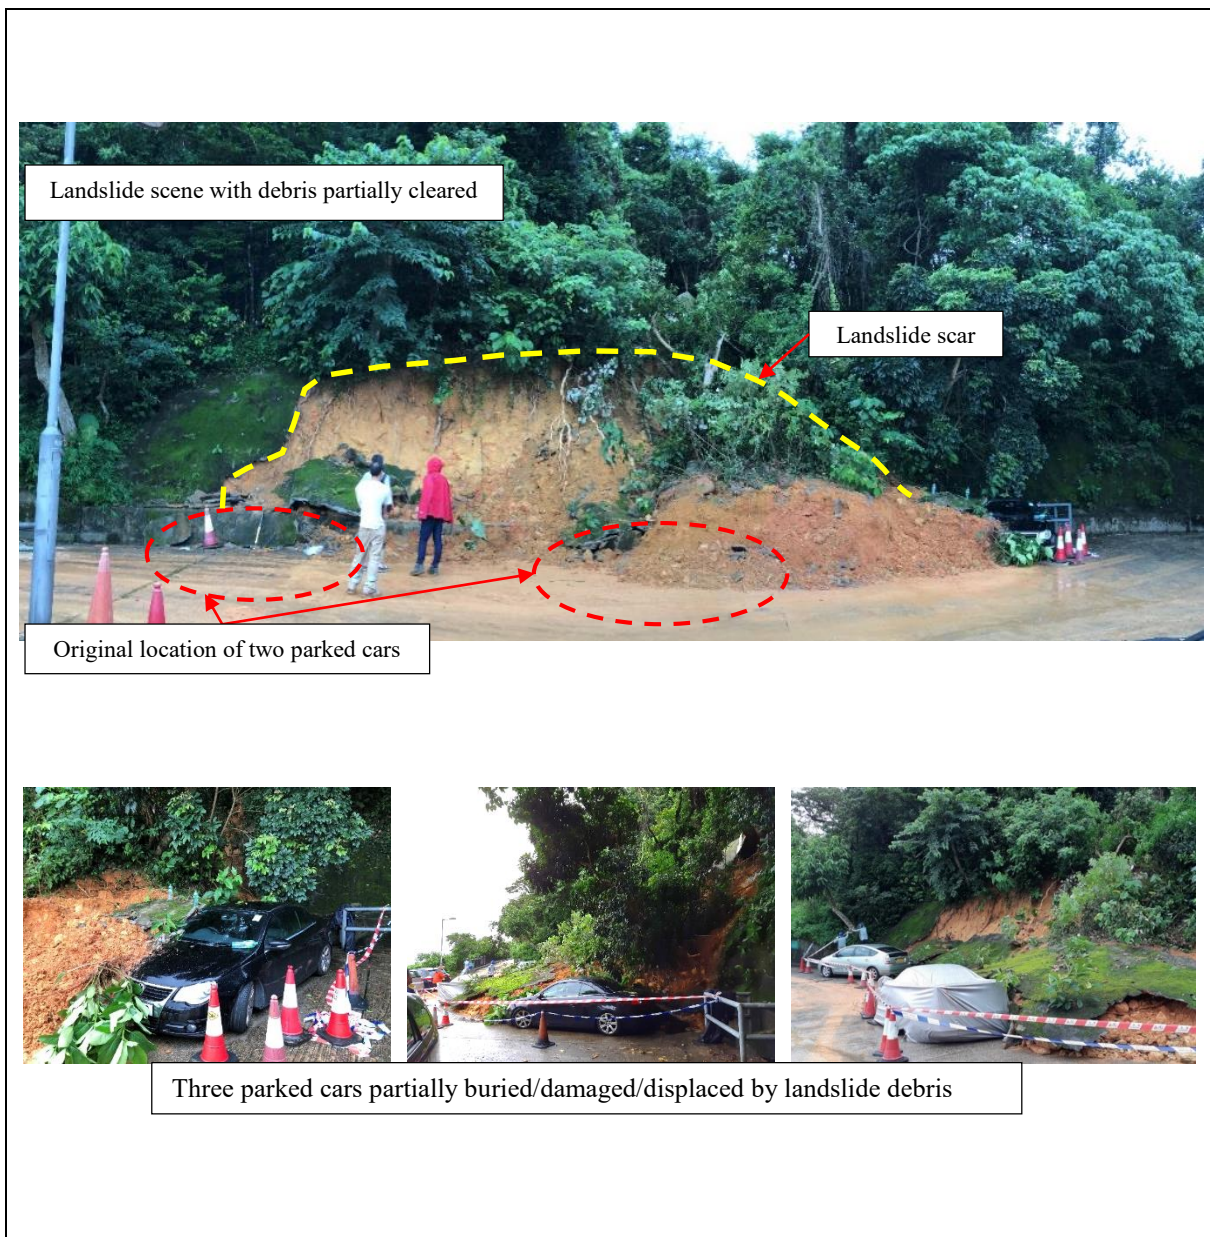
In the morning of 6 June 2020 when Landslip Warning was in effect, a landslide with an estimated failure volume of about 80 m³ occurred on a soil cut slope (Feature No. 8SW-A/C254) situated above an open carpark at Shan Liu Ha Road, Sai Kung (Figure 4.3). Three cars parked at the slope toe were partially buried, damaged or displaced by the landslide debris. The slope was generally covered with shotcrete and steeply inclined at about 65° prior to the failure. The failure extended from the crest of a concrete toe wall and involved almost the full height of the slope. No casualty was reported as a result of the landslide.

Figure 4.3 Views of the 6 June 2020 Landslide on a Soil Cut Slope at an Open Carpark at Shan Liu Ha Road, Sai Kung (Incident No. 2020/06/2631)

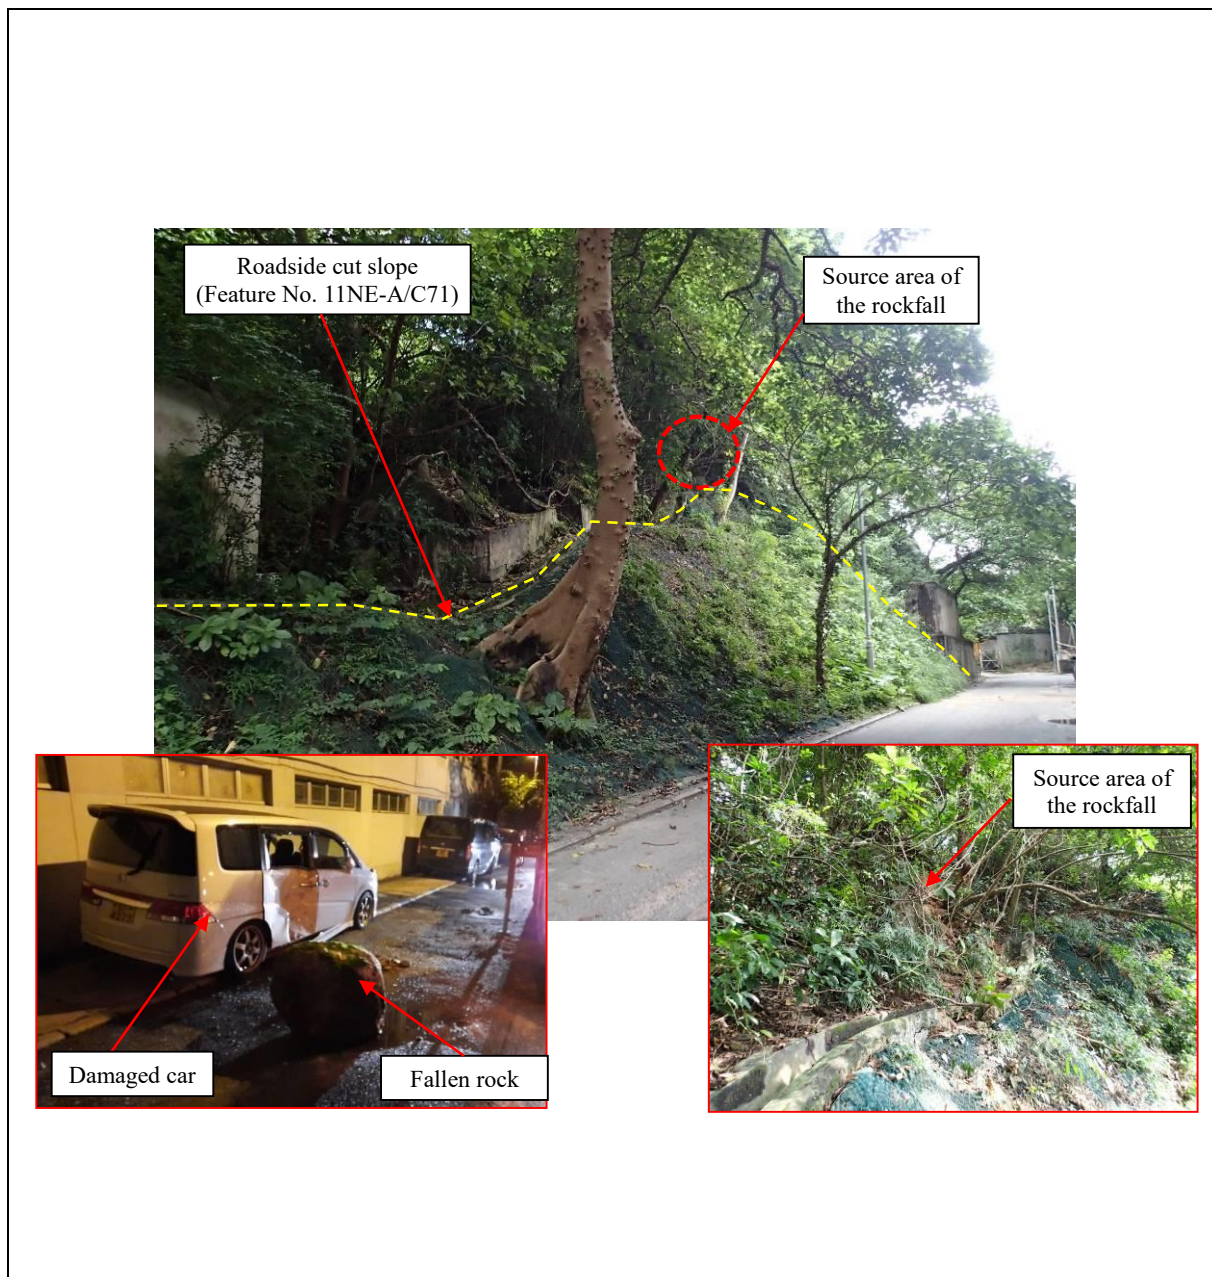
On 30 September 2020, a rockfall occurred on the natural hillside above Choi Shek Road, Ngau Tau Kok (Figure 4.4). A series of rainstorm warnings (including Black Rainstorm Warning) had been issued between 7:15 p.m. and 11:30 p.m. on 30 September 2020. A fallen rock block of approximately 1 m³ in volume, originated from a protruded rock mass above the crest of a roadside cut slope, damaged a private car parked at the roadside opposite to the slope. No casualty was involved. The incident was reported in the media.

Figure 4.4 Views of the 30 September 2020 Rockfall on the Natural Hillside above Choi Shek Road, Ngau Tau Kok (Incident No. 2020/10/2859)
