Bank erosion processes measured with UAV-SfM along complex banklines of a straight mid-sized river reach

Gonzalo Duró¹, Alessandra Crosato^{1,2}, Maarten G. Kleinhans³, and Wim S. J. Uijttewaal¹

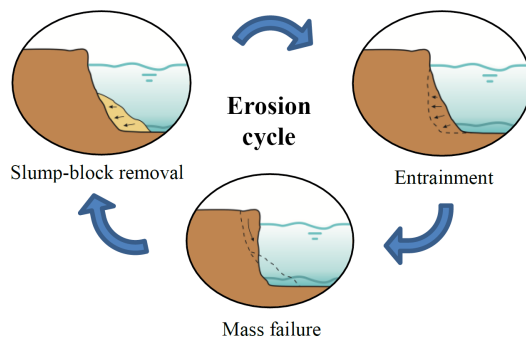
Figure 1. Schematic bank erosion phases: slump-block removal (left), entrainment of bare bank (right), and incipient mass failure (centre).

Bank erosion may consist of three phases (Thorne and Tovey, 1981): fluvial entrainment of near-bank riverbed and bank material, mass failure, and disintegration and removal of slump blocks. These three phases are particularly important

for cohesive banks since their retreat is typically delayed by the protection offered by slump blocks at their toe (Thorne, 1982; Lawler, 1992; Parker et al., 2011). The waste material settles at the bank toe where it remains for a time depending on its resistance to fluvial erosion and on the available capacity to transport the blocks. In contrast, loose waste material from non-cohesive banks is generally transported away relatively quicker by the river flow, leaving the bank sooner unprotected. Entrainment of near-bank bed material and the intact bank face occurs once the bank toe is exposed again (e.g. see Clark and Wynn, 2007), which continues until the collapse of the upper bank. Mass failure occurs due to geotechnical instability, which can be triggered by different factors, such as fluvial bank toe erosion (e.g. Darby et al., 2007) or a rapid drawdown of the river stage (e.g. Thorne and Tovey, 1981; Rinaldi et al., 2004).

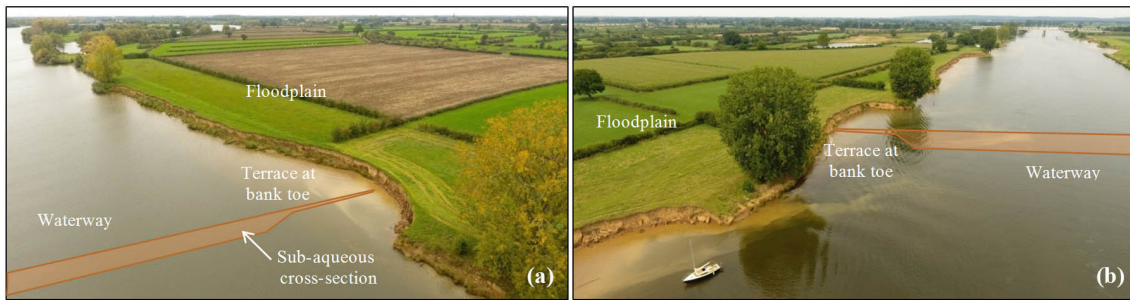
Figure 2. Restored bank in the Meuse River: upstream view of first 300 m (a) and downstream view of middle 500 m (b). Bank erosion has caused a series of bays in the 1200 m restored reach. Note eroded bank sediment in suspension.

The study site is the left bank of a 1200 m long straight reach (Fig. 2) located between the Sambeek and Grave weirs in the southeast Netherlands. This reach presents different bank retreat patterns after 7 years of restoration, with sub-reaches of rather uniform erosion and others with embayments of different lengths. Grassy fields used for grazing cover the riparian zone, followed by crop fields across the floodplain. In the near-bank area, there are poplar trees every 100 m, some of which have been dislodged during the erosion progression, which is possible to appreciate in Fig. 2a considering the ~ 200 m embayment between the foreground tree and the next in the background.

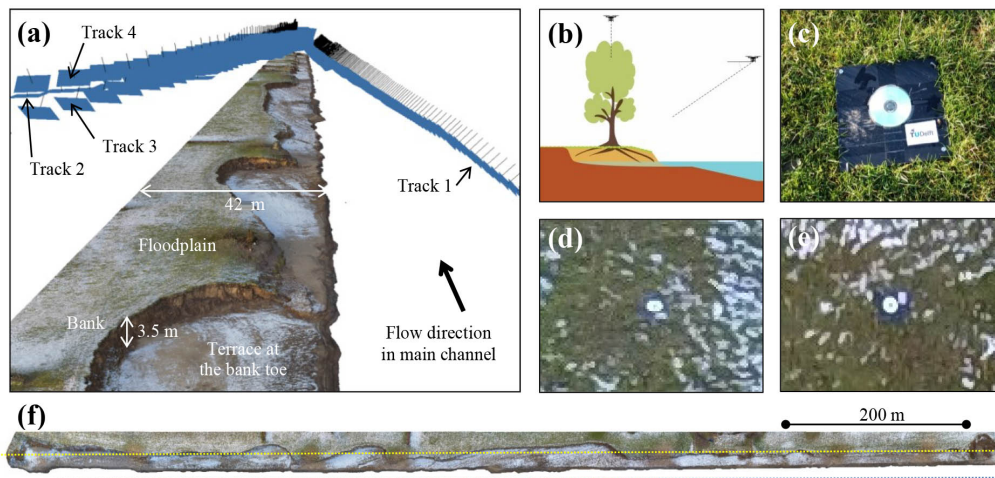
Figure 3. (a) Camera positions and orientations in perspective view. The digital surface model shows the low water condition during January 2017, which exposed a terrace at the bank toe. (b) Cross-sectional scheme of UAV paths. (c) Ceramic plaque with CD as ground-control point on the floodplain. (d) GCP in photograph from track 1. (e) Same GCP from track 2. (f) Top view of DSM with UAV track 1 in blue and tracks 2–4 in yellow.

black ceramic tiles (Fig. 3c) fixed to the ground with a circular reflector (12 cm CD) at its centre for their fast recognition in the photographs (Fig. 3d–e show how a GCP is seen from tracks 1 and 2). We measured the GCP coordinates using the Leica GS14 RTK GPS unit, which was also deployed for the cross-profiling.

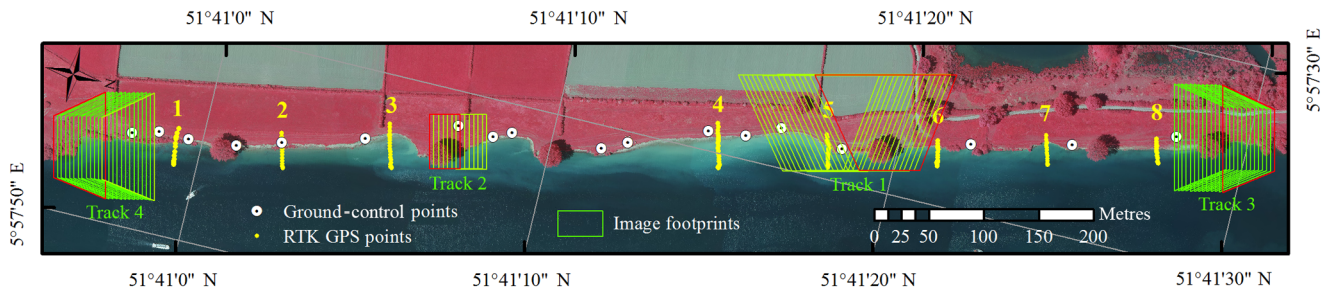
Figure 4. Study reach of the Meuse River with GCPs, RTK GPS measurements with cross-section locations and numbers, and some image footprints for all UAV tracks.

For the first step, the analysis of the minimum number of photographs needed to achieve the highest DSM accuracy, we compared the DSMs with RTK GPS measurements to quantify vertical precision. We took 129 points across eight profiles on 18 January 2017 (see Fig. 4) with a Leica

Six bank profiles were selected among those surveyed with GPS on January 2017 (Fig. 4) to compare the bank representation with the different survey techniques. Figure 11 shows the bank profiles at sections 1, 2, 4, 6, 7, and 8. These sections presented distinct erosion magnitudes and features after 7 years of restoration; for example, section 8 (Figs. 4 and 11) appeared close to the original condition, with a mild slope and nearly no erosion, whereas sections 6 and 7 had vertical scarps. The SfM DSM profiles are represented by continuous lines, the ALS profiles with dashed lines, and GPS points with circles. The SfM representation had better pro-

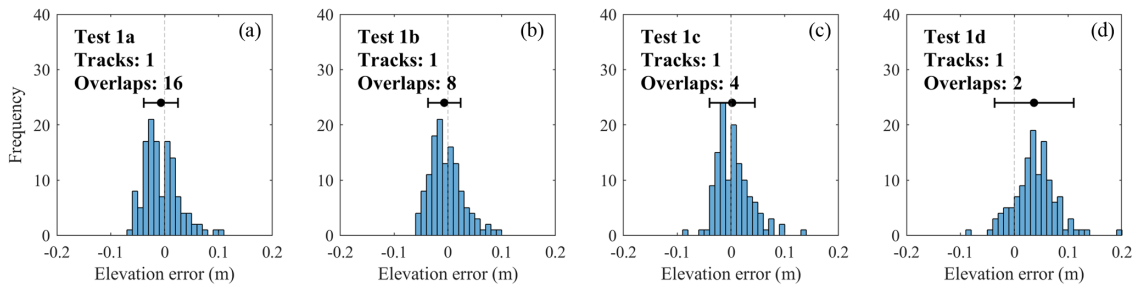
Figure 5. Elevation error distributions for SfM tests 1a, 1b, 1c, and 1d, assuming that the RTK points are correct and without error. Indicated overlaps are the minimum.

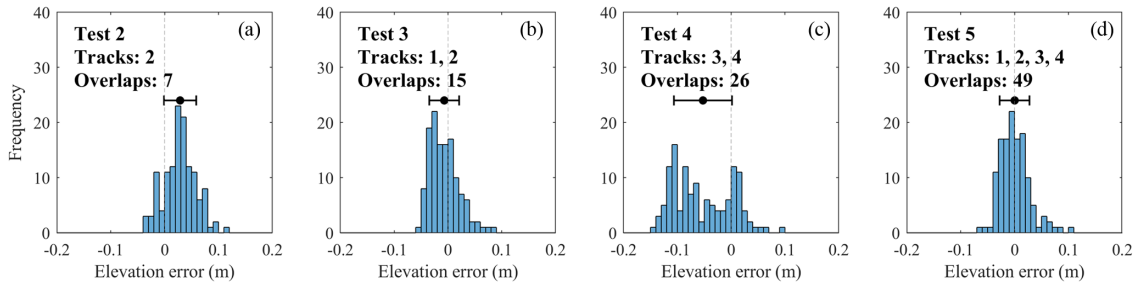
Figure 6. Elevation error distribution for tests 2, 3, 4, and 5. Ordinates indicate number of GPS points in each bin.

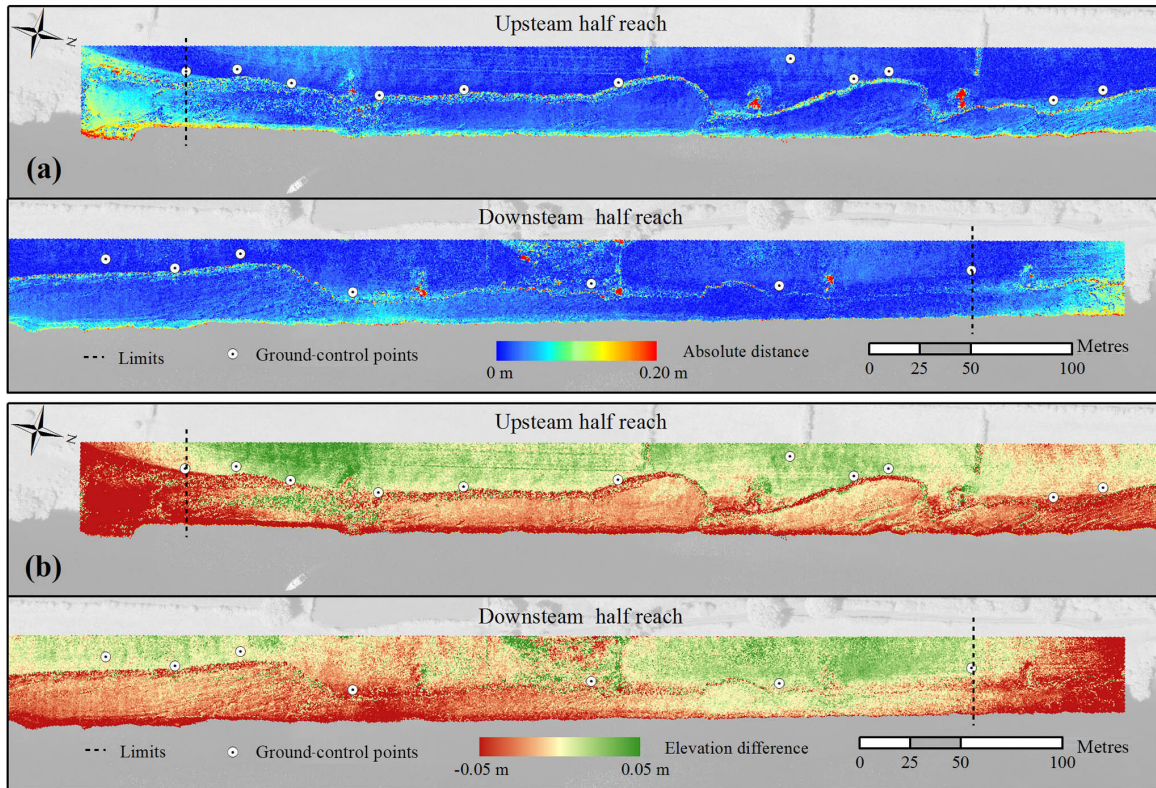
Figure 7. (a) Absolute elevation differences between SfM and ALS along the reach. (b) Signed elevation differences between SfM and ALS with a smaller scale range.

Compared to the ALS grid, the test 3 point cloud showed a good agreement over most of the reach. This is observable from Fig. 7a, corresponding to the blue areas that indicate elevation differences lower than 5 cm. However, two notable regions surpassed this difference: the bank and the extremes of the reach. The latter were zones beyond the GCPs, where higher errors in the DSM are expected when using parallel image directions due to inaccurate correction of radial lens distortion (James and Robson, 2014; Smith et al., 2014). Consequently, the results outside the GCP limits were not considered as reliable as those within, where distor-

Figure 7b presents signed elevation differences with a smaller scale range to highlight areas with positive and negative deviations between techniques. Green zones indicate higher ground elevations on the SfM DSM than in the ALS grid, red zones indicate the opposite, and yellow shows elevation matches. The upstream half domain presented a general tendency of SfM to overestimate elevations on the floodplain, and in turn underestimate them on the terrace. This trend is also observed in the upper part of the downstream reach. Nevertheless, these zones showed exceptions, such as a green patch at the terrace close to the dashed limit, and a red patch on the floodplain at the end of the upstream half reach. Despite the described general opposed behaviour between floodplain and terrace, the downstream reach evidenced two zones with consistent trends across the domain, covering both the floodplain and terrace. First, lower SfM elevations at the end of the largest embayment (downstream half reach), and second, SfM higher elevations at the end of the reach, before the dashed limit.

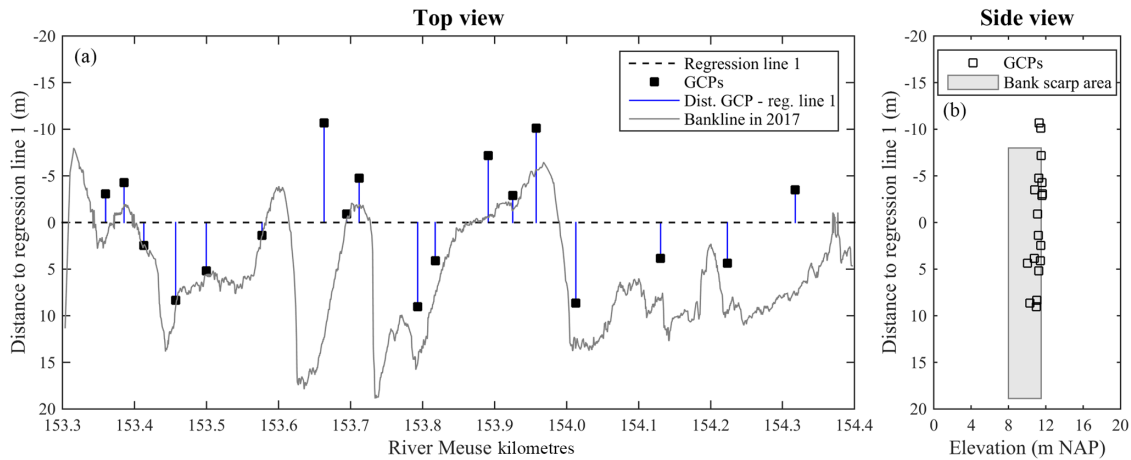
Figure 9. GCP horizontal distances to the regression line (a) and respective positions in potential rotation plane from the regression line (b).

tudes of the case study, with maximum bank heights of 3.5 m, indicated with a grey area in Fig. 9b. This side perspective of the domain evidences the potential plane of rotation, whose stability depends on the position of the GCPs.

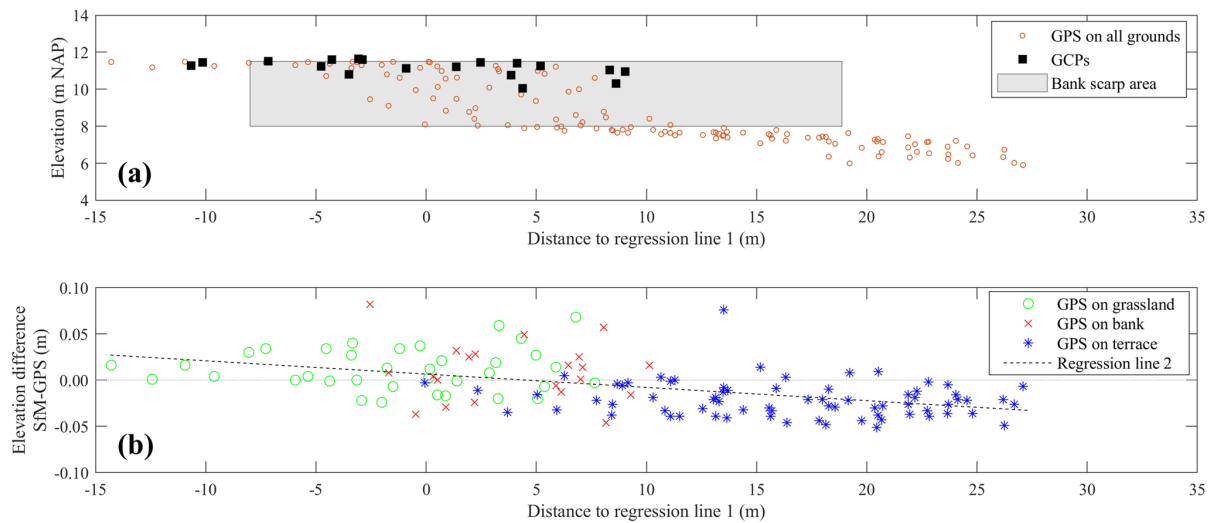
Figure 10. (a) Location of GPS measurements in potential rotation plane around regression line 1. (b) SfM DSM elevation errors across regression line 1, distinguished among areas of grassland, bank, and terrace.

The analysis made for test 3 on model rotation evidenced a linear trend with increased surface elevations on the floodplain side of the domain and decreased elevations on the main channel side (Fig. 10b). This tendency was probably caused by a rotation of the DSM around co-linear GCPs that may lead to rotated solutions of the Helmert transformation (Carbonneau and Dietrich, 2017). Yet, the areal SfM-ALS comparison within ± 5 cm range (Fig. 7b) did not evidence a clear axis along the whole domain that could suggest a rigid rotation of the DSM, since the ALS did have a constant mean accuracy across all surface types (Table 3). The linear rotation tendency, then, might have been obscured by the error range that was larger across the domain (Figs. 6b and 10b) than the mean rotation magnitude, whose elevation difference between the extremes of the cross-sectional domain was 6 cm, and 4 cm within the bank area. Thus, other sources of error were also present that resulted in the obtained error range.

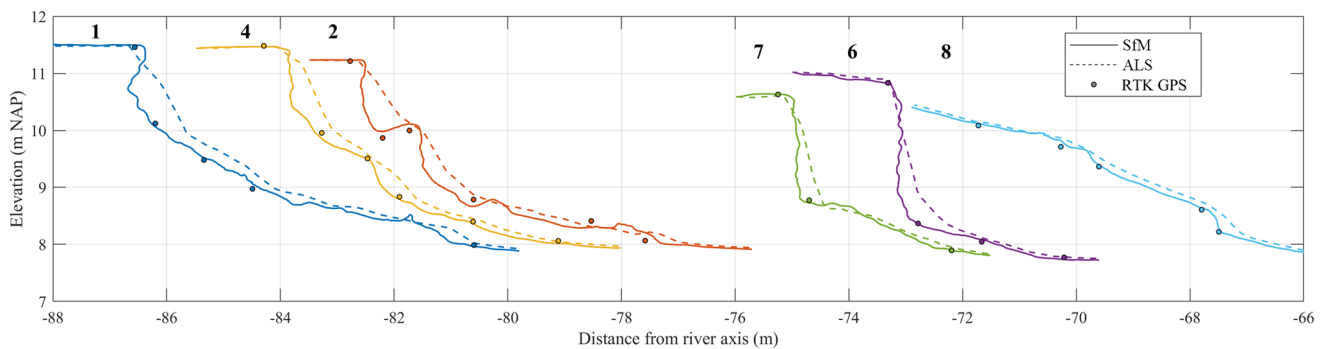
Figure 11. Banks measured with SfM (continuous lines), ALS (dashed lines), and GPS (circles) on 17–18 January 2017. Cross-sections are located, from left to right, at river kilometres 153.4, 153.9, 153.5, 154.2, 154.1, and 154.3 (see Fig. 4 for locations).

imity to the GPS points than the ALS in almost all cases. What is more, ALS generally overestimated the elevation corresponding to the GPS points, which confirms the bias observed in the comparison of bank elevations shown in Figs. 7 and 8.

SfM profiles showed detailed bank features, such as a collapsed upper bank laying at the toe (section 2), an overhang at the bank top (section 1), small-scale roughness on scarps (sections 6 and 7), and slump-block deposits (section 4). These features appeared as simple shapes in the profiles but they were confirmed with field observations. The ALS depicted simpler profiles, smoothed by coarser resolution, which made it difficult to identify characteristic features of the erosion cycle in them. Yet, ALS profiles had enough point spacing to capture gentle bank slopes with reasonable precision (section 8), but for steeper ones (sections 1, 2, and 4) and especially at scarps (sections 6 and 7), this technique provided lower accuracies.

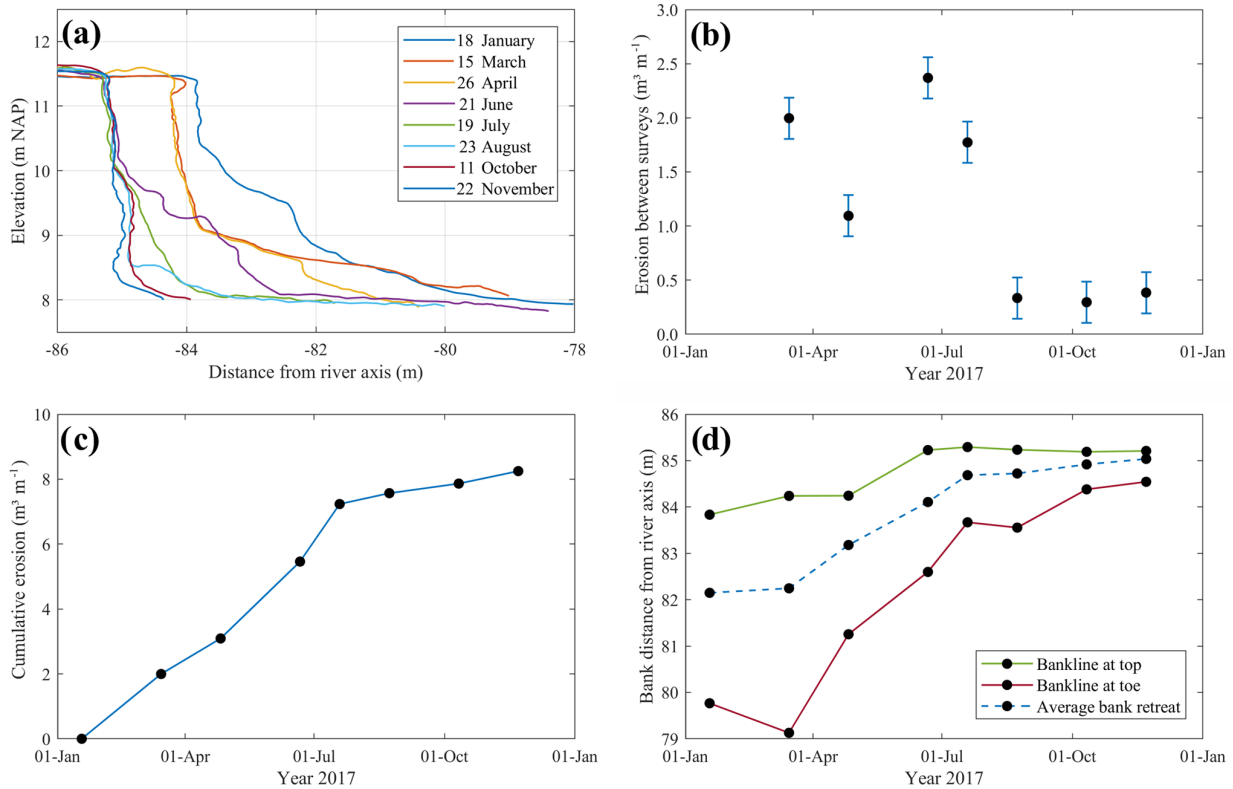
Figure 12. Sequential surveys at cross-section 4, Meuse River kilometre 153.9, over 2017. **(a)** Bank profiles from DSMs; **(b)** eroded volume per unit width between consecutive surveys; **(c)** cumulative erosion along surveys; **(d)** bankline locations at the top and toe of the bank.

The temporal development of section 4 (Figs. 4 and 11) is illustrated in Fig. 12a by a sequence of SfM-UAV surveys. The initial stage corresponds to the survey of Fig. 11 on 18 January 2017. The consecutive surveys showed the evolution of the vertical bank profile through which different processes can be inferred. The bank profile, initially characterized by a top short scarp and slump blocks along the bank face, experienced a mass failure and a further removal of blocks between 18 January and 15 March 2017. Between 15 March and 26 April, only toe erosion occurred. By 21 June, another mass failure happened, which left slump blocks along the lower half of the bank. On 19 July, these blocks were removed, leaving a steep bank face. Then, further toe erosion caused a small soil failure at the lower bank whose remains laid at the toe. On 11 October, this wasted material was removed. Then, until the last survey on 22 November, entrainment occurred at the lower half of the bank profile, further steepening the bank. In light of the results, the

bitrarily defined for this case at 11.1 and 8.1 m, respectively. The top bankline showed a major jump between April and June and a smaller one between the first two surveys, corresponding to mass failure events. The bank toe presented a more gradual retreat, with events of slumping and temporal accretion that were timely captured along the surveys. This alternative bank retreat representation provides evidence of the development of bank erosion at every survey. The contrast of bankline retreat at the top and toe of the bank illustrates how different processes on their own represent dissimilar erosion evolutions, since they constitute different phases of the erosion cycle, i.e. at the top mass failures and the toe slump-block removal and entrainment. Finally, the average bankline between bank toe and top would best represent the real retreat (dashed line in Fig. 12d), despite not necessarily indicating an actual bank location for a specific elevation. This approach logically considers all erosion phases and follows a similar trend to the cumulative erosion of Fig. 12c.

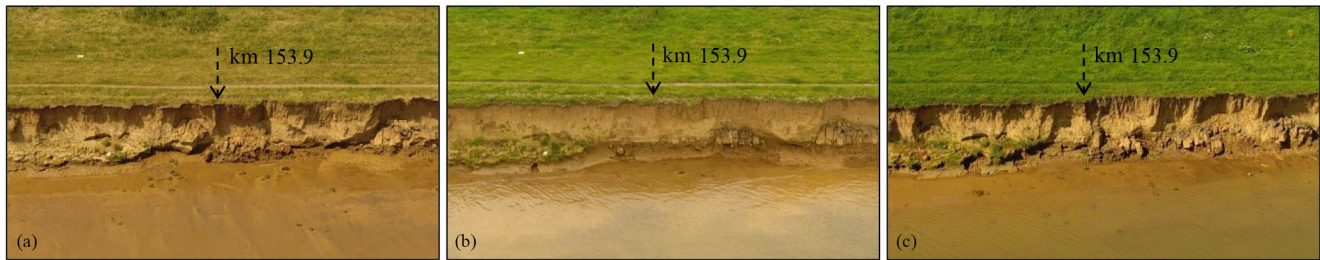
Figure 13. Zoomed-in UAV photos from track 1 at section 4, kilometre 153.9, showing diverse bank erosion stages: slump blocks at bank toe on 21 June (a), clean bank face after block removal on 19 July (b), and undermining on 23 August (c).

Finally, the availability of the UAV imagery provides additional information to analyse and interpret bank evolution through direct observation. Figure 13 shows photographs from the three consecutive surveys on 21 June, 19 July, and 23 August at section 4, kilometre 153.9. At this bank area, the sequence shows on the left side of the panels only entrainment at the bank toe, and from the centre (kilometre 153.9)

to the right, one or more erosion cycles. Cross-section 4 presented on 21 June (Fig. 13, left panel) slump blocks laying at the bank toe that were removed by 19 July. Then, on 23 August, this cross-section had incipient undermining at the lower bank and block deposition at the toe. The bank area at the right of section 4 experienced a second mass failure after 21 June, completing one erosion cycle, and further downstream it is more difficult to keep track of the cycles due to faster erosion rates. The UAV photos also evidence the progressive growth of grass over the floodplain, especially observable next to the walking path, which was captured along the surveys (Fig. 12a).
