MASSIVE METALLOSIS AFTER MEDIAL UNICOMPARTMENTAL KNEE ARTHROPLASTY MISPLACEMENT

Case report: We report the case of a patient who developed severe metallosis of the knee joint resulting from the secondary friction wear of both the femoral and tibial components of a unicompartmental knee arthroplasty due to malposition and consequent severe wear of the polyethylene insert. The mechanical failure was diagnosed one year after implantation, and metallosis became evident six months later. The patient was treated with a mass excision, extensive debridement, and a single-stage revision with a constrained total knee arthroplasty.

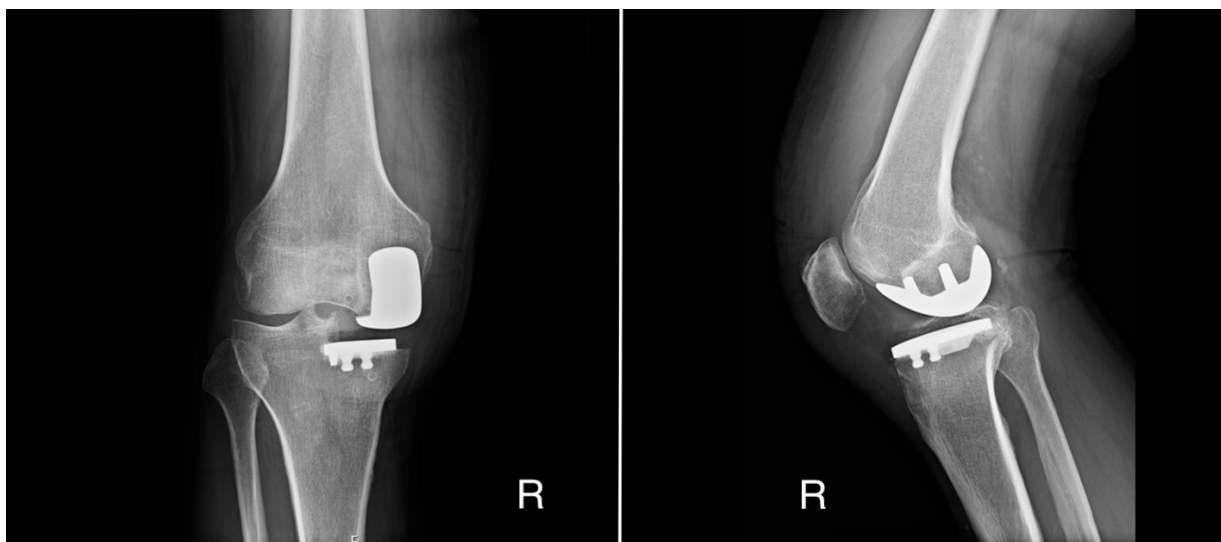
The patient was never satisfied with the results of the surgery, and in April 2021, 6 weeks after the implantation of the UKA, he complained about persistent right knee pain, swelling, and disability. At the examination and blood tests, no signs of infection were found. Early postoperative radiographs showed malposition of the UKA, with a valgus and too lateral tibial component (Figure 2).

Figure 2. Post-operative radiograms after primary unicompartmental arthroplasty: the tibial component is placed in valgus and lateral (2021).

In the present case, the tibial component appeared to be positioned in valgus and too lateral, leading to an incorrect alignment between the femoral and tibial implants. Due to the malalignment of the two components, the point of contact was reduced to only a small area where the load was concentrated. Therefore, the asymmetrical prosthetic joint space may have induced premature tibial component wear and, finally, poly breakage, which gradually led to both femoral and tibial metal wear and the spread of debris.

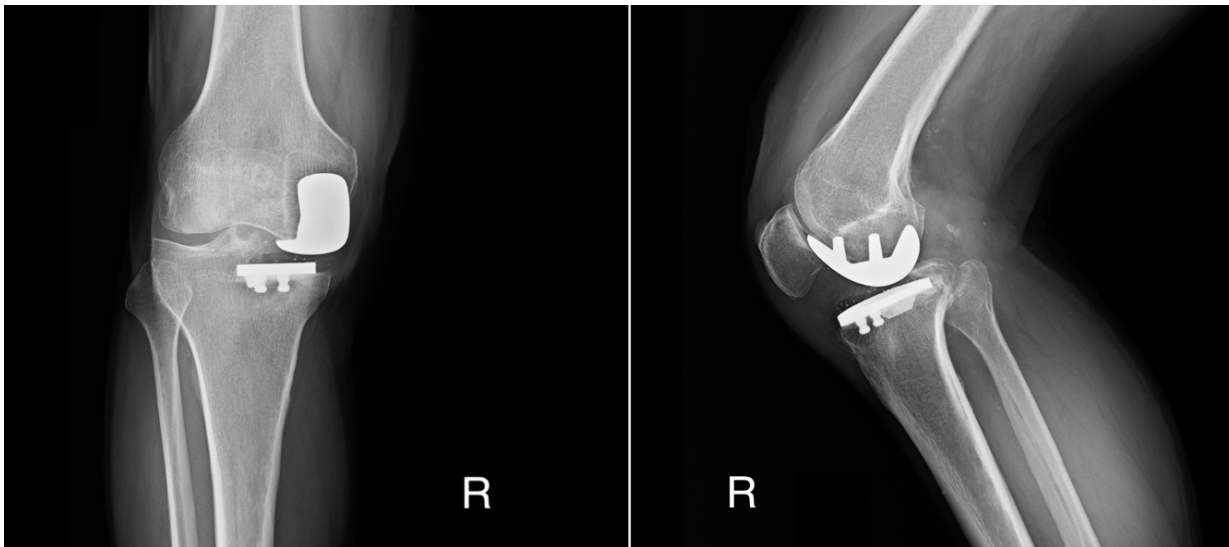
The patient underwent one year of rehabilitation therapies with no improvement of his symptoms, and in May 2022, he presented to our hospital because of increasing pain and disability for the last 4 months. The physical examination showed intact skin, a swollen joint with a range of motion of 10°-100°, and diffuse pain over the medial compartment; neither anteroposterior nor medial-lateral instability was found. There was no localized erythema, increased temperature, or wound discharge that could suggest a prosthetic infection or skin pigmentation. New radiographs demonstrated misplacement of the components with poly wear and some metal debris at the joint line that were not noticed in the beginning (Figure 3). A one-stage UKA to total knee arthroplasty (TKA) revision was then advised.

Figure 3. One year after primary unicompartmental arthroplasty radiographs: little metal debris between the prosthesis components was present (2022).

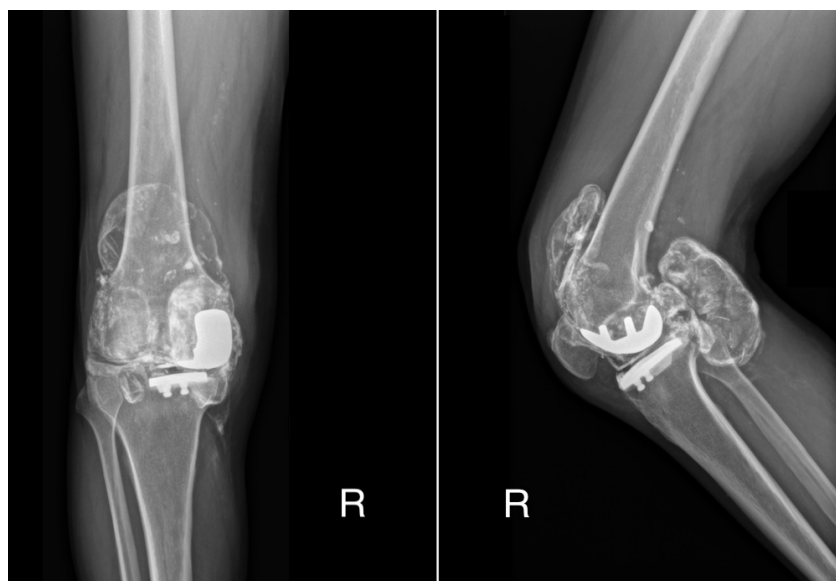
Ten months later, in March 2023, the patient underwent a pre-admission examination. His right knee was still swollen, with a massive popliteal Baker cyst; the ROM was limited to 10-90° and he complained of medial compartment pain. The patient presented no anesthesiologic contraindication to surgery. The results of blood tests were: C-reactive protein (CRP) 1.86 mg/dl, erythrocyte sedimentation rate (ESR) 26 mm/h, white blood cells (WBC) $10.56 \times 10^3/\mu\text{l}$, neutrophils 75%. The pre-surgery protocol included a standing long X-ray of lower limbs, standard anteroposterior (AP) and lateral right knee X-rays, and Patella Merchant view, which showed massive amorphous densities in the popliteal fossa and the suprapatellar pouch, other than around the prosthesis (Figure 4).

Figure 4. Two years after primary surgery (pre-admission) radiographs: massive metallosis of the right knee with radiographic “bubble sign” (March 2023).

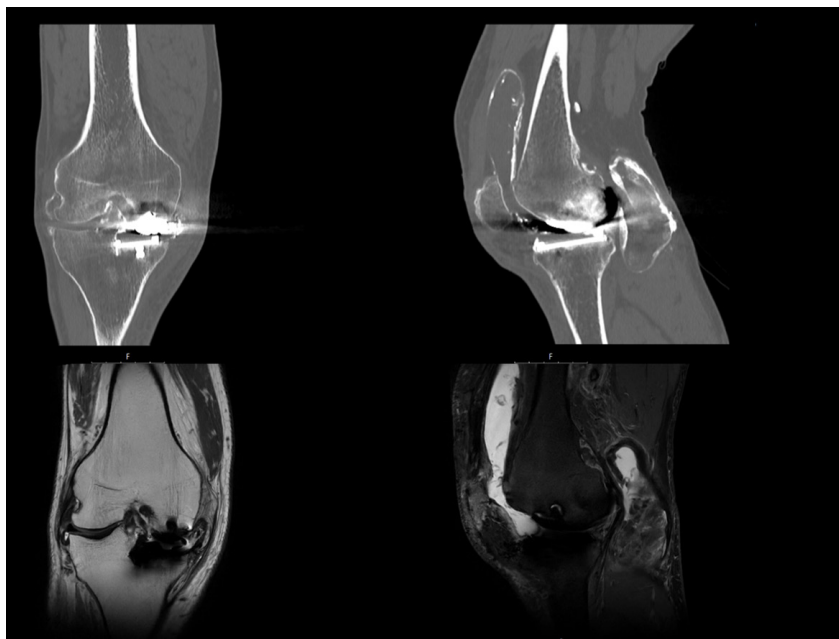
In addition, a magnetic resonance (MRI) and computed tomography (CT) scan with and without contrast medium were performed with the aim of ruling out the diagnosis between metallosis, chondromatosis and infection. From the radiological report emerged “Evidence of distension of the anterior capsular, the anterior recess and the gastrocnemius-semimembranosus bursa with atypical aberrant hyperplastic phenomena; poly wear and subluxation of the prosthesis with depression of the tibial component.” (Figures 5 and 6). The patient reported previous atopic reactions to metal contact, so atopy patch tests for metals were performed, and they were negative.

Figure 5. Pre-admission CT scan and MRI: effusion, polyethylene wear, atypical aberrant hyperplastic phenomena compatible with metallosis (June 2023).

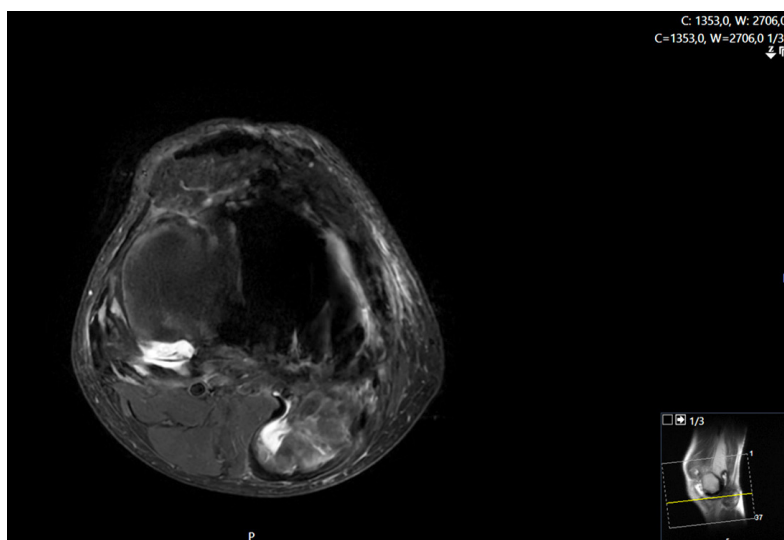
Figure 6. Pre-admission MRI: axial scan evidenced that metallosis posterior mass was medial and far from the popliteal neuro-vascular bundle (May 2023).

Surgery was performed in June 2023. At the time of admission, new blood tests were obtained, revealing an improvement in the inflammatory markers compared to those taken three months earlier (CRP 0.89 mg/dl, ESR 7 mm/h, WBC $7.74 \times 10^3/\mu\text{l}$). The surgical planning included the removal of the popliteal mass and one or two-stage revision of the UKA with a hypoallergenic total knee arthroplasty based on the results of intra-operative synovial fluid tests. Firstly, the patient was positioned prone, and a tourniquet was applied to the thigh. A posterior approach to the knee was used to remove the posterior capsule and the pseudo-tumor in “one block” (Figure 7). The excised tissue appeared soft and elastic with some gelatinous portions. The mass was capsulated and localized medial to the neurovascular bundle, so no issues were found in approaching and excising it.

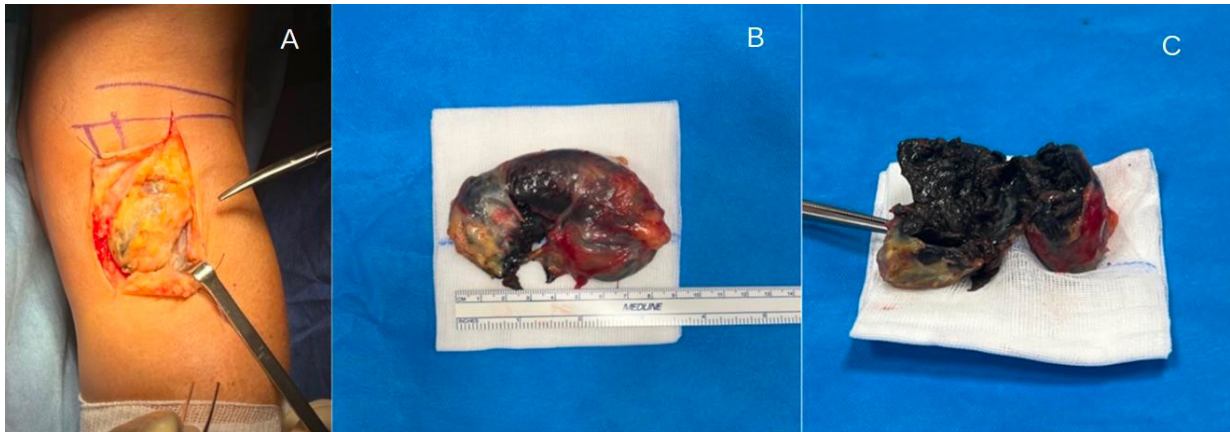
Figure 7. Intra-operative pictures. The posterior approach reveals a popliteal capsuled mass (A) that was excised in “one block” (B). The mass section shows a black and amorphous content (C).

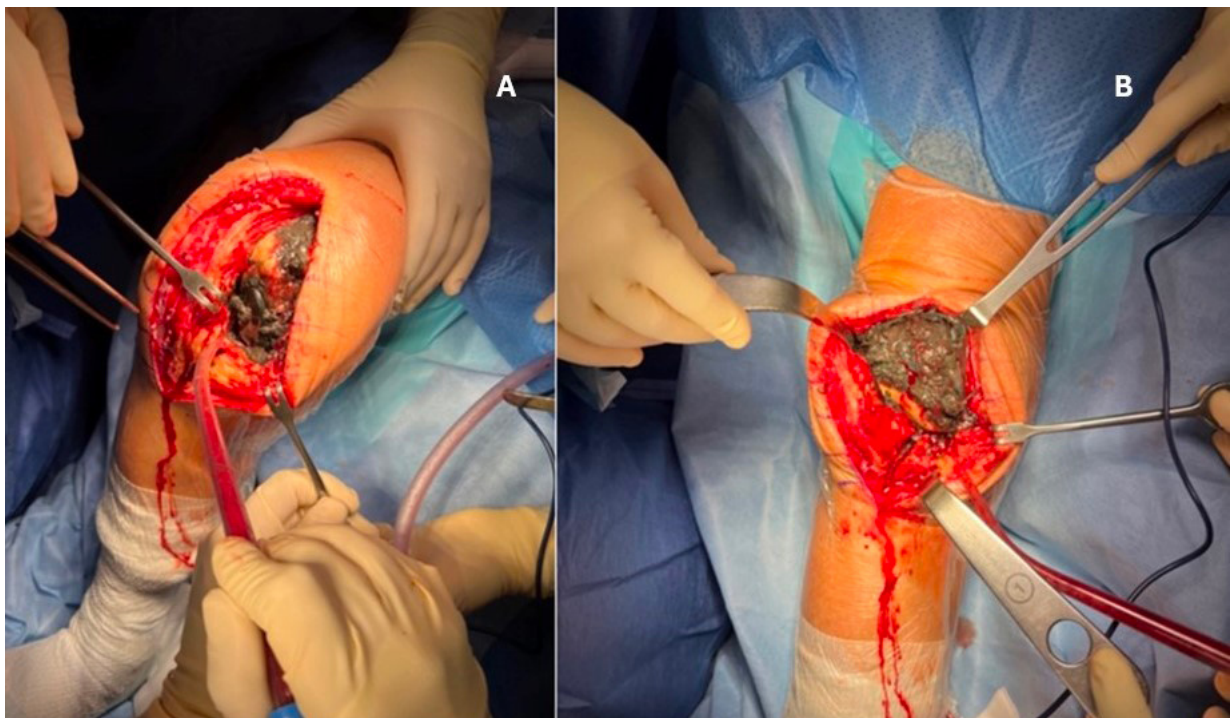
Secondly, in the supine position, an anterior medial parapatellar approach was performed, and multiple samples of synovial fluid were collected for intraoperative spot tests (leukocyte esterase and WBC count) in order to rule out infection. A severe synovitis associated with massive metallosis was noticed, while the tibial and femoral components were well fixed (Figure 8).

Figure 8. Intra-operative pictures. Anterior approach: massive metallosis around the prosthesis (A) and in the suprapatellar recess (B).

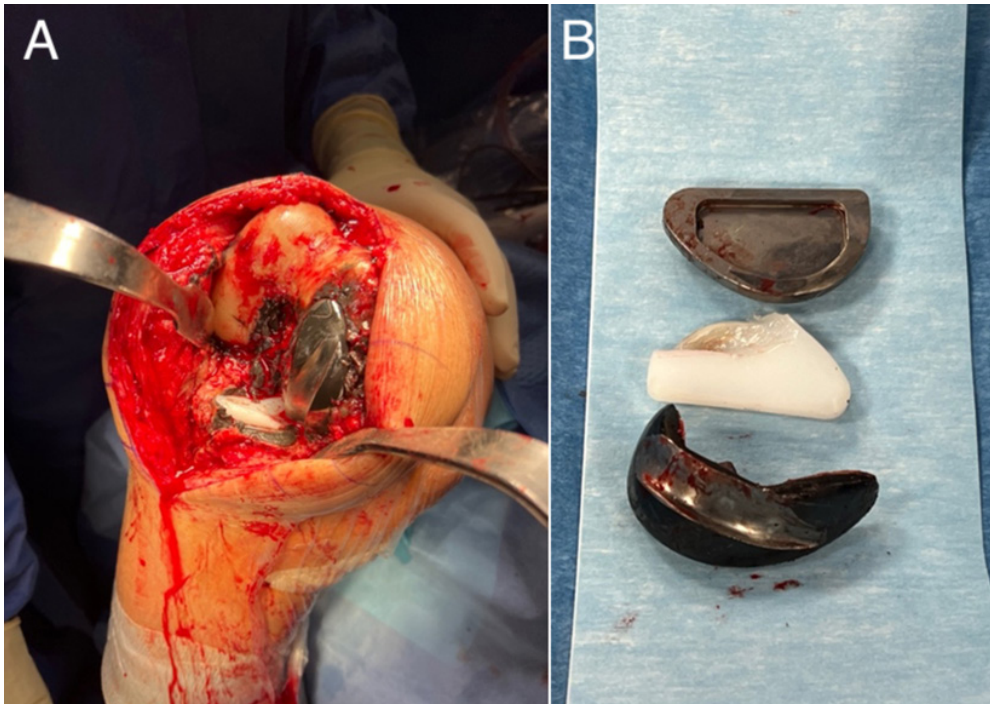
The polyethylene tibial insert showed severe wear that had caused secondary friction between the femoral and tibial metal surfaces, with subsequent macroscopically severe abrasion of the femoral component (Figure 9). The implant and residual cement were removed, and the periprosthetic tissue affected by the metallic debris was debrided. However, a complete removal of metallic particles was not possible. The removed material was sent for histological analysis, while multiple tissue samples were collected for culture.

Figure 9. Intra-operative view of the prosthesis components *in situ* (A) and after removal (B): no aseptic loosening was found, but there was severe polyethylene and femoral component wear.

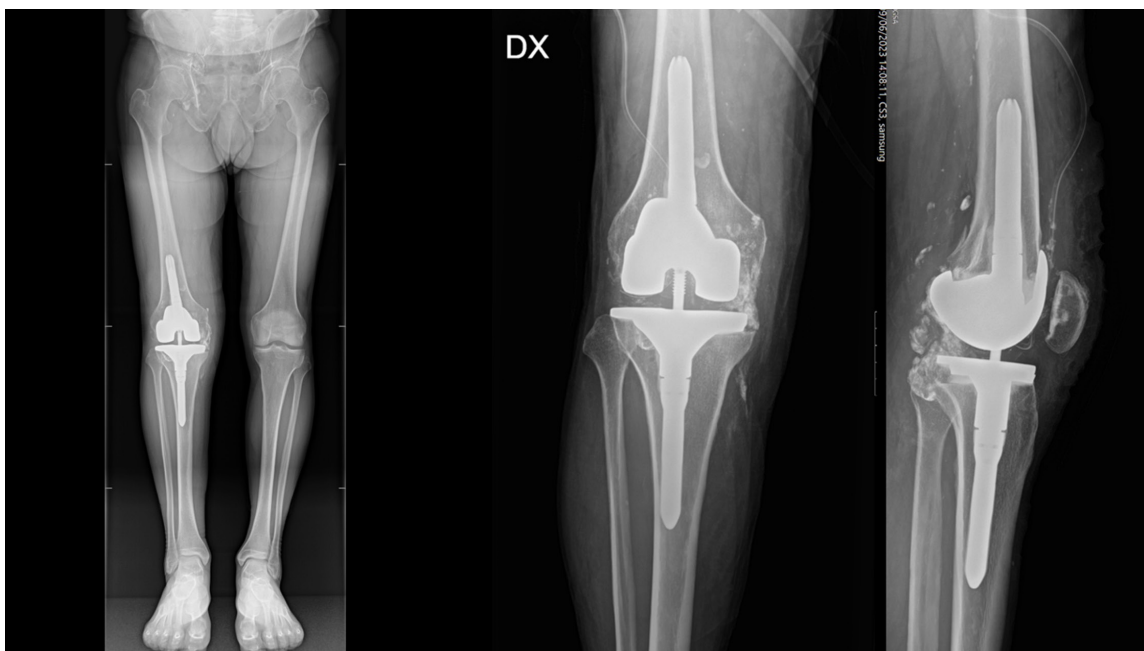
Figure 10. Post-operative radiograms: the revision TKA is well placed but some residual postero-medial metallosis is present because of the complexity of displaying and removing it during surgical debridement (June 2023).

The results of the intraoperative spot tests for leukocyte esterase and WBC were negative, so a one-stage TKA conversion was carried out. The bone loss following the UKA removal procedure and the extensive debridement of both bone and soft tissues affected by metallosis lead to the need for a revision system instead of a primary total arthroplasty. Finally, a nickel-free cemented condylar-constrained total knee arthroplasty was implanted (Genus[®], Adler Ortho, Cormano, Milan, Italy); the patella was also resurfaced, and the tibial bony defect was filled with cement (Figure 10). A drain was applied, and the wound was sutured with no tension.
