Supplementary Info:

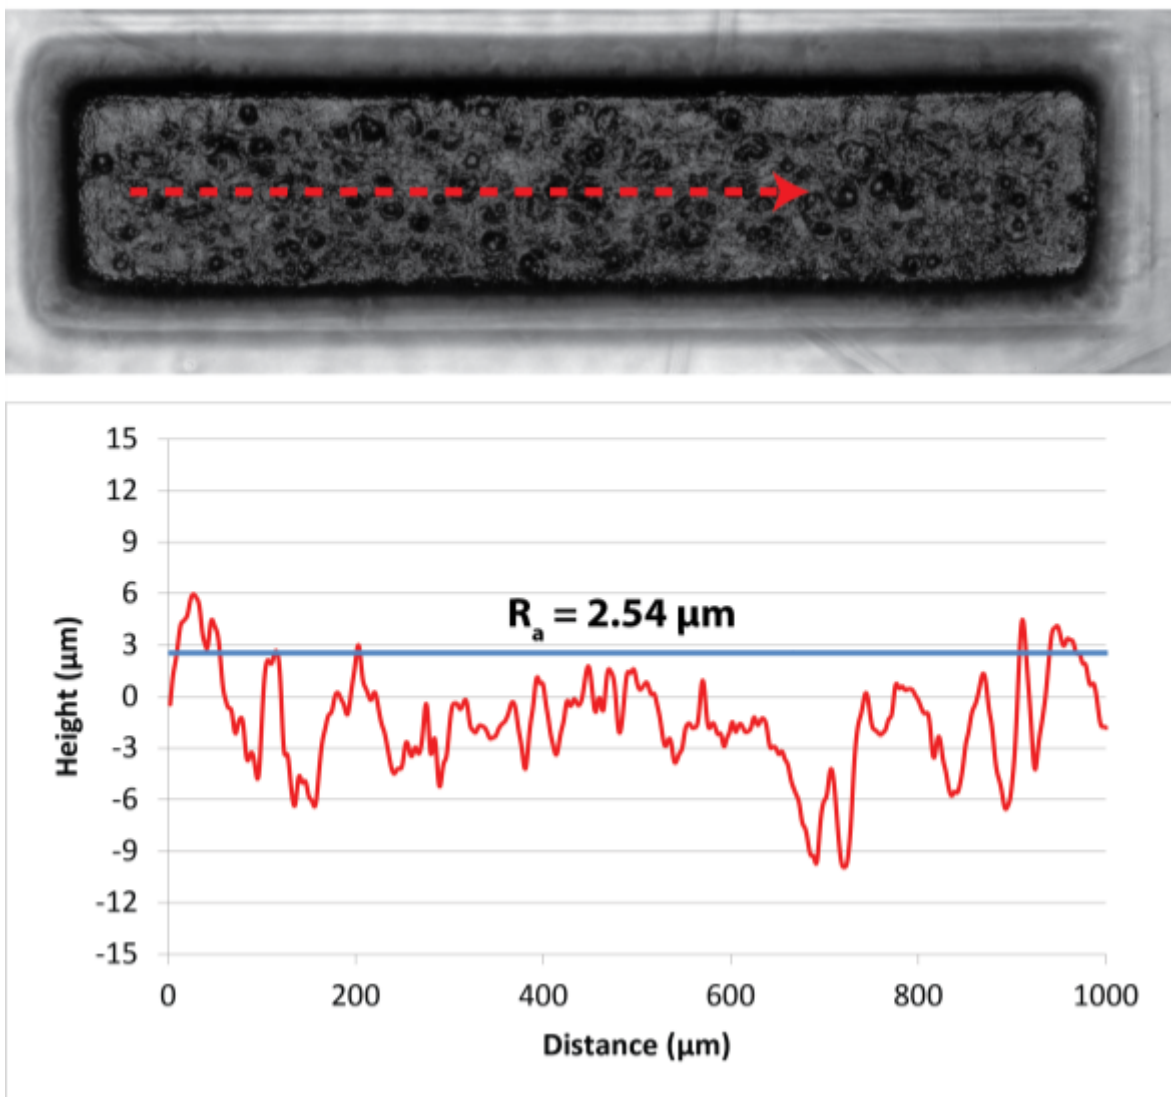
Fig. S1. (a) A representative micrograph of a bottom-facing trench and the orientation of line-scans measured using a stylus profilometer. (b) A representative line-scan of median roughness ($R_a = 2.54 \mu\text{m}$).
