ANALYSIS OF THE QUALITY ASSURANCE RESULTS FROM THE INITIAL PART OF PRODUCTION OF THE ATLAS18 ITK STRIP SENSORS

13th International "Hiroshima" Symposium on the Development and Application of Semiconductor Tracking Detectors (HSTD13), Vancouver, Canada

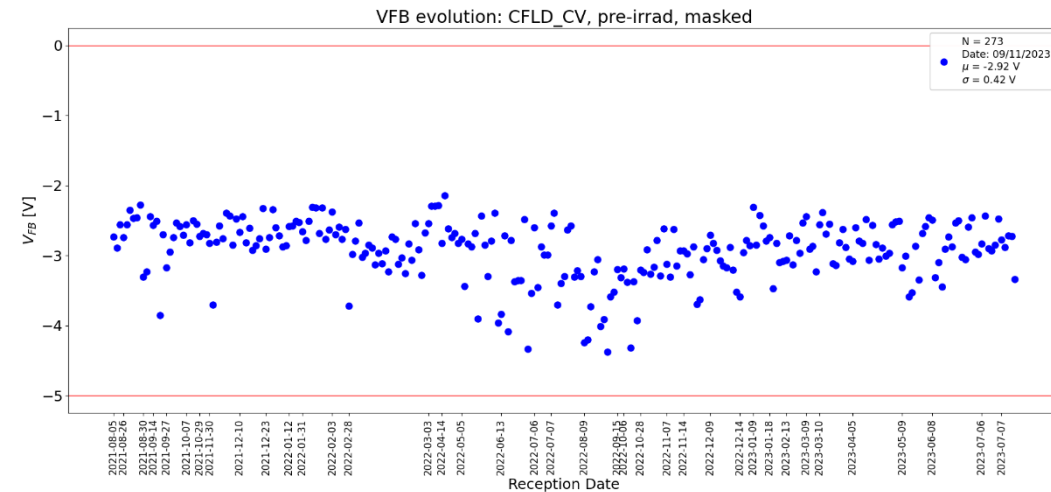
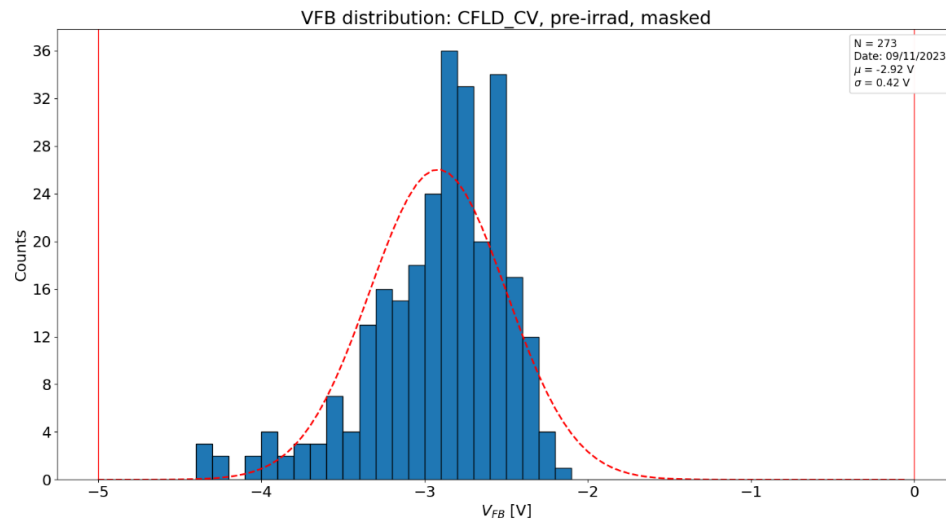
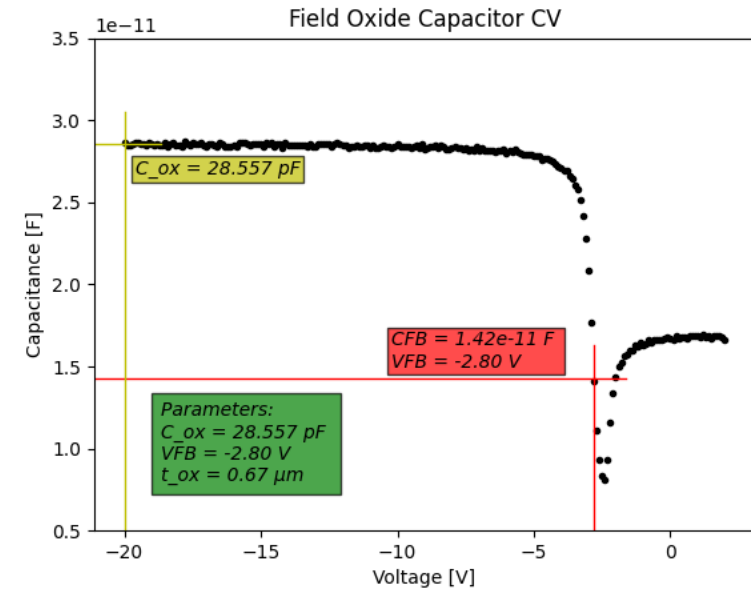
- High dispersion in VFB values.
- In general, a bit low values. Interface traps or trapped charge in the oxide.
- The VFB distribution shows a slight tail to low values in a few batches.

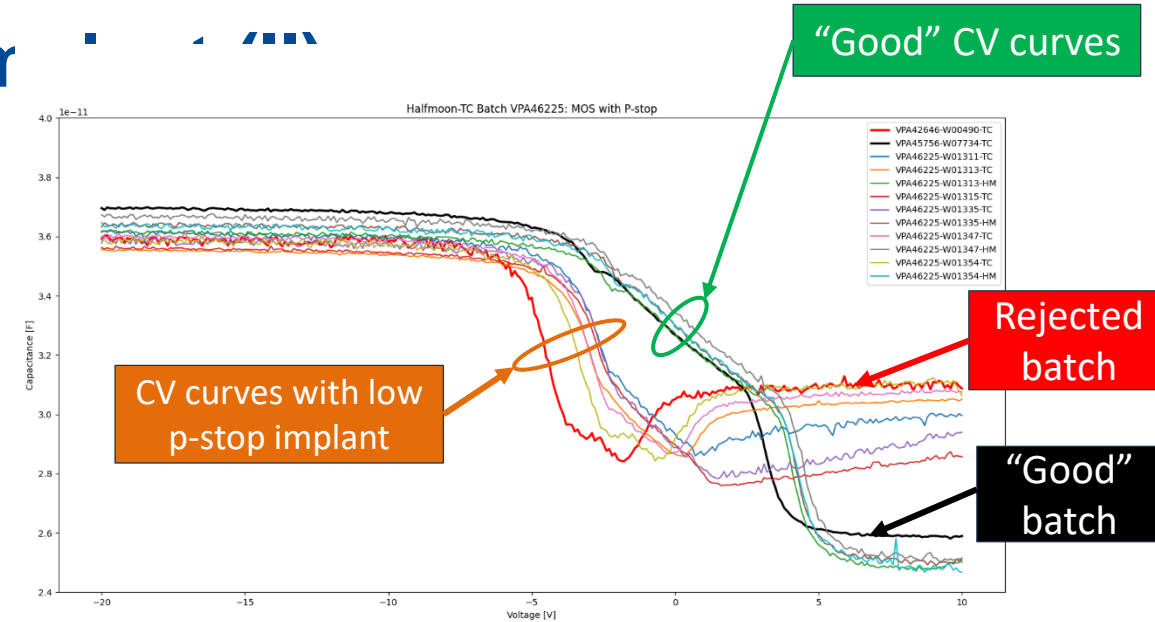
SREF from TC and other samples from 3 rejected batches

- A few batches have been rejected due to a low p-stop doping.
- The plot below, where SREF is represented for different batches, clearly shows the batches where the implant is low. Several data points measured for the suspect batches, unlike a typical one.
- Features corroborated by PTP performance on half-moons and MAIN sensors [5].

Rejected batch
