Impact of Terrestrial Neutrons on the Reliability of SiC VD-MOSFET Technologies

Abstract—**Accelerated terrestrial neutron irradiations were performed on different commercial SiC power MOSFETs with planar, trench, and double-trench architectures. The results were used to calculate the failure cross sections and the failure-in-time (FIT) rates at sea level. Enhanced gate and drain leakage were observed in some devices which did not exhibit a destructive failure during the exposure. In particular, a different mechanism was observed for planar and trench gate MOSFETs, the first showing a partial gate rupture with a leakage path mostly between the drain and the gate, similar to what was previously observed with heavy ions, while the second exhibiting a complete gate rupture. The observed failure mechanisms and the postirradiation gate stress (PIGS) tests are discussed for different technologies.**

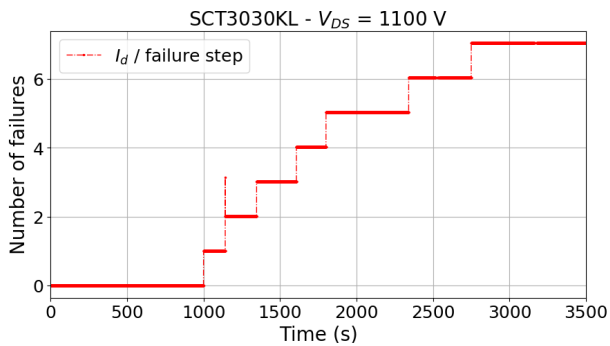
Fig. 4. Example of online measurement for Rohm devices (SCT3030KL) exposed at 1100 V. The drain current measured during the exposure is divided by the failure step size in order to highlight the number of failures during the run.

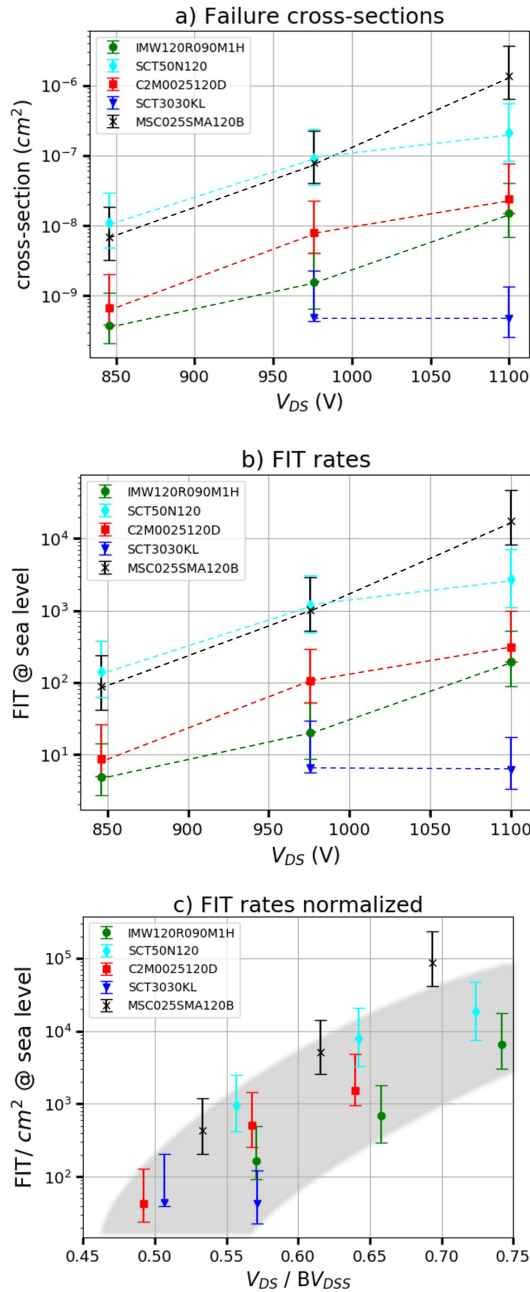
The failure cross sections are shown in Fig. 5(a) as a function of the bias during irradiation. In Fig. 5(b), the FIT rates are shown for the tested references, while in Fig. 5(c), the FIT rates are normalized with the active area and scaled by the avalanche breakdown voltage, such that a ratio of 1 would indicate that the critical field was reached. This approach was suggested and previously discussed in [9]. A common trend

Fig. 5. (a) Failure cross sections of SiC MOSFETs from different suppliers as a function of the bias during the terrestrial neutron irradiations. (b) FIT rates for 10^9 h of operation. (c) FIT rates scaled by avalanche voltage and normalized with the active area.

is observed for all the devices and highlighted by the gray shadow. The trench MOSFETs (i.e., IMW120R090M1H and SCT3030KL) appear to have lower FIT rates if compared to the planar architecture. In particular, the double-trench device (SCT3030KL), which has the highest avalanche breakdown voltage, has the best performance.

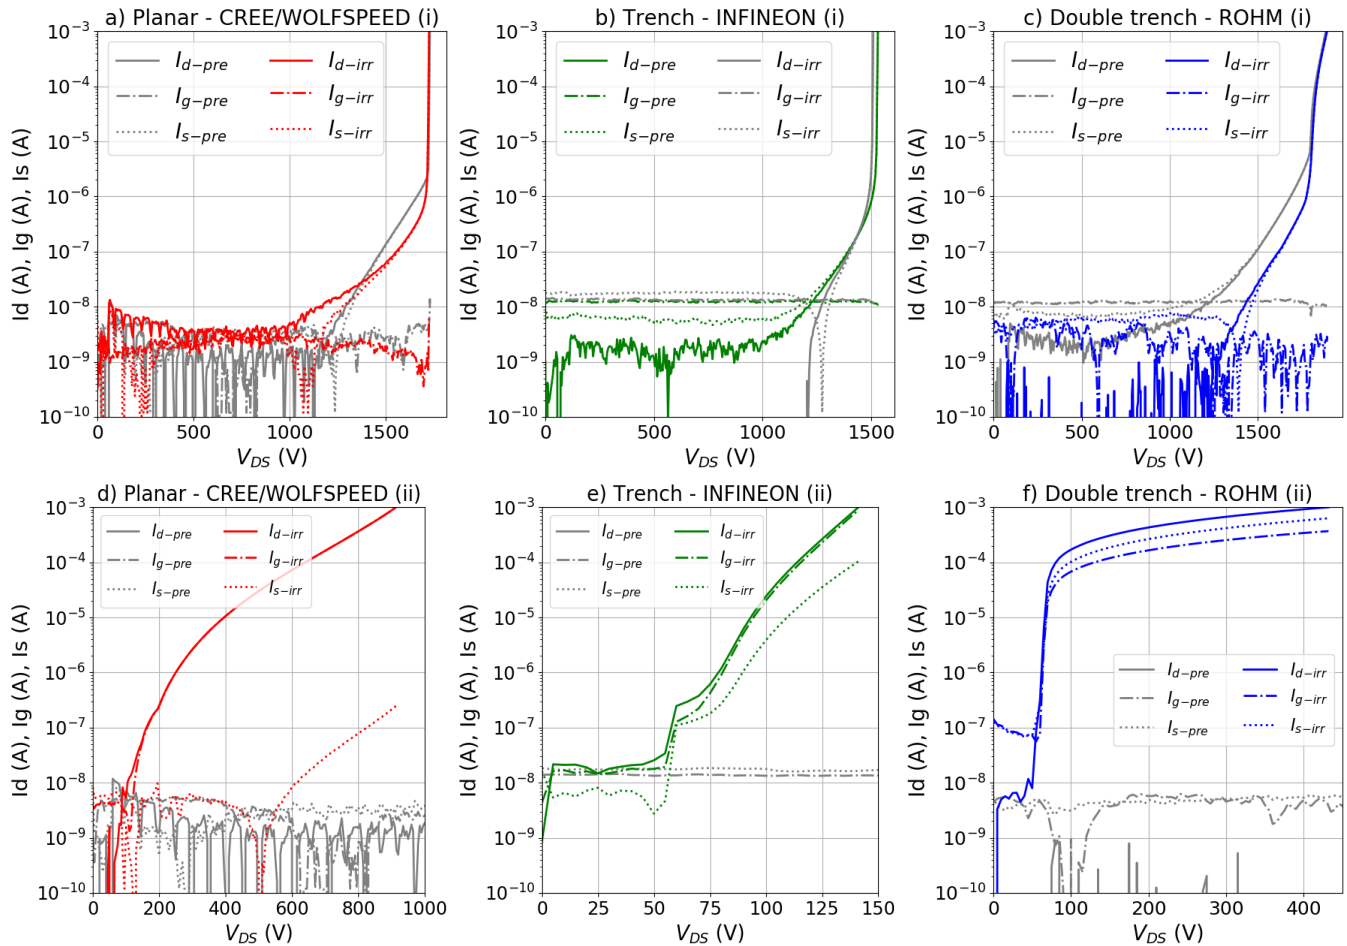
planar gate from Cree/Wolfspeed (i.e., C2M0025120D), trench gate from Infineon (i.e., IMW120R090M1H), and double trench from Rohm (i.e., SCT3030KL). As an example, the results are compared for the references tested at 976 V. BV_{DSS} measurements of the irradiated devices were performed at $V_{GS} = 0$ V and stopped at V_{DS} corresponding to $I_D = 1.00$ mA, which is defined as the breakdown voltage. At this current level, the device is still protected from a permanent breakdown of the body diode. Three different responses were identified for all the studied references: i) no damage observed with respect to a pristine device; ii) partial degradation of the device, which exhibited higher gate and drain leakage currents; and iii) ohmic trend of the leakage current caused by SEB. Examples of the leakage currents (I_D, I_G, and I_S) are reported as a function of the drain–source bias (V_{DS}) for the three references in Fig. 6. The top and the bottom panels show, respectively, the measurements for (i) and (ii) scenarios described above. A measurement of a pristine device for each reference is given in gray for comparison. In Fig. 6(a)–(c), the measurements are all in the same range as the pristine device, and the small differences observed are caused by part-to-part variations (i.e., the pristine device is not the same part as the irradiated one, but belongs to the same lot). For these devices, no damage was induced by the neutron exposure and no leakage current increase is observed, neither degradation of the blocking capability of the MOSFETs. Differently, a clear degradation was induced by the neutron exposure in the devices reported in Fig. 6(d)–(f). The leakage currents are orders of magnitudes higher with respect to the pristine level for all the three devices; however, the current paths (drain-to-gate versus drain-to-source contributions) differ among them.

Finally, the measurements for (iii) are not reported, but from the ohmic trend of the leakage current, it was concluded that the devices failed through an SEB during the exposure.

Fig. 6. Different responses were observed in the devices exposed to neutrons: i) no failure observed and no damage with respect to a pristine device, as in (a), (b), and (c) and ii) no failure observed, but partial degradation of the device, as in (d), (e), and (f). The measurements of the leakage currents (I_D, I_G, and I_S) were performed at $V_{GS} = 0V$ and with a maximum I_D current of 1 mA.

However, for the degraded device (ii) previously presented in Fig. 6(d), after the stress at negative V_{GS}, I_S decreased, meaning that higher current is flowing to the drain–gate path, rather than into the source pad, as shown in Fig. 8(d). This is evidence of an increased gate damage induced by the negative gate bias.

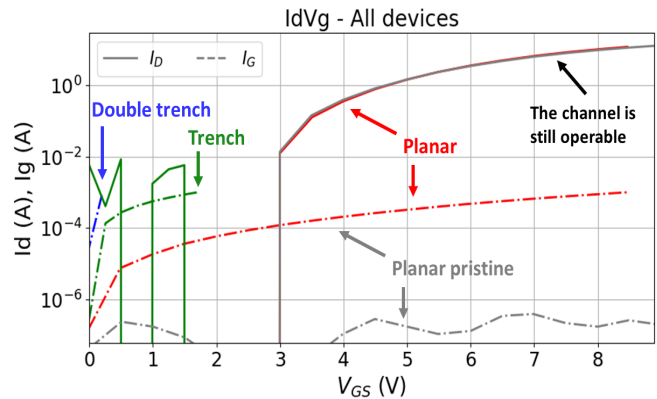
In order to investigate the different leakage path observed for (ii), I_D–V_{GS} and I_G–V_{GS} measurements were performed at $V_{DS} = 1$ V. The results are presented in Fig. 7, which shows that the gate oxide is still operable for the planar device (C2M0025120D) and the channel is still controlled by the gate voltage, but the gate leakage is higher with respect to the pristine level. The device exhibits a partial gate rupture with very high gate and drain leakage current and a gate–drain current path. This effect is similar to the degradation induced by heavy-ion exposure (i.e., SELC), previously reported in [18] and [19]. Conversely, repeating the measurement for the double-trench (SCT3030KL) and the trench (IMW120R090M1H) devices, the gate oxide was found to be heavily damaged and not operable anymore. Indeed, the channel is in OFF-state for these devices and no positive drain current flows. From these observations, it was concluded that the damage in the trench devices has the signature of a complete gate rupture.

Fig. 7. I_D–V_{GS} and I_G–V_{GS} measurements performed at $V_{DS} = 1$ V. The gate oxide is still operable for the planar Cree/Wolfspeed device (C2M0025120D) and the channel is still controlled by the gate voltage. Conversely, the gate oxide is heavily damaged and not operable anymore for the trench and double-trench structures.

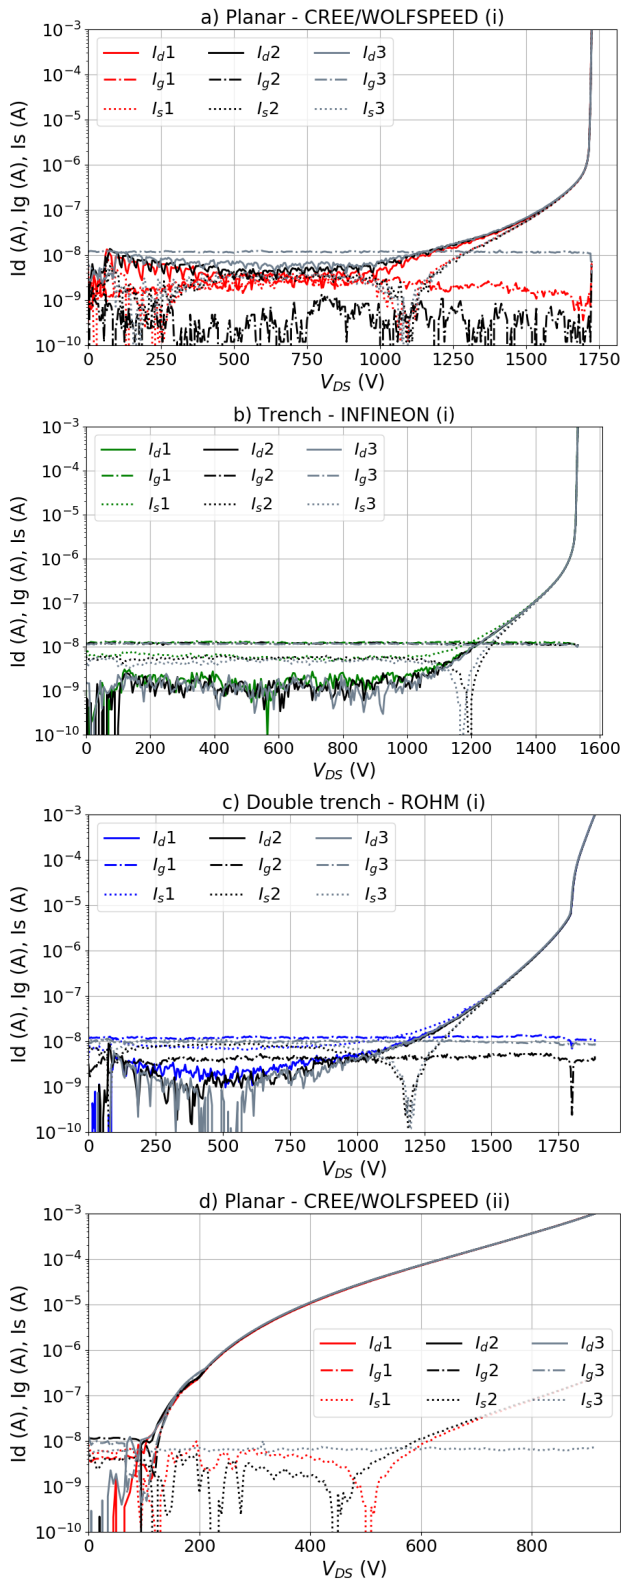
gate oxide might be affected. In order to study the effect of latent damage on the gate oxide integrity and on the blocking capability, breakdown voltage measurements were repeated after applying positive and negative voltage bias at the gate oxide, following the PIGS test as recommended in MIL-STD-750, test method 1080 [31]. V_{GS} was first swept positively up to the rated value for each reference (i.e., +15 V for Cree/Wolfspeed, +18 V for Infineon, and +22 V for Rohm) or until a leakage current of 1 mA was measured. Second, a $V_{GS} = -5$ V was then applied at the gate oxide. The results are shown in Fig. 8(a)–(c) for the three devices discussed before in Fig. 6(a)–(c), respectively, which did not exhibit any measurable damage after the exposure (i). No difference was observed in the breakdown point and in the leakage currents after these cycles. The small differences in the gate leakage current might be due to the instrument sensitivity. Hence, these devices are operable after the neutron irradiation, the leakage current is still within the specification (i.e., $I_G < 100$ nA), and no latent damage is observed after applying the gate bias.

Fig. 8. Breakdown voltage measurements after the PIGS test. The results are reported for (a) planar, (b) trench, and (c) double-trench DUTs, which did not show any damage during the exposure (i), and for (d) planar DUT which was partially degraded (ii). The first cycle reports the measurement just after the irradiation, while the second and the third represent the measurements repeated after applying a positive V_{GS} up to the rated voltage and a negative V_{GS} of -5 V, respectively.
