25th International Cryogenic Engineering Conference and the International Cryogenic Materials Conference in 2014, ICEC 25–ICMC 2014

Failure mechanism and consolidation of the compensation bellows of the LHC cryogenic distribution line

K. Brodzinski^{a*}, P. Cruikshank^a, J.L. Fournel^b, L. Taviani^a, N. Veillet^c,

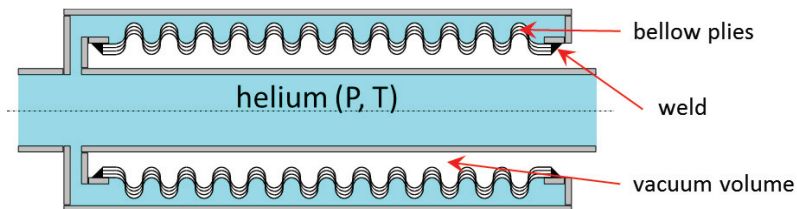
Fig. 3. The simplified bellow design.

The bellows chosen for the QRL installation are working with external helium pressure. Because of mechanical requirements the intermediate bellow part was fabricated as multiply assembly welded to the flanges on both extremities to provide lower stiffness and helium tightness, see Fig. 3.

The repairs required the order of additional spares. In parallel with existing old spares validation, CERN, together with the original bellows supplier, applied improvements in the compensator design. The new spares have a modified flange shape and weld between the plies extremity and the flange, see Fig. 8. The new design allows welding of the 4 plies in one passage. A similar design was successfully applied to the 5000 thermal compensators produced for the LHC cryo-magnets and based on DN80 non-perforated multiply bellows operated with superfluid helium. The other modification is to keep only one ply tight (on the helium side) and all other plies are perforated to create ventilation holes.

The old design required two superposed welds to separate mechanical withstanding (the rings reduces the stress on the bellows weld) and tightness. The cause of the crack is not clearly identified. The micrographic of welds shows an important lack of fusion of the second weld. This defect generates a notch effect which could explain the start-up of a crack. Further investigation would be necessary to identify the root causes of this defect.
