# Challenges and Lessons Learned from Fabrication, Testing, and Analysis of Eight MQXFA Low Beta Quadrupole Magnets for HL-LHC

Abstract—By the end of October 2022, the US HL-LHC Accelerator Upgrade Project (AUP) had completed fabrication of ten MQXFA magnets and tested eight of them. The MQXFA magnets are the low-beta quadrupole magnets to be used in the Q1 and Q3 Inner Triplet elements of the High Luminosity LHC. This AUP effort is shared by BNL, Fermilab, and LBNL, with strand verification tests at NHMFL.

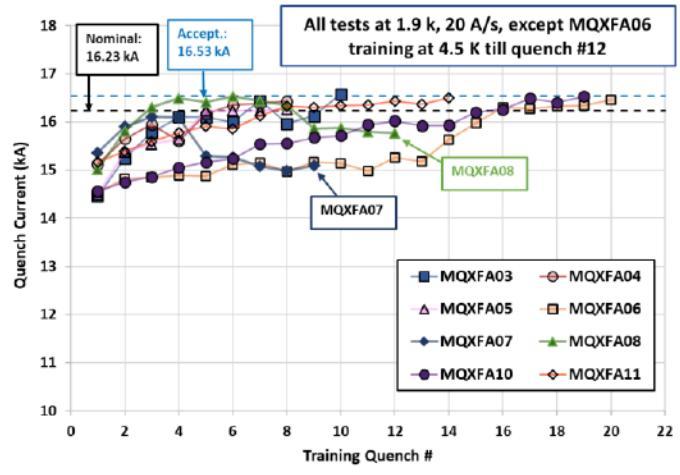
Fig. 1. Quench history of all the MQXFA magnets during vertical tests at BNL (only training quenches are shown). MQXFA06 was trained at 4.5 K until quench #12. The full quench history of MQXFA07 and MQXFA08 can be seen in Figs. 2 and 3.

Eight MQXFA magnets were tested in the vertical test facility. Fig. 1 shows the training part of their tests. Six of the eight magnets, MQXFA03-06 and MQXFA10-11, reached and held acceptance current, while MQXFA07 and 08 showed limited performance. MQXFA05 went through an additional endurance test; it initially reached acceptance current after eight quenches and demonstrated good training memory after two thermal cycles. The endurance test included 42 induced quenches at nominal current (16.23 kA) performed over two additional thermal cycles. At the end of the endurance test, the magnet reached nominal current at 4.5 K and again achieved acceptance current at 1.9 K.

By the time MQXFA07 was disassembled, the assembly of MQXFA10 was already in progress. Therefore, it was not possible to change the pole keys, and MQXFA10 implemented only the specification for the minimum pole-key gap, which was set at 0.3 mm for this magnet. MQXFA11 implemented both changes, and all of the subsequent assemblies of MQXFA magnets will do likewise. The successful test of MQXFA10 and MQXFA11 (Fig. 1) demonstrated the effectiveness of these changes.

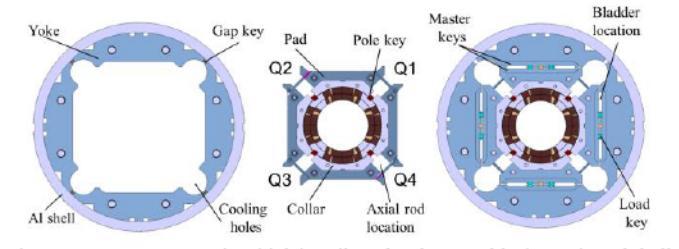
This shape was also present during the first assembly procedure (the one preceding the test), as shown by the blue markers. Surprisingly, the difference between the top and bottom dimensions of the coil-pack was not corrected by the loading operation. In other words, the asymmetry remained despite the fact that after the bladder operation the coil-pack is locked by identical loading keys inside the square cavity of the shell-yoke subassembly.

Fig. 4. Magnet cross-section (right), coil-pack sub-assembly (center), and shellyoke sub-assembly (left). Q1 to Q4 are coil quadrants as seen from the magnet's lead end.

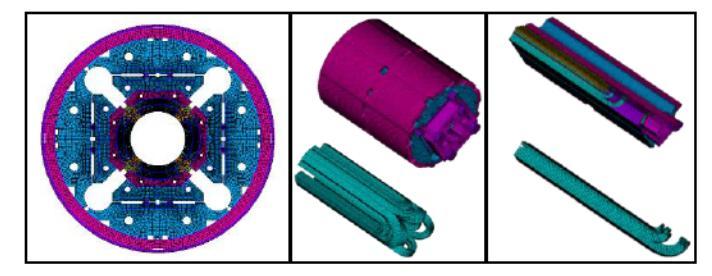
The effect on coil stress of closed pole-key gaps in Q3 was studied using three different finite element (FE) models: a 360degree full cross-section 2D model (see Fig. 9, left), a 360-

Fig. 9. Left: 360-degree, full cross-section 2D finite element model. Center: 360degree, full cross-section 3D model. Right: octant 3D model.

degree full cross-section 3D model (see Fig. 9, center), and an octant 3D model (see Fig. 9, right). Both 3D simulations reproduce an MQXF short model (MQXFS, with a 1.2 m magnetic length) to reduce the simulation time and increase the mesh density. The results in the end region were found to be consistent with those from the full-length model.
