A Metallurgical Inspection Method to Assess the Damage in Performance-Limiting Nb₃Sn Accelerator Magnet Coils

Alice Moros, Mickael Denis Crouvizier, Ignacio Aviles Santillana, Stefano Sgobba, Susana Izquierdo Bermudez, Nicholas Lusa, Jose Ferradas Troitino, Attilio Milanese, Ezio Todesco, Arnaud Devred, Giorgio Ambrosio, Maria Baldini, Paolo Ferracin, Jesse Schmalzle, and Giorgio Vallone

Index Terms—Metallurgical inspections, HL-LHC, accelerator magnets, MQXF coils, Nb₃Sn, quench damage assessment

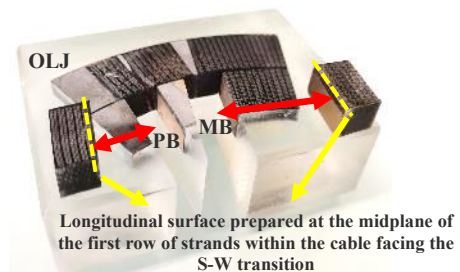
For a better understanding of cable integrity along the whole transition, longitudinal samples were extracted for the analysis of the cables facing the S-W transition on both the LJ and OLJ side (4 samples in total, each including a cable facing the S-W transition). A representative image of the extracted longitudinal samples with the cables of interest (OLJ case) is shown in Figure 7. The yellow dashed lines indicate the cable facing the S-W for both the PB and MB. Also, they highlight the surface prepared for the inspection, i.e., the midplane of the first row of strands belonging to the transition-facing cable.

Fig. 7. MQXFA07 quadrupole magnet coil AUP 214: 10 mm thick OLJ side embedded in epoxy resin for the metallurgical inspection. In this case, the extraction of longitudinal samples is illustrated. The red arrows point out the two samples extracted from the PB and MB, respectively. The yellow dashed lines represent the plane to be polished with the cables facing S-W.

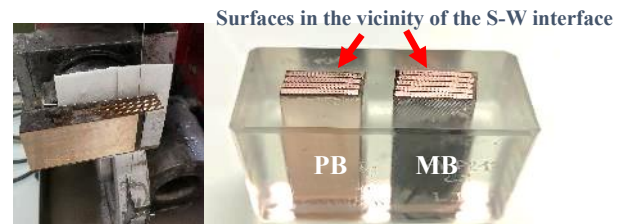
For the LJ side, a different approach was used. Both the PB and MB samples were further cut at the interface between the resin and the Cu wedge since it was expected to find transverse cracks at this location. After cutting, they were embedded in epoxy resin (see Figure 10). Instead of analysing the longitudinal cross-section of the cut samples, a deep Cu etching process was carried out on their transverse cross-sections. Since inspection of longitudinal cross-sections provides information about transverse cracks, it is expected that each crack identified in the longitudinal plane corresponds to a broken filament when inspecting the transverse cross-section after the Cu etching process. This was confirmed through the investigation of the LJ samples.

Fig. 10. MQXFA08 quadrupole magnet coil AUP 213: LJ-PB cut by DWS at the level of the resin-Cu wedge interface where the events are expected (left); LJ-PB and LJ-MB surfaces embedded in epoxy resin for the following Cu etching process (right).
