Analysis of the short-to-ground event in the LARP-AUP MQXFAP1 magnet, and its implication on the production and tests of the series magnets

Vittorio Marinozzi, Giorgio Ambrosio, Joseph Muratore, Piyush Joshi, Emmanuele Ravaioli, Stoyan Stoynev, Peter Wanderer

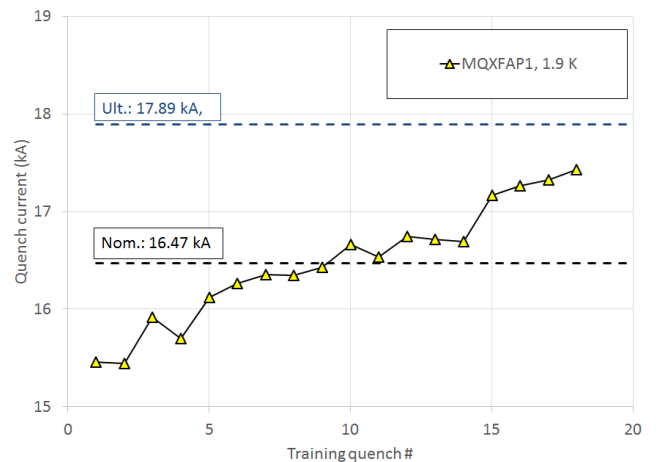
United States are today in the prototyping phase, and the test of the first prototype has been concluded in February 2018 [2] at Brookhaven National Laboratory. During training, magnet has reached nominal current (16470 A), while it was not able to reach ultimate current (17890 A) due to a short to-ground event during training quench 18. Training curve can be observed in Fig. 1.

Figure 1: training curve of MQXFAP1

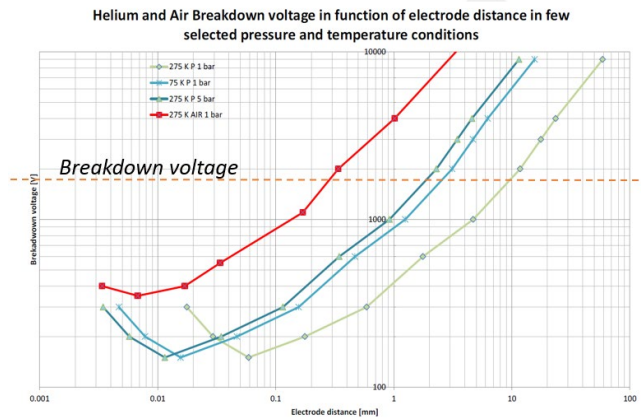
At room temperature, helium gas is a “good” conductor, at least compared with air. Figure 5 shows the breakdown voltage of air and helium gas at different temperatures and pressures [8]. It can be seen that the breakdown voltage is compatible with a ~10 mm path from the coil to the quench heater, considering that the hi-pot test was performed at room temperature (>275 K), but that there was not only helium gas, but some air too.

Figure 4: Helium and Air breakdown voltage, for different distances and pressures

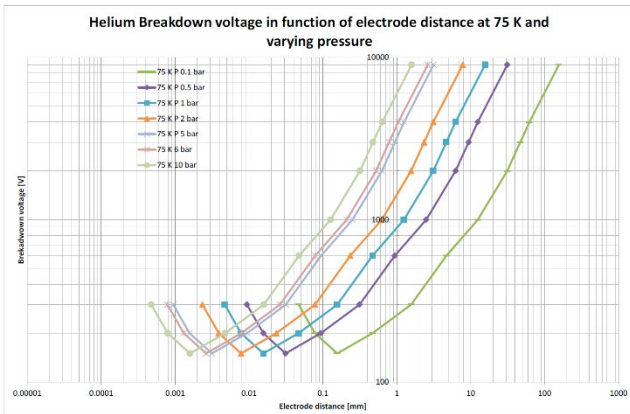
Helium gas breakdown voltage for a 200 μm path can be estimated to be ~ 330 V at 75 K and atmospheric pressure, as it can be seen in figure 7 [8]. Therefore, the expected peak voltage [10] (350 V at 130 K) is comparable to or larger than the helium voltage breakdown, and a discharge could be expected in case of a failure, with subsequent damage of the coil.

Figure 7: Helium breakdown voltage, for different distances and pressures

Moreover, assuming that just a fraction of this pressure can be actually taken by this seal, for instance 10% (~ 10 atm), the helium breakdown voltage would be > 1 kV (see Figure

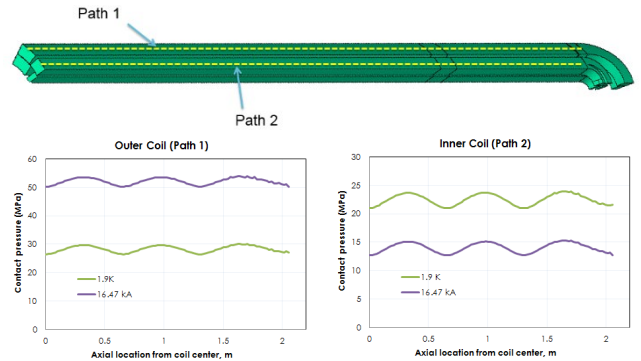
Figure 8 shows the contact pressure between the coil and the structure, in two different paths. It can be seen that it is always beyond 100 MPa (or 100 bar).

7). Therefore, in this more realistic case, we can conclude there is some margin to prevent shorts between the coil and the outer layer heater of the longest coils, although it could be assessed by more accurate modelling. The robustness of the electrical insulation can be therefore considered good by this analysis.

Figure 8: Contact pressure between outer layer of MQXFA coils and structure, at nominal current.
