First results of an aging test of a full scale MWPC prototype for the LHCb muon system

Aging studies for a multi-wire proportional chamber of the LHCb muon system have been performed using the CERN Gamma Irradiation Facility. The irradiated four-gap chamber corresponds to a full size prototype with 1500 cm² sensitive area and has been operated with an Ar/CO₂/CF₄ (40:50:10) gas mixture. A linear charge of ~ 0.25 C/cm for 100 m wire length has been accumulated over a period of 6 months, which corresponds to the charge collected in 5 LHCb years. The aging influences observed do not prohibit the use of these chambers in the LHCb experiment.

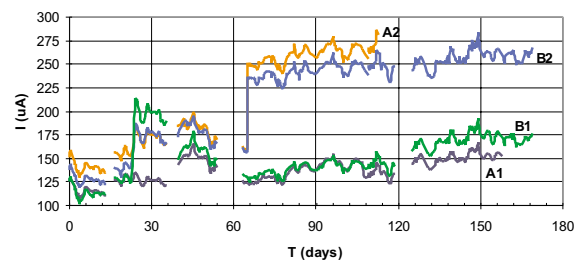
Figure 2. Currents drawn in each of the four gaps as a function of time. The breaks in the data indicate periods where the aging test was interrupted.

justed so that the currents in each gap were about $100\ \mu\text{A}$. The voltages of gaps A1 and B1 were not changed during the test and stayed at 3.15 kV. The voltages for gaps A2 and B2 were increased after 2 months from 3.0 to 3.2 kV. Figure 2 shows that the final currents were in the range of 120-160 μA in gap A1 and 240-280 μA in gaps A2 and B2 (depending on the temperature and pressure). The linear current density was smaller than $0.03\ \mu\text{A}/\text{cm}$. Several times per day the source was turned off to measure the dark currents.

The test was concluded on the 27th of July 2001 after collecting a maximal charge equivalent to five LHCb years in gap B2. The reasons for interrupting the test were a broken wire in gap A2 close to the wire fixation bar on the 4th of June and a high voltage instability of the gap A1 on the 16th of July.

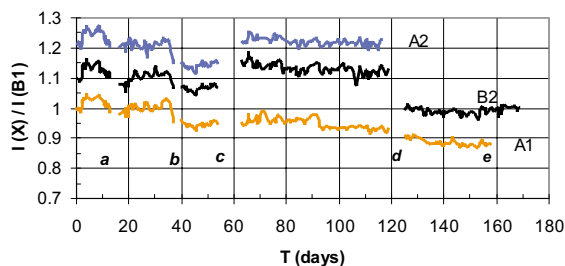
The relative current dependence on time is shown in Fig. 4. The gaps indicate periods where some intervention in the GIF area or on the chamber took place. In general the fluctuations of the relative currents go in the same direction for the three irradiated gaps at all times, indicating that they are rather related to the behaviour of the

reference gap B1 and not to aging effects in the irradiated gaps.

The final measurement results with the source are given in Table 5. No deterioration of the B2/B1 and A2/B1 ratios is observed within the relative precision of the measurement, which is about 5%. The decrease of about 18% in the A1/B1 ratio is difficult to interpret, since A1 is an outer gap which might have undergone gain variations due to insufficient stability in gap size.

Figure 4. Relative current of gaps A1, A2 and B2 to B1 as a function of irradiation time, measured at the initial HV applied to each gap (3.0 kV for A2 and B2 and 3.15 kV for A1 and B1).
