CERN-PS /90-62 (HI)

PERFORMANCE OF THE CERN HIGH-INTENSITY RFQ

E. Tanke, M. Vretenar and M. Weiss
PS Division, CERN, CH-1211 Geneva 23, Switzerland

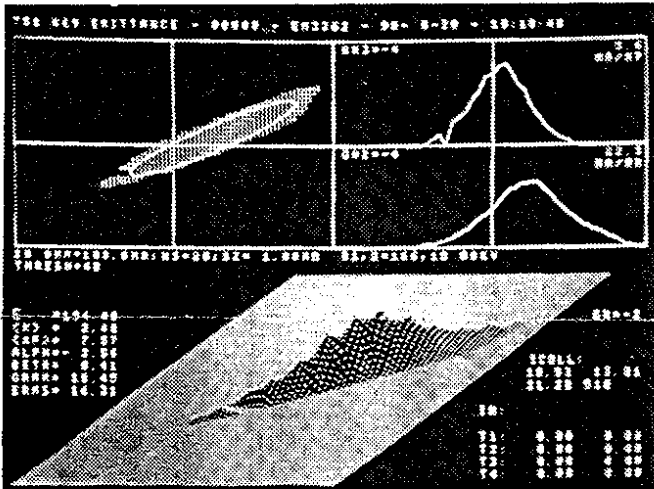
Output beam emittances: the measured output emittances are shown in Figs. 4 and 5. The normalized r.m.s. value, $\epsilon_{rms,n}$, is about 0.6π mm-mrad. For comparison, we also show emittances measured before the accident, see Figs. 6 and 7. Their $\epsilon_{rms,n}$ value is about 0.5π mm-mrad. The corresponding input emittance values are $\epsilon_{rms,n} \approx 0.4\pi$ mm-mrad.

Figure 6: Horizontal output beam emittance, before accident

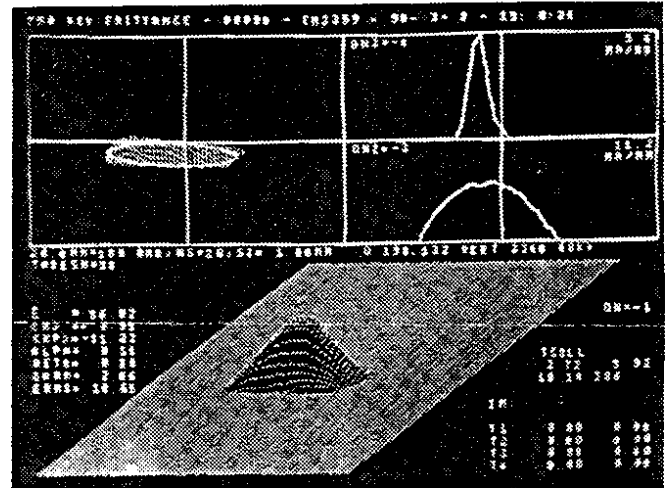
Figure 7: Vertical output beam emittance, before accident
