MECHANICAL CONSOLIDATION OF THE LHC INNER TRIPLET MAGNET SUPPORTING SYSTEM FOR REMOTE ALIGNMENT

Abstract

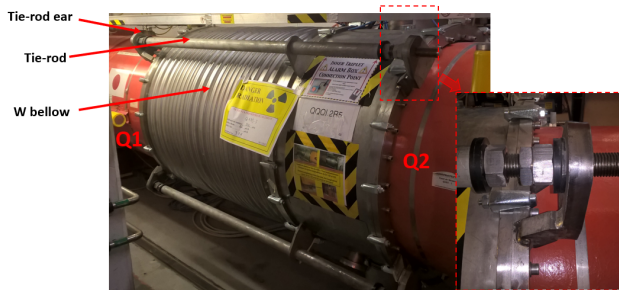
In order to cope with the longitudinal loads due to vacuum forces, between magnets and then to the DFBX which is anchored to the ground, the magnet vacuum vessels are rigidly linked by tie-rods placed outside of the interconnection bellows (see Fig.1).

Figure 1: As-installed view of the Q1-Q2 interconnection.

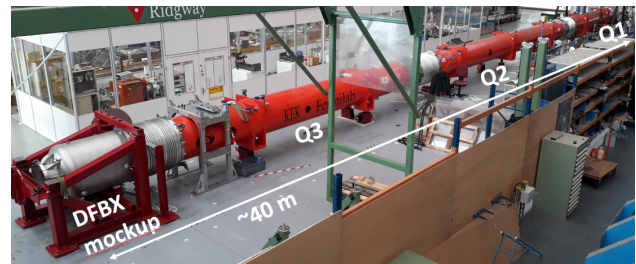
In order to better characterize the working conditions and realignment kinematics of the triplet string a test bench was setup on the surface by using LHC spare magnets (Fig. 6).

Figure 6: Layout of the triplet string test in 2019.

This setup was designed to be vacuum pumped as this is the dominant contribution to the longitudinal displacement. Although we know that cryogenic circuit pressure and temperature have an impact on the triplet kinematics this is expected to be less significant.

On initial vacuum pumping, the magnet Q1 moved back by 9.5 mm. Overnight the building air temperature had decreased by about 5°C so the next morning the magnet was found to have moved further back by 1.5 mm due to thermal contraction of the magnet string.

It was then concluded that the interconnect tie-rod system as installed was indeed not stiff enough to prevent a large longitudinal movement of the Q1 magnet in operating conditions. With time, because of temperature variation and friction release, this brought one of the Q1 magnet jack in contact with its body and some transverse vacuum load was then supported by the jack body itself. When operated in this situation, with a transverse load on the jack head, large friction effects within the jacks impair their magnet vertical realignment capabilities. In the different situation tested, vertical realignment was however always possible provided the friction force was overcome, with no measurable stick slip effect. The radial realignment was always possible and was seemingly unaffected in the various situations tested on our setup.
