Gamma irradiation of ATLAS18 ITk strip sensors affected by static charge

Specific Issues observed in QC testing

Sensors affected by static charge in real experiment

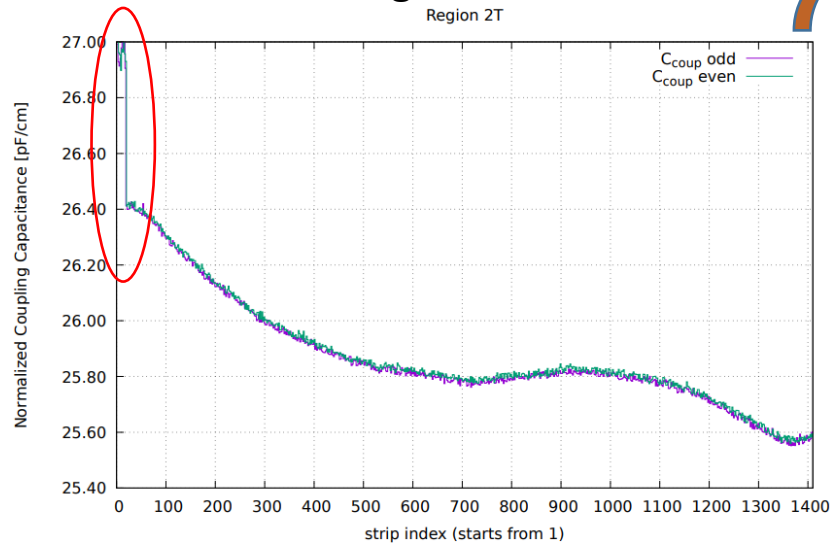
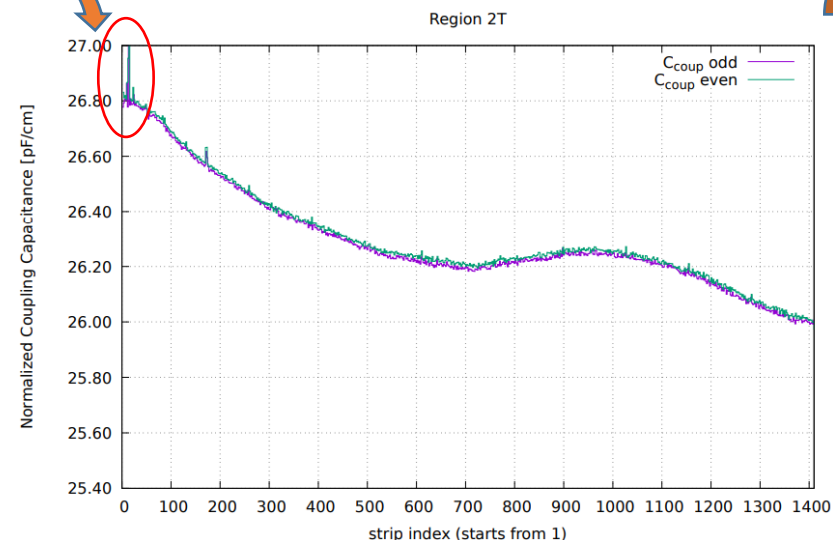
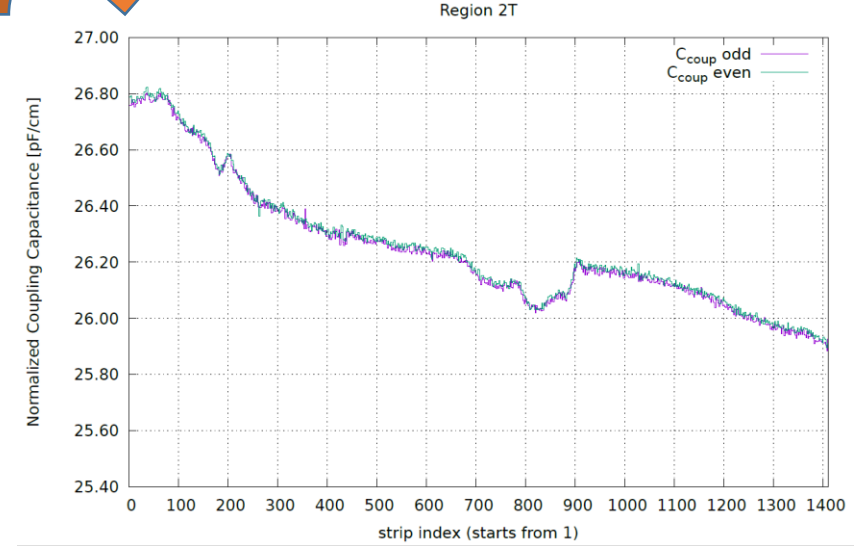
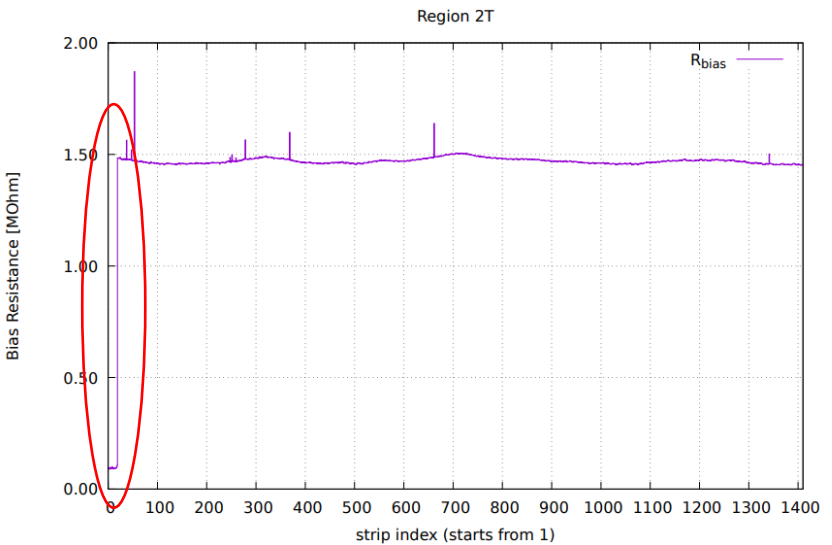
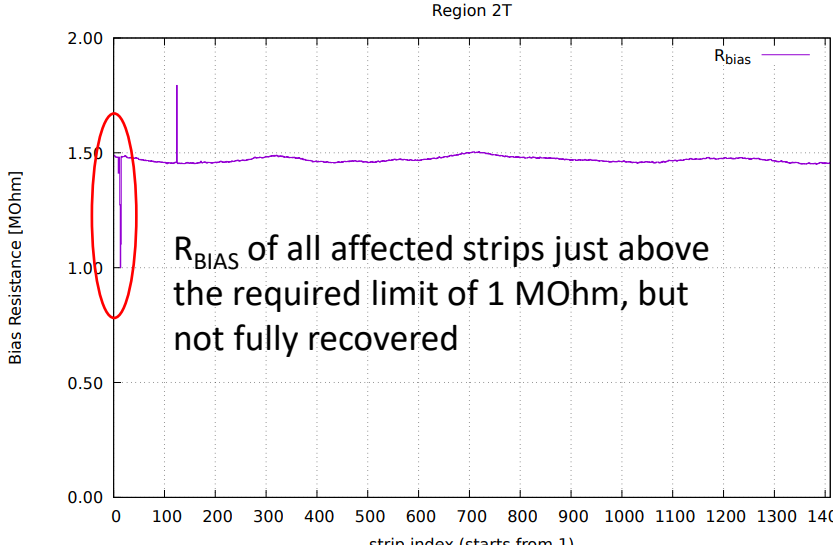
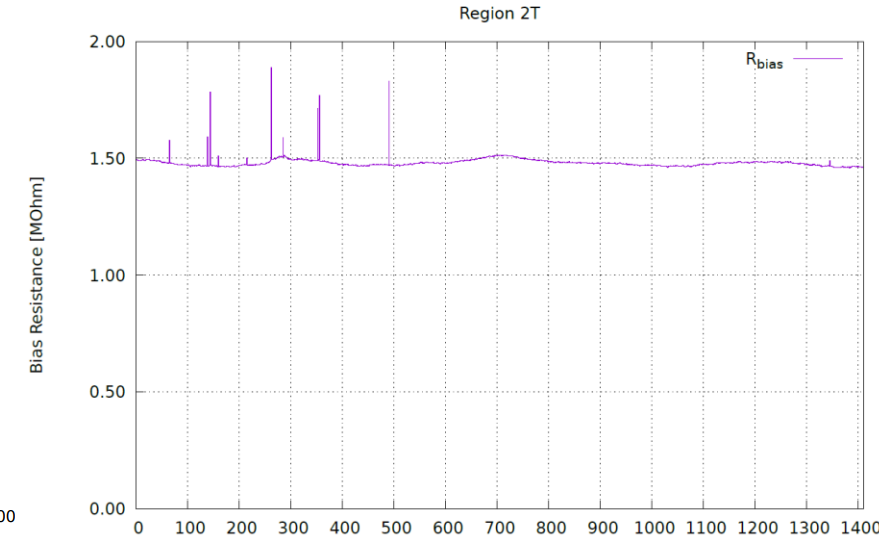
R1-W620: Full Strip Tests - reference sample

Test after "not irradiation"

Test after gamma 1.5krad

Region 2T

Test right before irradiad.

Test after additional 1.5 krad
