Gamma irradiation of ITk silicon strip modules with early breakdown

LHCP 2024: 12th Edition of the Large Hadron Collider Physics Conference
Boston, Massachusetts — 3-7 June 2024

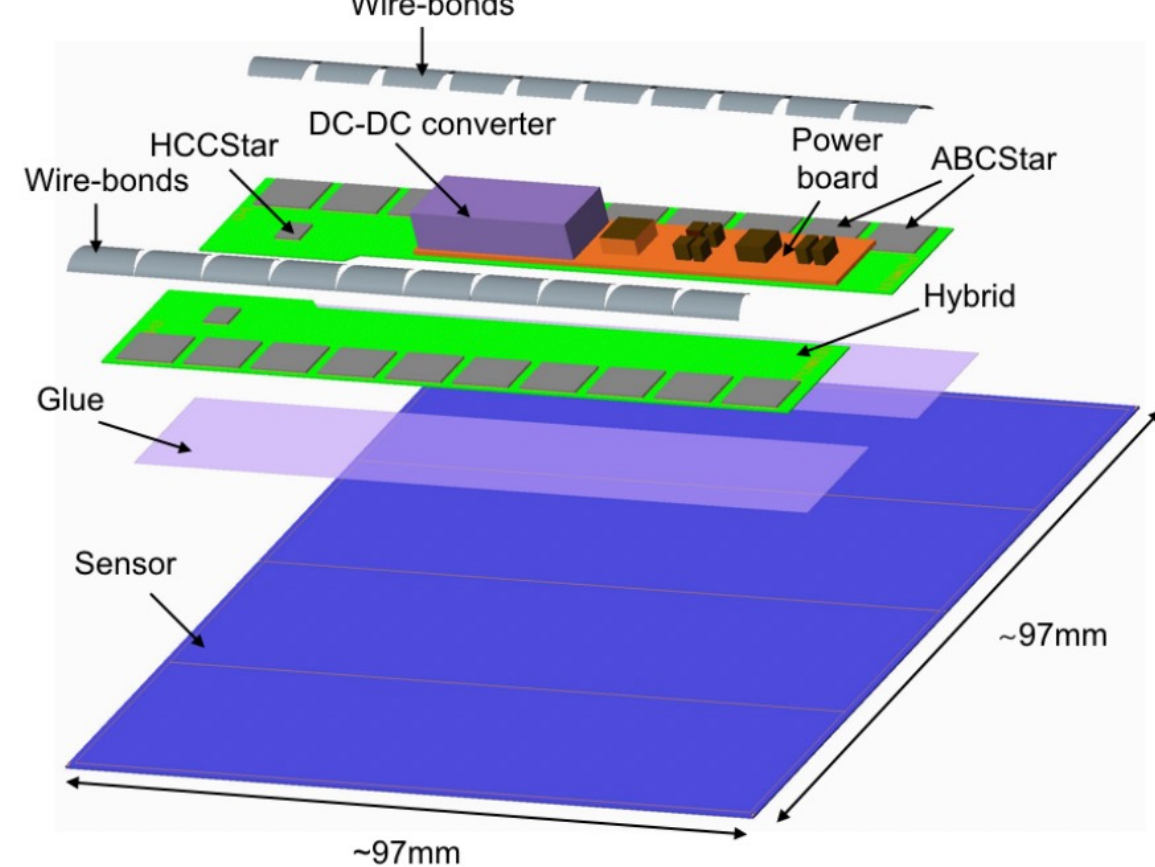
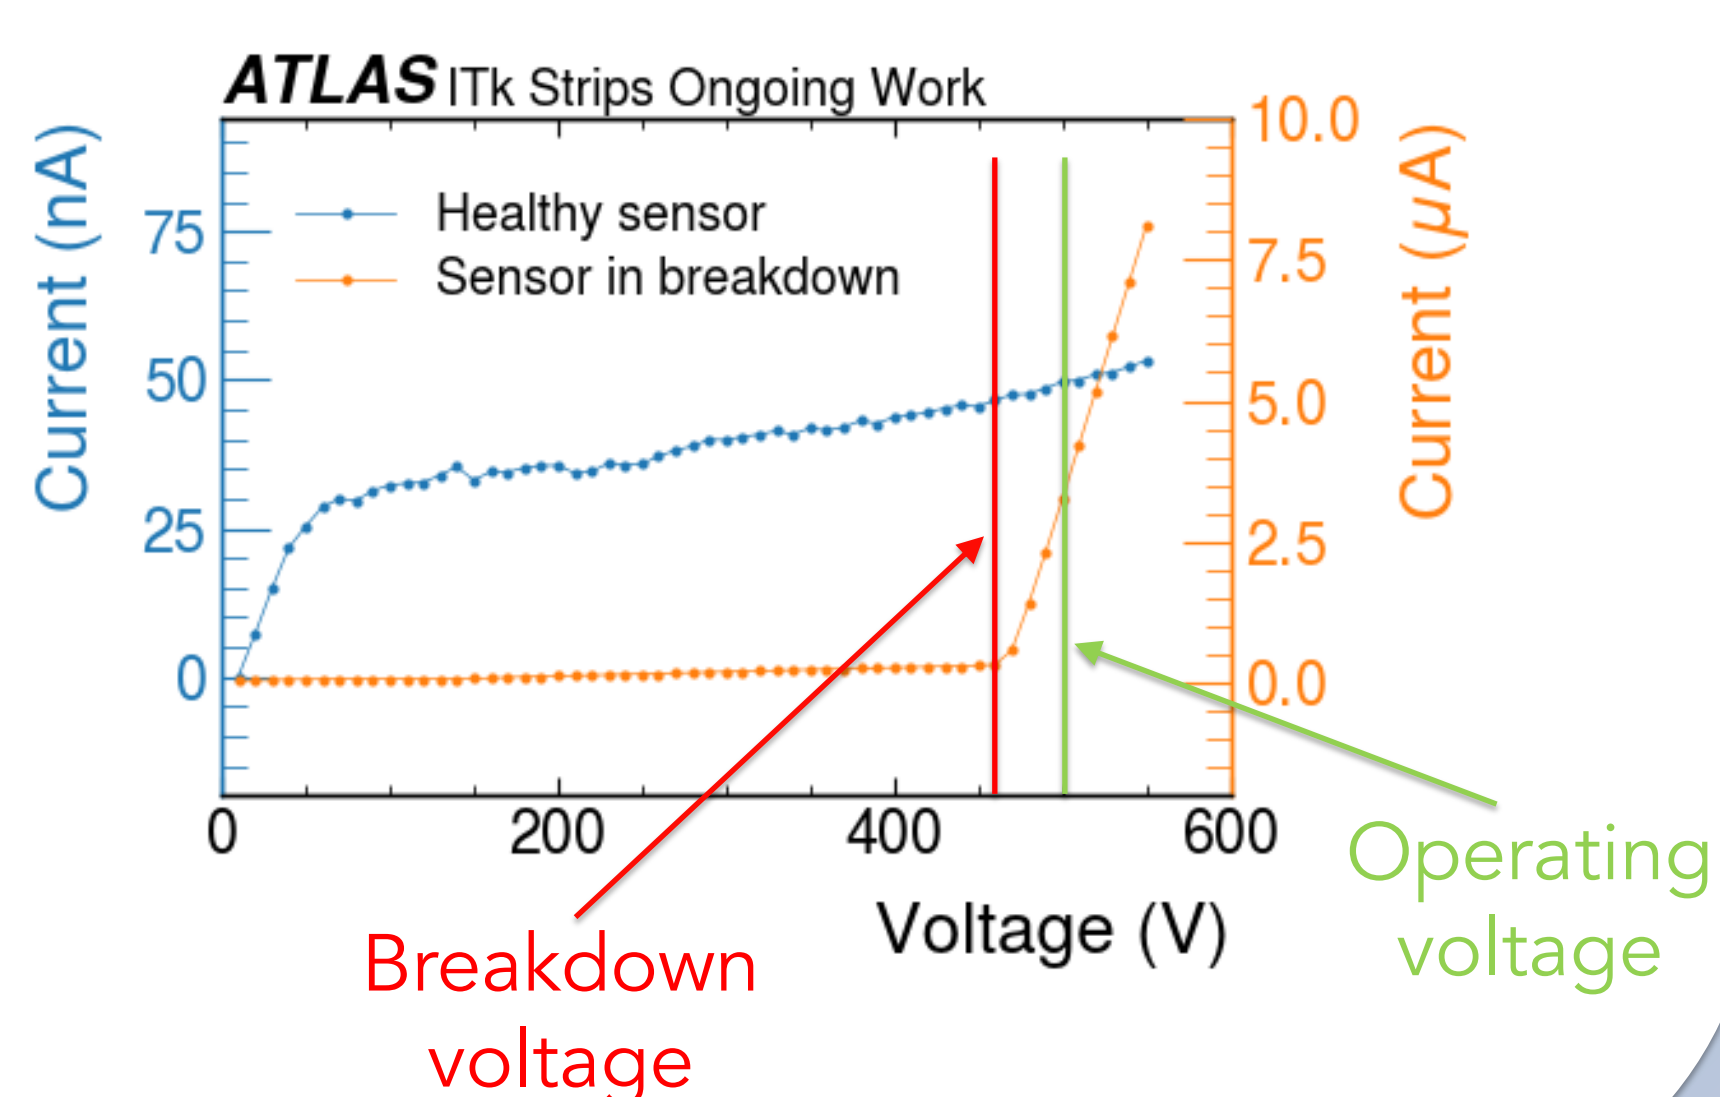
Expanded view of ITk short-strip barrel module [1]

- ITk silicon strip sensors consist of a **silicon sensor**, **hybrids** (host readout electronics), and a **power board** (power, monitor, and control electronics)
 - Sensors require **-500V bias voltage** for operation
 - Early breakdown** observed during module assembly due to
 - Mechanical damage (chips, cracks, scratches)
 - Static charge
 - Long-term application of bias voltage
 - Glue on the guard ring [2]
 - Can we reliably recover these modules?

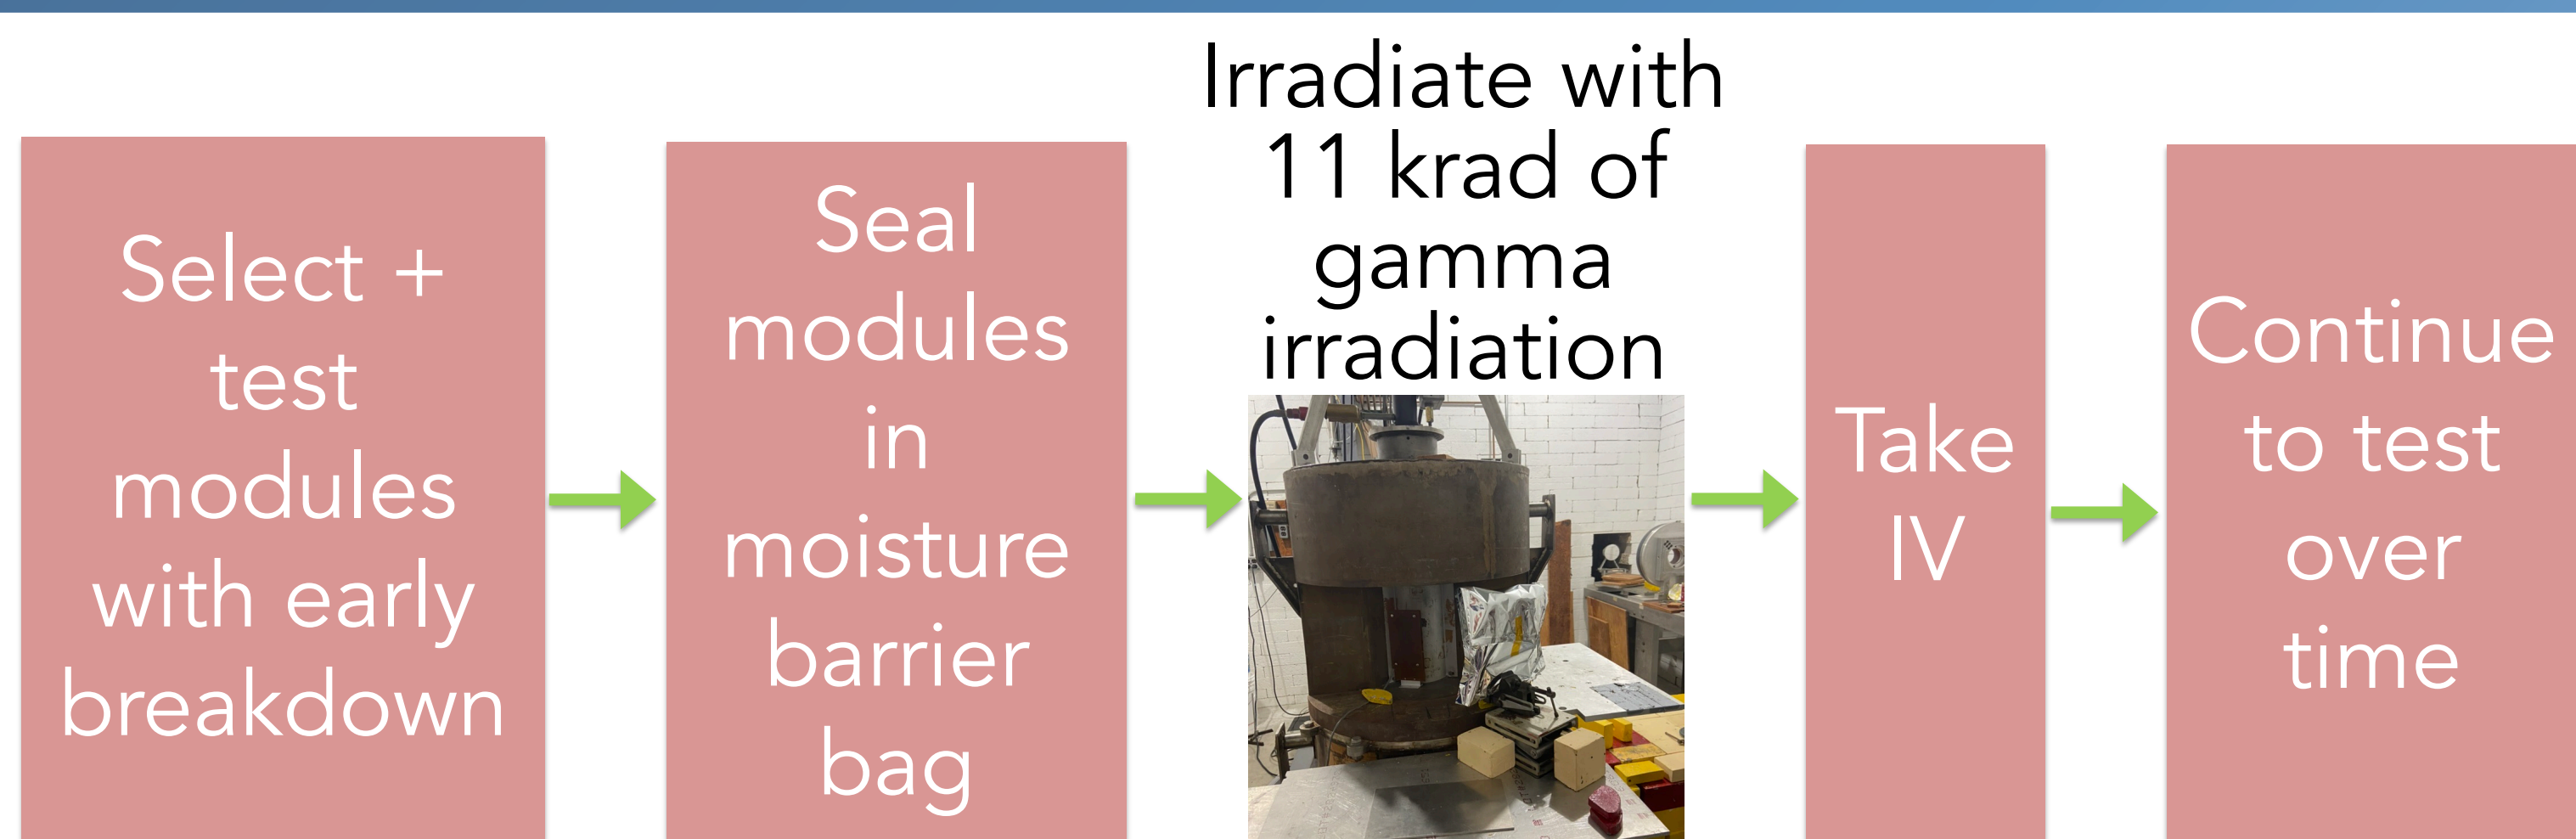
Irradiated module	Special characteristics
BNL-PPB2-MLS-242	Breakdown ~520V, unbonded
BNL-PPB2-MLS-243	Breakdown ~450V, unbonded
BNL-PPB2-MLS-213	Breakdown ~500V, glue on the guard ring

- Two **unbonded** modules developed early breakdown after gluing the hybrid onto the sensor
 - Irradiated before continuing assembly
- One module with **glue on the guard ring** irradiated (known cause of early breakdown [2])

- Sensors irradiated by Prague group showed early breakdown cured by 11 krad of gamma radiation [3]
 - Will we get the same effect after gluing?
- Similar ionizing irradiation can be performed at BNL gamma facility with ^{60}Co source
- We irradiated modules with 11 krad of ionizing radiation at BNL, equivalent to 1 week in HL-LHC
