Study of Bump Bonding Technology[#]

S. Cihangir, J. Andresen, J. A. Appel, G. Cardoso, D. C. Christian, C. Kendziora, S. Kwan, M. Marinelli, M. Ruschman, M. Turqueti, M. L. Wong, S. Zimmermann

Fermi National Accelerator Laboratory*
P. O. Box 500 Batavia, IL 60510, USA
selcuk@fnal.gov

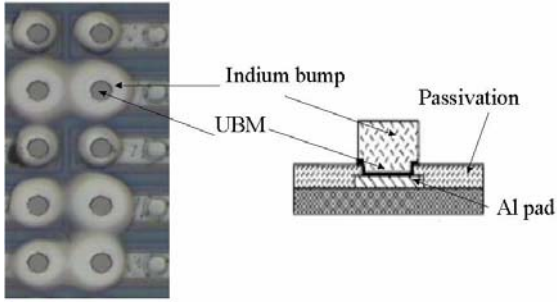
Figure 1: Indium bumps

Figure 1 shows actual and schematic views of indium bumps. The dark circle in the centre is the UBM (Under Bump Metalization). The indium bump, which is a cylindrical shell, appears as light ring adhered to the glass.

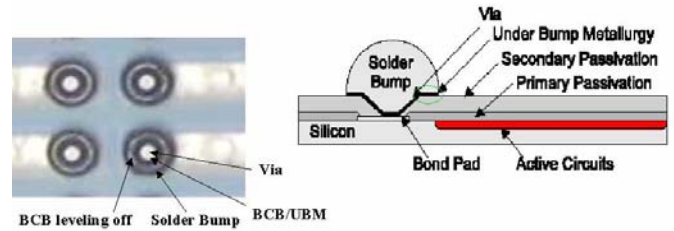
Figure 4: Solder bumps

Figure 4 shows actual and schematic views of the solder bumps in these modules. The manufacturer used a chemical product called BCB (Benzocyclobutane) for plating and it remained over the UBM. At the bottom of the via of the bumps, the light is reflected up, but not on the walls of the via. This forms the bright circle in the middle and the first dark ring. The light is reflected on the flat part of the UBM again, forming the bright ring. The last dark ring is the solder bump, which is a cylindrical shell.
