# JTA Skyway 2017 Routine Inspection of Bridge Structures

Prepared For:  
Jacksonville Transportation Authority

Prepared By:  
RS&H, Inc. with/  
FIT Engineering, LLC

Final Draft Report

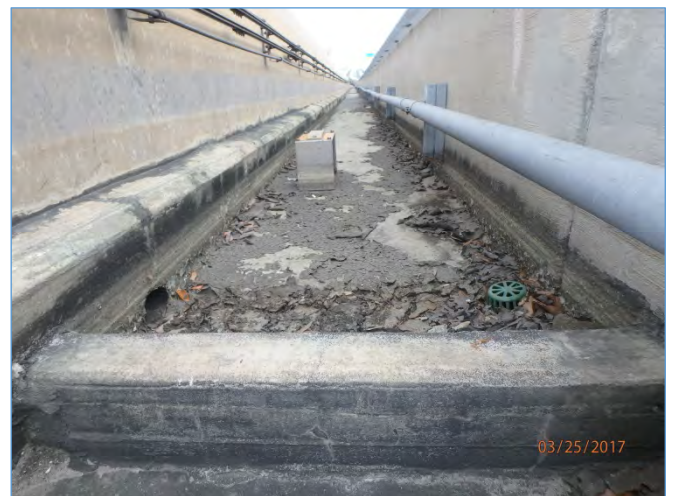
Span 245L After Partial Debris Removal

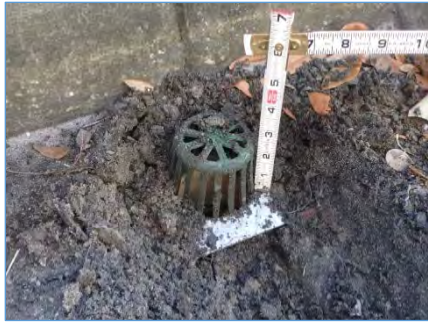
The three photos below were taken at a time when there had not been a rain event for weeks. These illustrate a significant amount of soil accumulation at the drains which is fairly typical throughout the system.

Buried Drain Cap at Pier 247, LT Guideway

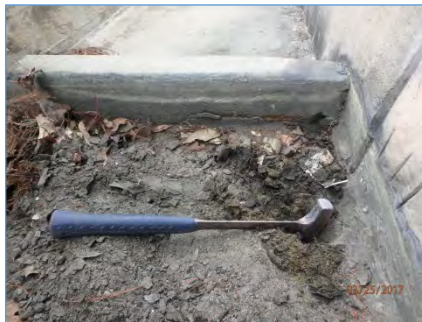
Missing Drain Cap and Clogged Pipe above Pier 255, RT Guideway

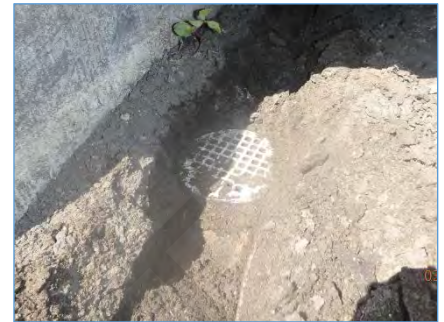
Buried Drain Cap at Pier 409R

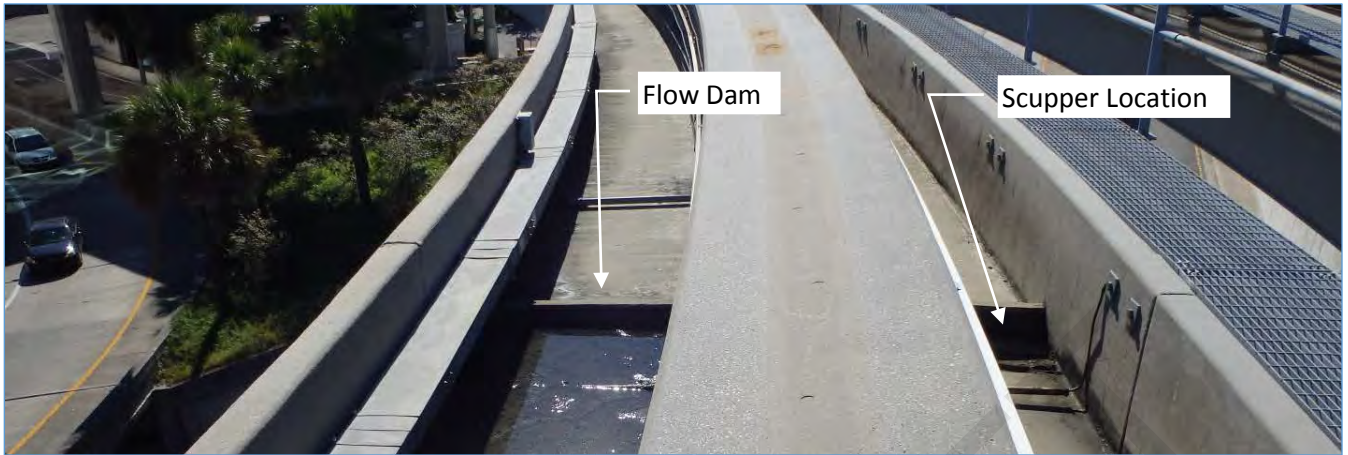
There are a number of locations in the system in which water ponds at a low spot on the deck and there is no apparent means to convey the water off the deck. One example is at Pier 242. This pier carries a curved section of steel box girders and is super-elevated, with the low side on the right. Figure 4 shows that the drainage scuppers are located on the inside deck of each guideway section, which is on the high side of the super for the Right Guideway. Water ponds on the low side. See the photo below.

Pier 242 RT. Guideway, Looking Back

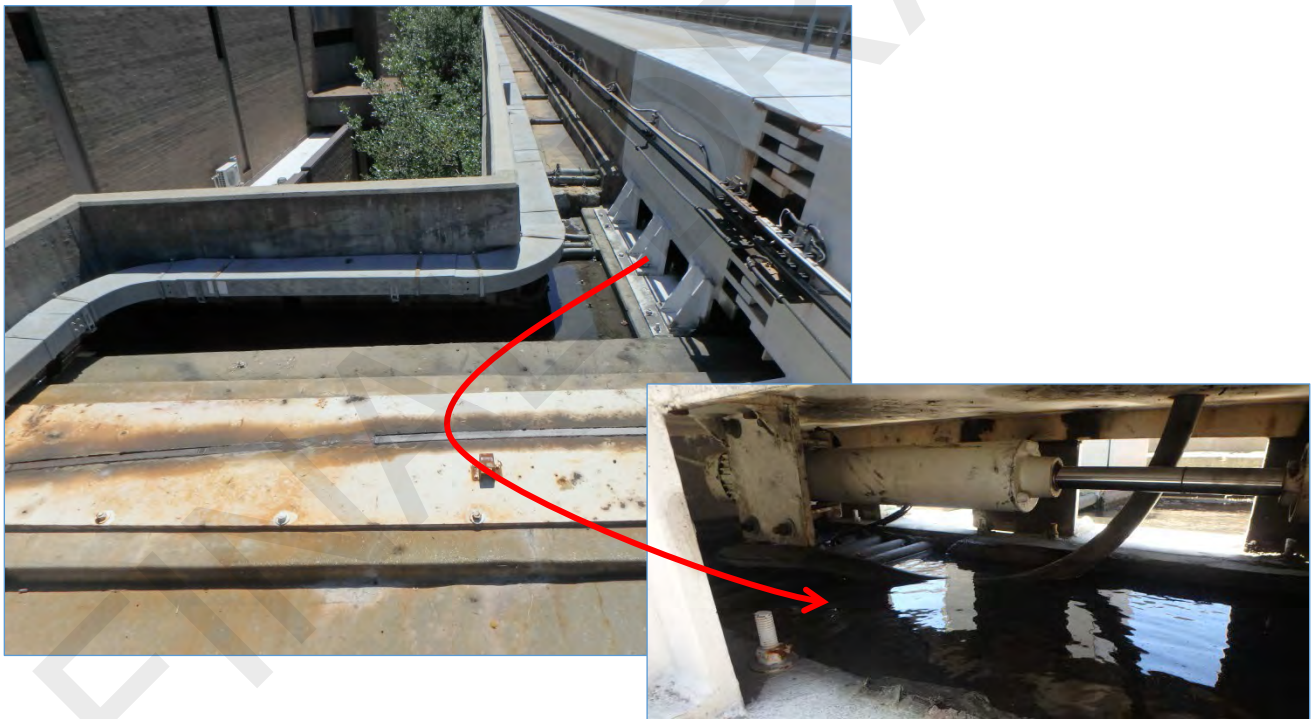
Another example is in Span 75R. There is standing water up to 3 in. high before the first switch beam pedestal which is located 10 ft. behind Pier 76R. There is no evident means of conveyance to the drain pipe at the pier.

Span 75R Before Pier 76, Water Ponding Behind Switch Beam Pedestal #1 and Underneath Switch Beam

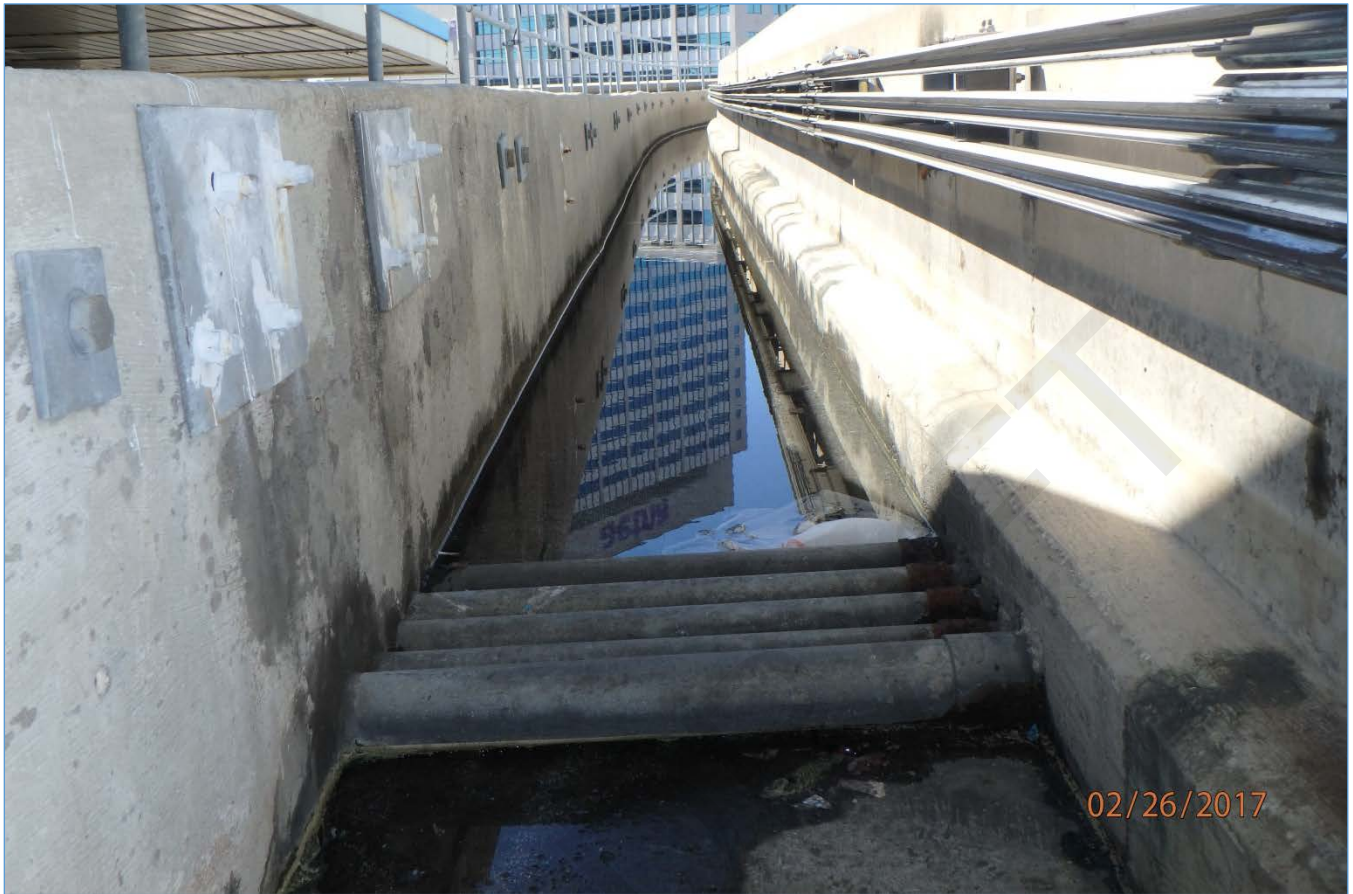
A third example is the Right Guideway at the San Marco Station. In Span 240R there is standing water for the full length of span on the left side of the guidebeam only. There is a series of metal conduits that cross the guideway transversely, about 5 ft. from Pier 240. The conduits sit almost right on top of the deck (1/8in. max gap, filled with debris) and so water cannot get to Pier 240 to drain. See the photo below.

Span 240R: Ponding Water Left of the Guidebeam Blocked By Debris and Transverse Conduits on the Deck

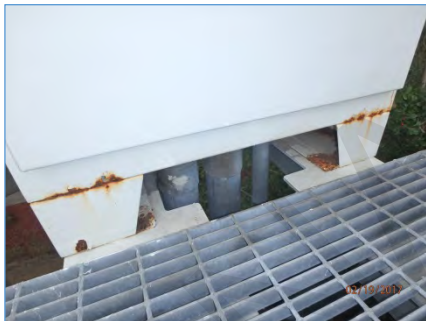
Surface Corrosion on Electrical Control Cabinet in Span 204R

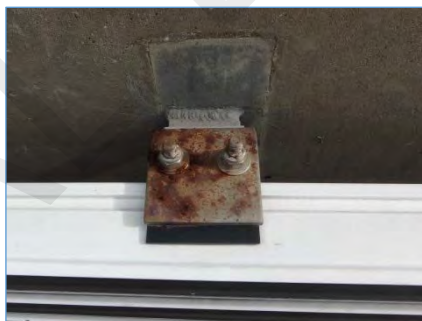
Surface Corrosion on Power Rail Bracket in Span 206R

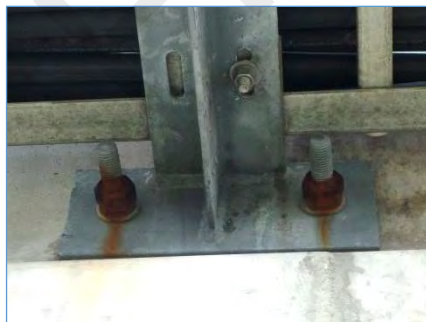
Non-galvanized Nuts for Cable Tray Brackets, Starter Line

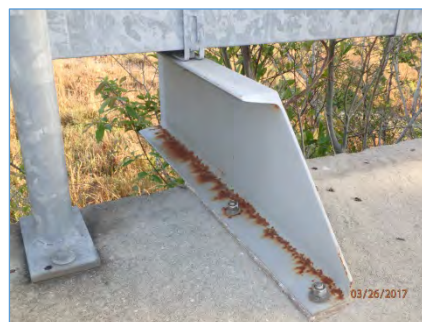
Surface Corrosion on Cable Tray Support Brackets in Span M2

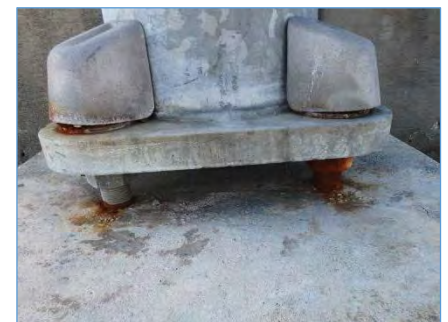
Surface Corrosion on Traffic Signal Post Anchor Bolts in Span M2.

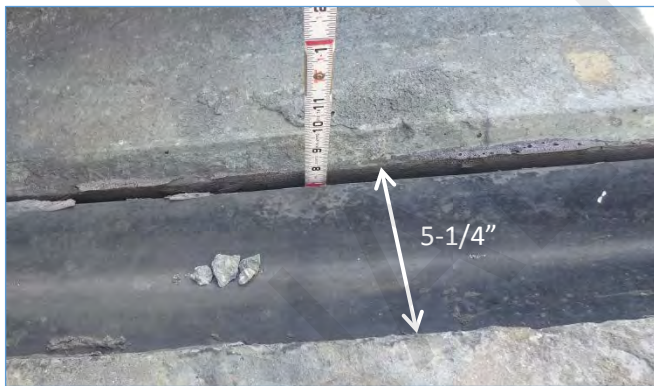
Of the 192 compression seals in the system, 84 were found with adhesion loss for nearly the full length of the joint and 23 more had partial adhesion failures. At a number of the piers, there is a gap between the seal and either the deck or pier cap. Gaps were noted between 1/8" and 1/2" wide. See the photos below. Two compression seals are hanging down; one at 81L and the other at Pier 228R. The compression seal at Pier 52A, for the rear span, is missing altogether (was likely never installed).

Pier 232R: Joint Width Exceeds Seal Capacity

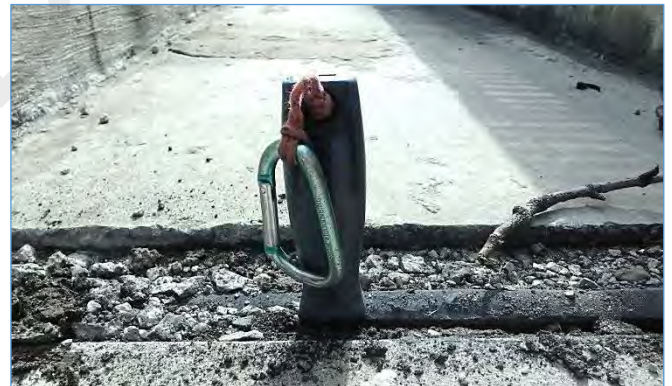
Pier 210R: Typical Seal Adhesion Failure

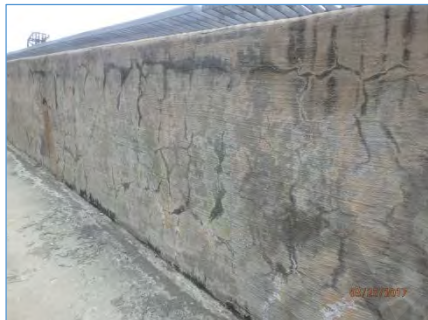
Hairline Map Cracking for 10ft.,  
Span 250R

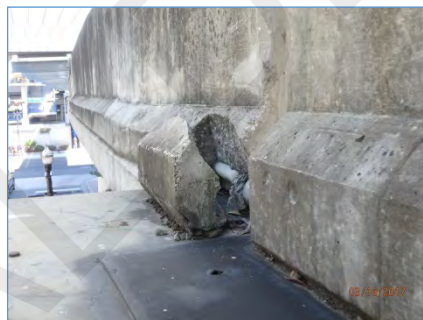
12in. x 6in. x 6in. Spall in Sidewall  
Bottom Edge Over Pier 78

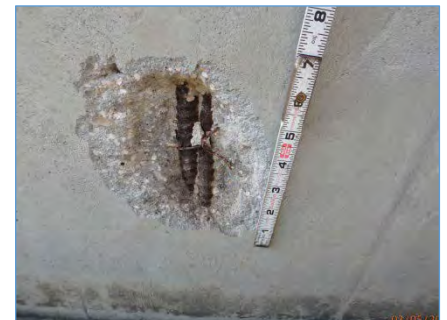
Spall with Exposed and Corroded  
Rebar, Span 5N

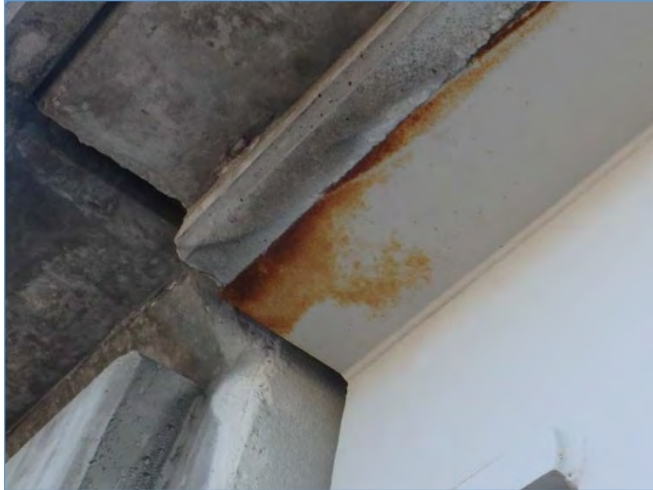
Active surface corrosion is present at isolated locations throughout the system, with the worst conditions noted in the Starter Line (although this section supposedly received a refinishing approximately 12 years ago). Nearly all splice plates in the system have light to moderate corrosion and in the Starter Line, active surface corrosion is present at isolated locations on the members themselves. See the photos below. Bubbling and peeling paint exposing primer was also noted on the exteriors of the boxes in the Starter Line at isolated locations.

Span 31N: Surface Corrosion on LT Top Flange

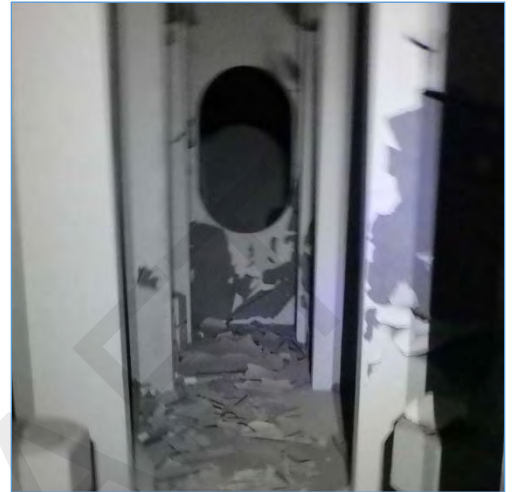
Pier 11 Cross Girder

The interior faces of the Starter Line boxes and pier cross girders (Spans 6-11 and 29-31) have a substantial amount of peeling paint, exposing primer. This interior coating failure was not found anywhere else in the system. See the photos below.

- Clean out the insides of the boxes that have organic debris. This material is hazardous and will need to be performed by a specialty contractor that can safely remove the organics, likely with vacuum tubes.
- Clean and spot paint the interiors of the boxes at locations in which the corrosion is considered “moderate” or “heavy”.
- Clean and spot paint the exteriors of the boxes at locations in which the corrosion is considered “moderate” or “heavy”.
- Develop a plan for a full coating replacement of the exteriors of all boxes and cross girders. Include the re-painting of the top coat on the interior faces of the spans in the Starter Line.

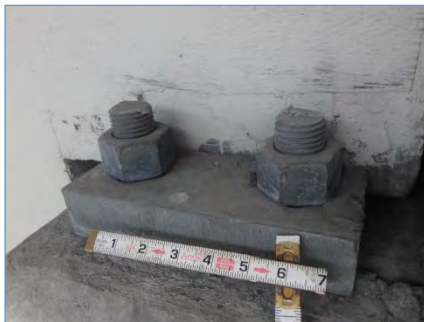
Keeper Plate Nut Missing Washer

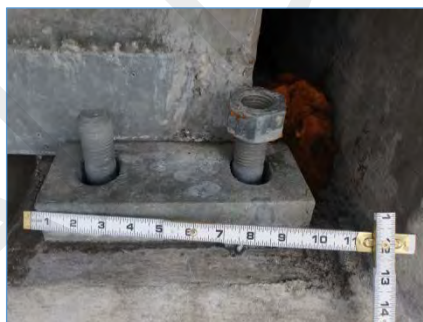
Keeper Plate Bolt Missing Nut

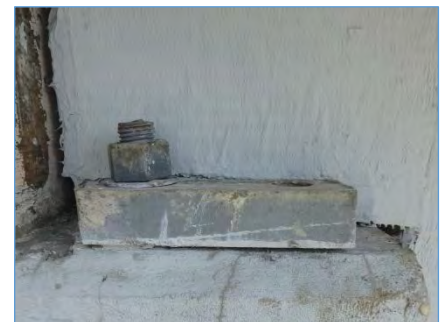
Keeper Plate Missing Anchor Bolt

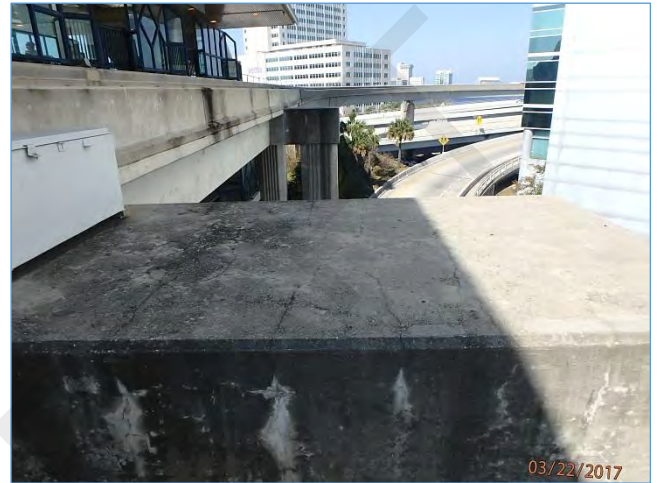
The worst substructure cracking in the system is located on the pier caps and load bearing struts at the San Marco Station; Piers 237 thru 240. Numerous shear, flexure and shrinkage cracks are present on the caps and the struts, noted up to 0.04" wide. The major design difference between these piers and those elsewhere throughout the system (including at other stations), is the unsupported length of caps. For nearly the same depth of section, these caps (and struts) are spanning much longer distances. Elsewhere in the system, the maximum cap length between column centerlines is about 35'. At the San Marco Station, the cap and strut lengths range between 47' and 57'. See the photos below.

Pier 238: Flexure/Shear Cracks Across Cap at RT Column

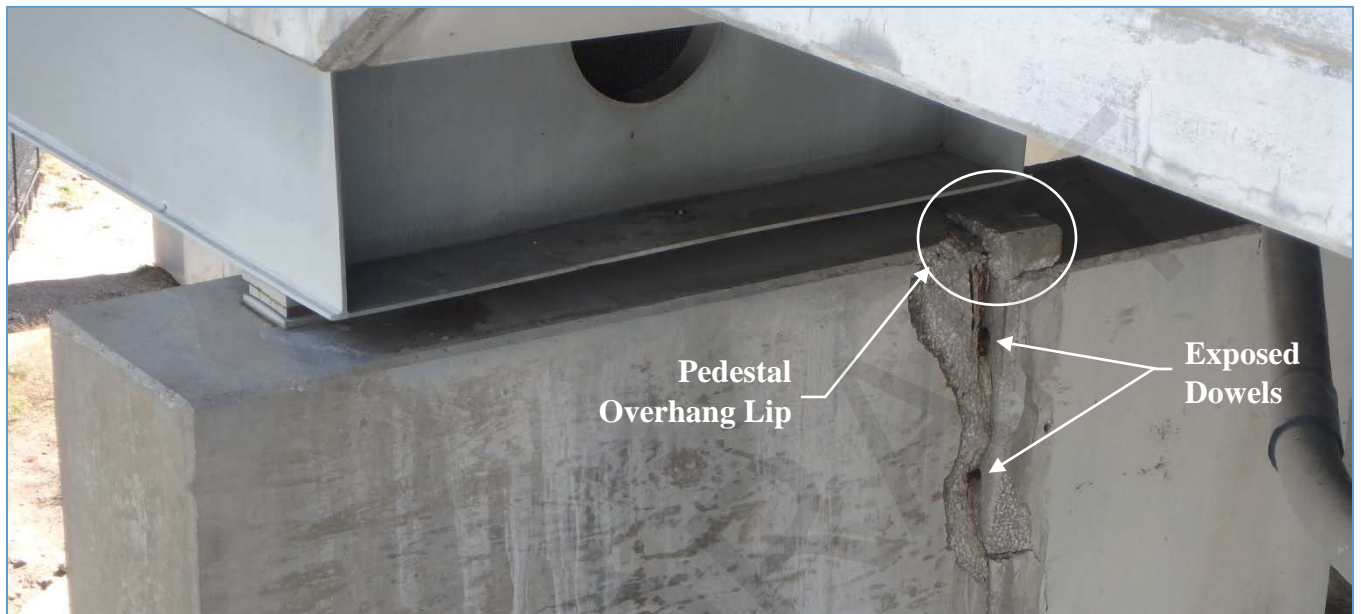
Acosta Bridge Pier R-1 Left, Rear Face

At Pier R-1 Left, there is spalling along the vertical interface between the Guideway pedestal and the Acosta Bridge pedestal. On the front face, the spall is full height, but in the upper half, the spall is approximately 15" wide and 5" deep, exposing two horizontal dowels and one vertical dowel. See the photo below.

The Guideway pedestal was constructed with a top elevation 5" above the Acosta Bridge pedestal. There is a 7" wide lip that overhangs the Acosta Bridge pedestal as shown in the photo above. This lip is cracked, full width of the pedestal. The left ~3" of the masonry plate for the left bearing (which is 25" x 9") sits on top of this lip.

The rear face of the pedestal at Pier R-1 Left also has spalling along the interface, with the worst of the spalling occurring on the Acosta Bridge side, exposing two pieces of rebar. A section of the pedestal lip, measuring 7" x 5" x 3" has also spalled off.
