JTA Skyway 2019 Routine Inspection of Bridge Structures

Jacksonville Transportation Authority

RS&H, Inc. / FIT Engineering, LLC

Final Report

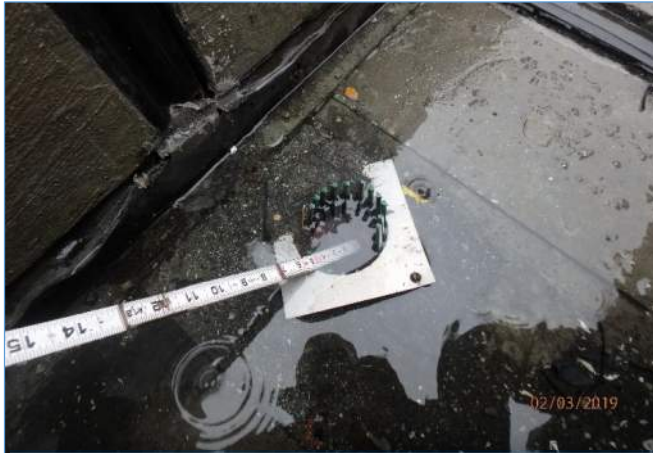
It is apparent that maintenance crews have broken or removed many of the grates since the last inspection - atrium grates are missing at 18 piers and are broken at 37 piers. 80% of these instances have occurred since the previous inspection. It is possible that this was done on purpose to provide for easier flow of water through the grates, but that also allows the debris to go down and clog the pipes. Significantly clogged drains were noted at 25 piers and at many of these, the pipes were filled with water to the top of the deck, resulting in standing water on the deck. It should be noted that much of the deck inspections in 2019 were done during or right after rain events. See the photos below.

Pier 219R: Broken Atrium Grate and Drain Pipe Clogged and Filled with Water

- Thoroughly remove the soil and debris from the top of the deck, especially at the scupper locations. This should be done on a regular basis.
- Repair/replace the deck drain grates listed in Appendix D-1 that are broken, inverted or missing. Consider replacing with grates that are flush with the deck to make cleaning around the drains easier.

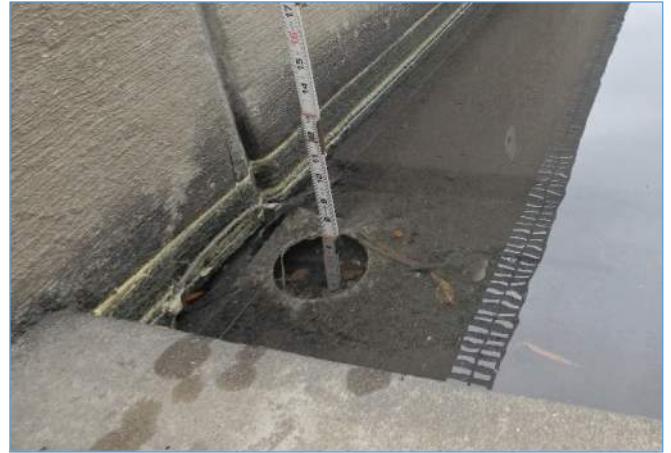
Span 244R: Missing Atrium Grate and Drain Pipe Clogged and Filled with Water

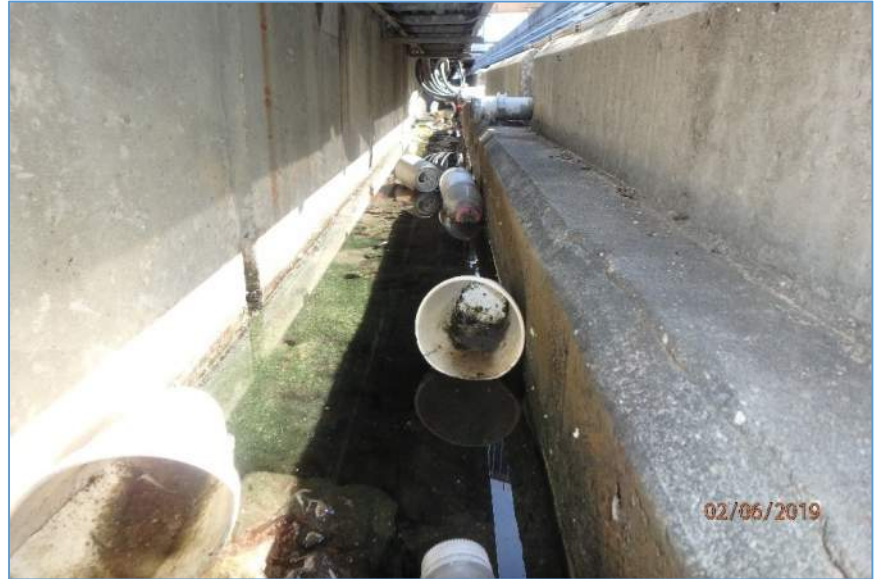
There are several locations in the system in which water ponds at a low spot on the deck and there is no apparent means to convey the water off the deck. In the Starter Line, there is trash, wet debris and standing water throughout many of the spans. In some cases, this is due to the debris preventing the water from reaching the nearest drain, but in many cases, there is no nearby means of drainage. The photo to the right shows standing water, trash and debris between the sidewall and guidebeam pedestal in Span 2N. There are no drains at Pier 2 or 3N. The nearest drain is located at Pier 5.

Span 2N: Trash, Debris and Standing Water

- Repair the eroded areas between the slab-on-grade spans at the O&M facility. Provide a means to convey the stormwater and prevent further erosion.
- Inventory the locations with water ponding issues that cannot be alleviated with the maintenance solutions listed above. At each location, investigate an engineered solution. Perhaps this entails piping through the guidebeam pedestal or coring through the deck and installing additional means of conveyance.

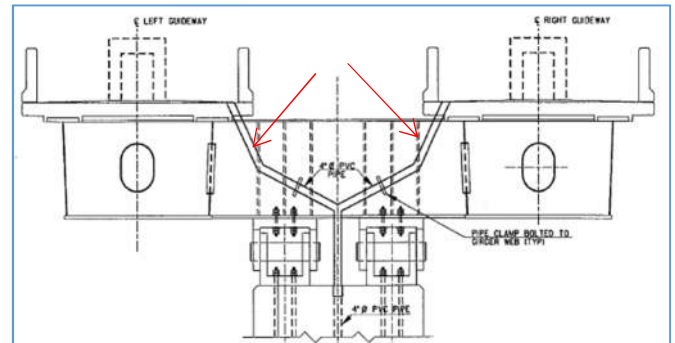
Figure 4. Pier 242 Drainage Details

Another example is at Pier 242. This pier carries a curved section of steel box girders and is super-elevated, with the low side on the right. Figure 4 shows that the drainage scuppers are located on the inside deck of each guideway section, which is on the high side of the super for the Right Guideway. Water ponds on the low side. See the photo below.

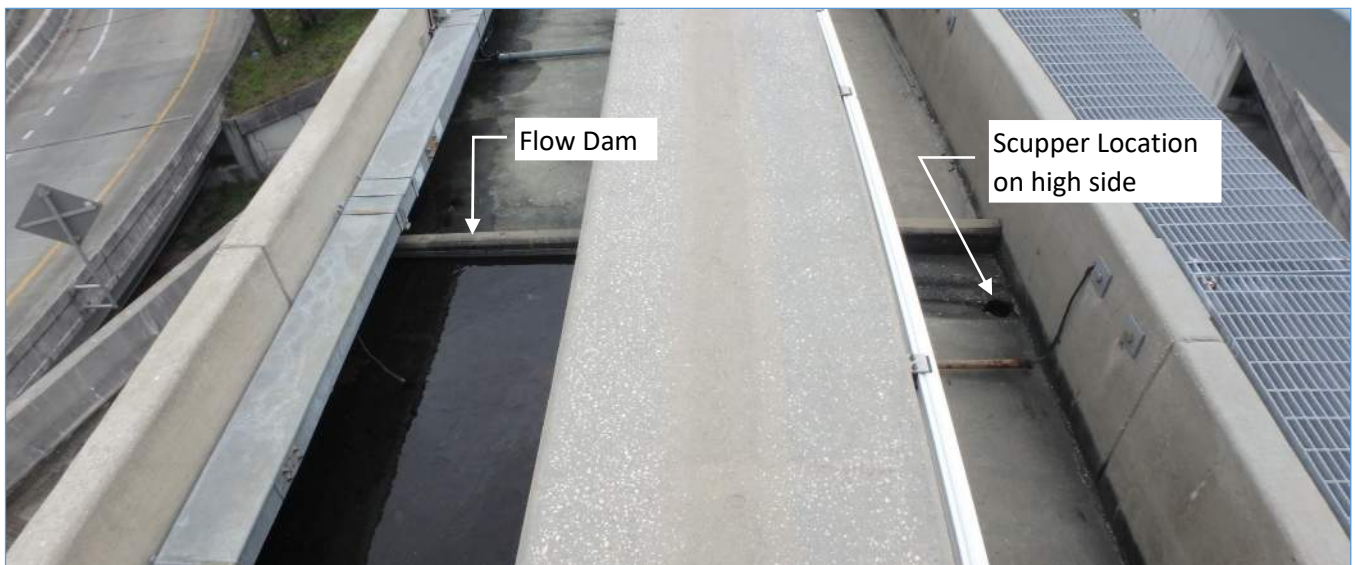
Pier 242R: Guideway, Looking Back Showing Standing Water on the Low Side and Scupper on High Side

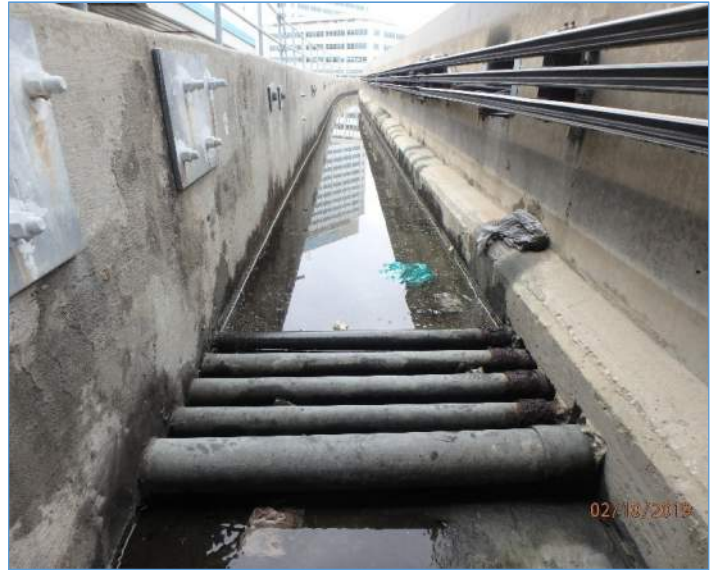
A third example is the Right Guideway at the San Marco Station. In Span 240R there is standing water for the full length of span on the left side of the guidebeam only. There is a series of metal conduits that cross the guideway transversely, about 5 ft. from Pier 240. The conduits sit almost right on top of the deck (1/8in. max gap, filled with debris) and so water cannot get to Pier 240 to drain. See the photo to the right.

Pier 240R: Standing Water Blocked by Conduits

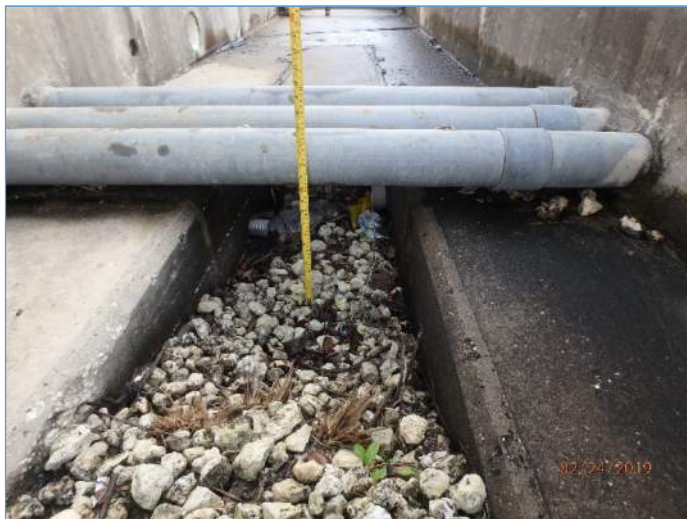
Erosion Between Slab-on-Grade Spans at the O&M Center

Shown in the photo to the left is an area of erosion between two slab-on-grade finger spans at the O&M Facility. Concrete was poured between the slabs in an effort to stop the erosion, but that just moved the affected area further back. This area is between M1B2 and M1B3 and measures 4' L x 18" W x 1' D and has narrow voids up to 2' deep below the poured slab. This represents an increase since the last inspection. A similar area of erosion is present between M1B2 and M1B3.

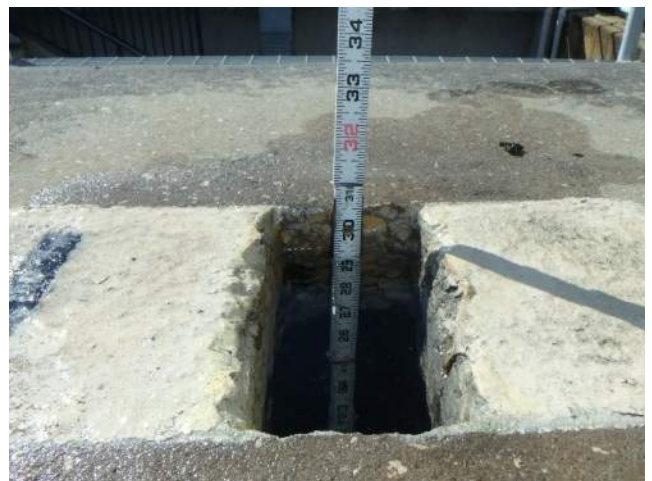
There is a significant amount of standing water inside the guidebeam in Span 2N. The top of the beam has a 6.5" x 3.25" hole that allows water to enter, but the hollow guidebeam sits on a solid pedestal, so there is no means for the water to drain. See the photo to the right.

Span 2N: Water Inside Guidebeam

- Drain the water from inside the guidebeam in Span 2N.
- Install a downspout at the end of the drain pipe in Span 42S Cross.
- Investigate and repair the water dripping from the right overhang of Span 409R onto Water Street (EB) from the first deck downspout past Pier 409R.

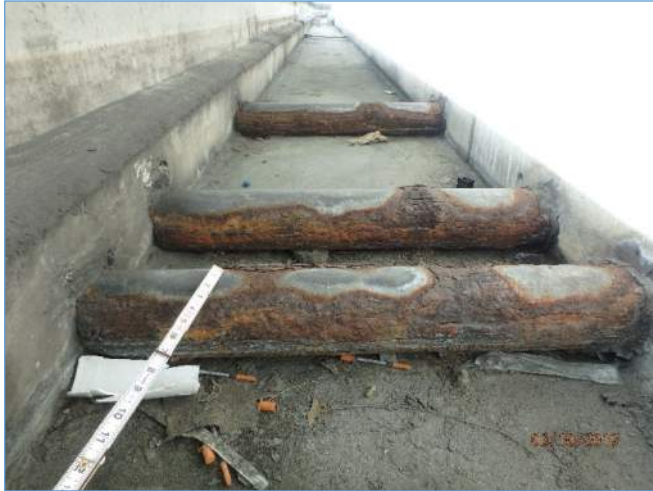
This project did not include an inspection of the mechanical and electrical components of the Skyway, but there were some structural defects noted that pertain to the electrical system. Many of the electrical conduits, straps and bracket that sit on the deck have heavy to severe corrosion and section loss due to standing water and debris accumulation on the deck. Conduits at San Marco Station have the most significant deterioration, with 100% section loss and exposed wires. See the photos below.

Pier 239L: Heavy Surface Corrosion on Conduits

- Remove soil and debris accumulation at transverse conduits on the deck.
- Replace conduit, brackets and straps on top of the deck with severe section loss.

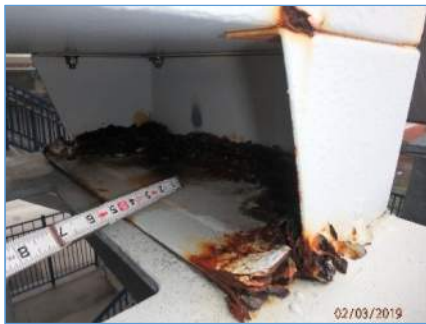
Heavy Corrosion on Electrical Cabinet Legs in Span 409R

- Remove the corrosion and repaint the bases of the electrical control cabinets throughout the system.
- Replace the nuts for the cable tray support brackets in the Starter Line with galvanized or stainless nuts. Also replace the nuts and washers for the electrical control cabinet support brackets in Span 409L.

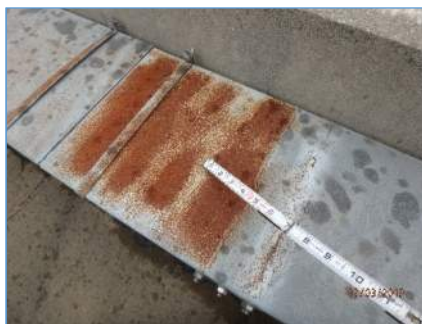
Surface Corrosion on Cable Tray Top in Span 29N

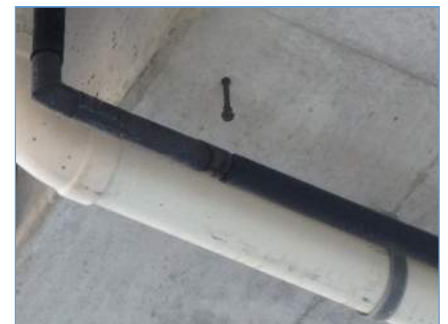
Broken Pipe Hanger Due To Surface Corrosion in Span 1N

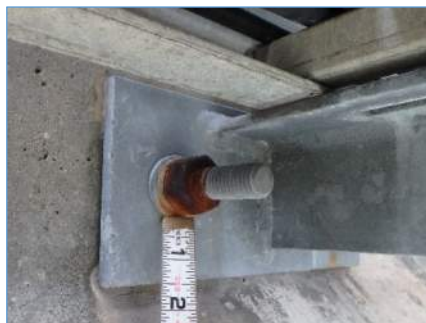
Corrosion on Nuts for Cable Tray Brackets, Starter Line

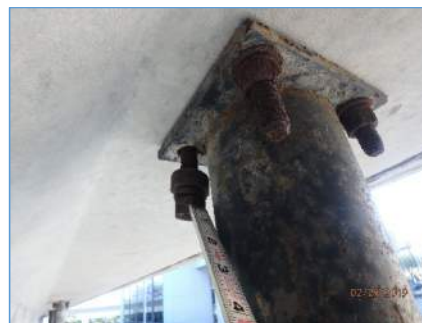
Heavy Corrosion and Bent Bolt for the Traffic Light in Span 55L

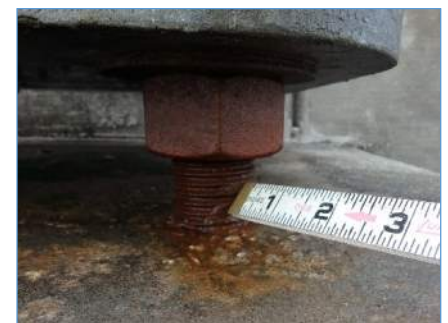
Surface Corrosion on Traffic Signal Pole Anchor Bolts in Span M2

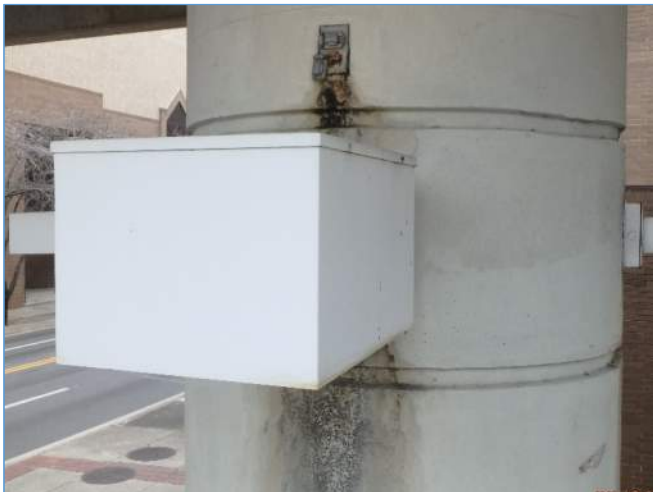
Many of the piers in the North Line have electrical outlets attached to the columns that are missing one or both of the hinged weather covers. There is an outlet cutout on Pier 52 that is missing cover plate. There is active water dripping from the light connections and the electrical outlet attached to the column at Pier 76. See the photos below.

Pier 76: Overview of Water Leakage from Electrical Components

- Repair electrical cable tray defects listed in Appendix D-2 including missing straps, missing covers and broken or missing sidewall brackets.
- Investigate and mitigate the cause of the water leaking from the electrical outlet and light connections on the column of Pier 76.

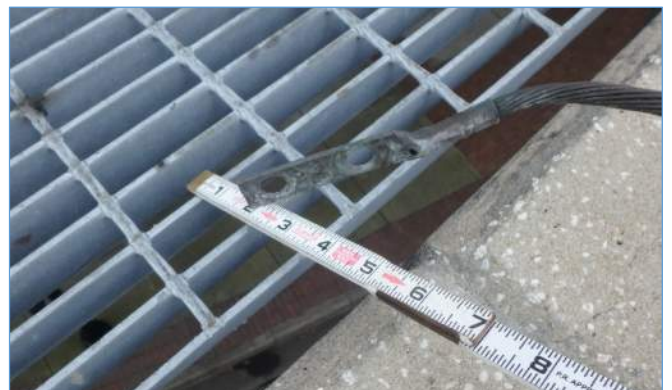
There are multiple locations in the system in which the ground wire attached to one of the metal components is detached. See the photo to the right.

Span 78L: Detached Emergency Walkway Ground Wire

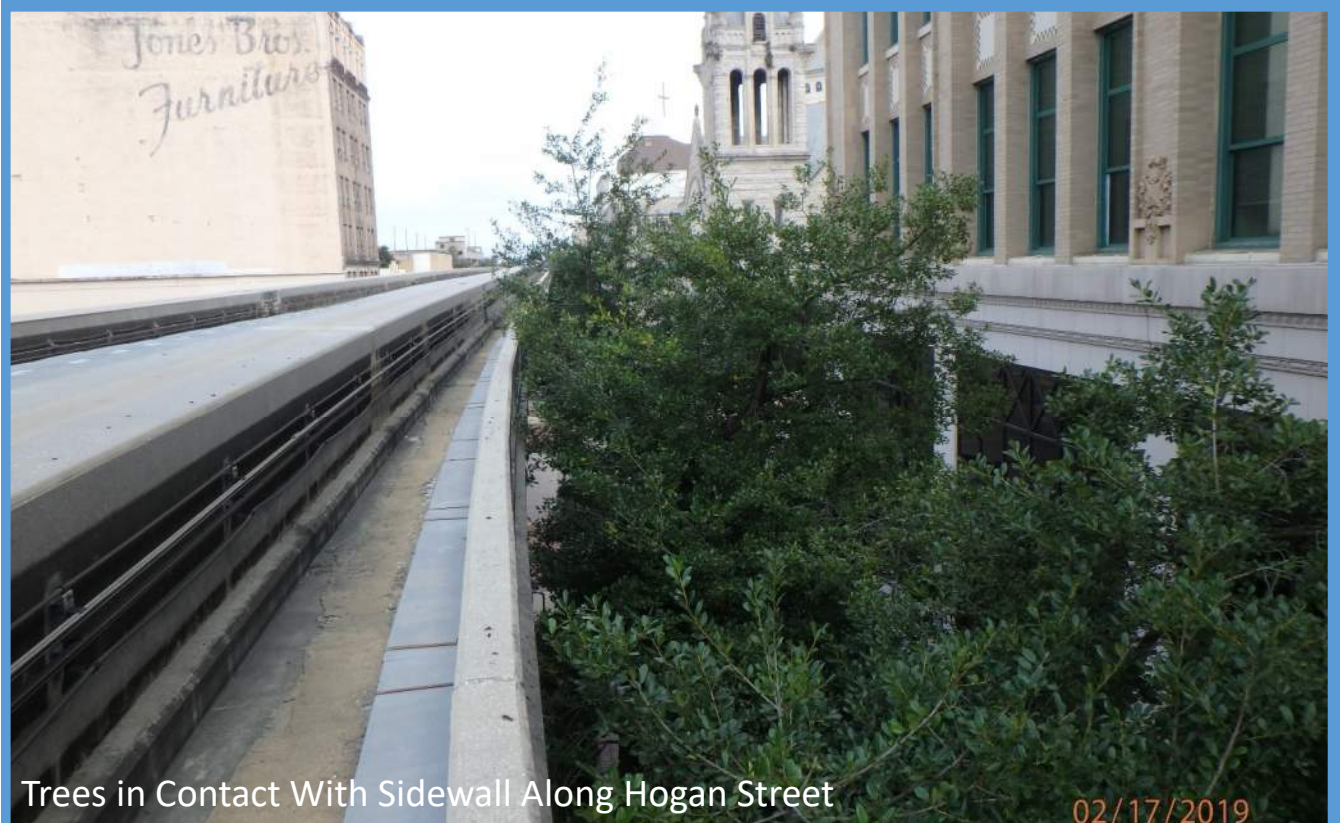
Trees in Contact With Sidewalk Along Hogan Street

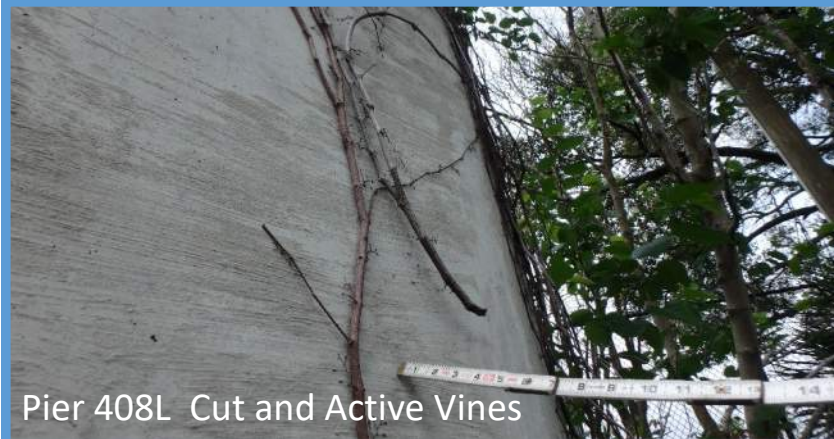
Vines are growing up the column of Pier 406R and are attached to the box beam bearings, deck overhangs of Spans 405 and 406 and climbing over the left sidewall. Vines are also growing up Piers 401 and 408L. Many were previously cut, but new ones are growing up as well. Vines are also growing over the slope protection under Span M2 behind the O&M building.

Pier 408L Cut and Active Vines

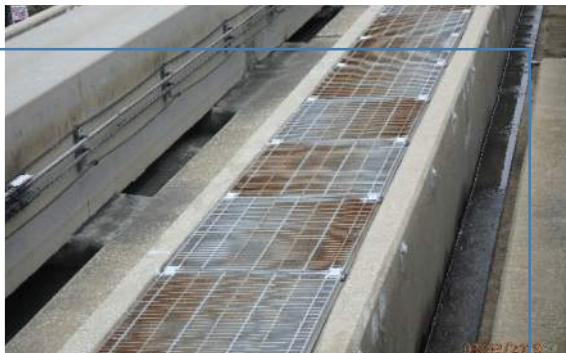
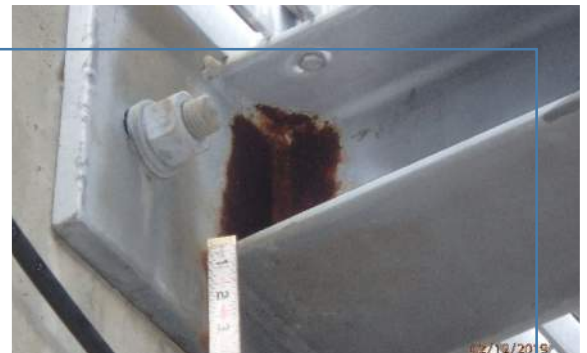
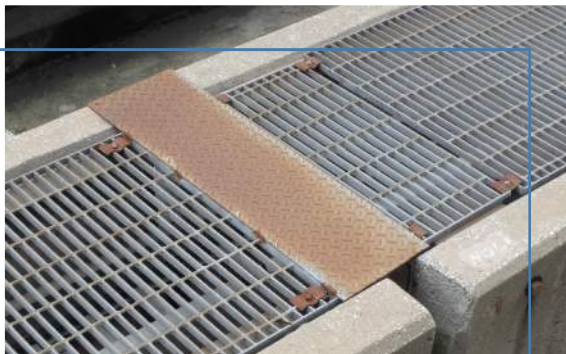
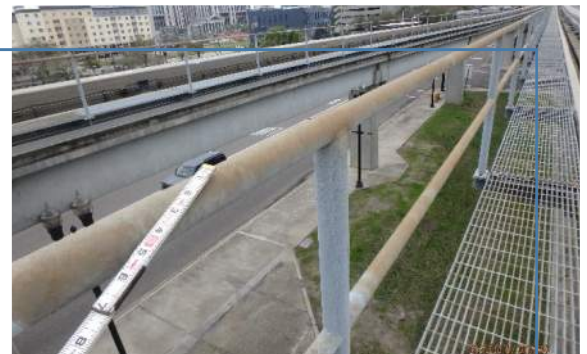
Figure 6. Typical Emergency Walkway Surface Discoloration and Corrosion Locations

The emergency walkway components are in satisfactory to good condition. There is light to moderate surface discoloration and corrosion on the emergency walkway grating, plates, clips and bolts, and the railing at various locations throughout the system. Numerous brackets supporting the cantilevered type walkways have moderate to heavy surface corrosion at the connection to the sidewalls. See Figure 6 below.

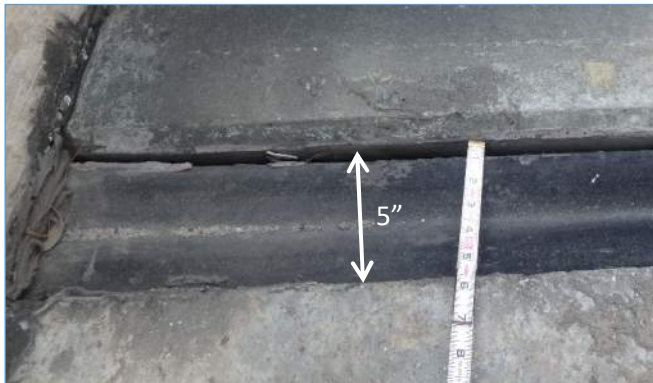
The deck expansion joints are in poor to severe condition overall; many have failed altogether. Several of the deck joints are filled with soil and debris. Of the 187 compression seals in the system, 116 were found with full depth adhesion loss, most for nearly the full length of the joint and 12 more have partial adhesion failures. At 38 locations, there are gaps noted from 1/8" to 3/4" wide between the seal and either the deck or pier cap. At Pier 81L, the compression seal is hanging down and at Pier 52A for the rear span, the seal is missing altogether (was likely never installed). These defects are significant as the failure of the joints permits water to fall through and onto the beam seat below, accelerating the deterioration of the beams and bearings. Also, failed deck joints in the vicinity of the stations results wet tile, causing a slipping hazard. This was noted at (but not limited to) Central Station and San Marco Station. See the photos below.

Pier 232R: Joint Width Exceeds Seal Capacity

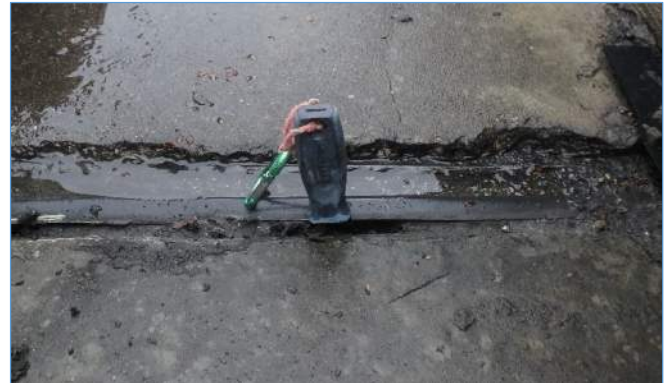
Pier 205R: Typical Seal Adhesion Failure

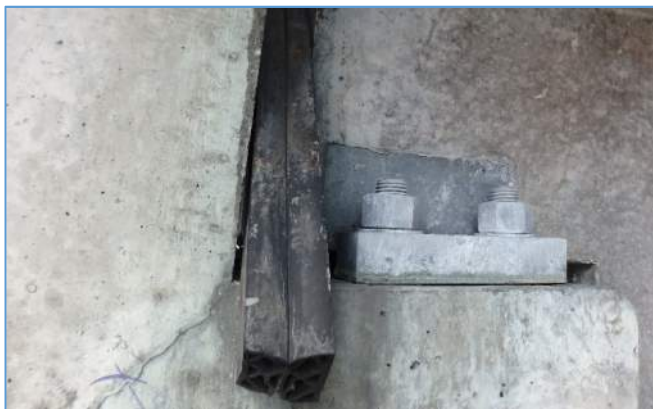
Pier 81L: Joint Seal Hanging Down

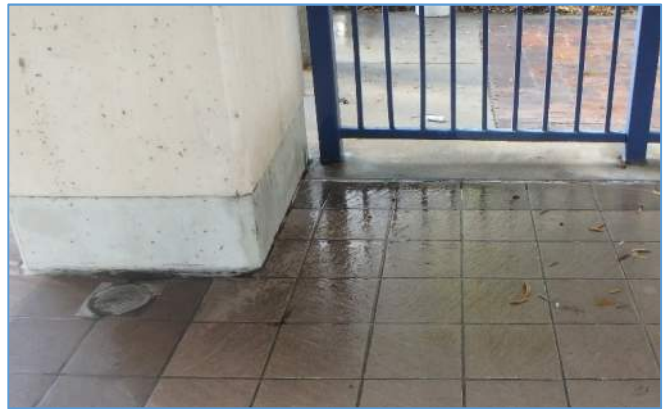
Pier 44S: Wet station tile due to failed deck joint

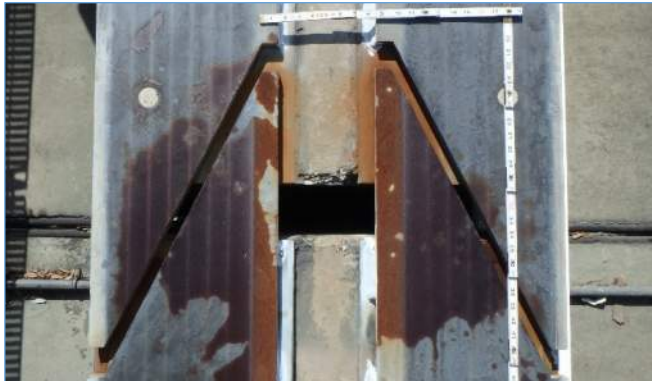
Light to moderate surface corrosion was noted on the sliding plates at 51 of the guidebeam joints; no section loss was noted at these locations. At Piers R-1L and 78R, one of the tack welds for the top sliding plates is cracked, but the plates are still secure. See the photos below.

Pier 250L: Surface corrosion on the sliding plates

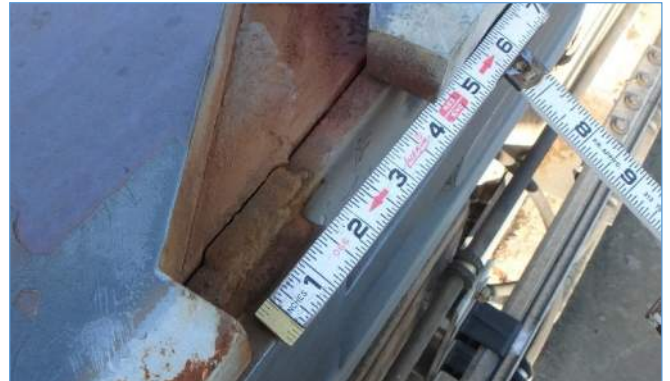
Pier R-1: Tack Weld Crack

At the Acosta Bridge Piers R-1 and R-6, the joints are expanded beyond their maximum limits, with measured openings between 4-1/4" to 5" at around 68 degrees, rendering the side fingers with little surface area to slide against. Retrofit steel plates have been installed behind the fingers at both R-6 guidebeam joints to provide additional sliding surface. On the left side, 1 of 8 plates has fallen off and the fingers have only 7/8" of remaining embedded plate surface to slide against. On the right side, 2 of 8 embedded plates have fallen off and the two remaining retrofit plates attached at the lower set of fingers have cracked welds and are not secure. At Piers 78L and R-6L, one of the fingers is broken off. See the photos below.

- Pier R-6: Reinstall the fallen retrofit expansion extension plates and repair the unsecured ones.
- Patch the spalls in the concrete pourbacks; locations are listed in Appendix D-5.
- Apply a corrosion inhibitor to areas on the steel plates and fingers with surface corrosion that do not come in contact with the train tires.
- In the long term if the guidebeam is to remain, an engineered solution to retrofit the joints should be investigated due to the deterioration of the pedestals (see the Guidebeam section of this report). Perhaps this could involve replacing the single joint with two that coincide with the deck joints. Another option would be to retrofit the current configuration by replacing the bond breakers with thin sliding plate bearings.

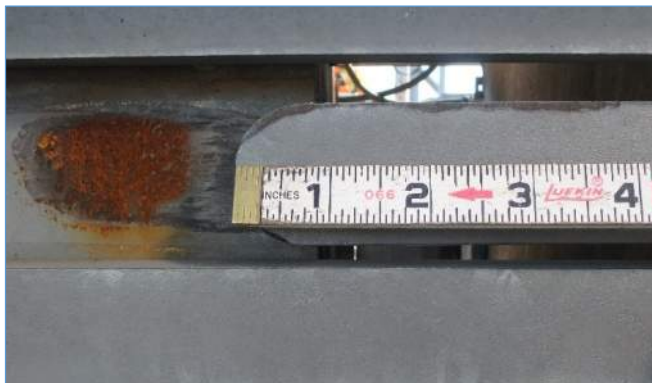
Pier R-6L: 7/8" Available Sliding Surface

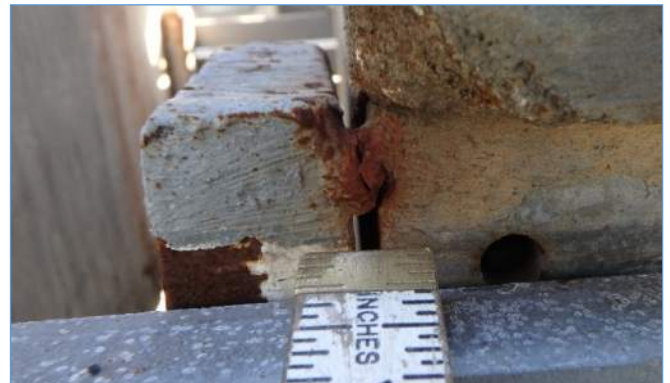
Pier R-6R: Retrofit Plate Tack Weld Crack

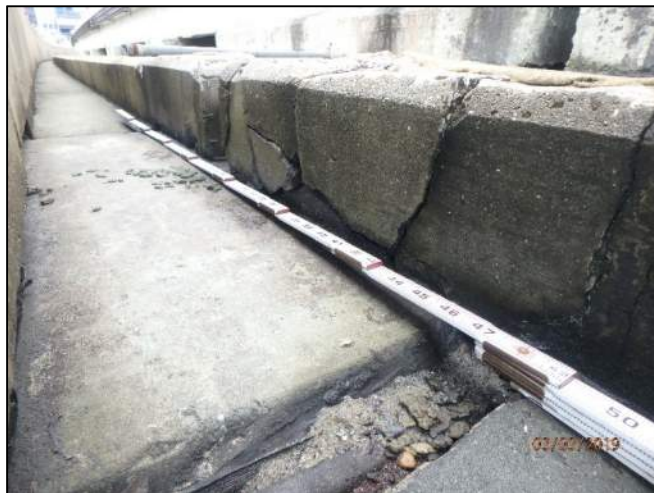
In the Starter and North Lines, the second pour exhibits heavy cracking, fractures and delaminating at a number of pier locations. This is caused by the joint in the second pour not coinciding with the joints in the deck as described in the Expansion Joint section of this report. In the South and River Lines, a number of the lift point patches for the tee beams have delaminations and failures, some exposing the lifting steel. See the photos below.

Second Pour Delaminations Above Pier 38

- Remove the debris and any loose concrete from on top of the deck.
- Patch all deck and tee beam top flange spalls listed in Appendix D-6 with depths 1in. or greater. Second pour spalls that do not affect the bearing of the guidebeam pedestals can be ignored.

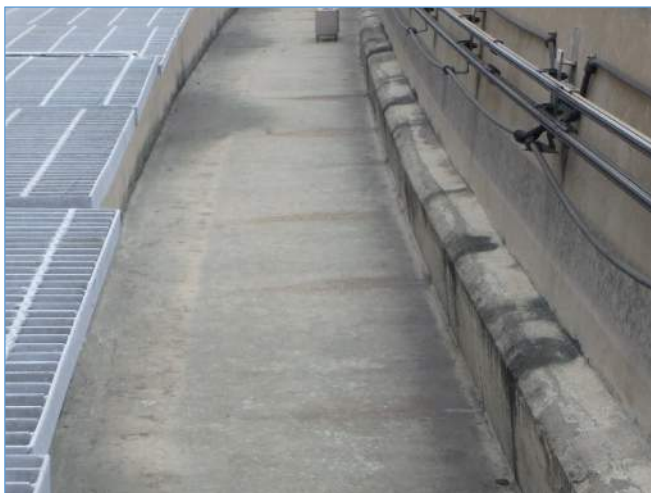
The top surfaces of the cast-in-place decks of the steel box spans exhibit transverse cracking, typically spaced three to five feet apart, although spaced closer together at some locations, especially over continuous piers. The cracks are mostly hairline but some were measured up to 1/32" wide. See the photos below.

Span 234L: Transverse Deck Cracking

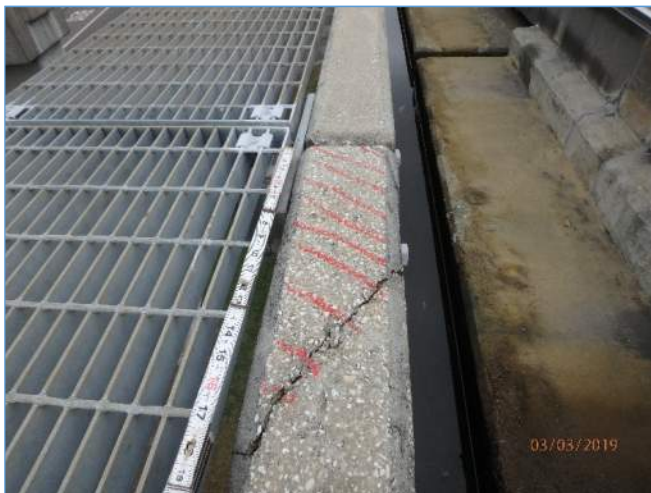
There are four locations in the system where the top surface of the sidewalk exhibits delaminations and spall/delaminations extending for 20ft. or more. This was noted in Span 203 Cross (South), 225L (South), 253R (River) and Span M5 (O&M). Other defects were noted at various locations, such as the atypical cracking and larger than typical spalls. At the JRTC construction site, the left sidewall (and tee beam top flange) of Span 5N is cutout for 25in. due to a clearance conflict with a new building column. Some of the longitudinal reinforcing bars were cut, but some remain; it is presumed that this will be repaired as part of the building construction. See the photos below.

Span 19S: Delamination, Top of Left Sidewall

- For the spalls listed in Appendix D-7 with exposed rebar, coat the rebar with a galvanizing spray.
- Patch all spalls listed in Appendix D-7 with depths 1in. or greater.
- Seal all cracks listed in Appendix D-7 with widths 0.03in. or greater.

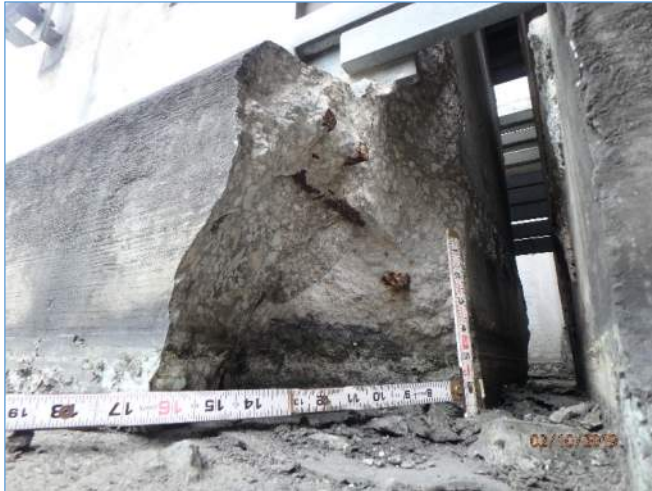
As described in the Deck Joint section of this report, there are three joints at most expansion piers – the deck joint at the rear face of the pier, the deck joint at the forward face of the pier and the guidebeam joint which is above the center of the pier. This configuration requires that the end 18 inches of the guidebeam and pedestal to slide back and forth with the expansion and contraction of the decks. Even though a neoprene bond breaker is present between the top of the pier cap and the guidebeam pedestal, this configuration has led to significant cracking, delaminations and spalling of the pedestals. Isolated spalls and failed or delaminated patches are also present on the top edges of the guidebeams. See the photos below.

Pier 237: Large Pedestal Spall at an Expansion Joint

- At the expansion joints, remove all unsecure pedestal concrete and thoroughly clean out the joint areas.
- Patch all spalls listed in Appendix D-8 that are on the top edges of the guidebeam.
- At the switchbeam locations, remove active corrosion and recoat areas of failed paint on the beams and mechanism support plates, brackets and bolts.
- Develop a plan to re-paint the steel guidebeams and switchbeams.

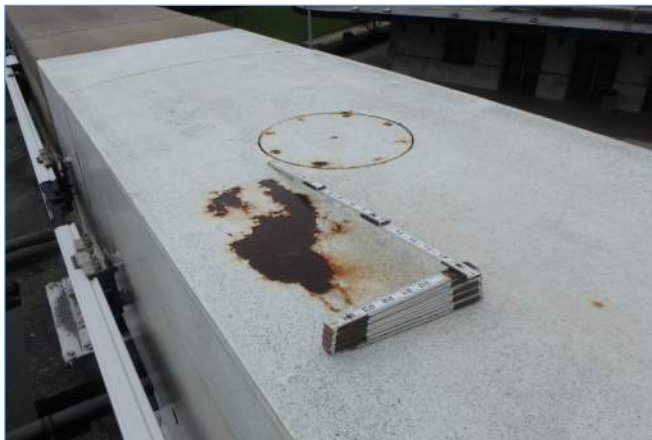
The paint on the steel guidebeams and switchbeams is in poor condition. The paint is very chalky, which is accelerated by direct UV degradation. There is surface corrosion at isolated locations on beams and on many of the switchbeam baseplates, mechanism support brackets, and hardware. Spot painting is evident, but there are locations where corrosion is active and causing significant section loss. See the photos below.

Span 8S: Surface Corrosion on Steel Guidebeam

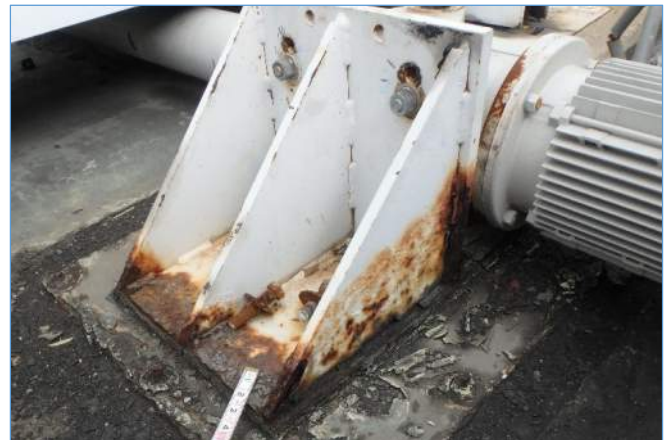
Span 233L: Section Loss on Bolts and Motor Bracket

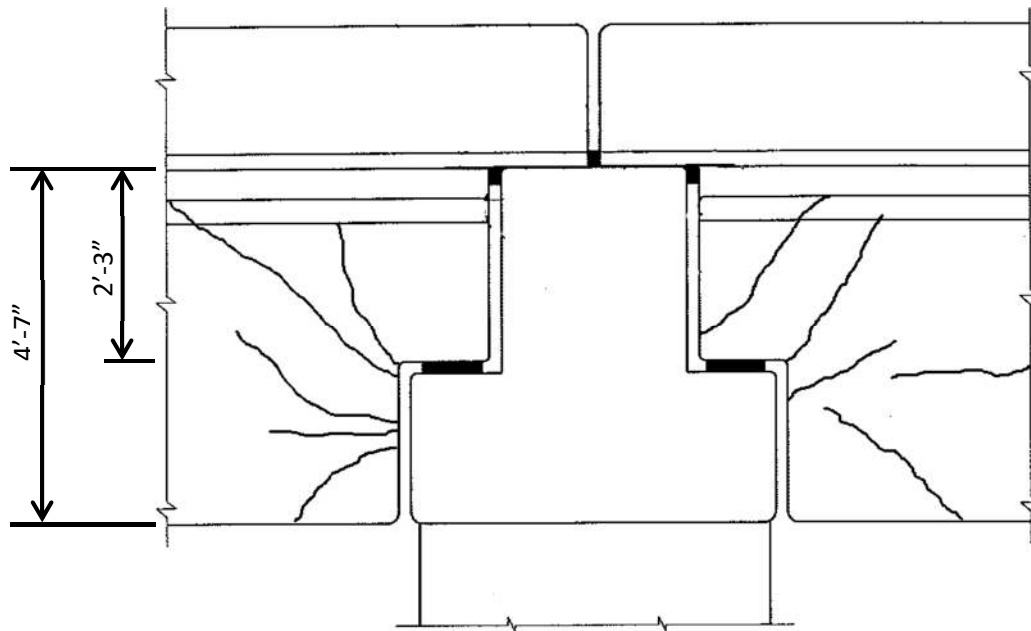
Figure 14. Typical Crack Location and Orientation at Tee Beam Ends

The primary issue of concern with the tee beams is the shear cracking of the stems at the dapped ends. The cracks are diagonal and radial in orientation and are prominent at the expansion ends. See Figure 14 below.

This type of shear and radial cracking is present in nearly all stem ends at expansion piers and to a lesser degree, in the stem ends at continuous piers. Some of the cracks are up to 5 feet in length and many extend into the top flange. Also, many of the stem cracks are reflective on both faces of the stem indicating that the crack fully extends through the stem at these locations, most notably those that originate directly from the notched corner of the beam stem.

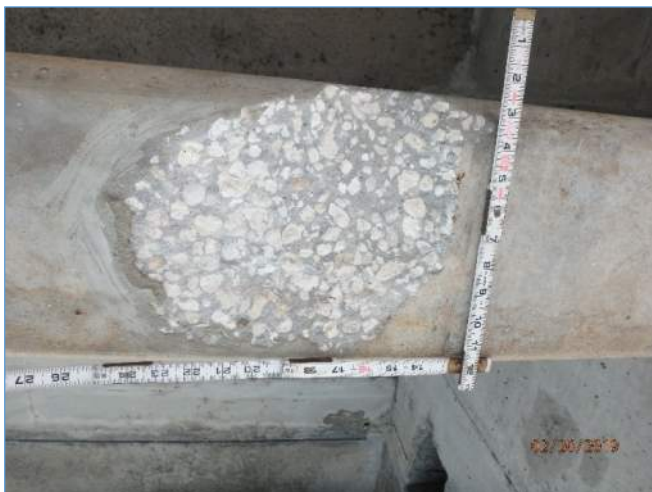
Other common deficiencies noted on the stems were spalling and delamination of the concrete, most of which are located along the bottom edges of the stems. There were no exposed prestressed tendons noted other than end exposure at spalls located on the front or rear face of the stem above an expansion pier. The photos below illustrate the worst cases of each deficiency type.

Span 75R: Looking Up at 10-1/2" x 9" x 1-1/2" Spall, Left Stem Near Pier 76R

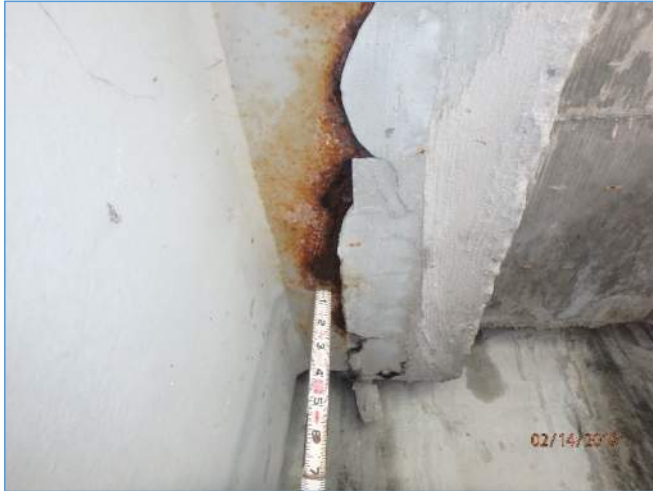
Active surface corrosion is present at isolated locations throughout the system. This condition has worsened since the previous inspection. Of the 160 field notes regarding corrosion on the exterior faces of the beams, 78 have a disposition of "new" or "increase". One common location for corrosion is on the undersides of the top flanges adjacent to expansion piers due to water draining through failed deck joints. For example, on Span 236L at Pier 237L (San Marco Station) there is a 20" x 3" area of moderate to heavy surface corrosion on the underside of the right top flange, with 6 square inches of up to 1/16" pitting. See the photos below.

Span 236L: Surface Corrosion on RT Top Flange

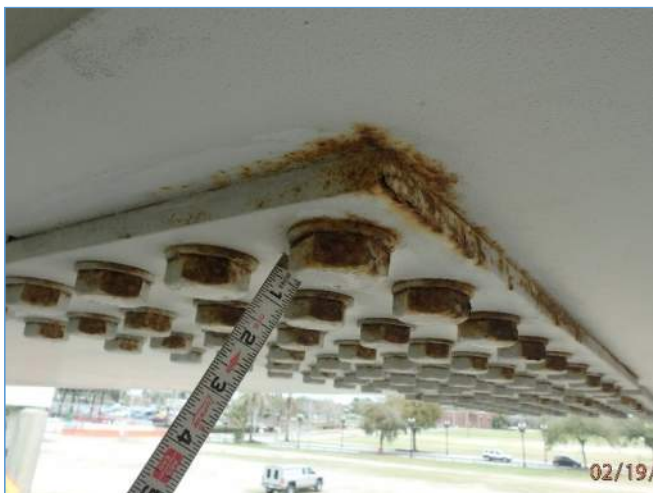
The other common location for corrosion is on the splice plates and bolts. Nearly all beam splices in the system have light to moderate corrosion on the bolts and in many locations, also on the plates. The front face of the Pier 10 cross girder exhibits 5 SF of peeling paint with heavy surface corrosion and pitting up to 1/32" deep. See the photos below.

Span 10N: Corrosion on Splice Plates and Bolts

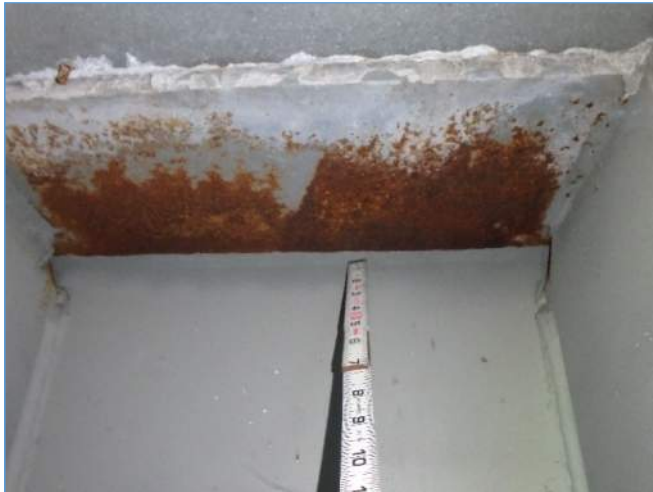
Light to moderate surface corrosion was noted at isolated locations in the interiors of the boxes, most commonly at the splices, on the bracing bolts and members and on the top flange and bearing stiffeners near expansion ends of beams. These conditions have increased since the previous inspection. The only location noted with significant section loss caused by the corrosion is the bottom flange splice bolts in Span 52A LT. These bolts have up to 20% section loss; previously noted as 15%. See the photos below.

Span 408L: Corrosion on Top Flange at Bearing

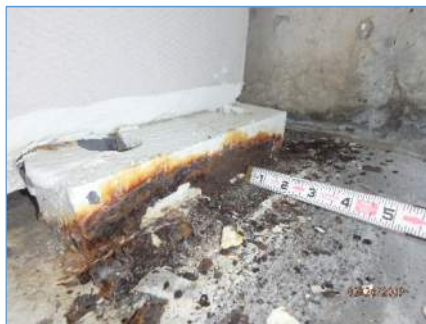
Keeper Plate with Corrosion

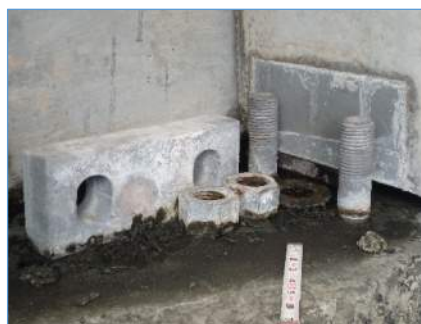
Keeper Plate not Installed

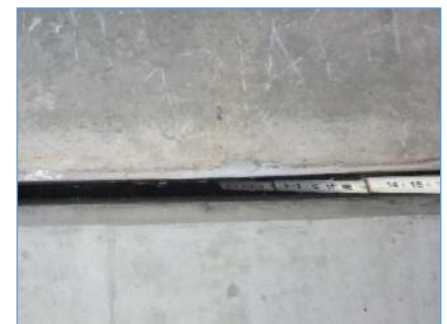
Missing Pad at Pier 62R

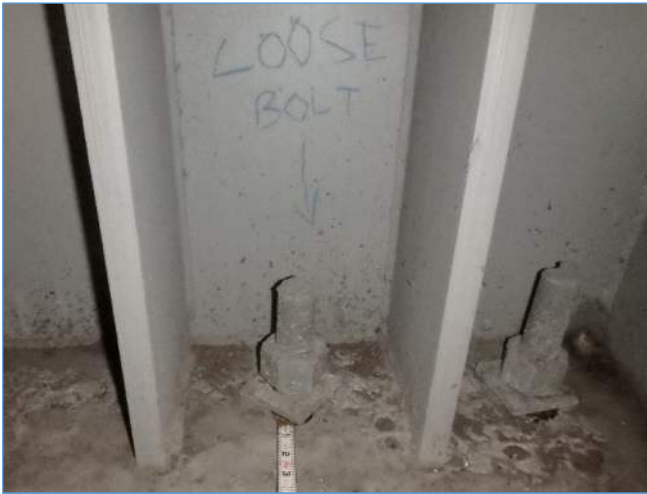
- Anchor bolt nuts not fully engaged
- Missing jam nuts
- Surface corrosion on sole plate and/or masonry plate (INCREASE since previous inspection)
- Gaps between plates
- Bird debris on and around the anchor bolts
- At Pier R6, the right anchor bolt for the left bearing is loose and can be rotated 1/2".

Pier R6: Loose Anchor Bolt and missing Jam Nuts

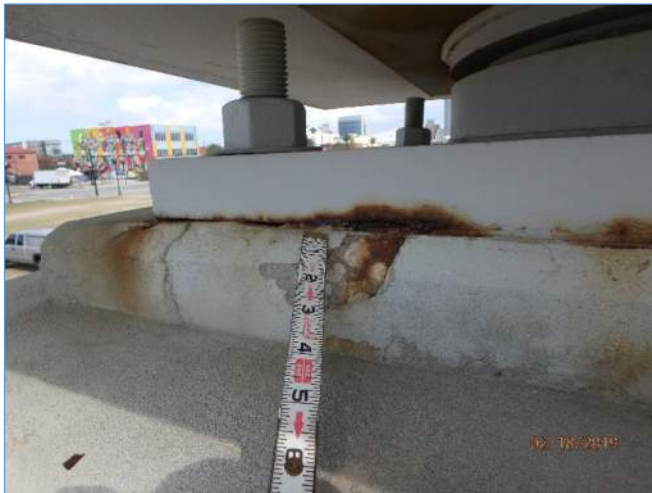
Pier 10: Surface Corrosion on Bearing Plate

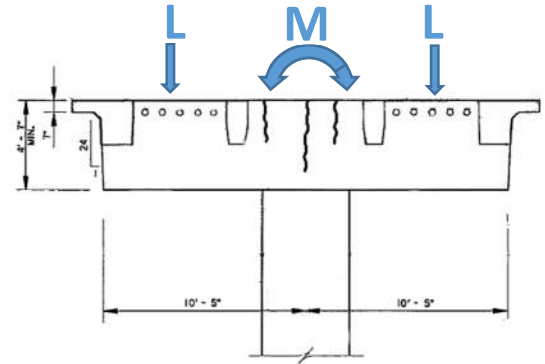
Figure 18. Pier Rear/Front View

Another prevalent crack type found throughout the system is flexural cracking on piers with hammerhead or “T” style pier caps. This configuration is quite common. See Figure 18.

There are variations in the shapes, depending on whether the pier is carrying concrete or steel beams, or is expansion or continuous, but the forces in the cap are similar and result in negative moment in the cap over the centerline of the column. See the photo below.

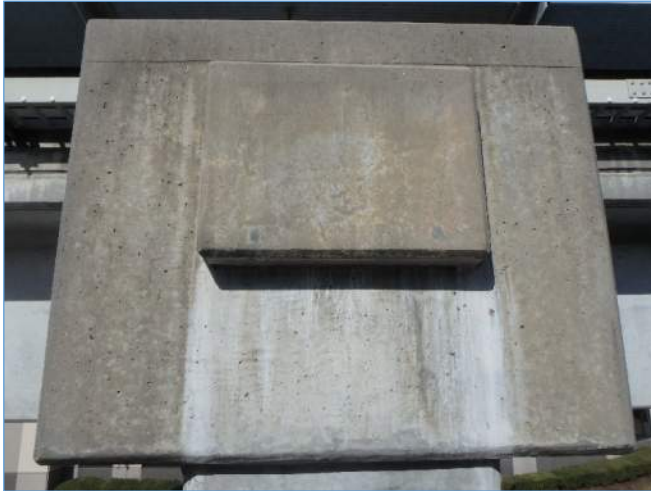
There are two common deficiencies associated with the post-tension pier caps in the starter line and they have to do with the precast covers attached to the left and right faces of the caps over the PT duct blockouts. Caulk, applied around the perimeter of the covers, is failing at a number of locations and there are gaps typically 1/4in.

wide between the tops of the covers and the pier caps. Also, efflorescence is leaching out from the bottom of many of the covers. See the photos below.

Pier 20N: Efflorescence Leaching from PT Cover

- Although not a structural issue, it is recommended to remove the moderate to heavy staining and algae growth from the pier caps and columns.
- Remove debris and bird nest from on top of the pier cap bearing seats.
- Seal the gaps around the PT Cap blockouts in the Starter line.
- Seal the gaps between the brick and column at the bases of the Hogan Street piers.
- Patch all spalls listed in Appendix D-13 with depths 1 in. or greater.
- Seal all cracks listed in Appendix D-13 with widths 0.02 in. or greater.
- Monitor the large pier cap delaminations associated with steel box beam bearings for growth or spalling (no changes noted since 2017).
- Consider an engineered repair of the pier cap delamination at Pier 258R.

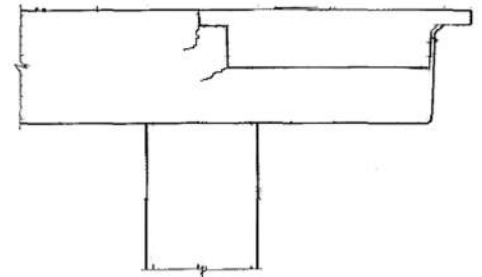
Figure 19. Pier Rear/Front View

The third common crack location is not associated with a particular pier type, but rather a pier detail, namely the 90° re-entrant corners on the rear and front faces of the pier caps. See Figure 19. This detail is present at locations in which the cap transitions from rectangular section to inverted-tee section.

This detail occurs on multiple pier types including both one and two column piers. See the photo below.

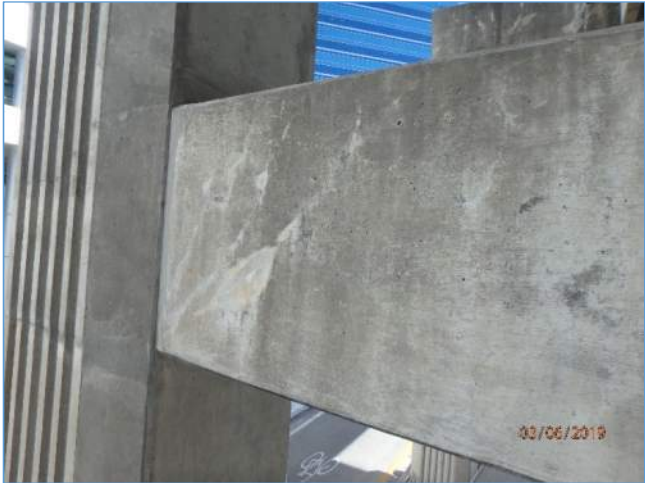
The worst substructure cracking in the system is located on the pier caps and load bearing struts at the San Marco Station; Piers 237 thru 240. Numerous shear, flexure and shrinkage cracks are present on the caps and the struts, noted up to 0.04" wide. The major design difference between these piers and those elsewhere throughout the system (including at other stations), is the unsupported length of caps. For nearly the same depth of section, these caps (and struts) are spanning much longer distances. Elsewhere in the system, the maximum cap length between column centerlines is about 35ft. At the San Marco Station, the cap and strut lengths range between 47ft. and 57ft. See the photos below.

Pier 238: Diagonal Shear Cracks on Strut at RT Column

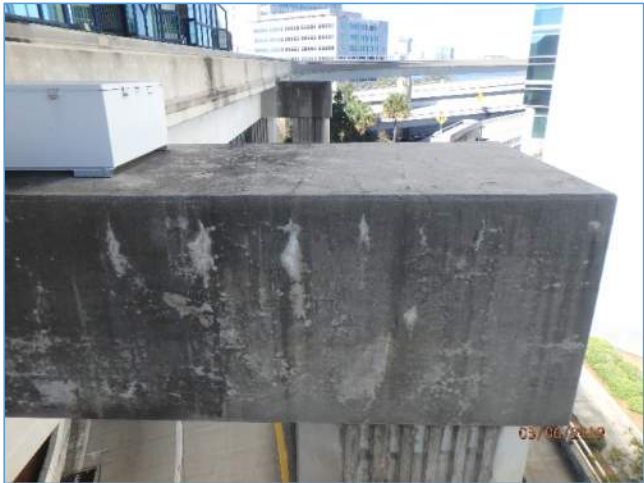
Pier 238: Flexure/Shear Cracks Across Cap at RT Column

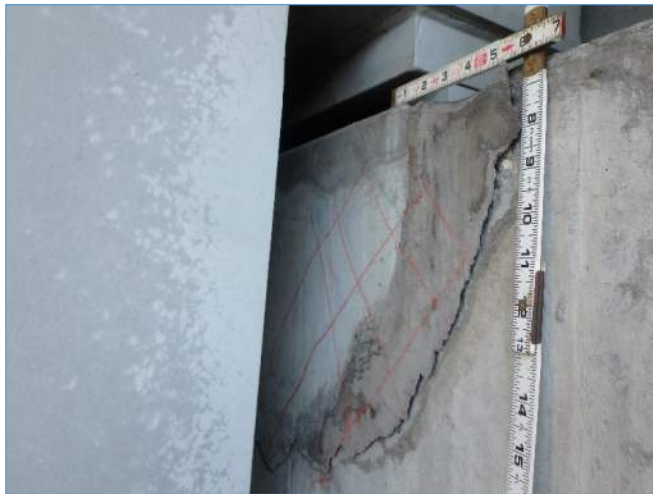
A number of spalls and delaminations were noted on the pier caps. There are three locations with significant delaminations on the pier caps. All three are located below bearing elements for steel box girders. These are possibly the result of the bearing anchor bolts being cast too close to the face of the cap and when the steel beams expand and contract, they pull and push on the anchor bolts, which in-turn could cause the concrete to delaminate. These conditions have not worsened since the 2017 inspection. See the photos below.

1. 3'-0" x 1'-7" on the rear face of Pier 235, below the left span, left bearing (A portion of this area has been previously patched, but the patch is also delaminated.)
2. 2'-9" x 1'-1" on the rear face of Pier 258L, below the right bearing
3. 4'-0" x 4" X 3" on the rear face of Pier 258R, below the left bearing, extending 2" below masonry plate.

Pier 258L: Large Delamination Below the Right Bearing, Rear Face

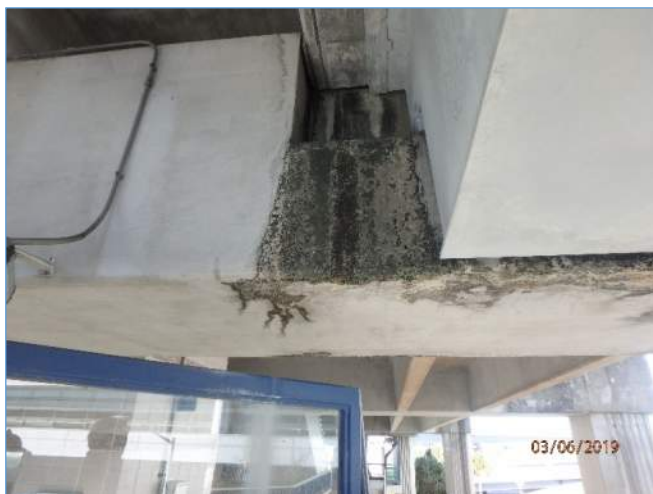
Water staining and organic growth (green or black algae, mold, or mildew) are common on the expansion pier caps and to a lesser extent, on the columns. This is a result of failed deck joints permitting rain water to drip onto the caps. Bird nests and debris are present on many of the beam seats. See the photos below.

Pier 237R: Staining on Pier Cap
