JTA Skyway 2019 Routine Inspection of Bridge Structures

Jacksonville Transportation Authority

RS&H, Inc. / FIT Engineering, LLC

Final Report

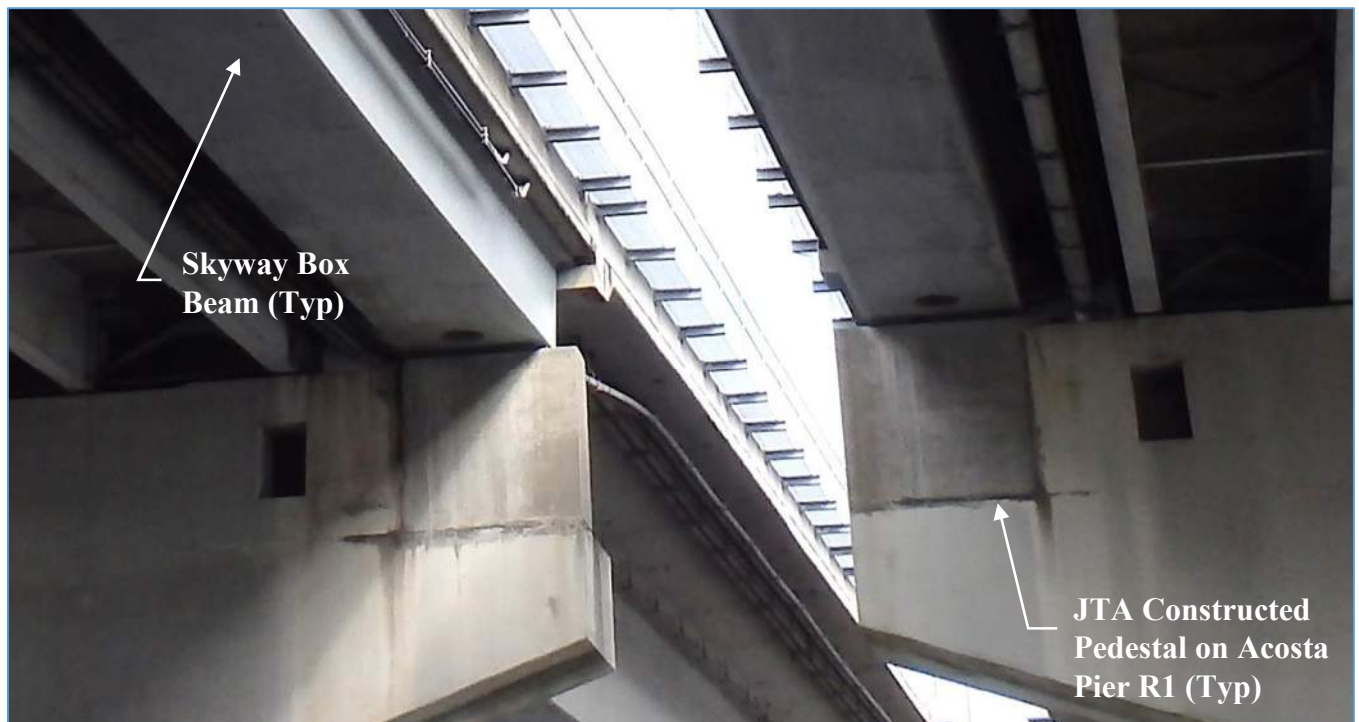
Acosta Bridge Pier R1 Supporting Guideway Superstructure (Photo from the 2017 Inspection)
