AIRCRAFT ACCIDENT REPORT

UNITED AIRLINES FLIGHT 585
BOEING 737-291, N999UA
UNCONTROLLED COLLISION WITH TERRAIN
FOR UNDETERMINED REASONS
4 MILES SOUTH OF
COLORADO SPRINGS MUNICIPAL AIRPORT
COLORADO SPRINGS, COLORADO
MARCH 3, 1991

**Adopted: December 8, 1992
Notation 5498B**

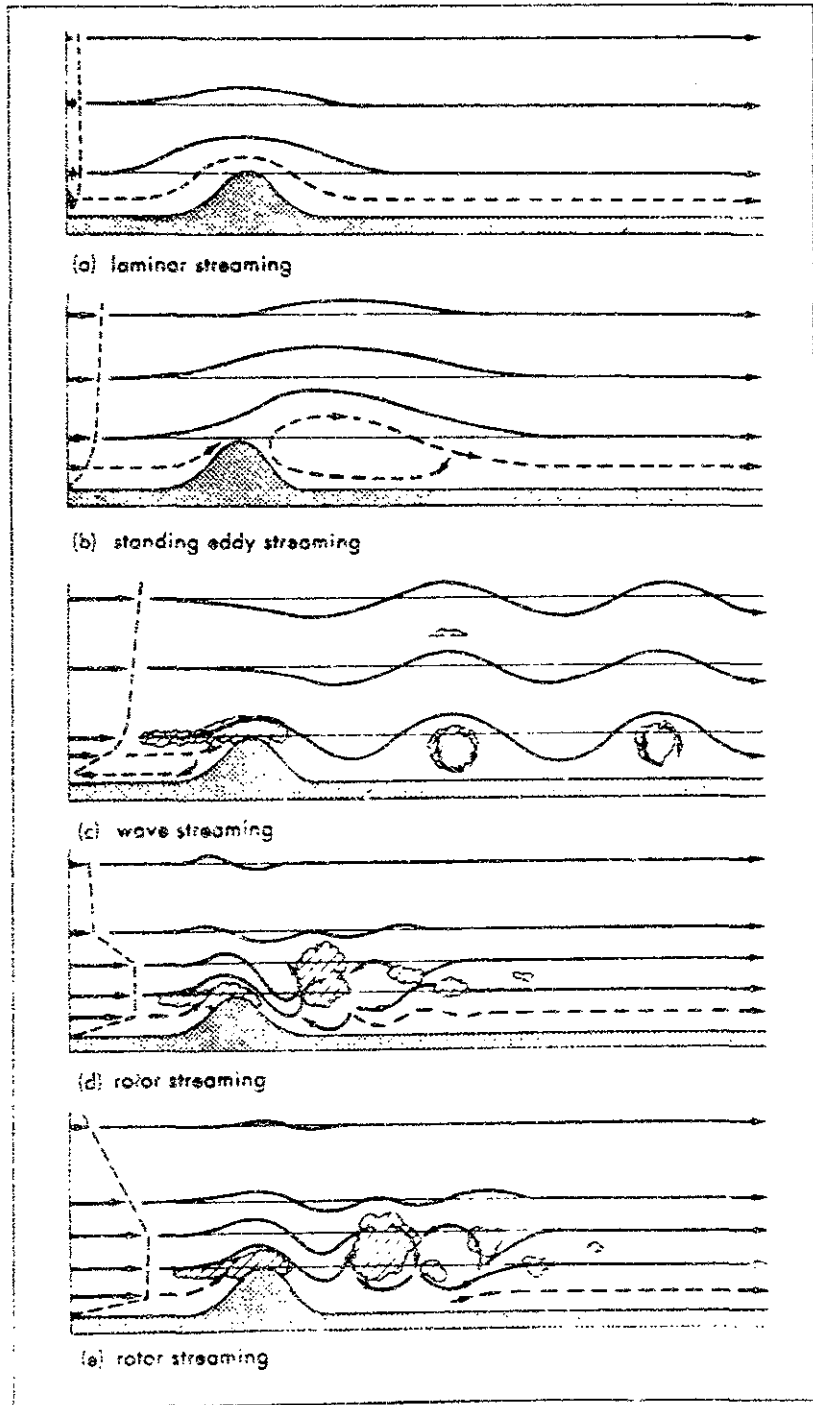
According to the World Meteorological Organization, the base of rotor clouds is generally near or below ridge lines, yet the tops may be considerably higher than ridge lines and may merge with the lenticular clouds [lens-shaped] directly above. Unlike the lenticular clouds, rotor clouds show evidence of strong and occasionally violent turbulence. They are constantly forming on the windward side and dissipating on the leeward side and appear to rotate--the upper portion moves forward while the lower portion moves backward towards the mountain. A succession of rotor clouds may appear at regular intervals downwind from the mountain ridge. Rotor clouds develop in standing eddies that form in the lower layers under the crests of the mountain wave. Lenticular clouds may be visible above these clouds. However, rotor clouds often provide the only visible evidence of the mountain wave. Clouds may or may not occur with rotors, depending on the moisture profile of the atmosphere. Therefore, rotors may be invisible to the eye. (See figure 2).

A glider instructor, who had been in the COS area for more than 25 years, stated that around 1200 on the day of the accident, he observed a rotor hit the ground with estimated wind speeds of 70 to 80 miles per hour. He was inside a building at a wrecking yard when he heard the roar of the wind.

Figure 2.--Types of airflow over ridges: (a) laminar streaming; (b) standing eddy streaming; (c) wave streaming; and (d and e) rotor streaming. Dashed line on left indicates vertical profile of horizontal wind speed

He then went outside and saw a rotor impacting the ground in the yard, which he said was about 1/2 mile east and 5 miles north of the extended centerline of runway 35 at COS. Tree limbs were blown off and car hoods were damaged. He believed that the rotor was part of a line of rotors extending north to south which would most likely have extended to the area where the accident occurred. He stated that the year's weather activity had been highly unusual with many days of strong downslope winds and rotors. He said that he had experienced vertical velocities of 5,000 to 6,000 feet per minute in rotors and that rotors can be as small as a "gymnasium" or many miles long. He added that the force of rotors impacting the ground has severely damaged houses, railroad cars, and trucks.

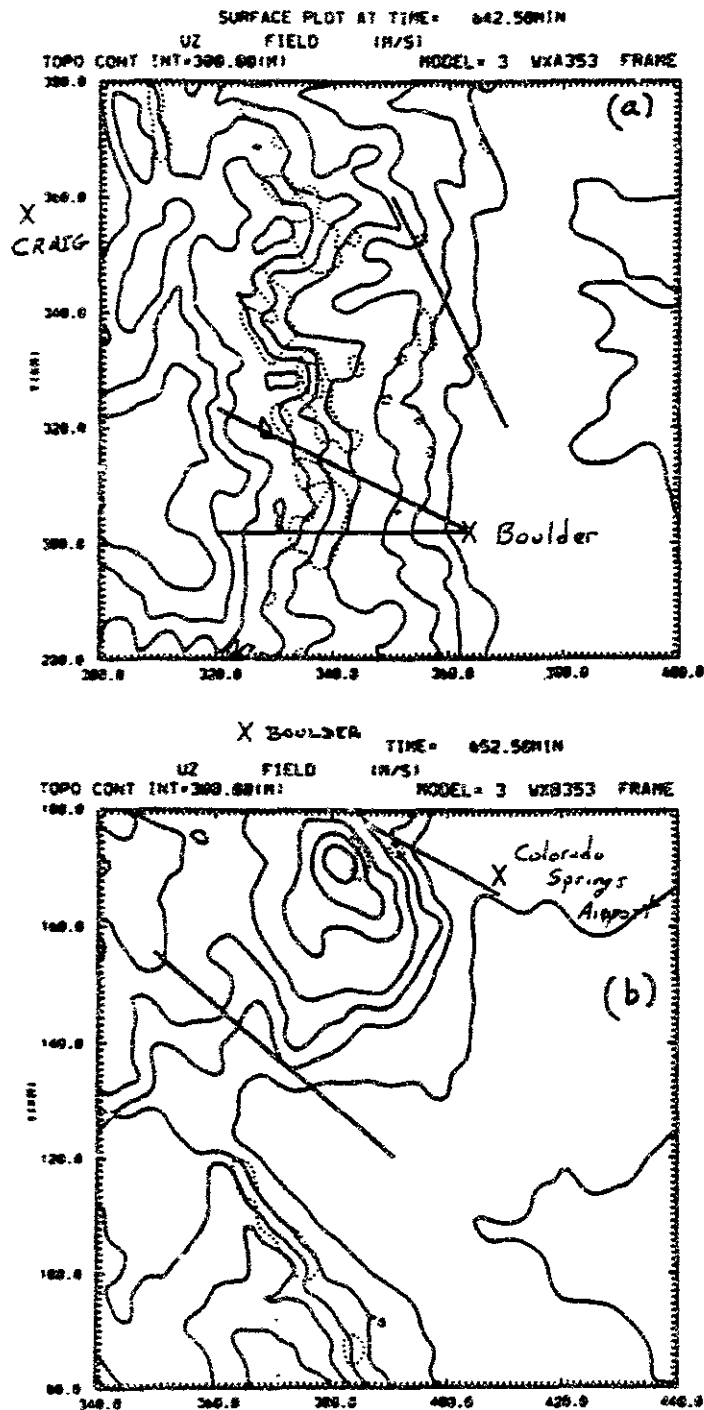
Fig. 1 Orography associated with the third and fourth high-resolution domains. The contour interval is 300 m. The quasi-linear nature of the front range relief in the Boulder area is evident in Fig. 1a whereas the orography in Colorado Springs area is dominated by Pikes Peak and the Palmer divide. The heavy solid straight lines designate where vertical cross sections of various fields were analyzed.

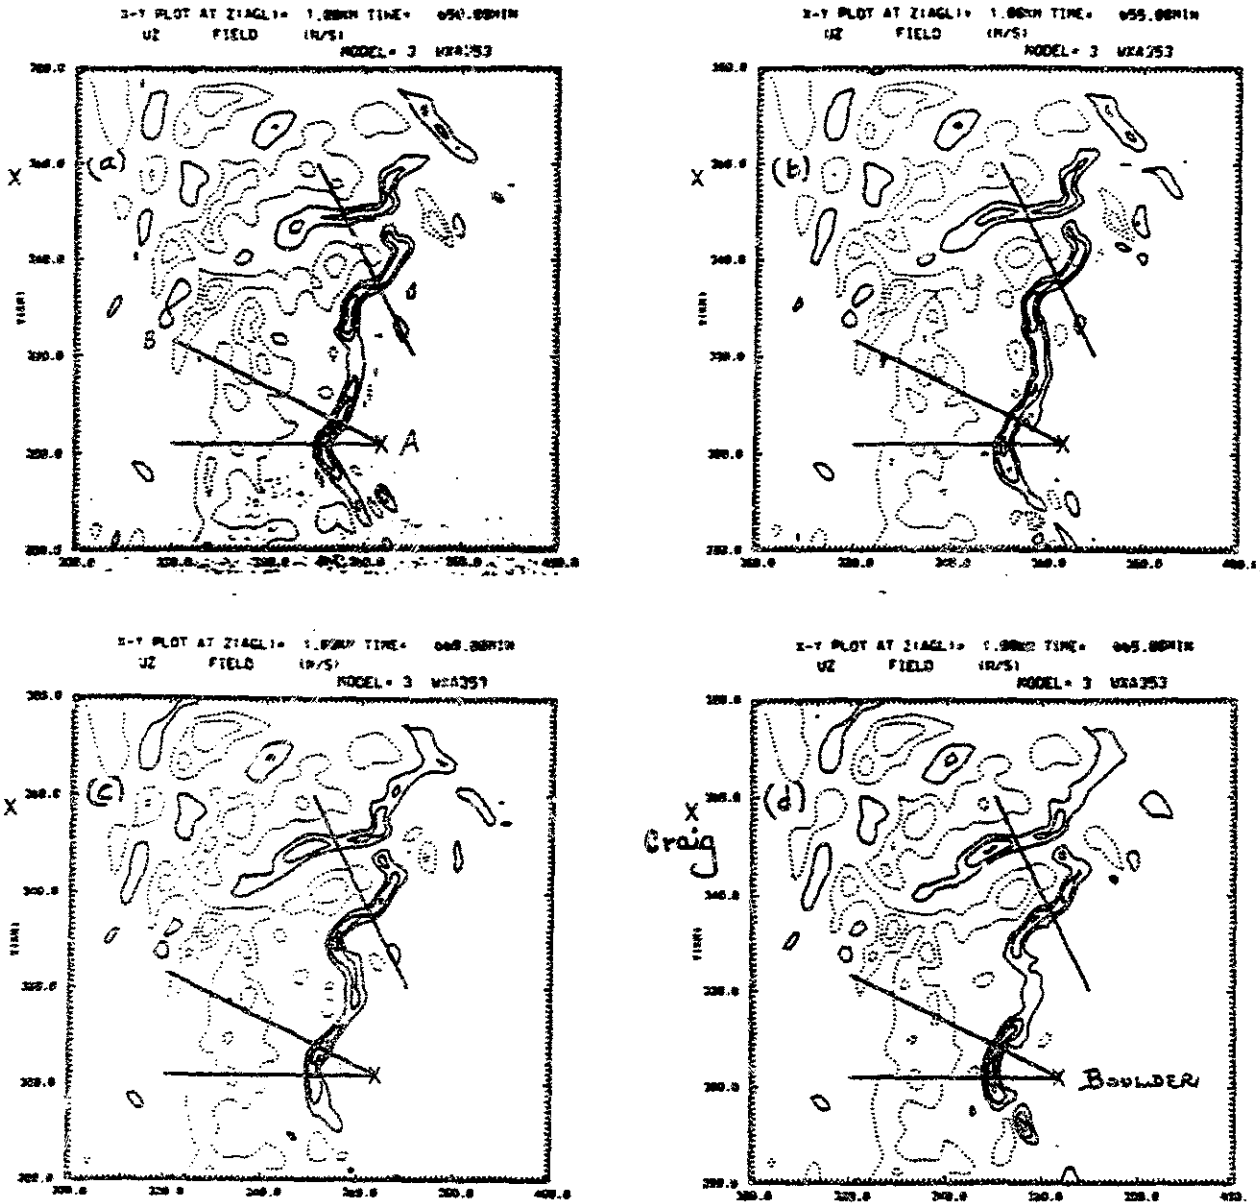
What the simulations show is a strong concentrated region of upward motion (or jump) with upward velocities exceeding 40 m/sec snaking up and down the Front Range, basically along the foothills of the Rockies in the Boulder region. Fig. 2 shows vertical velocity, w , at four different times spaced 5 minutes apart at 1 km above ground level (AGL). These plots are from the high resolution Boulder area subdomain (Fig. 1a). The jump surges to and from the plains at times which can be seen in the temporal and spatial variability of w in Fig. 2.

Fig. 2 Horizontal cross sections of w at 1 km Above Ground Level (AGL) over the Boulder region high-resolution domain. Four times are shown and are indicated on plots. The contour interval for w is 5 m/s where positive values are shown with solid and negative values with dashed contours. The crosses mark Boulder and Craig in these plots.

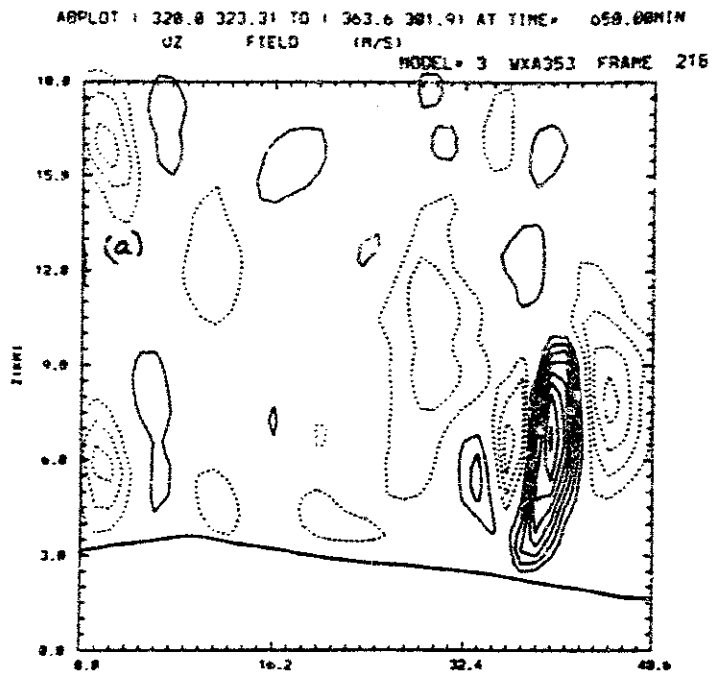
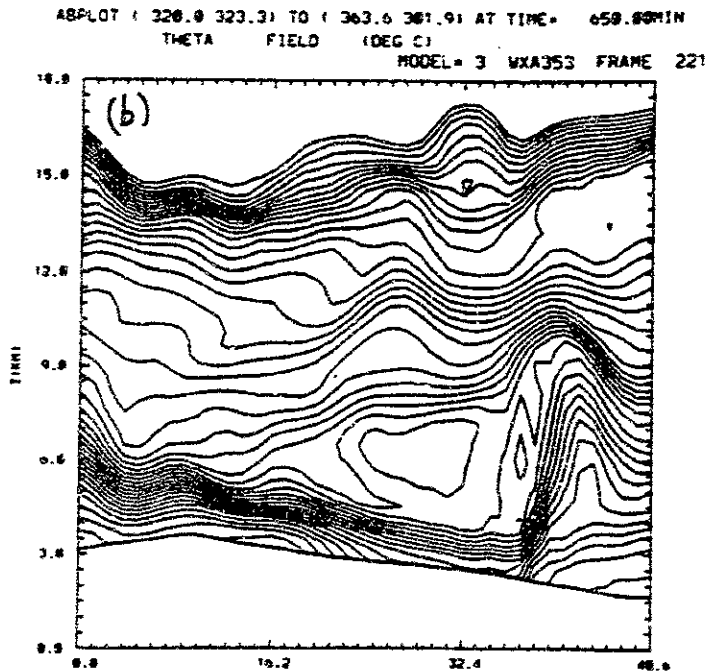
Fig. 3 shows vertical cross sections of w and θ (potential temperature) for the solid line marked A-B in Fig. 2. Note how the width of this updraft is about $4 \Delta x$ wide which means it is resolution limited. The plot of θ along A-B gives a good approximation of the air motion. Since θ is approximately conserved, the contours of θ represent trajectories of the air. The rebounding nature of the flow can be seen in this figure.

Fig. 3 Vertical cross sections of w and θ along line A-B shown in Fig. 2. The contour interval for w is 5 m/s and for θ is 3 degrees Kelvin. Both plots are for $t=650$ minutes.

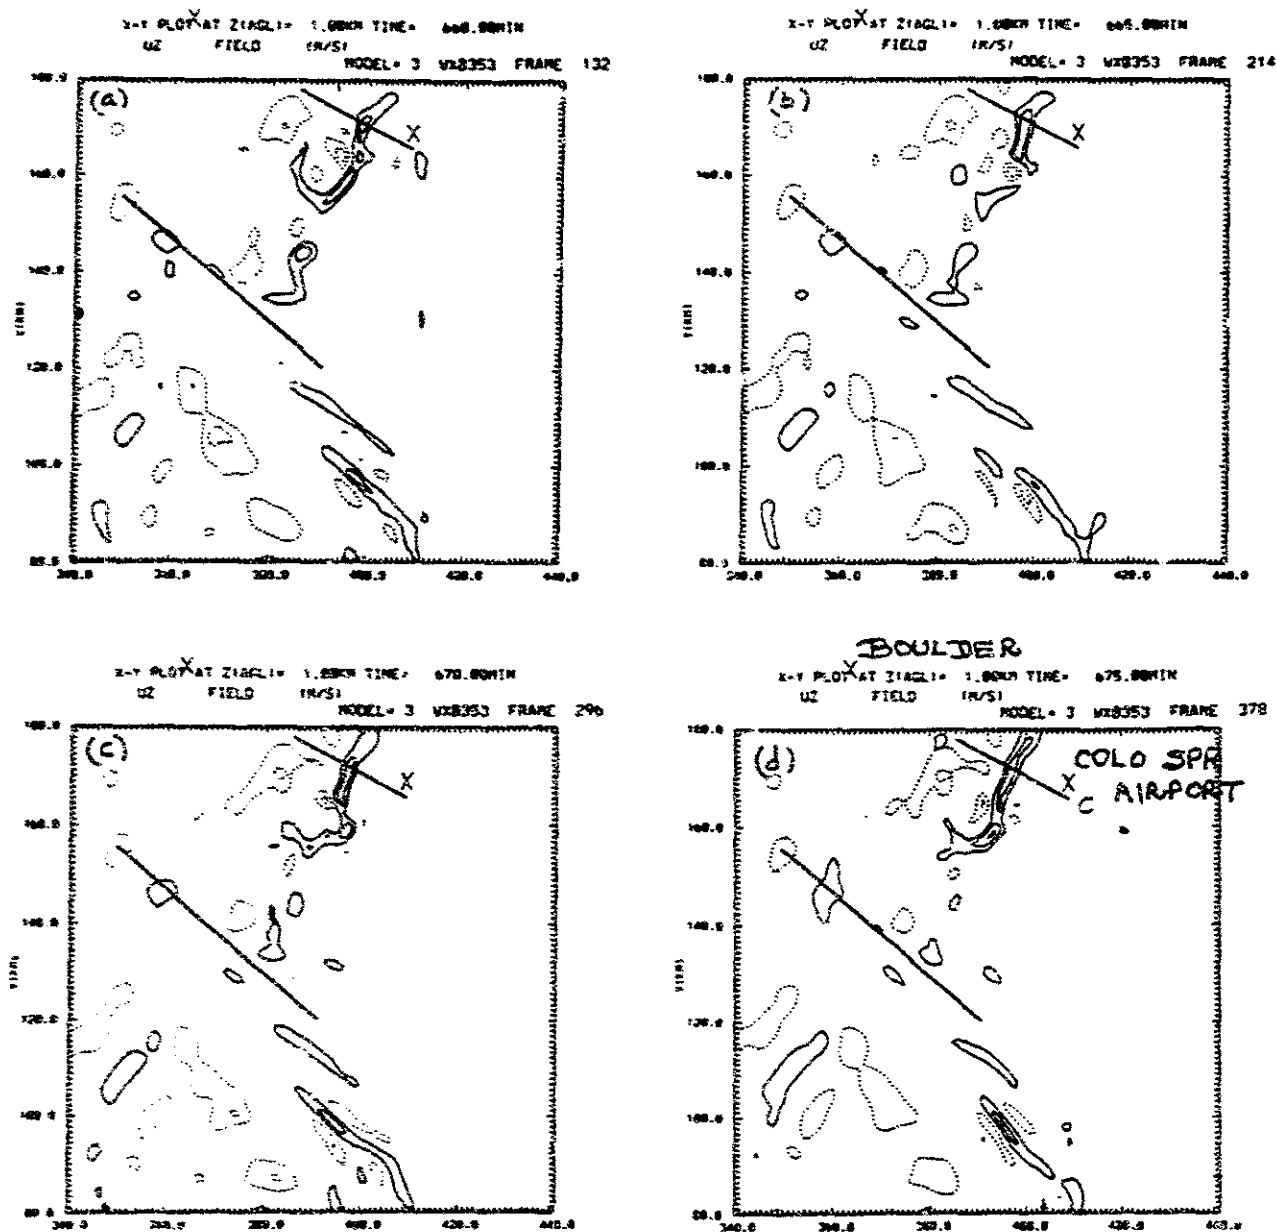
In the Colorado Springs area the jumps exhibit much more variability than along the Boulder region front range. As noted earlier the orography is highly structured in the Colorado Springs area and dominated by the presence of Pikes Peak and the Palmer divide. Fig. 4 shows w at 1 km AGL for the Colorado Springs subdomain (Fig. 1b) for four times spaced 5 minutes apart. The updraft associated

with the flow coming off the valley between Pikes Peak and the Palmer divide shows a fair amount of time variability in this figure. Fig. 5 shows vertical cross sections of w and θ for the heavy line marked C-D in Fig. 4. Once again we see that the width of the updraft (≈ 20 m/s amplitude in this case) is four grid points wide indicating poor model resolution. The θ field again shows a jumpy like nature to the air trajectories but not as clearly as in Fig. 3. We conclude from these results that the horizontal shears associated with these jumps are resolution-limited (the shear is forced by the model to be spread out over about 4 km) and are therefore about 10 m/s per km. We fully expect that higher resolution simulations would show much larger shear values since, when a model selects the narrowest scales it can resolve for its largest gradients, we usually find the gradients are even larger when we are able to use still higher resolutions.

Fig. 4 Horizontal cross sections of w at 1 km Above Ground Level (AGL) over the Colorado Springs region high-resolution domain. Four times are shown and are indicated on plots. The contour interval for w is 5 m/s where positive values are shown with solid and negative values with dashed contours. The crosses mark Boulder (outside the domain) and Colorado Springs airport in these plots.

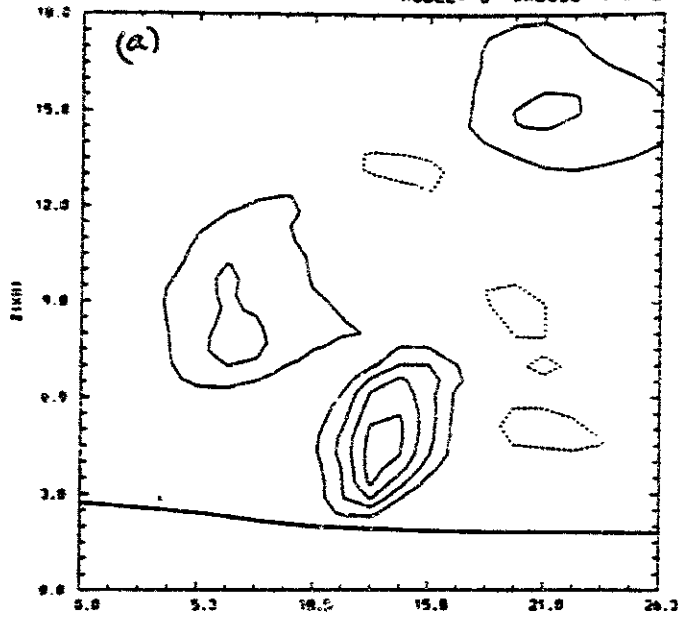
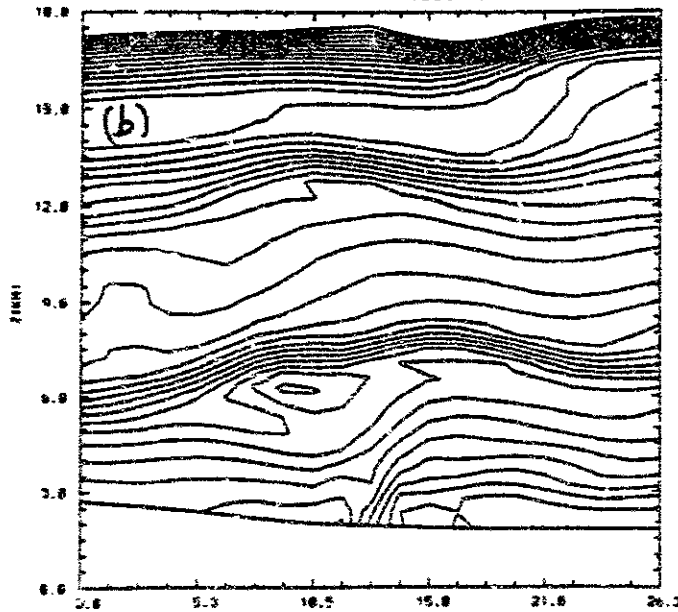
Fig. 5 Vertical cross sections of w and θ along line C-D shown in Fig. 4. The contour interval for w is 5 m/s and for θ is 3 degrees Kelvin. Both plots are for $t=675$ minutes.

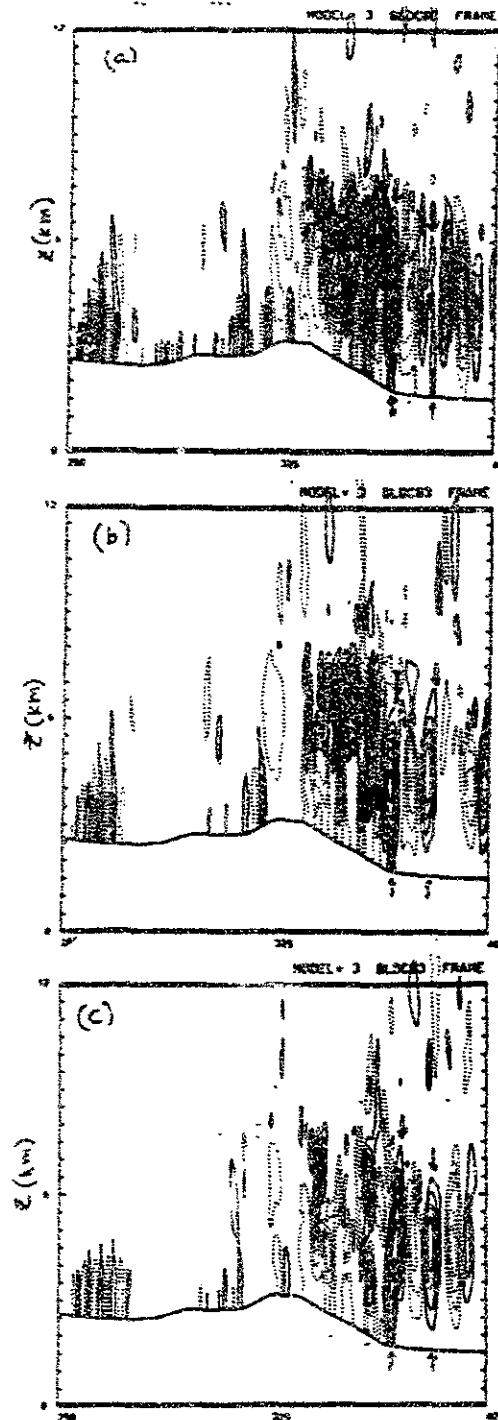
We have performed some idealized *two-dimensional* simulations of the 9 January case which show that at higher resolutions small-scale eddies are generated within the high-wind regions on the mountain slope and these eddies, containing very high velocities both in the horizontal and vertical which vary sharply over short distances, travel down the lee slope and out onto the plains. Some results of these experiments are shown in Fig. 6 which shows a train of updrafts and downdrafts in the lee of the mountain peak. Such eddies appear to be similar to those observed with lidar observations by Nieman et al. These idealized simulations, we believe, appear to be on the verge of resolving the truly transient eddies and traveling updrafts that are perhaps the most relevant to aircraft safety. However, because of the idealized nature of this experiment, it is unwise to attempt to extrapolate these results to the real situation.

Fig. 6 Vertical velocity patterns from a two-dimensional simulation of the 9 Jan 1989 event. The contour interval is 2 m/s with solid representing updrafts and dashed representing downdrafts. The two updrafts marked with arrows are moving out onto the plains at about 6.5 m/s. The horizontal resolution for this case is .833 km. Maximum horizontal shears are about 10 m/s per km.
