Accident

Aircraft Type and Registration:	Airbus A321-253NX, G-OATW
No & Type of Engines:	2 CFM International SA LEAP-1A33 turbofan engines
Year of Manufacture:	2020 (Serial no: 10238)
Date & Time (UTC):	4 October 2023 at 1151 hrs
Location:	London Stansted Airport
Type of Flight:	Commercial Air Transport (Passenger)
Persons on Board:	Crew - 11 Passengers - 9
Injuries:	Crew - None Passengers - None
Nature of Damage:	Damage to several cabin windows and impact damage to the left horizontal stabiliser
Commander's Licence:	Airline Transport Pilot's Licence
Commander's Age:	54 years
Commander's Flying Experience:	4,905 hours (of which 2,300 were on type) Last 90 days - 128 hours Last 28 days - 27 hours
Information Source:	AAIB Field Investigation

Synopsis

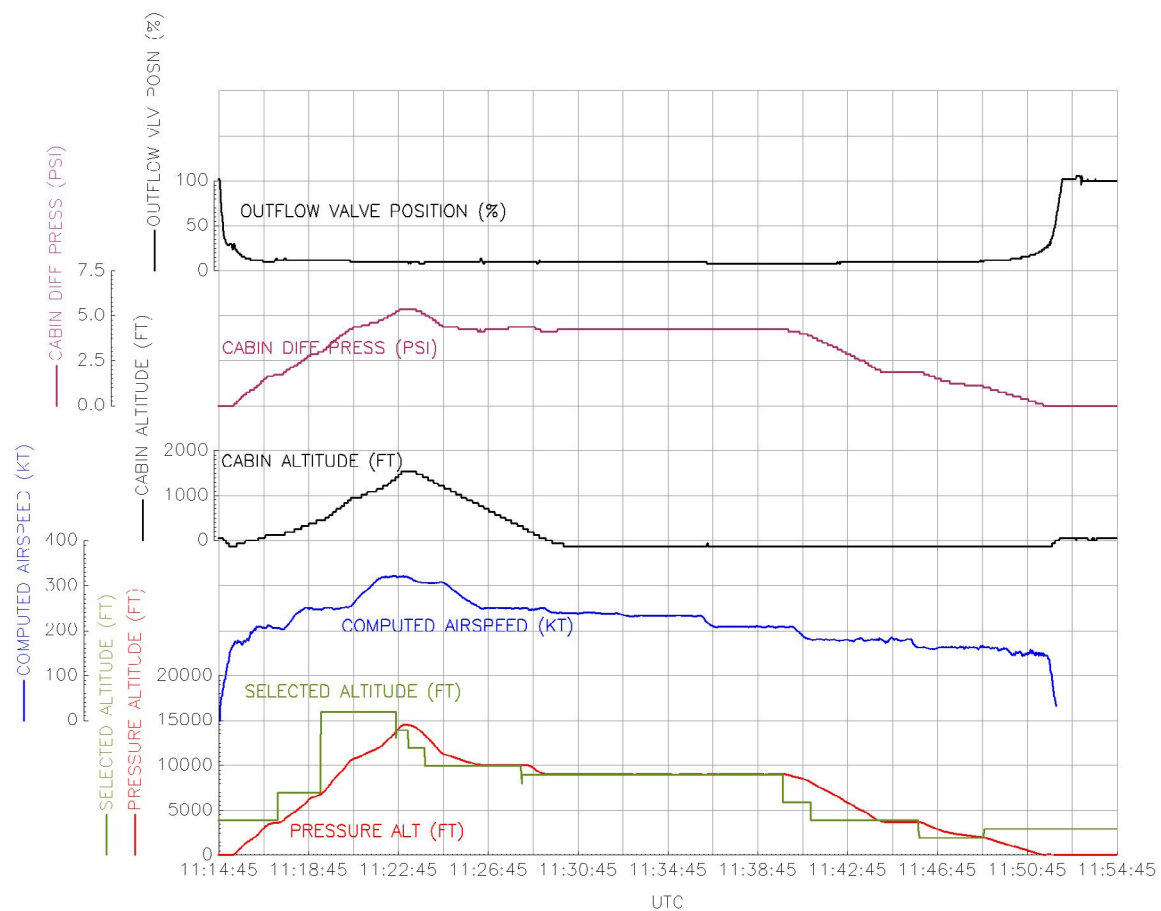
Figure 3
G-OATW FDR data

The aircraft took off from Stansted at 1115 hrs, climbing progressively to a maximum of 14,504 ft³ at 1123 hrs (Figure 3). The cabin altitude increased during this time, reaching a recorded maximum of 1,536 ft. The aircraft then descended to FL 100 initially, followed by a further descent to FL 90 while circling to the north-west of the airport. No pressurisation warnings were recorded during the flight, which landed back at Stansted Airport at 1151 hrs.
