Post-irradiation examination of a prototype tantalum-clad target for the Beam Dump Facility at CERN

The Beam Dump Facility (BDF) is a planned new fixed-target installation in CERN’s North Area that is expected to start operating by the end of the decade. A high-energy proton beam of 400 GeV/ c will be delivered in 1-s pulses of 4×10^{13} protons every 7.2 s, amounting to 4×10^{19} protons on target (PoT) per year and a resulting average thermal power deposition of 305 kW. The experiment requires high-Z and high-density target materials and involves challenging thermomechanical conditions; hence, a core made of refractory metals is proposed in conjunction with a water-cooling circuit. Since direct contact of water with the target materials—tungsten and a molybdenum-based alloy, TZM—would induce erosion and corrosion, the target blocks are clad with a tantalum alloy by means of hot isostatic pressing. To verify the reliability of the design and manufacturing process of the BDF target, a reduced-scale prototype target was manufactured and irradiated with an accumulated 2.4×10^{16} PoT in 2018. This paper presents the results and conclusions of the post-irradiation examination (PIE) c

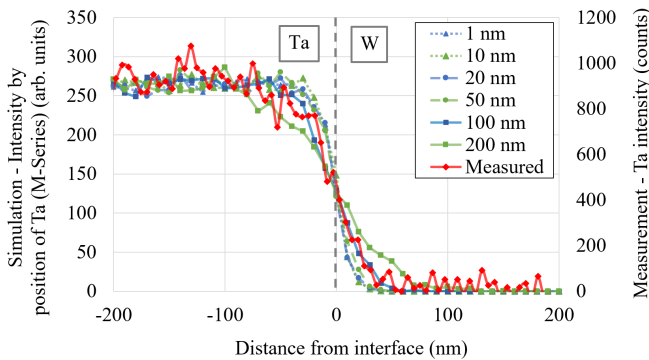
FIG. 12. Ta signal perpendicular to the interface measured by EDS mapping compared with the simulated Ta signals from electron beams of different diameters.

The diffusion bonding of BM1 (Ta/W) was determined by EDS mapping, which showed multiple Ta signals on the W side in the form of tips. The longest tips had a depth of 180 nm from the interface, while along the interface, the tips occurred at distances of 0.1–1.0 μm , similar to the size of the newly formed W grains at the interface. In addition, an EDS line scan was performed perpendicular to the interface, which revealed an S-shaped logistic function. Comparing the measured EDS signal of Ta with the simulation results showed a correlation with the 100-nm beam diameter (see Fig. 12). The expected electron-beam diameter of the machinery used was 10 nm, meaning that the beam diameter was ten times that predicted.
