BY MARK LACAGNINA

EMS Control Loss

Investigators were unable to determine why a loss of control occurred during an emergency medical services (EMS) flight the night of Dec. 14, 2004, in Apache Junction, Arizona, U.S. The final report by the U.S. National Transportation Safety Board (NTSB), issued in late April 2007, discussed four previous control system discrepancies encountered by pilots of the Eurocopter AS 350B3 and a phenomenon called “hydraulic servo transparency.”¹ However, the report contained no analysis of the findings of the investigation.

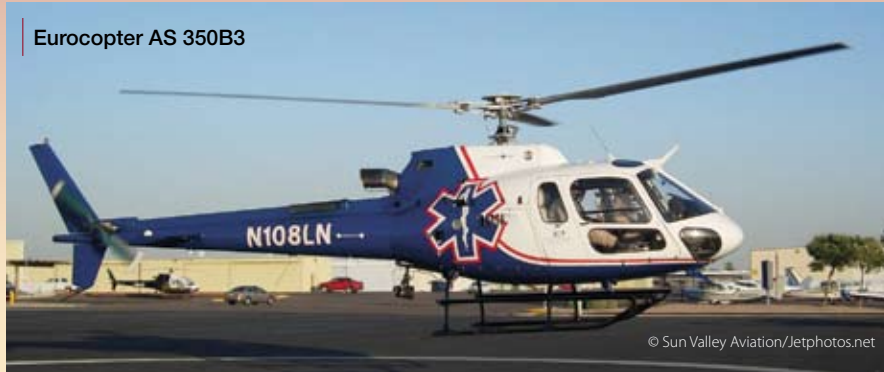
The report said that NTSB investigators discussed the hydraulic servo transparency phenomenon with Eurocopter engineers and flight test pilots. The phenomenon, also called “control reversibility,” can occur during maneuvers that result in increased loading on the helicopter and rotor system. The load thresholds vary according to helicopter speed and gross weight, and atmospheric density altitude.

“As explained by Eurocopter, when the helicopter reaches a threshold

G-loading for the phenomenon onset, the hydraulic system does not have enough pressure available to move the main left lateral, right lateral and fore/aft servos against the dynamic forces being fed back from the rotor system into the controls,” the report said. “At the onset of servo transparency, the flight controls essentially go from boosted to manual reversion, where they remain until the G-loads decrease below the onset threshold values.”
