STS-1 Orbiter Final Mission Report

August 1981

National Aeronautics and
Space Administration

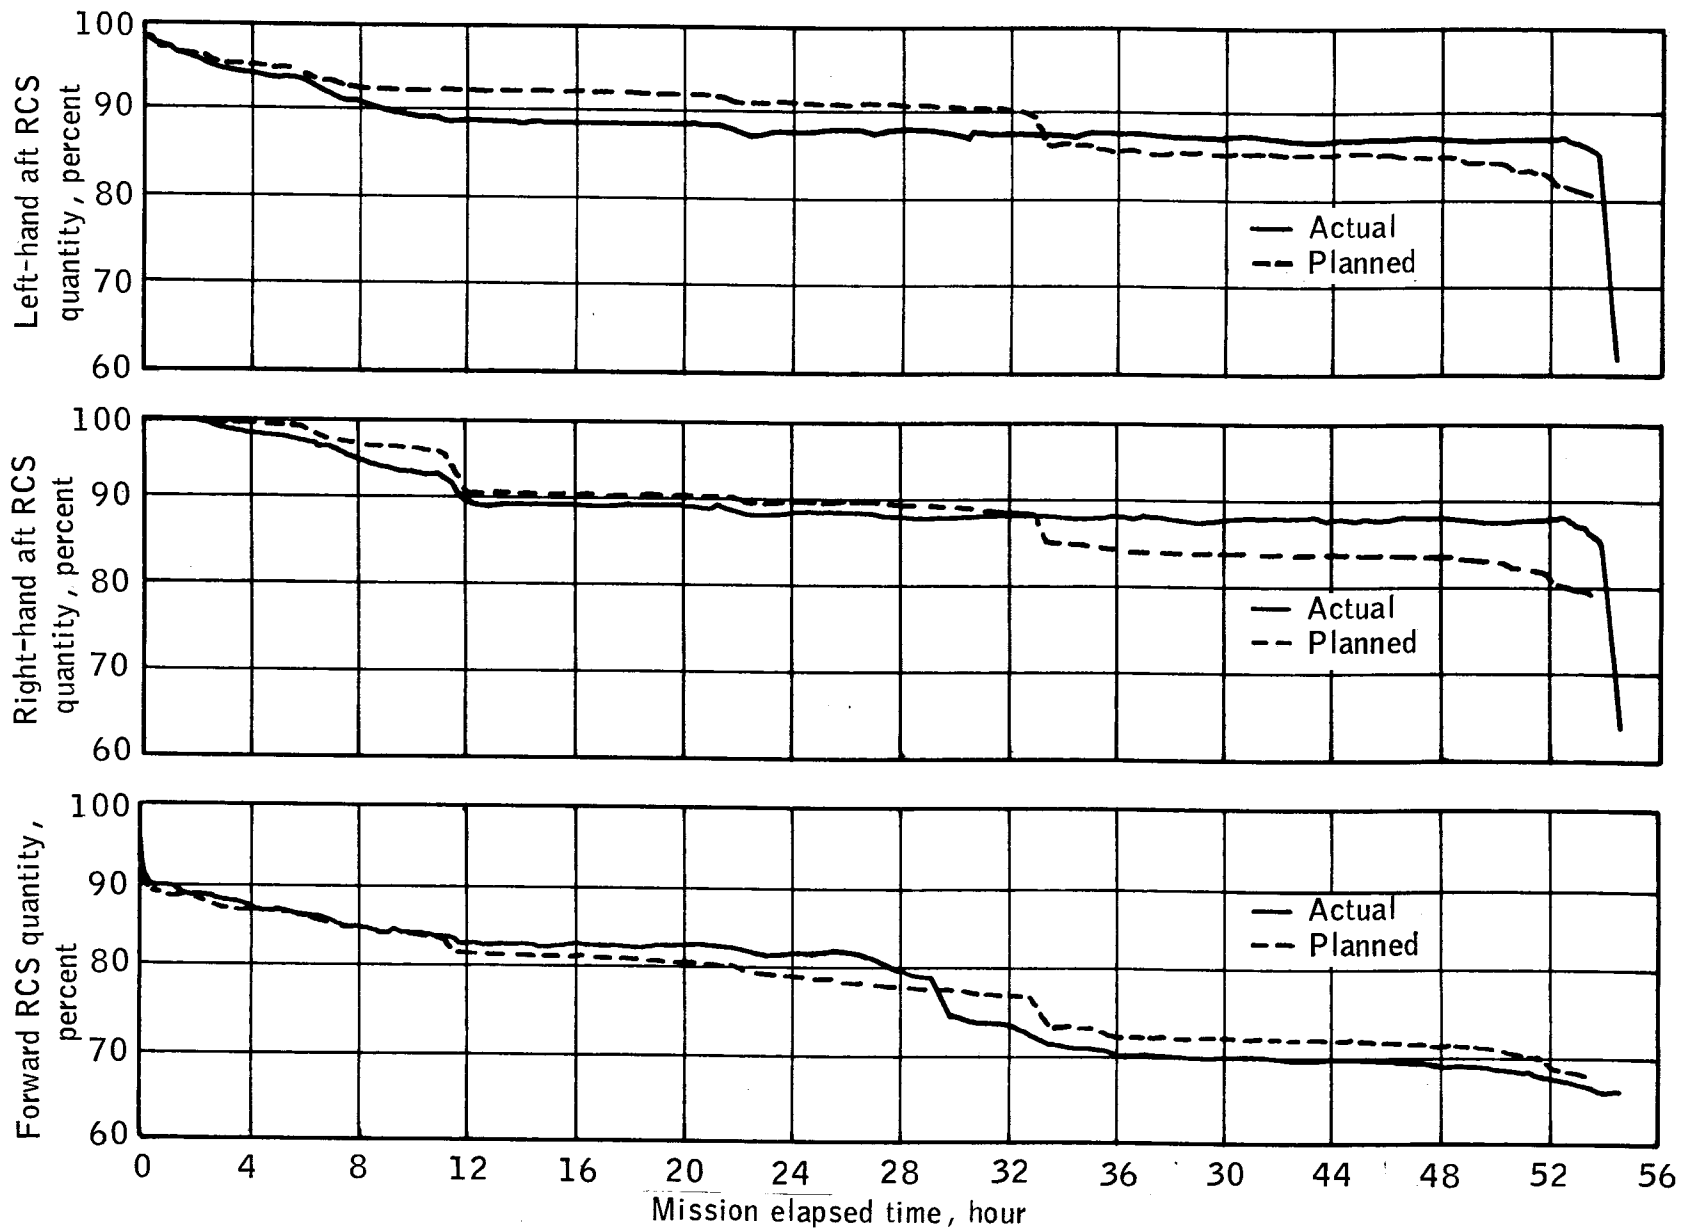
Figure 2-3.- RCS propellant remaining as a function of time during STS-1.

Propellant consumption from the RCS was close to preflight predictions, as illustrated by figure 2-3. A tabulation of propellant used from the RCS as a function of mission phase is shown in the following table.

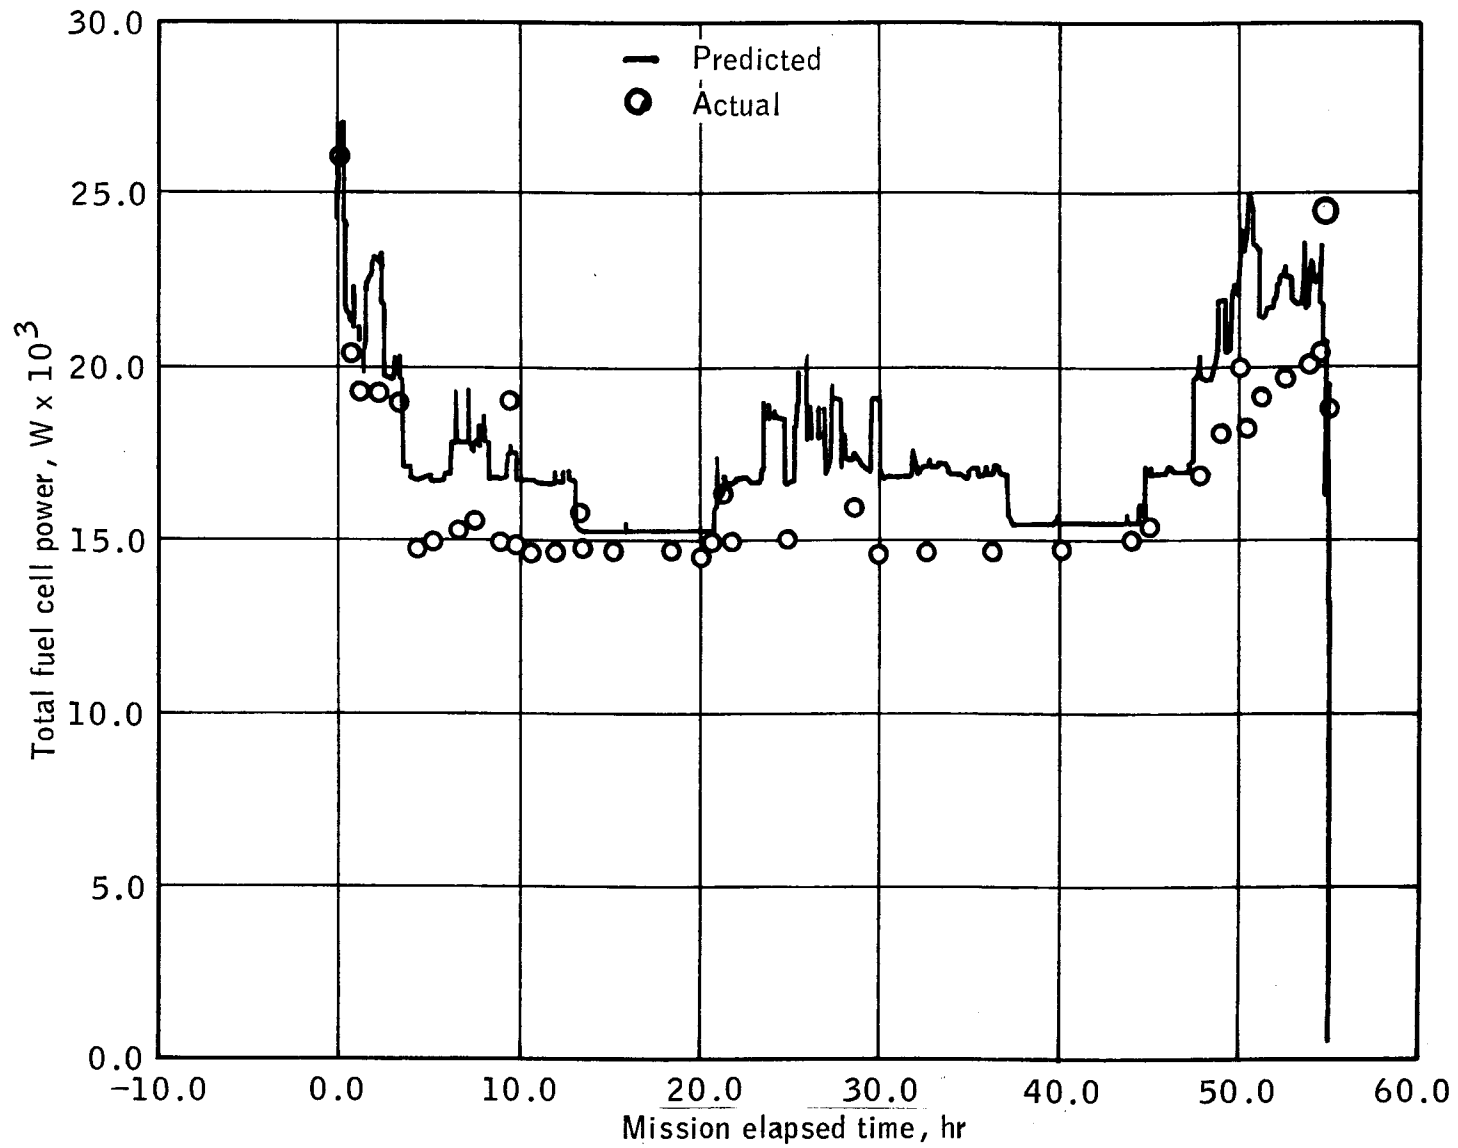
Figure 2-10.- Total fuel cell power during STS-1.

Fuel cell performance was normal for all ground and flight phases of the STS-1 mission. Preflight performance predictions used to develop flight power profiles and voltage margins as well as to establish launch commit criteria closely approximated the flight performance. The actual electrical loads experienced during the ascent, on-orbit, and entry phases of the flight were slightly lower than predicted, as shown in figure 2-10.

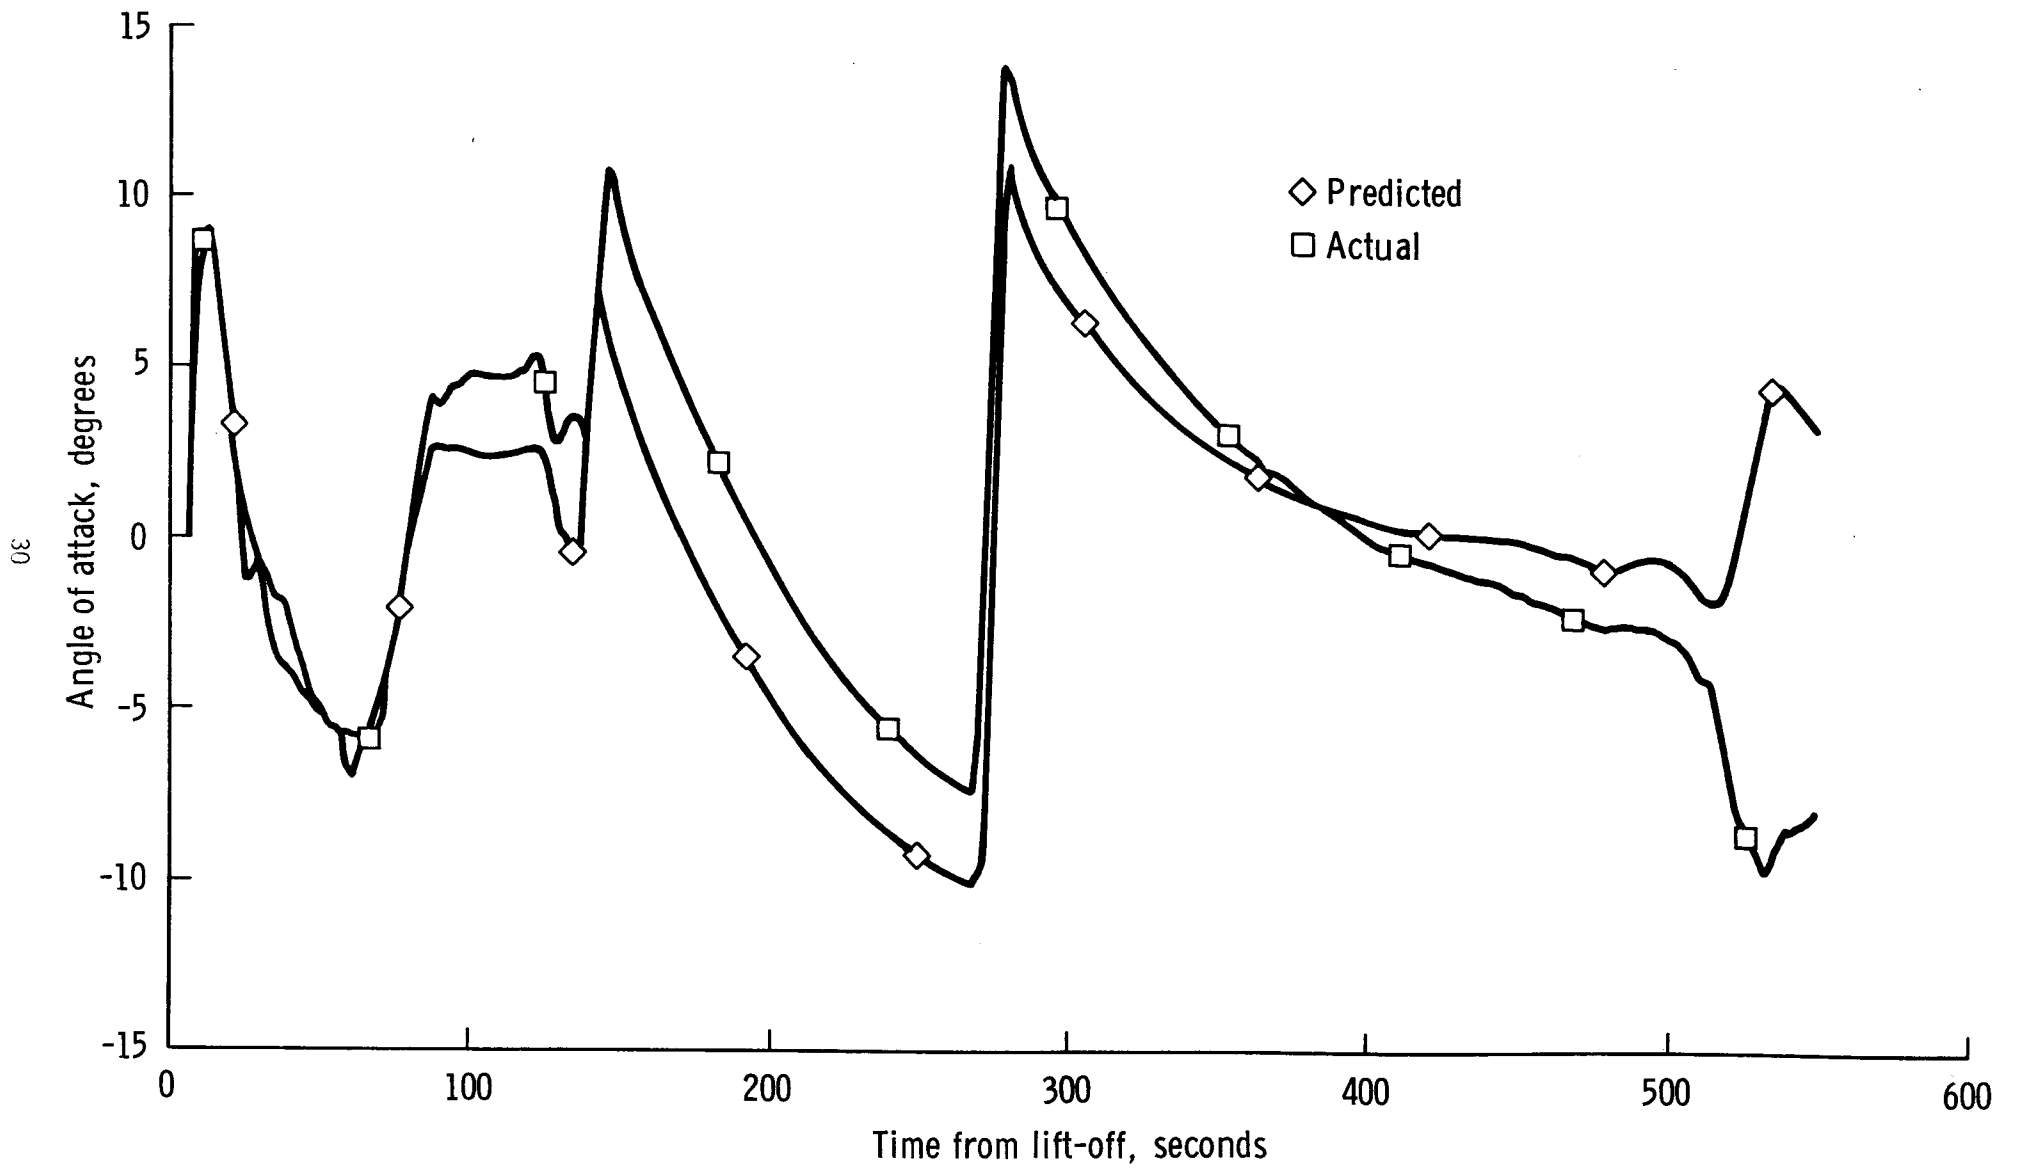
Figure 2-11. - Comparison of predicted and actual angle of attack for STS-1 launch phase.

Figure 2-11 presents a comparison of the navigation derived angle of attack for both the primary avionics software system (PASS) and the backup flight system (BFS) for STS-1 along with the preflight prediction. The fact that both PASS and BFS obtained identical solutions for this parameter provides excellent evidence that their navigated states were synchronized, and since the software requirements were implemented independently, this also provides evidence that the navigation subsystem was performing normally. The difference between the preflight predicted and actual flight angle of attack is attributable to the trajectory lofting that occurred during the first stage. The fuel optimal powered explicit guidance (PEG) allowed the altitude rate error to be nulled by gravity, while thrust acceleration was being used more efficiently to accumulate downrange velocity.

The flight data show that the ascent guidance, navigation, and control performed in a normal manner. One minor area of concern is the lofting problem (Section 8.0, integrated problem I-1). Another minor area of concern is the fact that the initial attitude error and rate in the pitch axis was not as small at lift-off as expected. The initial attitude error and rate were due to the swaying motion that occurs between main engine ignition and lift-off. A study is in progress to determine if this transient requires any corrective action.

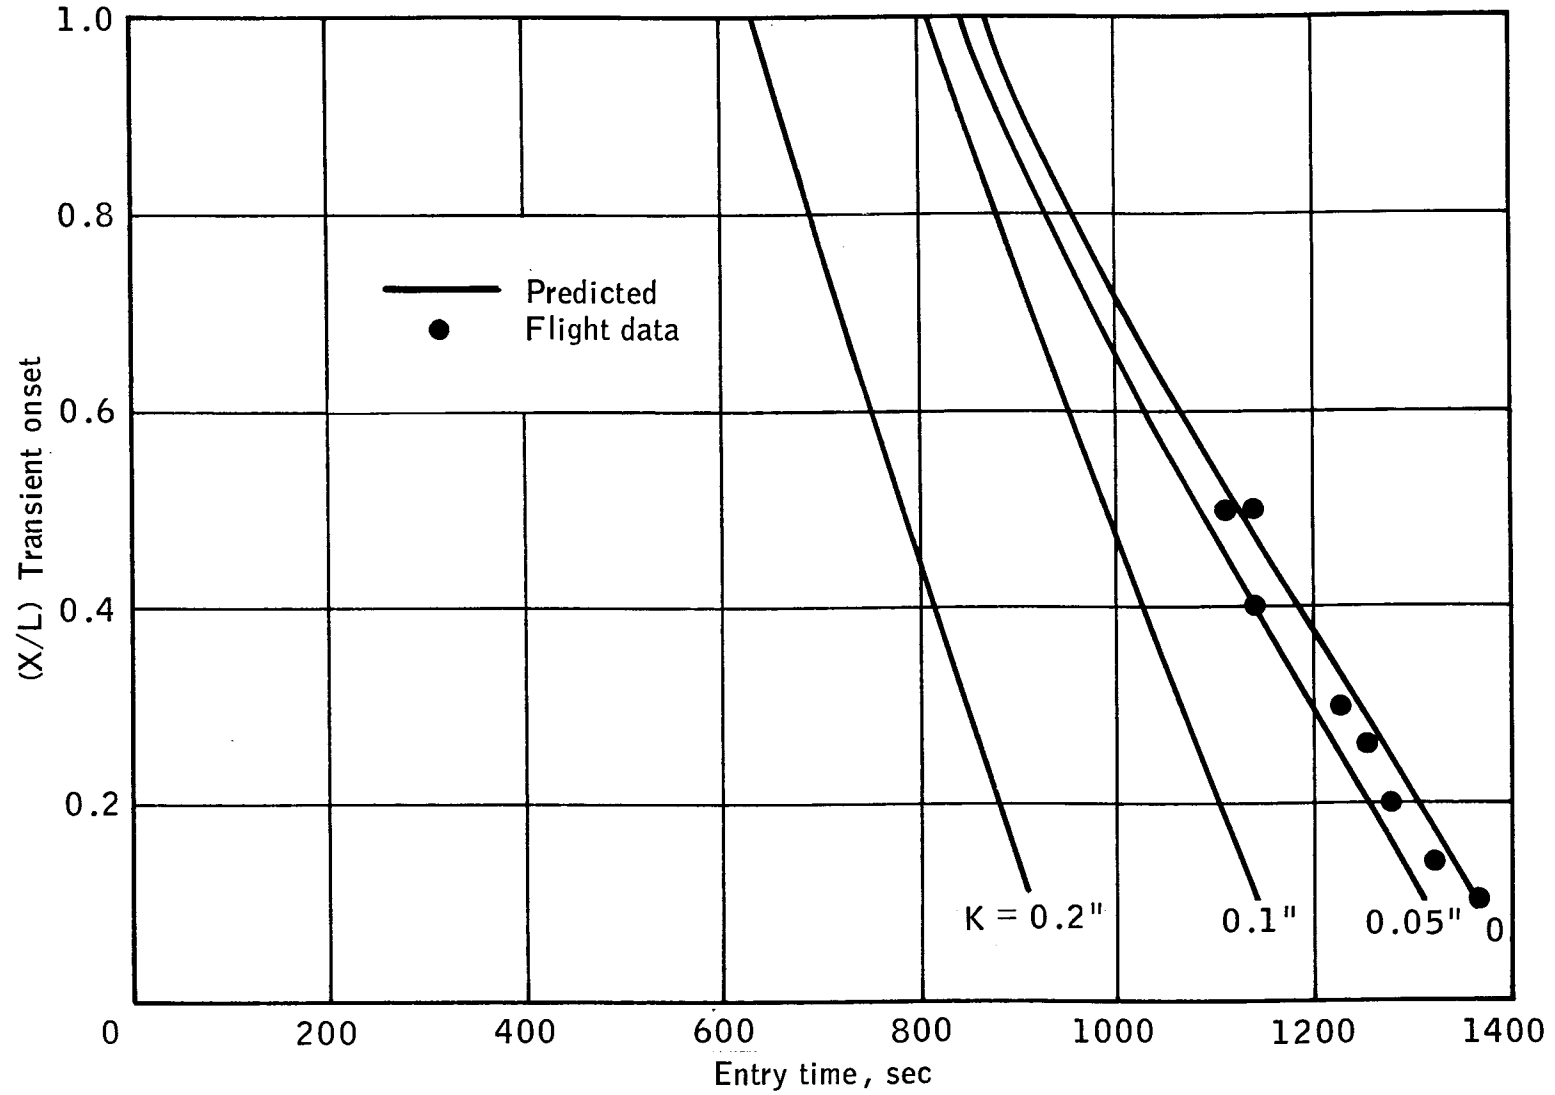
Figure 2-29.- TPS roughness effect on STS-1 boundary layer transition times

criterion predictions (figure 2-29). The higher velocity data are required to evaluate the aft fuselage boundary-layer environment. These data will allow a larger roughness criterion to be imposed on the installation of the Orbiter TPS. The data agreed with the turbulent predictions and with the laminar predictions lowered by 20 percent.

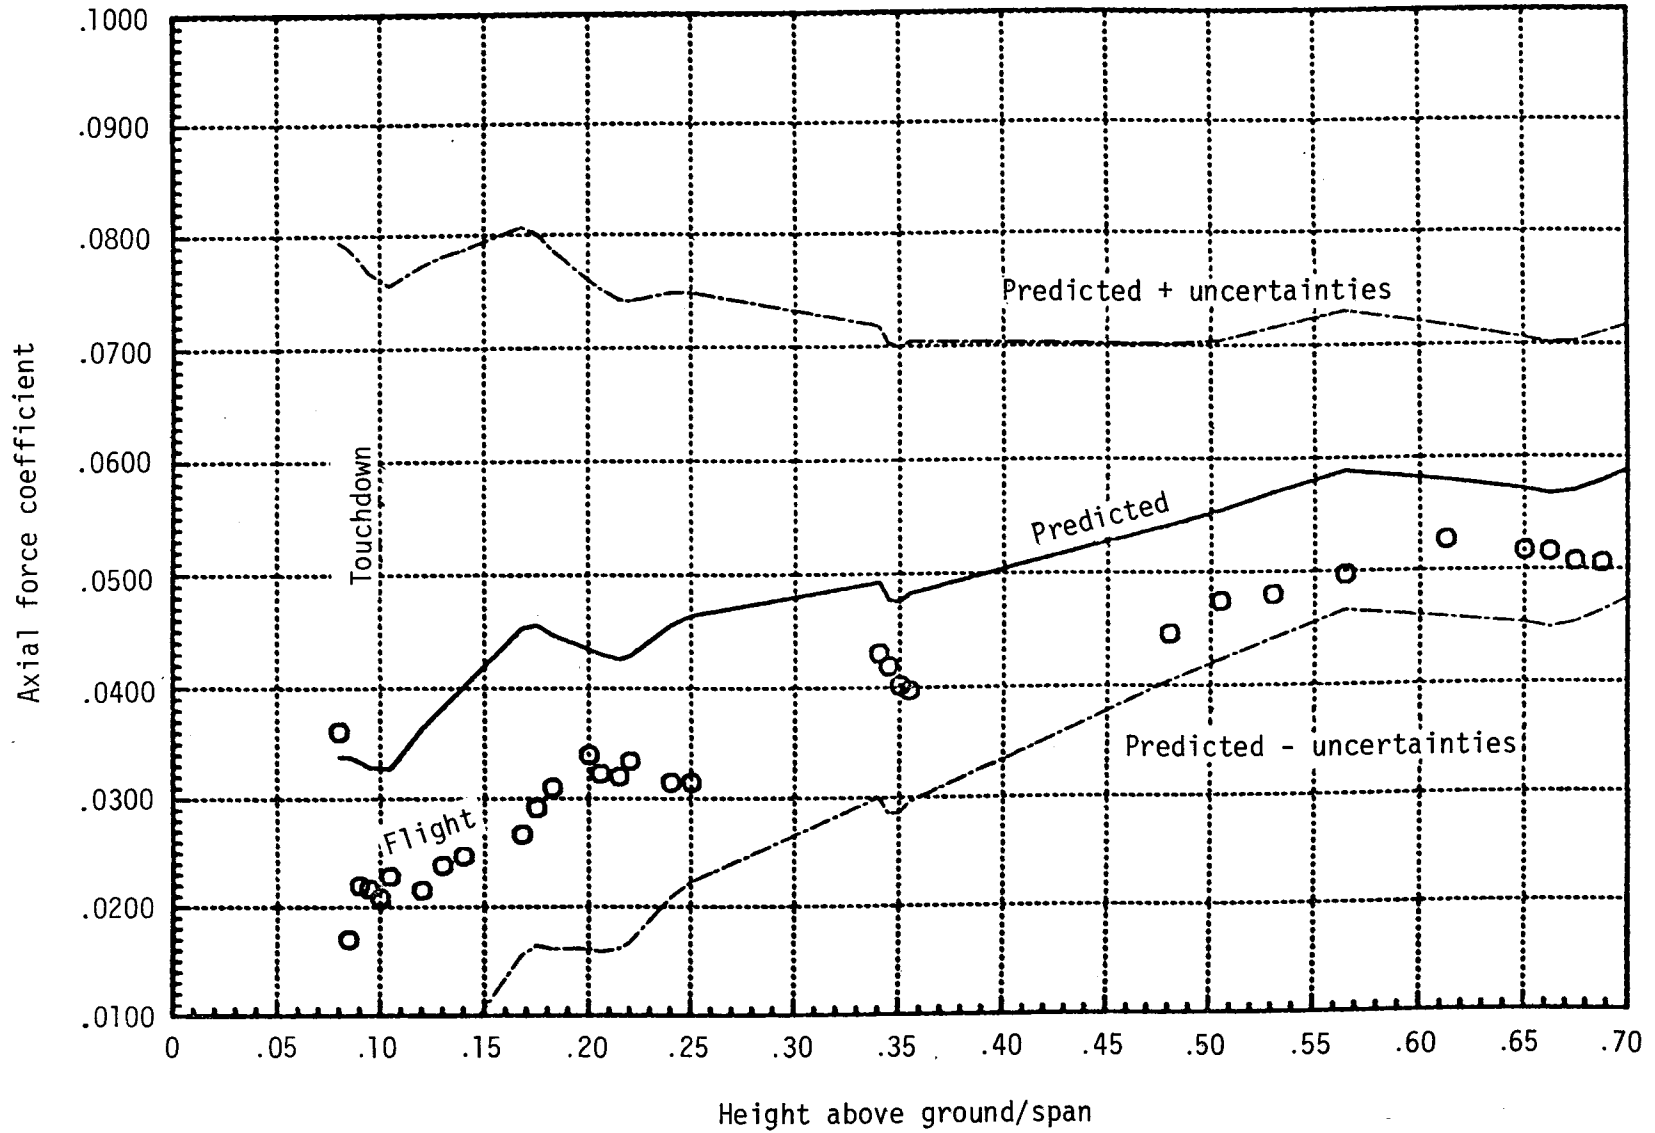
Figure 2-31.- Lower than predicted axial force coefficient during landing.

2.9.2.1 Performance and Trim. - Comparisons of the predicted lift-to-drag (L/D) ratio and the predicted \pm uncertainties data with the calculated STS-1 L/D ratio are shown in figure 2-30. There was no discernable difference between the predicted and actual calculated values down the last 100 ft before touchdown. At that point, ground effects occurred which caused the L/D to be higher than predicted. This difference was traced to the axial force coefficient that was lower than predicted (fig. 2-31).

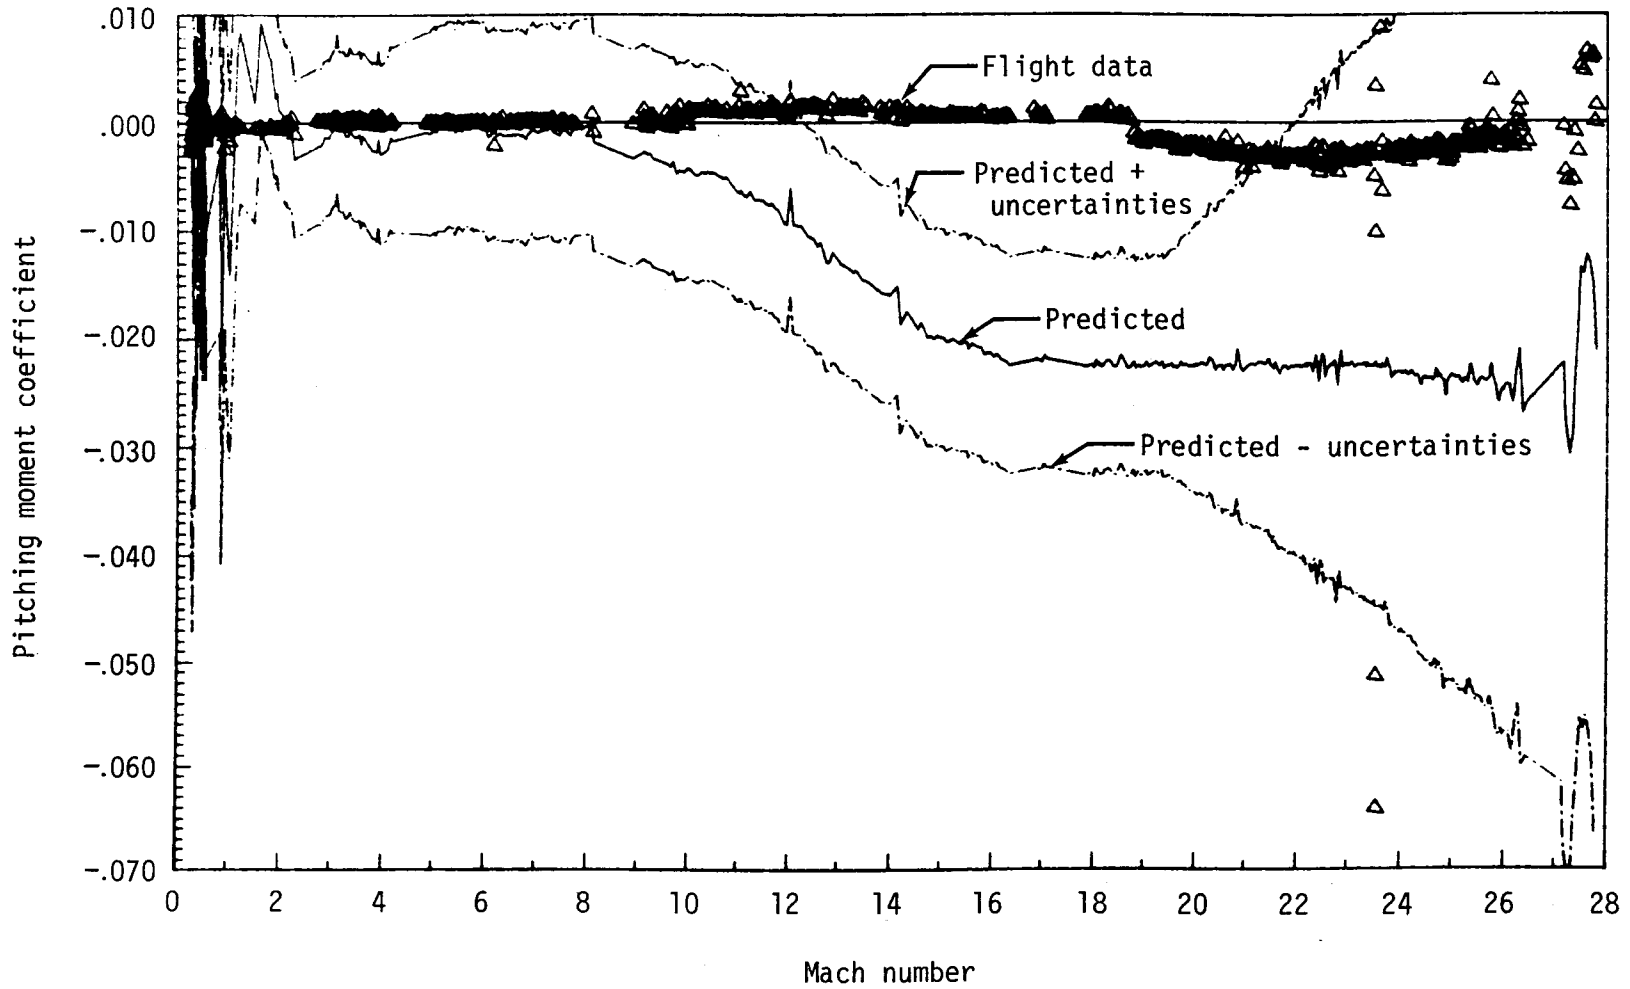
Figure 2-32.- Pitching moment coefficient during entry phase.

The body flap functioned as predicted except at the higher Mach numbers (28 to 8) where the body flap was down 7 degrees further than predicted. Between Mach 21 and 12, the pitching moment coefficient flight values fall outside the predicted and uncertainties bank (fig. 2-32) (Section 8.0, flight test problem report 39). Below Mach 8, the pitching moment coefficient followed the predicted value.

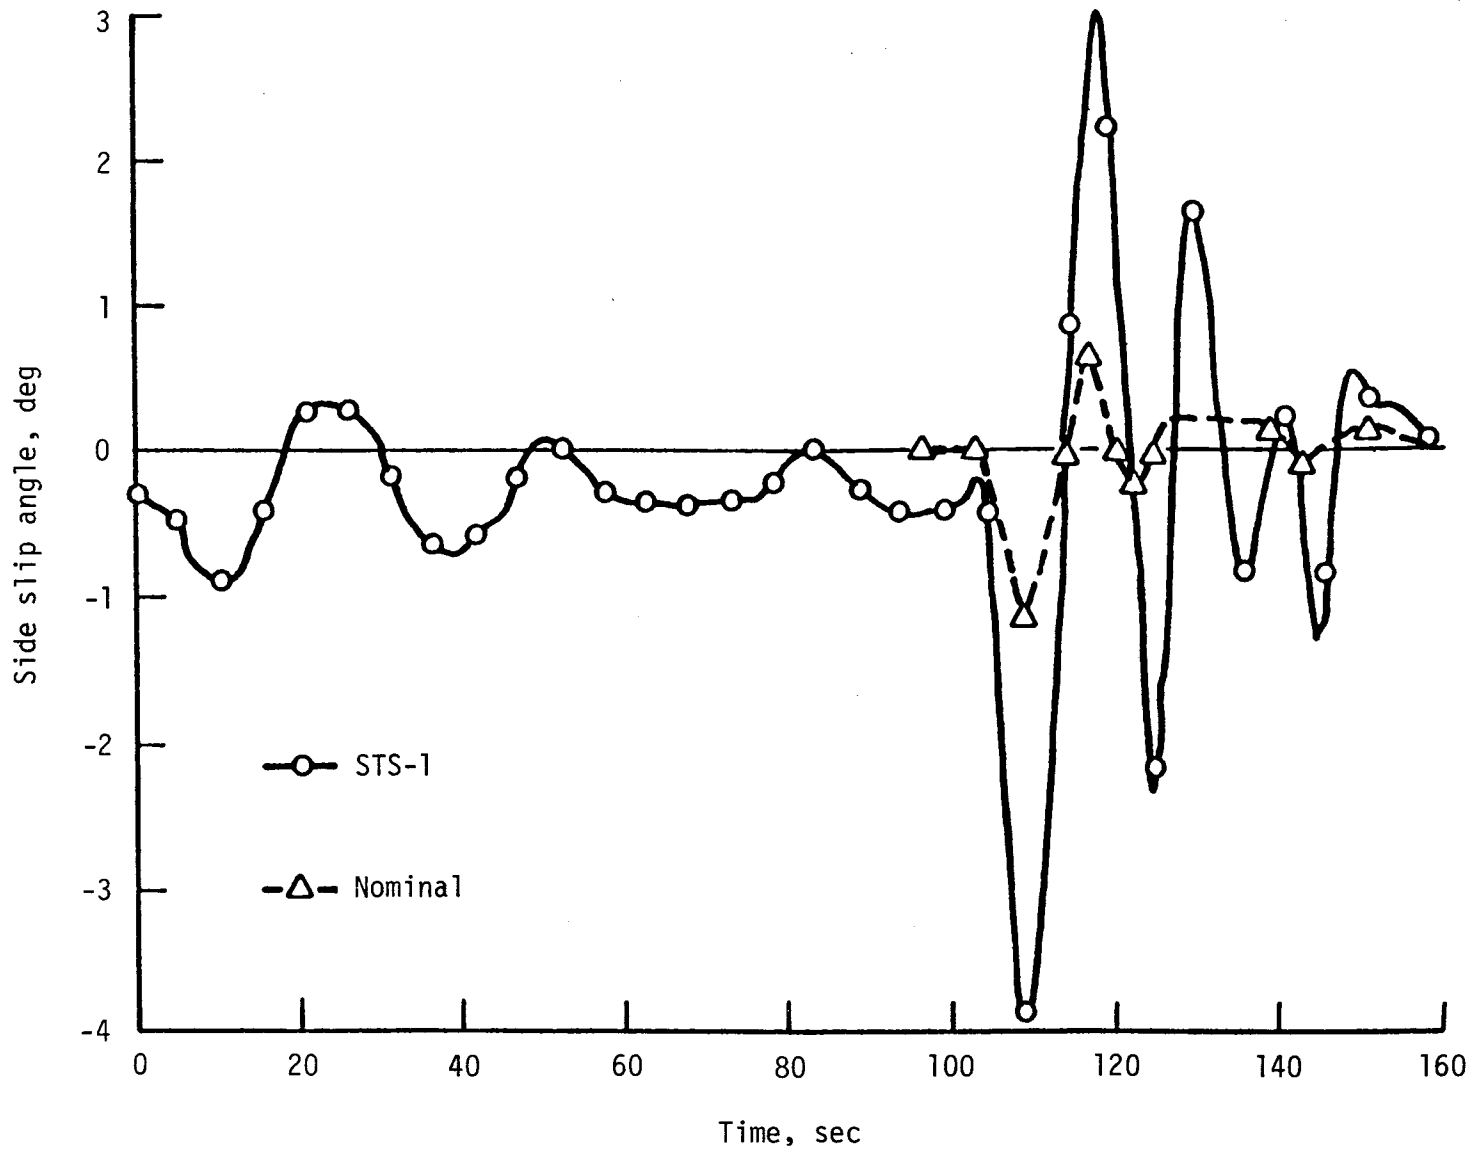
Figure 2-33.- Oscillations from first bank reversal.

2.9.2.2 Bank Reversals. - The initial bank reversal was performed at a dynamic pressure of 14 lb/ft. This reversal created several cycles of lightly damped motion that resulted in peak beta values of 4 degrees (fig. 2-33). Analysis and motion matching studies have shown that this discrepancy resulted from the rolling moment from the yaw thrusters. The predictions had this roll moment included, but at a higher level (fig. 2-34).

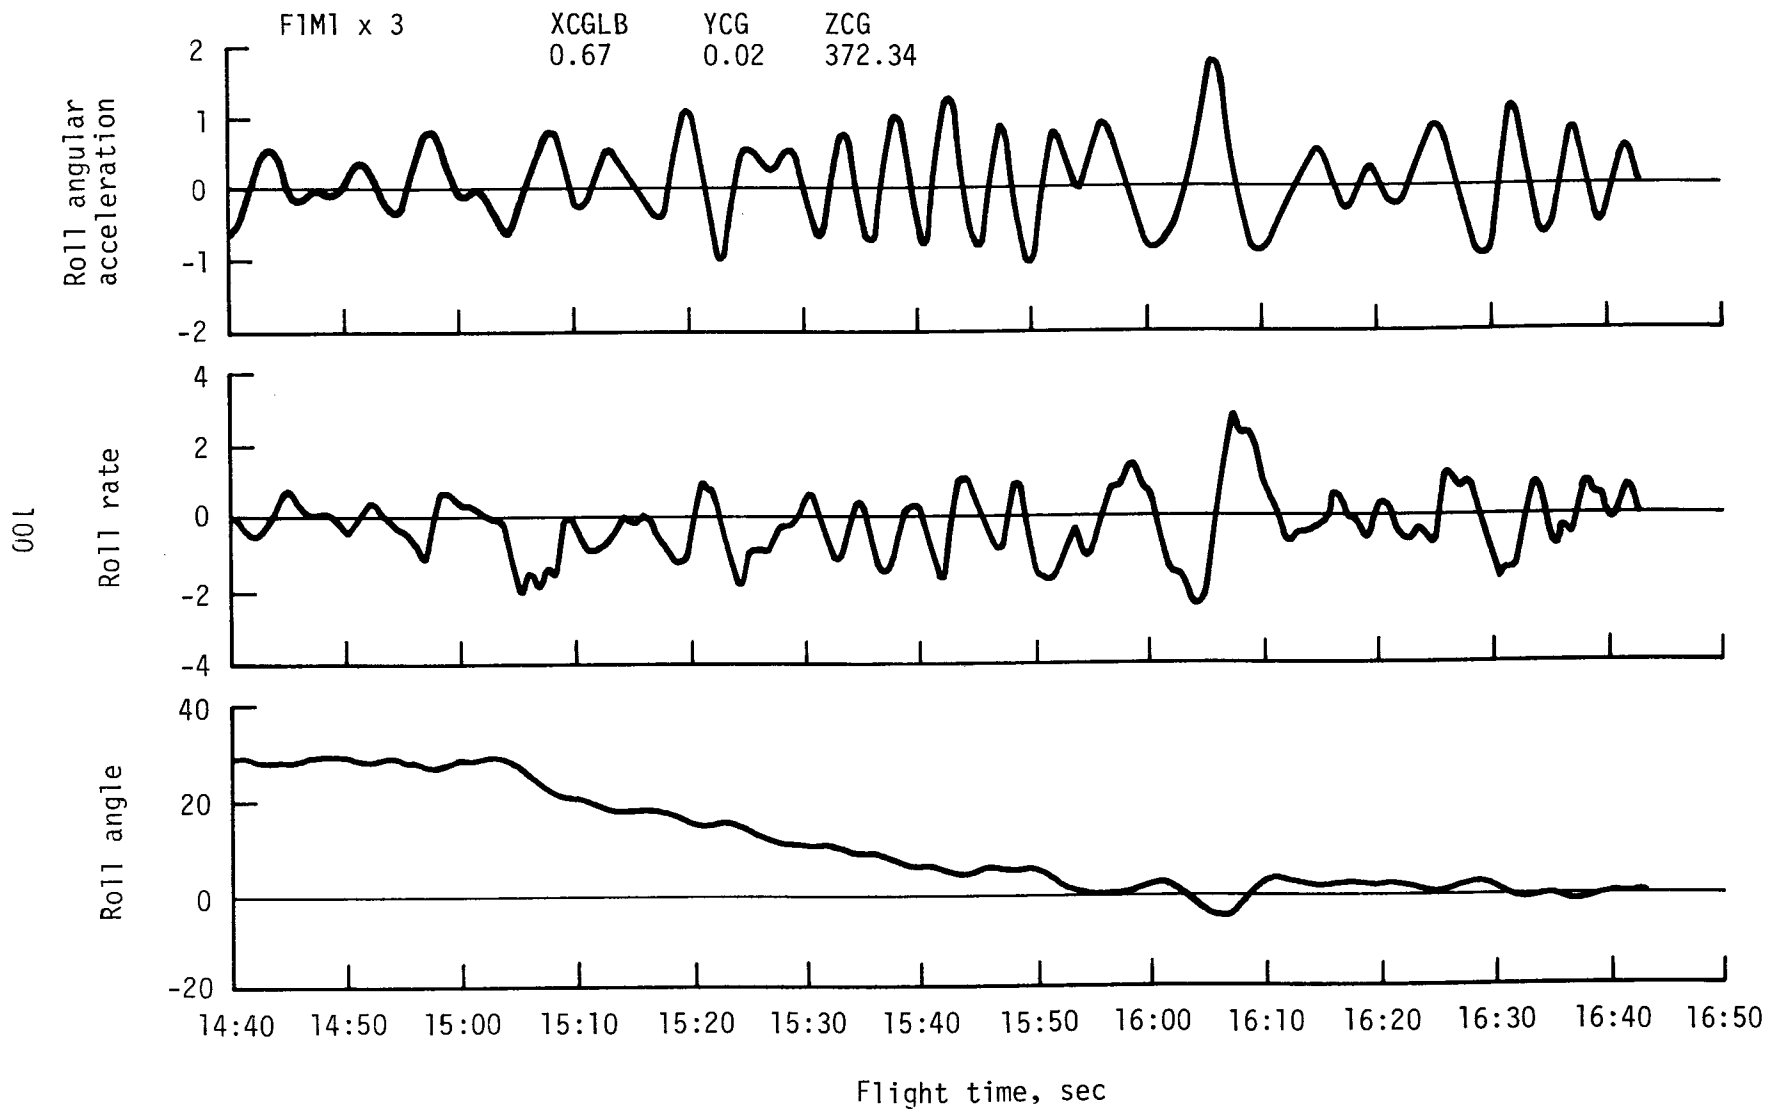
Figure 2-37.- Transonic undamped low frequency oscillations.

2.9.2.3 Transonic Oscillation. - Figure 2-37 shows an undamped low frequency oscillation that was apparent during the Mach 2 to Mach 1 region. Motion matching studies using optimization programs were attempted, but repeatable stability and control derivatives could not be obtained. Consequently, specially designed maneuvers will be conducted and STS-2 to more clearly identify the coefficients.

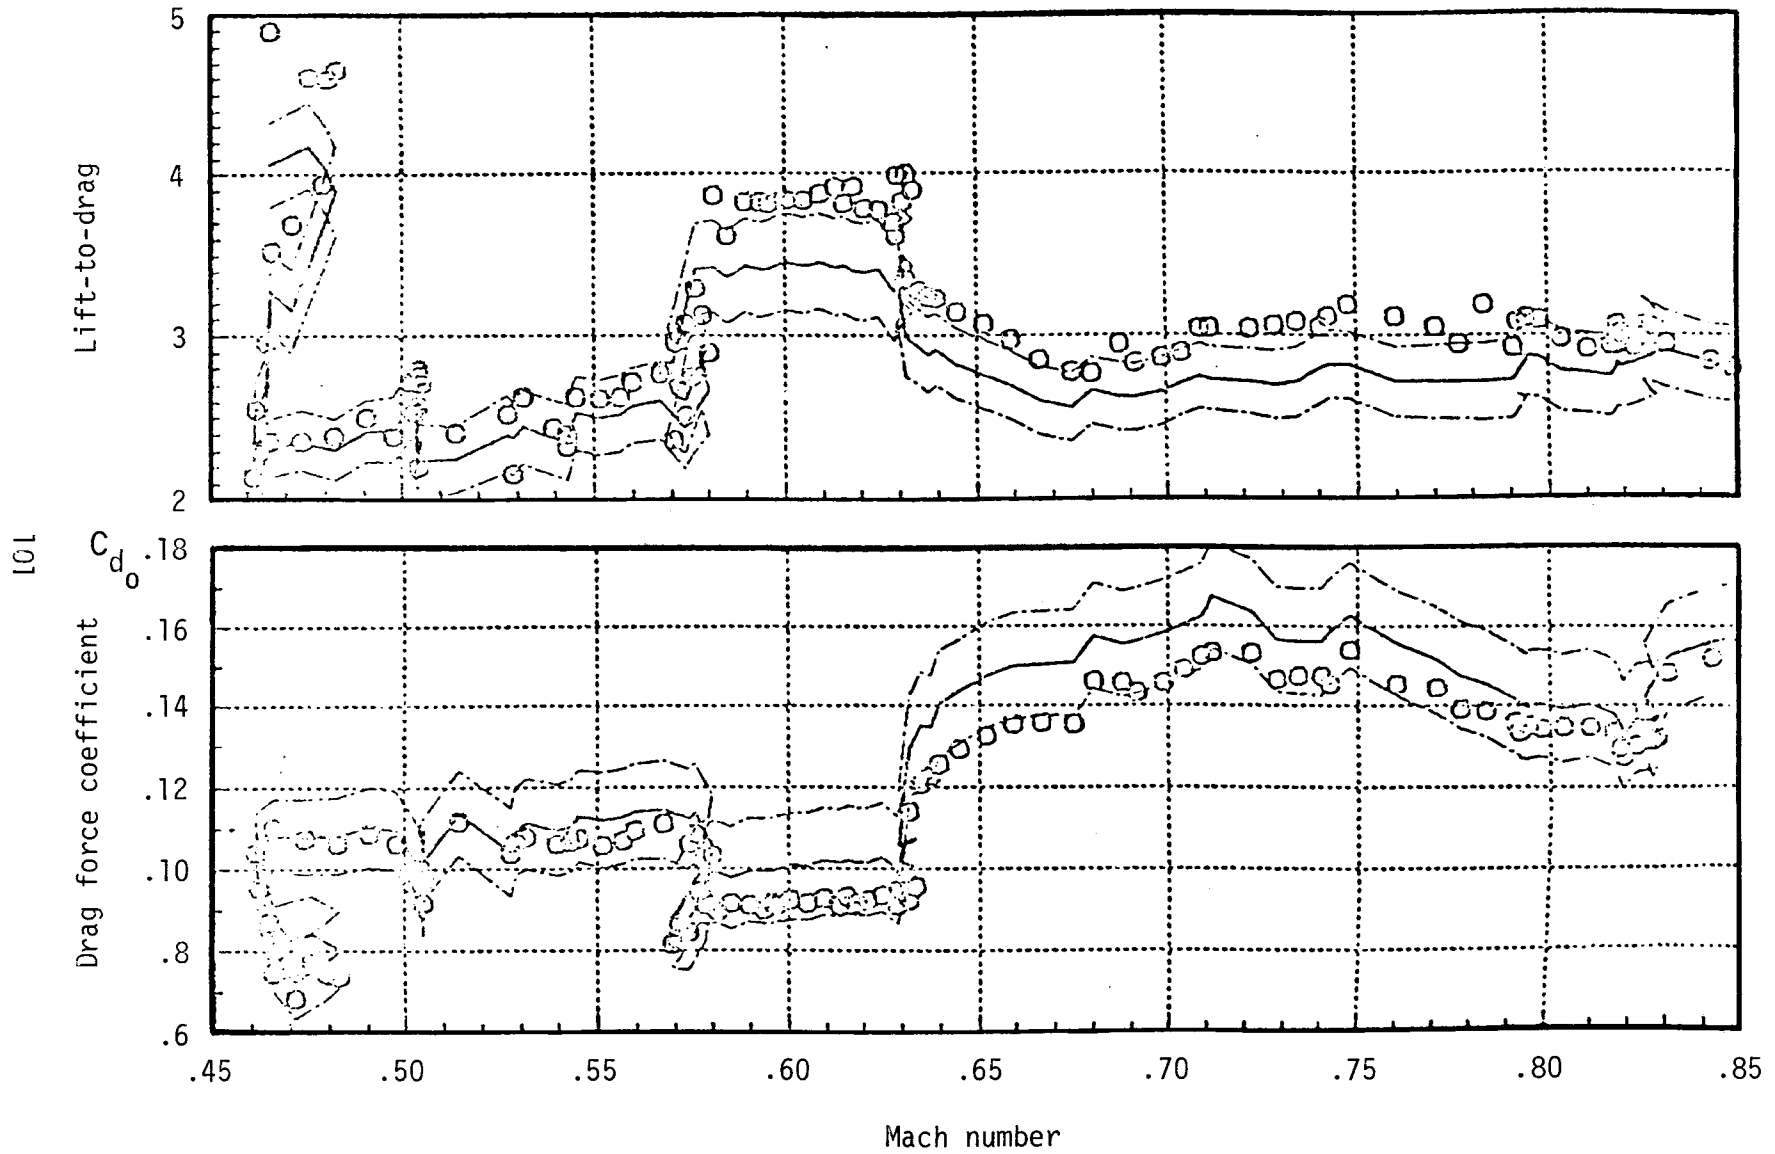
2.9.2.4 Approach and Landing. - An evaluation of the aerodynamics during the approach and landing phase showed differences from the preflight predictions in both the drag force coefficient (fig. 2-38) and the speedbrake drag (fig. 2-39). The difference along with the increased L/D discussed previously, contributed approximately 1000 ft of the 3200 ft landing point overshoot.

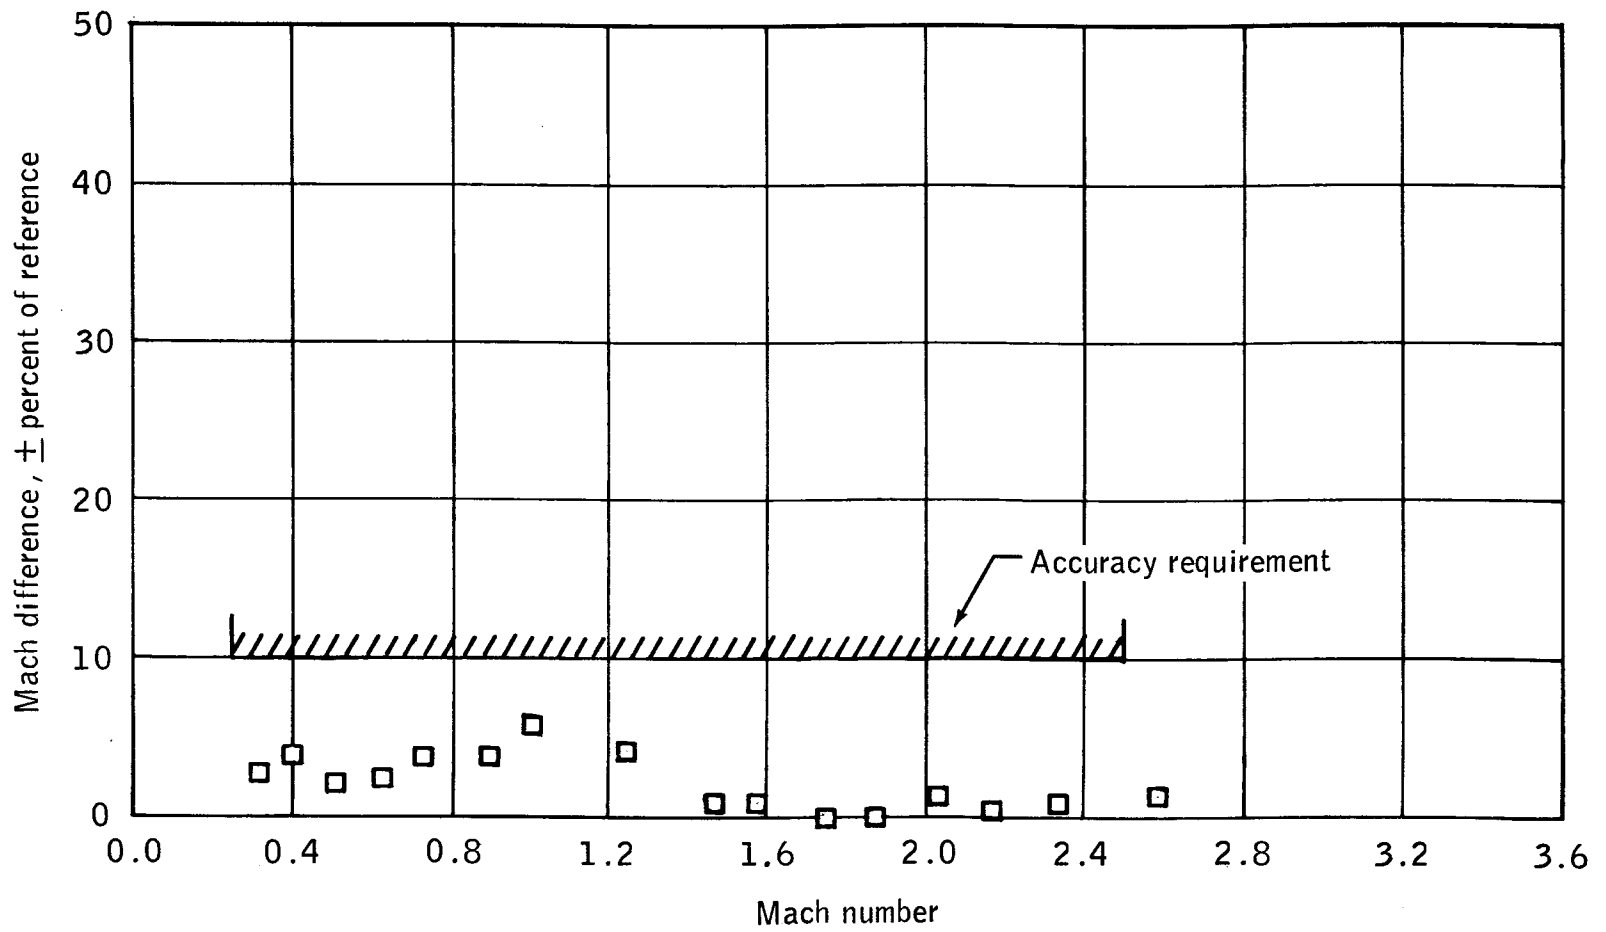
Figure 2-40.- Quick-look analysis of air data system accuracy for mach number.

A preliminary analysis to determine whether the calibrations provided air data that satisfied operational accuracy requirements has been performed. This analysis used onboard velocities and landing site touchdown +5 hour atmospheric data to develop reference air data which are then compared to the side probe data. The difference is compared to operational accuracy requirements. The results of this analysis are presented in figures 2-40 through 2-43, where comparisons for Mach number, angle-of-attack, dynamic pressure, and velocity are made. On the basis of these comparisons, the conclusion is that the air data probe wind tunnel calibrations provided air data parameters within operational accuracy requirements.

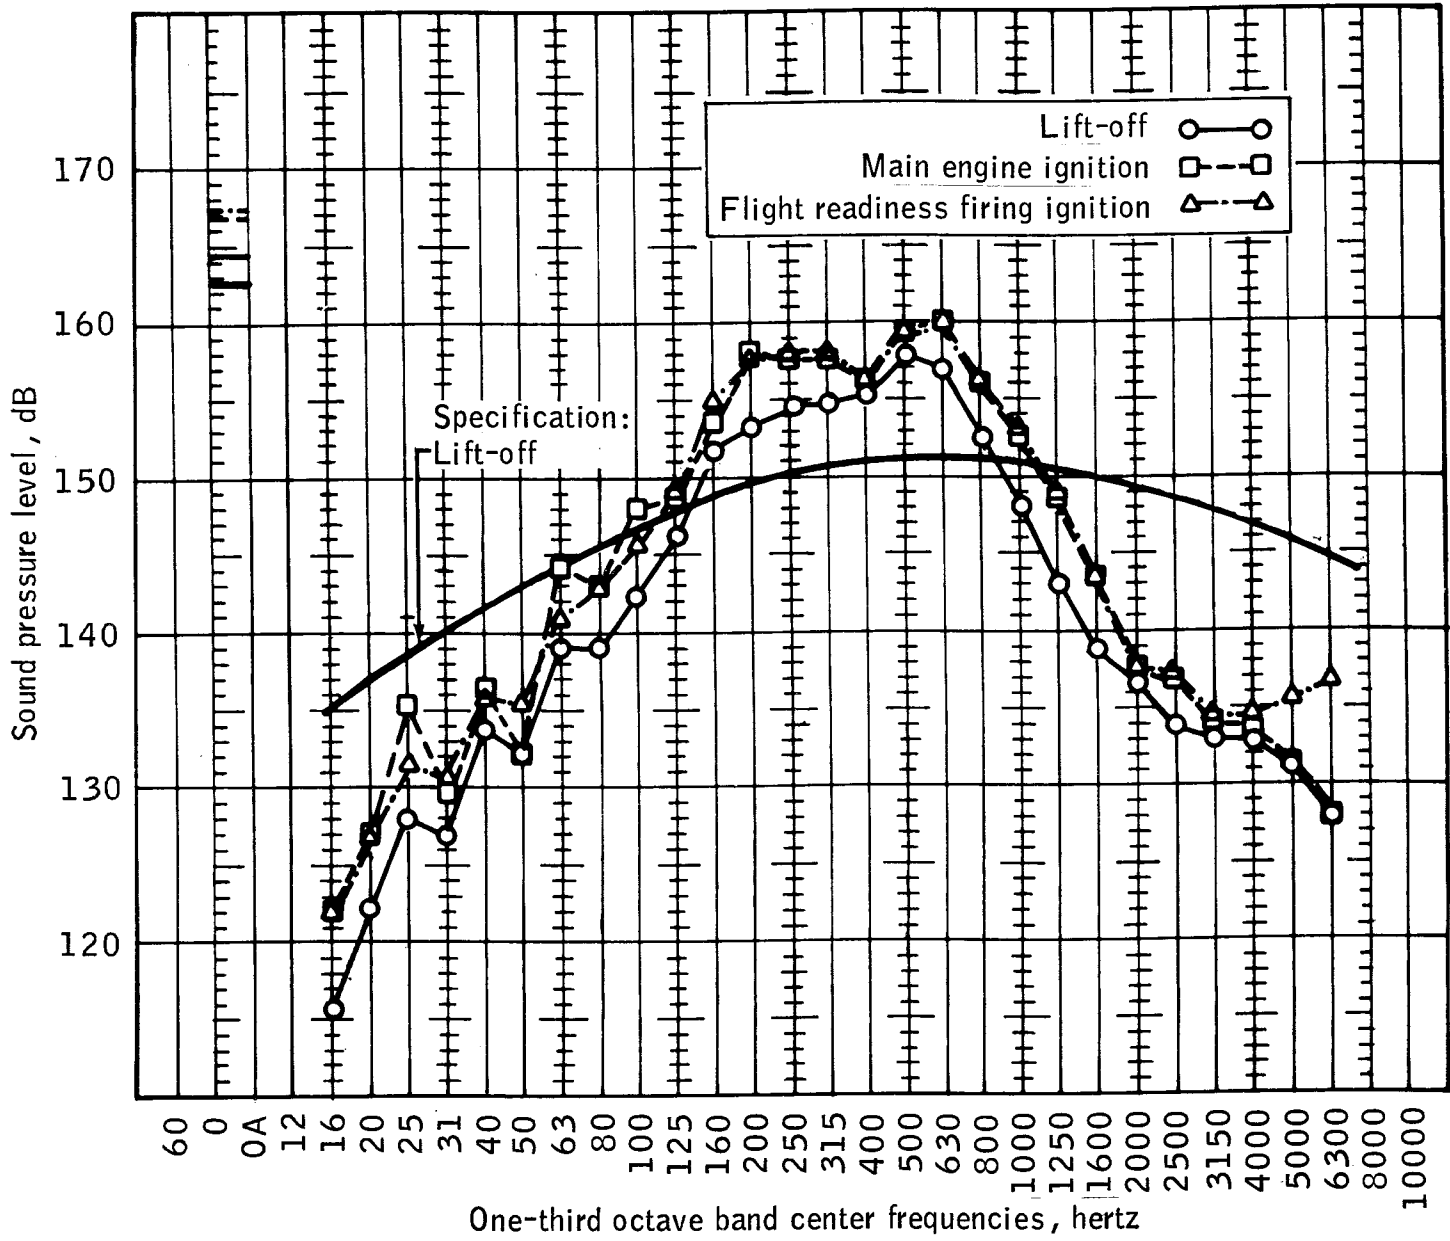
Figure 3-1.- Comparison of launch phase. Noise level at the tip of the vertical tail.

Acoustical data measured on the Orbiter active transducers were reviewed for compliance with the design specification criteria. Data were reviewed for the time period from main engine start through the supersonic phase of ascent and for the entry phase of maximum dynamic pressure. The measured data were within specification with the exception of two areas; i.e., the top of the body flap and the tip of the vertical tail. These two areas were also above specification during the flight readiness firing. Figures 3-1 and 3-2 show a comparison of the noise levels measured for these two areas during STS-1 lift-off and during the flight readiness firing. After the firing and prior to STS-1, a detailed evaluation of the structure and the thermal protection system (TPS) loading in these areas showed no constraints for STS-1, and since the STS-1 and flight readiness firing levels are about the same, no constraints apply to STS-2.
