STS-1 Orbiter Final Mission Report

August 1981

National Aeronautics and
Space Administration

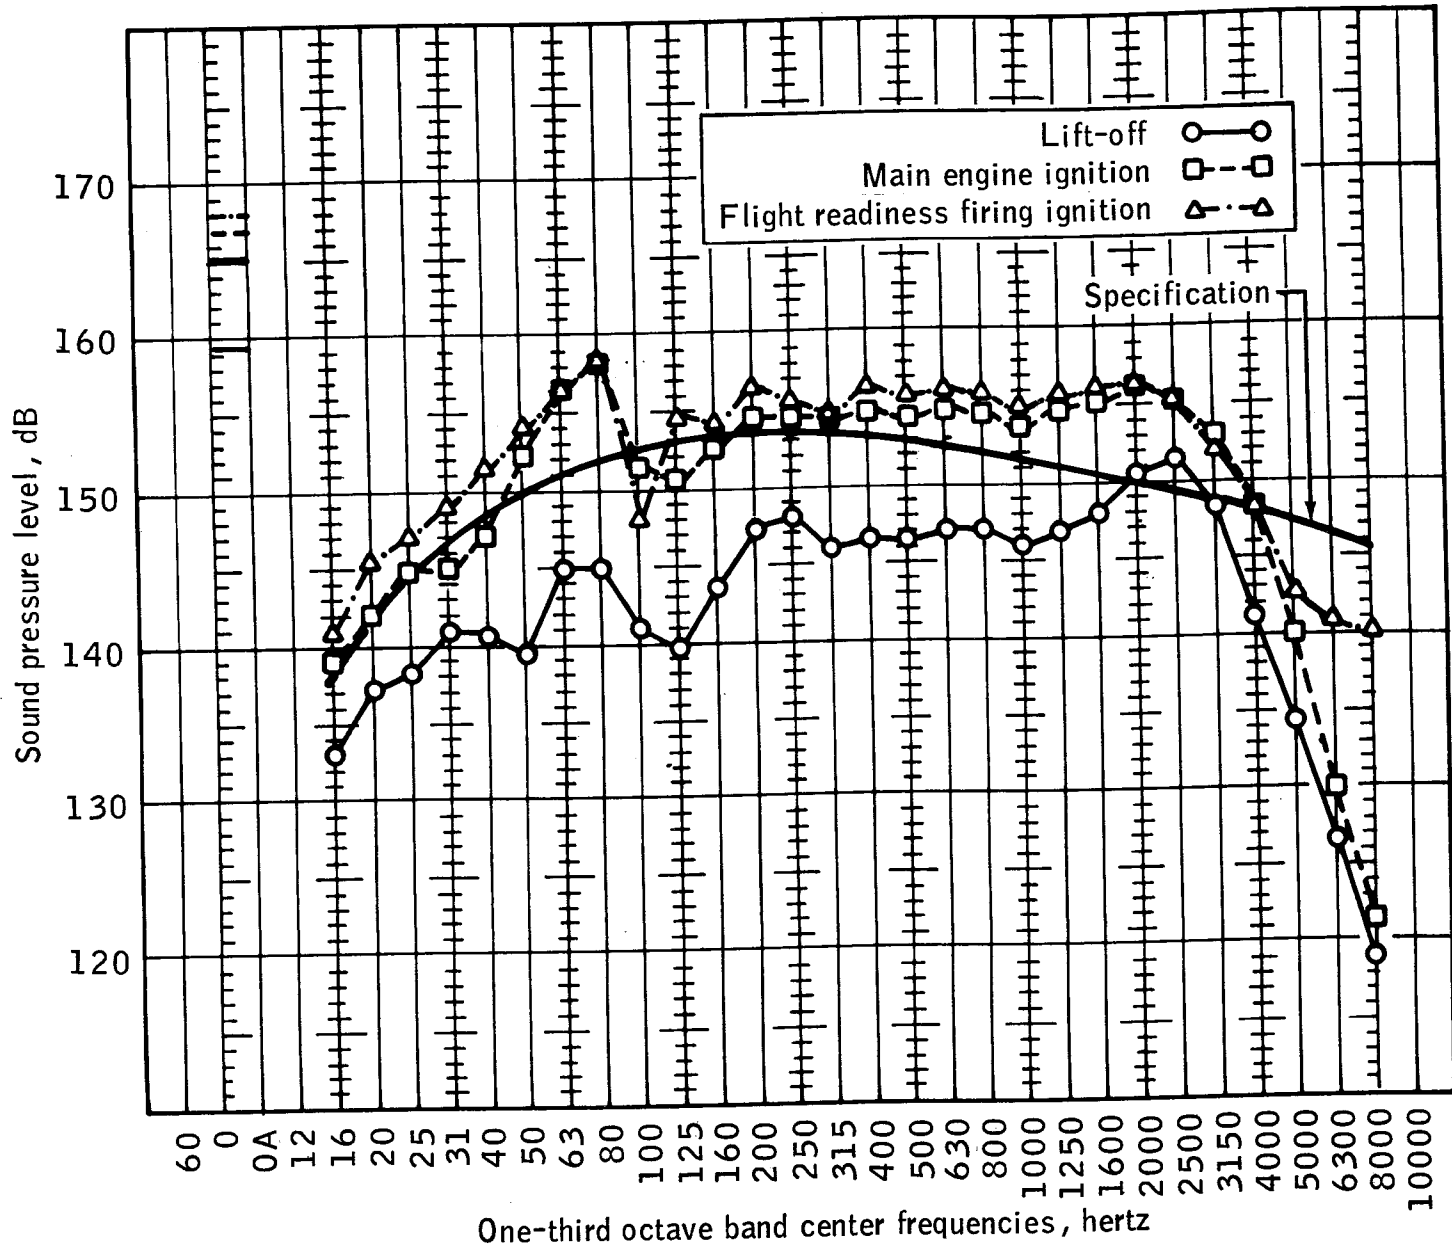
Figure 3-2.- Comparison of launch phase noise level at top of body flap.

Acoustical data measured on the Orbiter active transducers were reviewed for compliance with the design specification criteria. Data were reviewed for the time period from main engine start through the supersonic phase of ascent and for the entry phase of maximum dynamic pressure. The measured data were within specification with the exception of two areas; i.e., the top of the body flap and the tip of the vertical tail. These two areas were also above specification during the flight readiness firing. Figures 3-1 and 3-2 show a comparison of the noise levels measured for these two areas during STS-1 lift-off and during the flight readiness firing. After the firing and prior to STS-1, a detailed evaluation of the structure and the thermal protection system (TPS) loading in these areas showed no constraints for STS-1, and since the STS-1 and flight readiness firing levels are about the same, no constraints apply to STS-2.

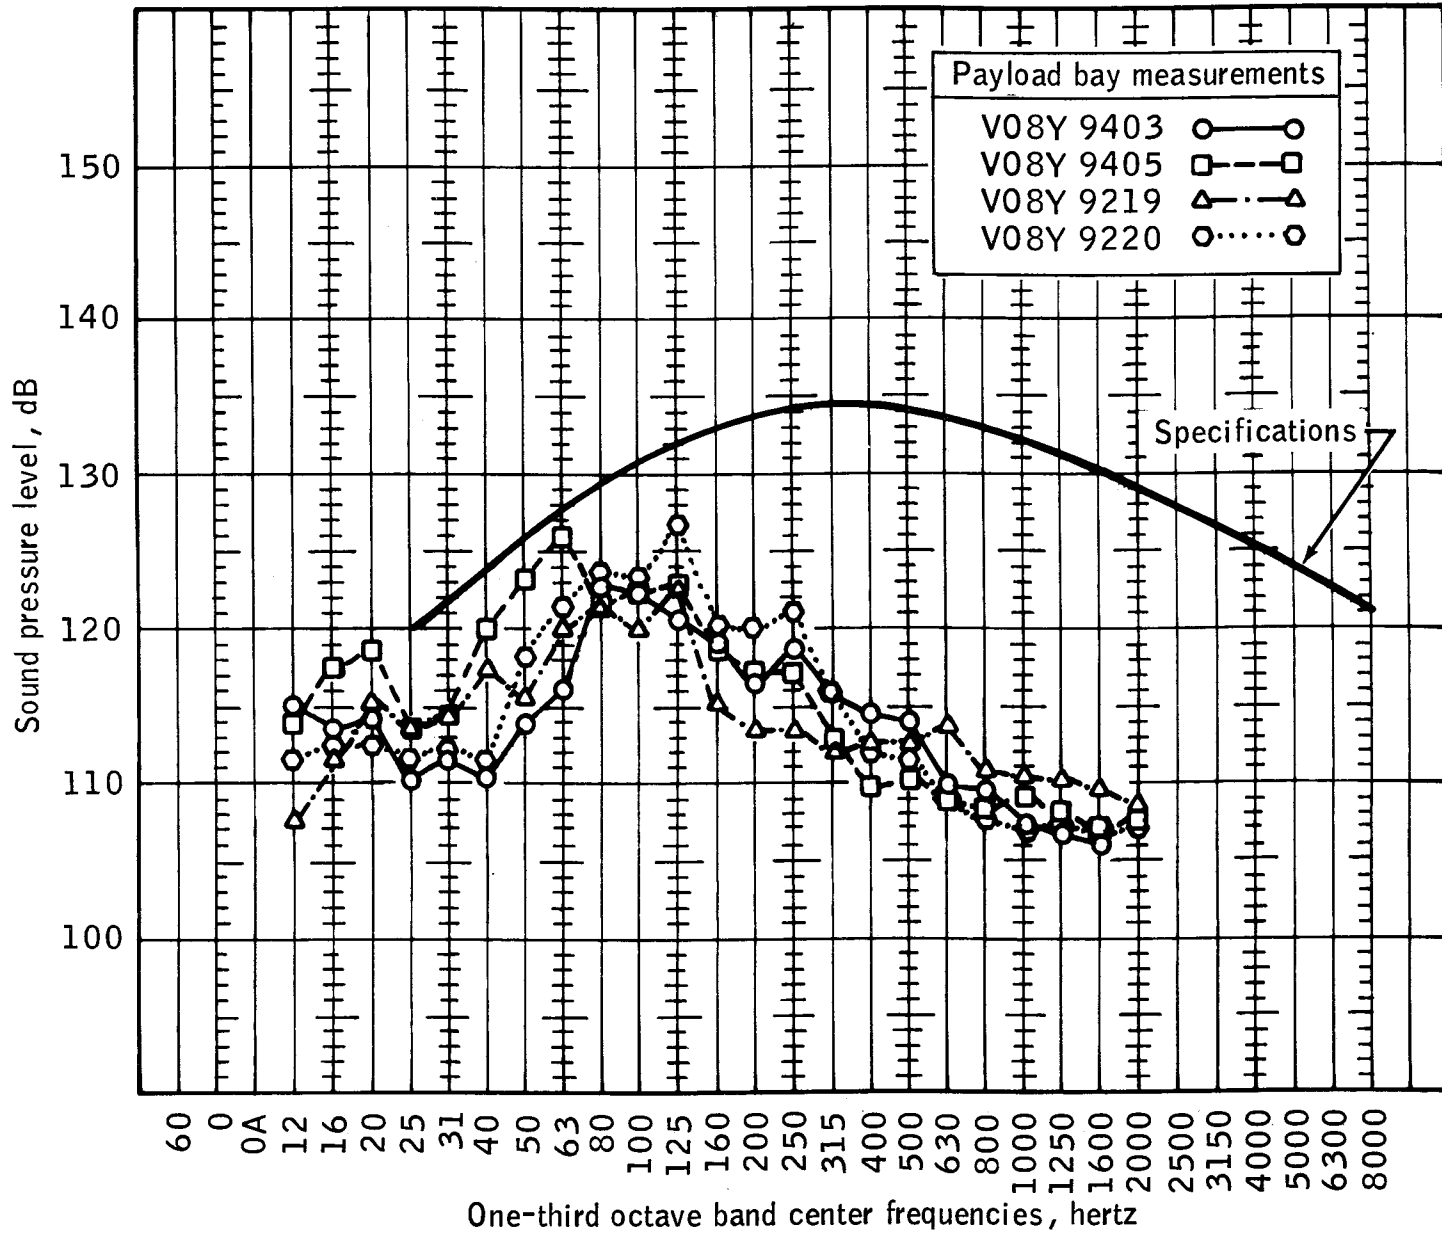
Figure 3-3.- Internal acoustic measurements from payload bay at main engine start.

The plots in figures 3-3, 3-4, and 3-5 are one-third octave bands representing the frequencies of 12.5 to 2000 Hz for analyzing averaging time of 1.0 second. In the frequency range from 12.5 to 80 Hz, the measured noise level is in agreement with the specification curve. From the 80 Hz to 2000 Hz the attenuation of the noise level was greater than predicted. The variance from the specification is around 5-8 dB at the midfrequency and reaches as much as 15-19 dB at the extreme upper frequency. The overall dB level for the four internal microphones ranged from 130 to 133.5 as compared to the 145 dB for the specification criteria overall. Figure 3-6 is a space average plot of the four internal microphones for the SSME ignition and SRB ignition/lift-off event times. The space averaging takes into consideration the influence of any microphone that may be reading high or low relative to the other microphones. The overall dB levels of 133 and 130 for each time event are still below the specification criteria.

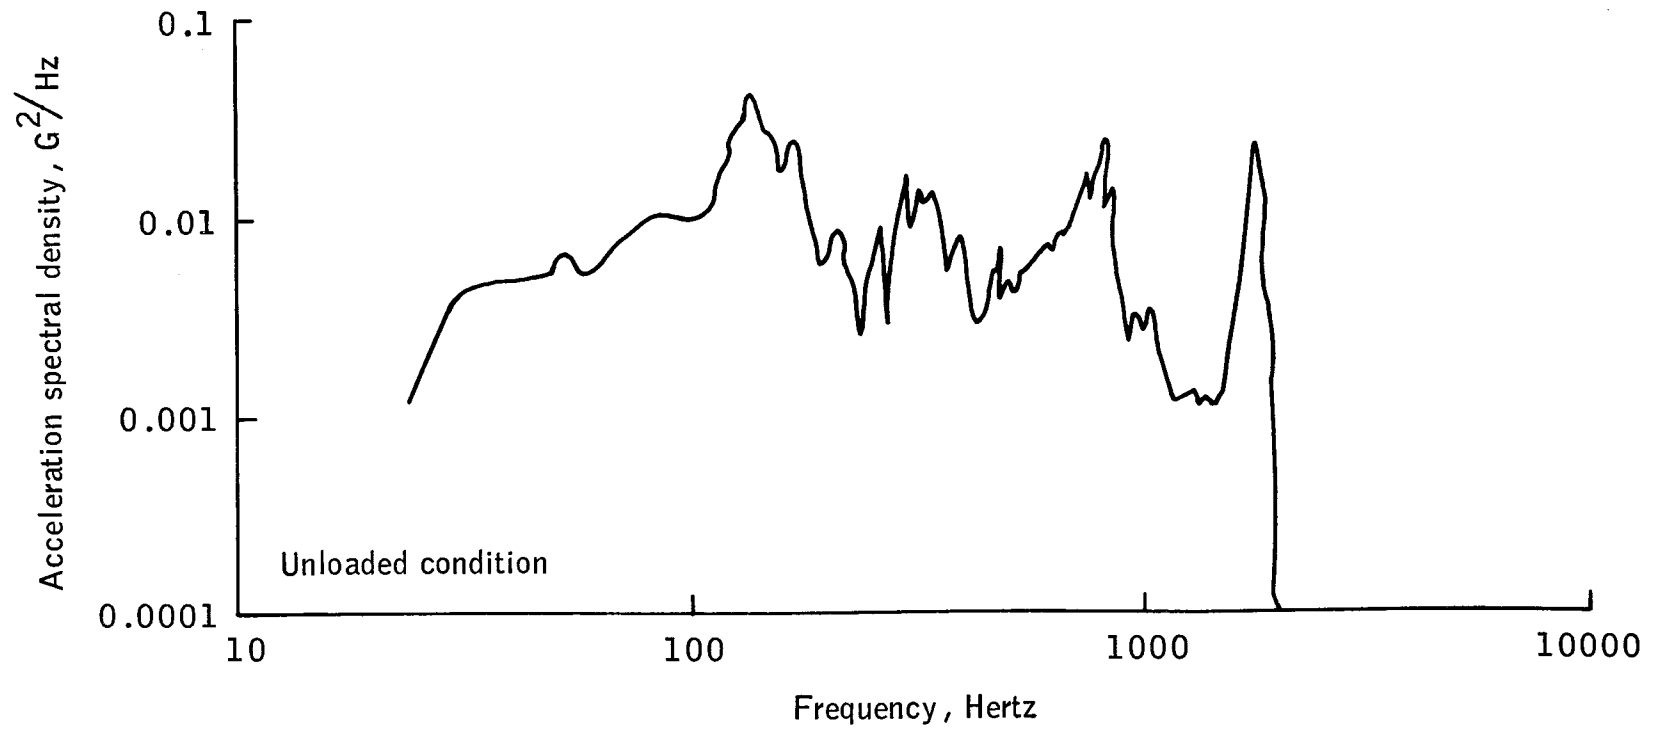
Figure 3-7. - Payload bay random vibration data for envelope of 12 measurements.

Vibration data analyzed from the STS-1 mission were obtained from 12 high-frequency transducers located on the main longeron, keel, and trunnion areas. The vibration was analyzed in the frequency band of 20 to 2500 Hz at an analysis bandwidth of 2 Hz and 10 Hz. Acceleration spectral density plots were made for the same event times as the acoustics. Figure 3-7 is an envelope of the 12 measurements. The envelope represents the highest peaks of the measured level for the transducers for all the event times.

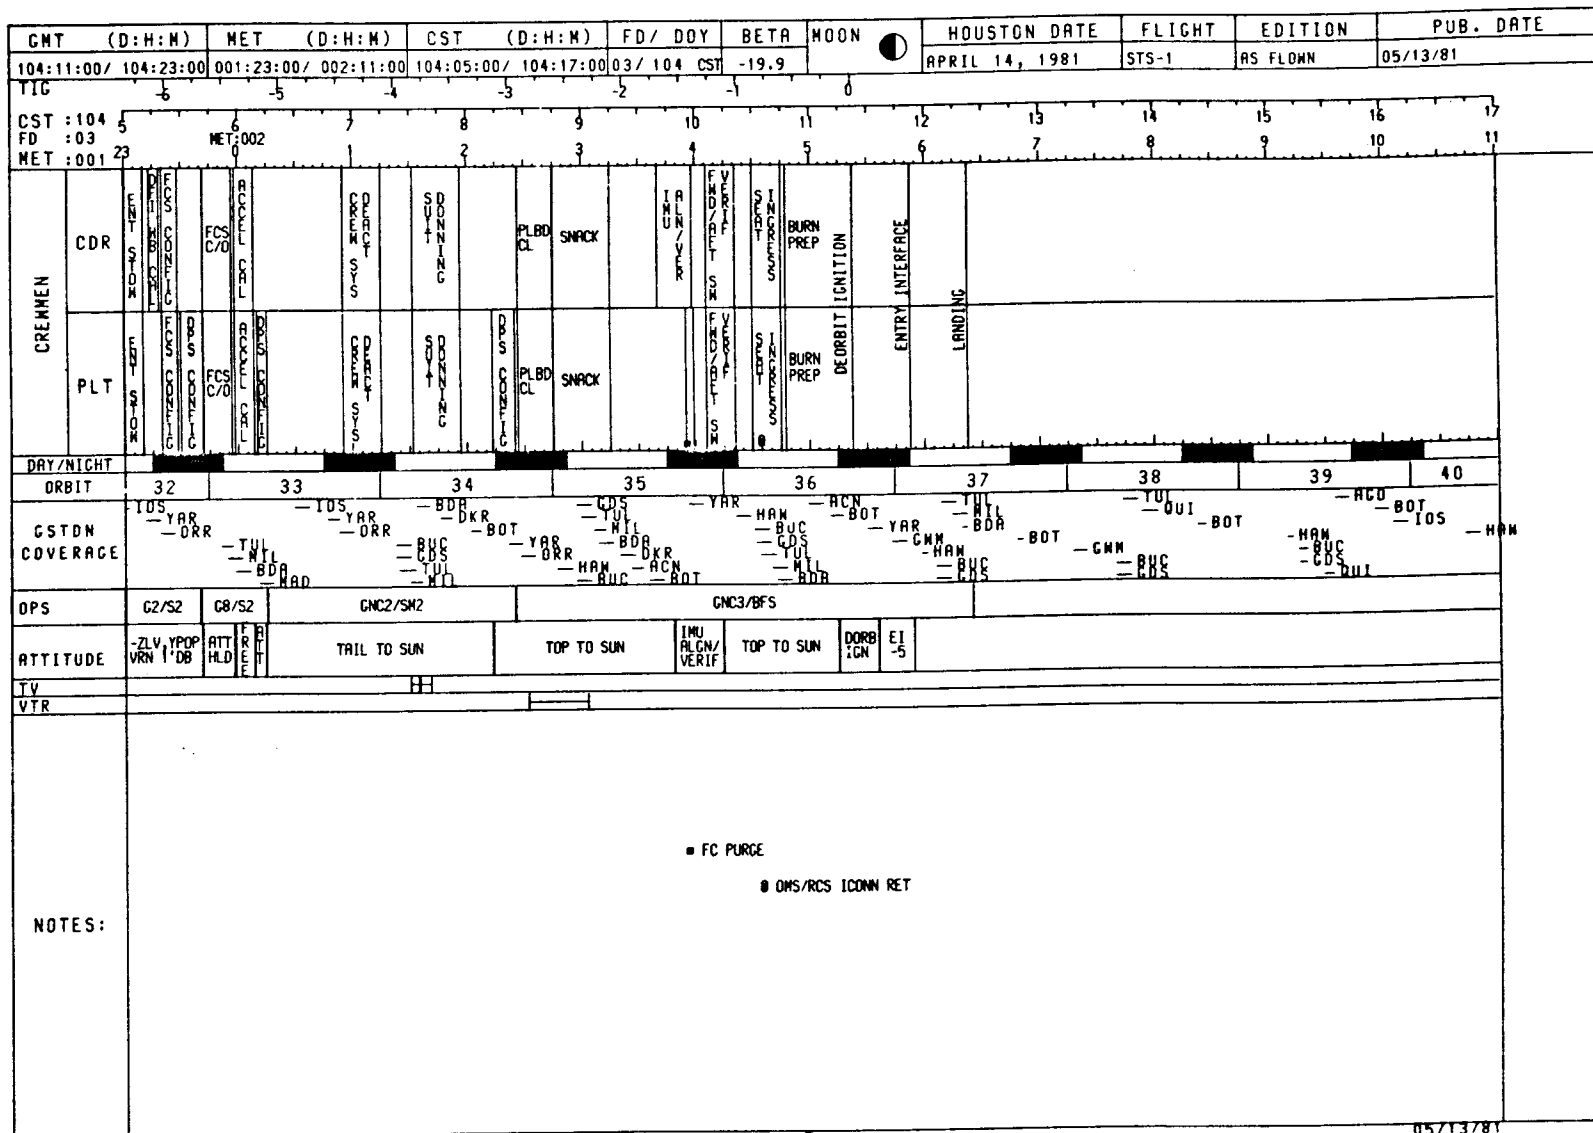
Figure 7-1.- Concluded

Flight control operations were satisfactory for STS-1. The few anomalies that occurred did not affect vehicle systems operations, onboard or ground monitoring, or mission duration. Activities followed the planned timeline very closely throughout the flight. The as-flown flight plan is shown in figure 7-1.
