Lessons Learned from Waldo Canyon

FIRE ADAPTED COMMUNITIES
MITIGATION ASSESSMENT TEAM FINDINGS

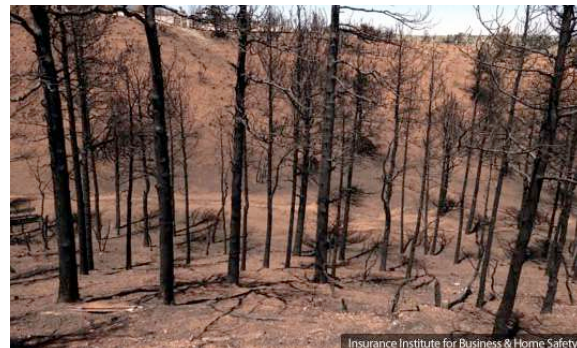
Each home had a deck overhanging the slope. Figure 6 shows a view from the top of slope where the deck was located, looking down slope. The spot fire in the wooded area crowned and separation from homes to the trees was insufficient to avoid a direct flame contact to the overhanging decks. Fire then spread from the deck to the interior of the homes. An interview with a homeowner, who was present during the site visit and whose house was destroyed told members of the assessment team that the house had a lower and upper deck, and that one deck was constructed using wood, while the other deck was built using a wood-plastic composite decking product.

Figure 6: View down slope from a Talleson Court home. Note the lack of needle vegetation on the trees, indicating the fire crowned in these trees. Source: IBHS.

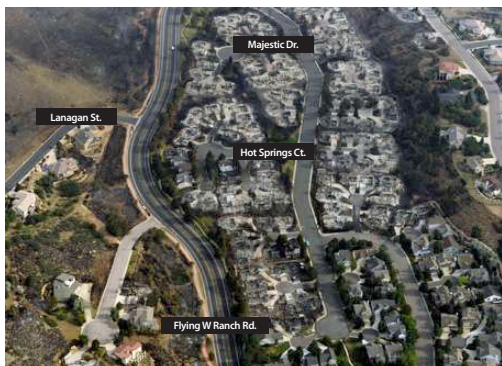
Aerial photographs of the Majestic Drive area before and after the fire are shown in Figures 8 and 9. As shown in Figure 8, the fire burned down to Flying W Ranch Road, burning the vegetation on the west side of the road (left-hand side in Figure 8). Flying W Ranch Road is a major thoroughfare through the community and is approximately the width of a four-lane road: it consists of two lanes with a center common turning lane and wide, paved shoulders. Because of the width of Flying W Ranch Road, the homes in this area ignited either from direct or indirect ember exposure or home-to-home spread. Although it was not determined which of the homes in the Majestic Drive area were ignited by embers and which were specifically ignited through home-to-home fire spread, because of the relatively close between-home spacing, it is probable that many of the 135 homes destroyed in this area were the result of home-to-home fire spread.

Figure 9: Majestic Drive area of the Mountain Shadows neighborhood after the Waldo Canyon Fire. Source: Colorado Springs Division of the Fire Marshal.

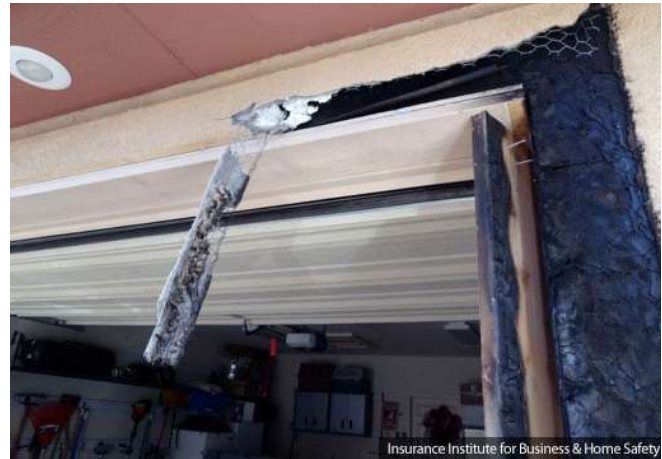
The exterior siding on the garage of a Lanagan Street home (the location of this street is shown in Figure 3) consisted of an exterior insulation finishing system (EIFS) assembly (Figure 19). In this case, the EIFS assembly consisted of a thin noncombustible stucco-like outer layer, an underlying foam insulation board, oriented strand board sheathing, and wood framing. There was a (metal) weep screed at the base of the wall to allow for drainage of water that gets behind the outer-most siding layer. As seen in Figure 19, combustible components in the middle and right-hand columns ignited. The apparent cause was from an accumulation of embers at the base of the EIFS wall. The bottom of the weep screed is perforated to allow for water to exit the wall assembly. These perforations also allowed for easier access of the accumulating embers at the base of the wall to the combustible components in the wall assembly (Figure 20). The combustible materials included the foam insulation, wood-based sheathing, building paper or house wrap and wood framing.

Figure 20: The components of this EIFS system include a noncombustible stucco outer coating, and inner layers of combustible foam insulation, wood-based sheathing, and wood framing. Source: IBHS.

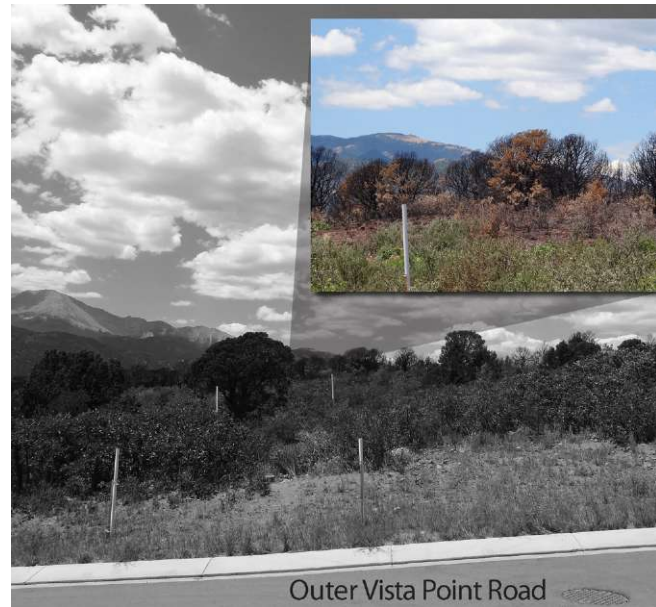
Information about the inspection of two undamaged homes in the Cedar Heights neighborhood and one undamaged home in Mountain Shadows neighborhood is provided here. The fire came close to the Cedar Heights neighborhood (Figure D1), but did not reach it. The Outer Vista Point Road home in this neighborhood would be considered a perimeter home and the Manor Rock Lane home was an interior home. The Darien Way home in the Mountain Shadows neighborhood was an interior home.

Figure D1: The fire came within about 500 feet of the neighborhood at the Outer Vista Point Road perimeter. Source: IBHS.

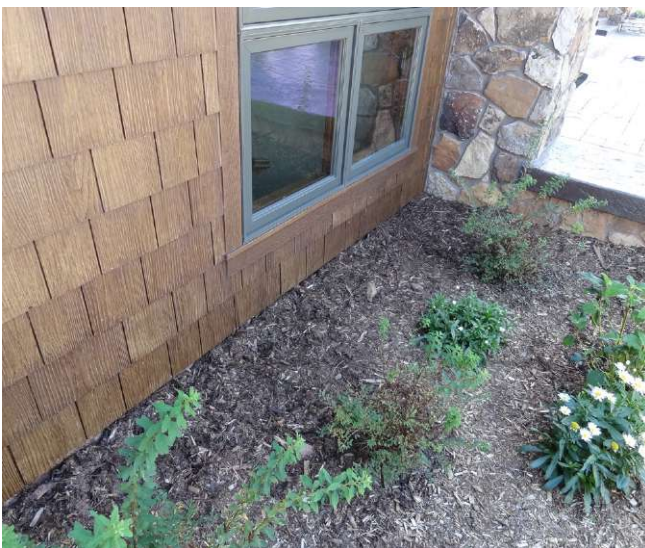
Figure D3: These photographs depict the vegetation management (defensible space) in the area at the front of the house. The upper photograph is representative of the 5-to-30 foot zone and the lower photograph is representative of the 0-to-5 foot (near home) zone. Source: IBHS.

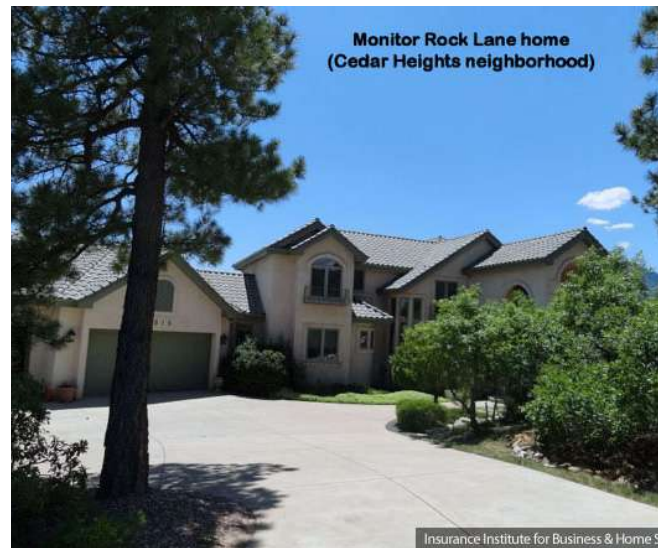
Ignition of near-home vegetation increases the chance for flame contact exposure to the exterior wall (siding, windows and other components) and the under-eave area, including any under-eave vents. A noncombustible stucco-type cladding was used on this home, but in this case, the windows and under-eave areas would still be vulnerable. The same detail whereby the wood-based sheathing is exposed at the bottom of the wall was used on this home, making a nominally noncombustible wall vulnerable because of a combustible component in the wall assembly (Figure D14). This detail was also observed on the Outer Vista Point home (Figure D4). Note the open window in Figure D10. Although a wildfire was not threatening this home on the day of the site-visit, residents should remember that windows should be closed when a wildfire is threatening. In order for the defensible space of a home to be effective, it must be consistently implemented and maintained.

Figure D9: The Monitor Rock Lane home located in the Cedar Heights neighborhood. Source: IBHS.

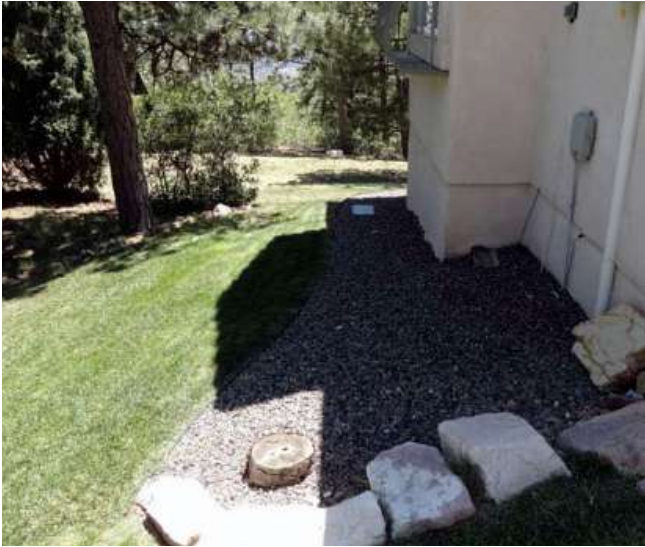
Figure D12: The left side of the house had good defensible space, particularly in the 0-to-5 foot near-home zone. Source: IBHS.

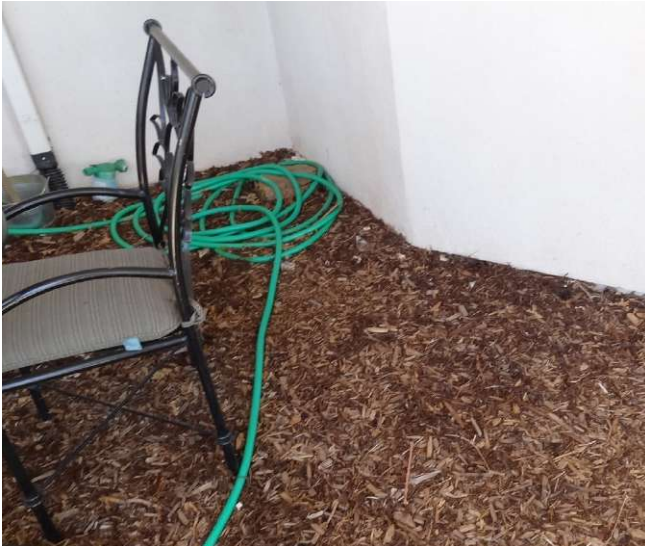
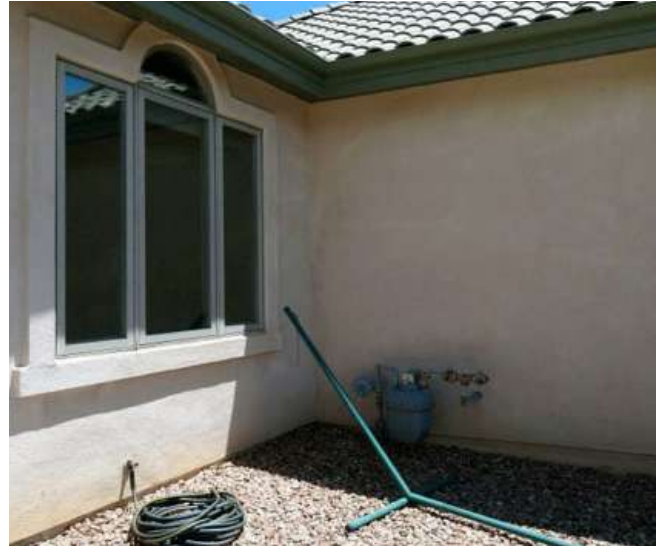
Figure D15: The defensible space in the near-home zone on the right side of the home was good. Source: IBHS.

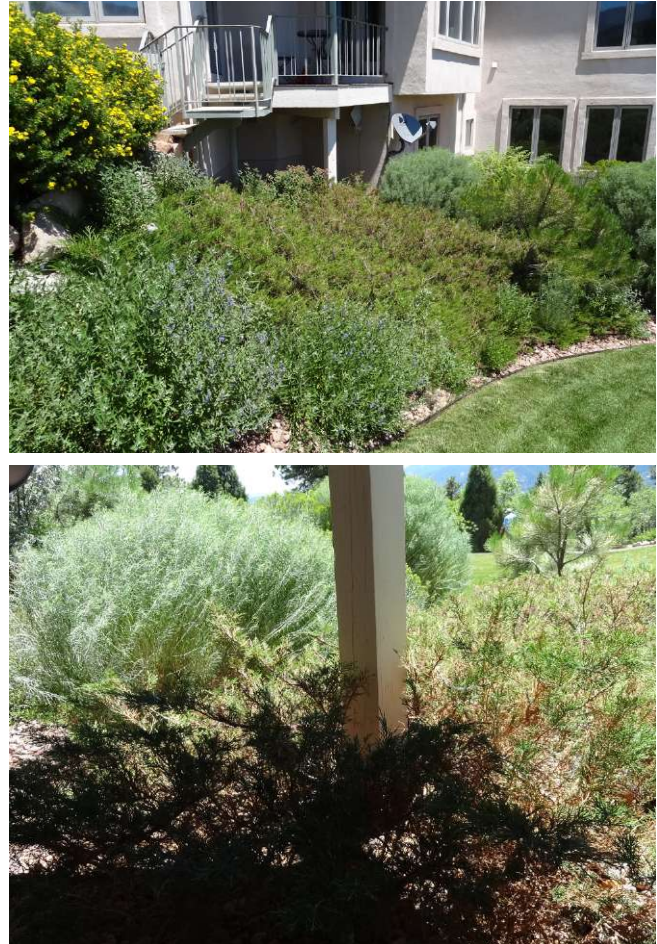
Figure D18: These photographs show the solid surface deck (upper) and the near-home vegetation under and near the deck (lower). The lower photograph was taken while under the deck. Source: IBHS.

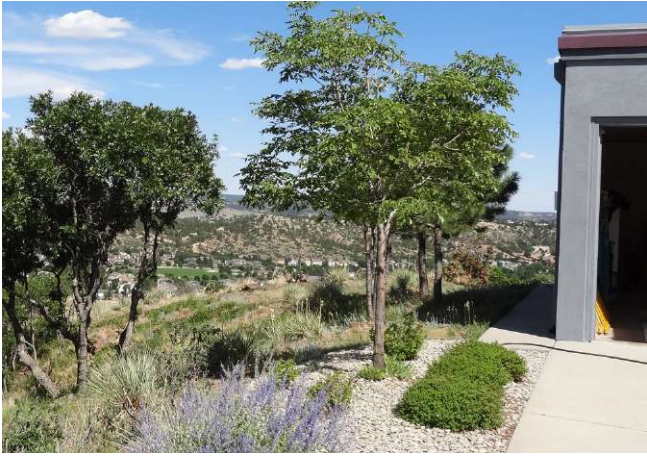
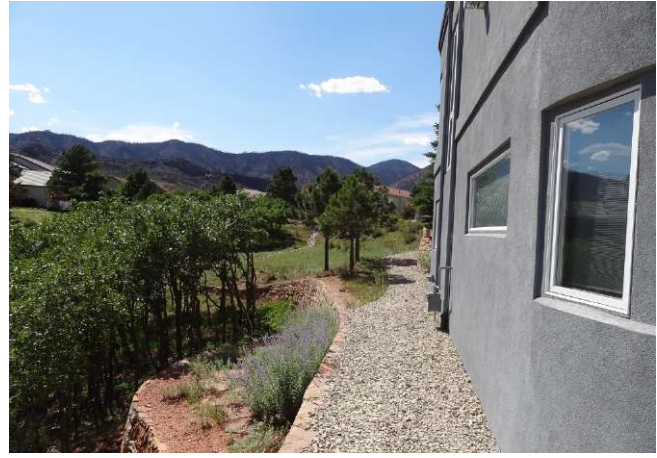
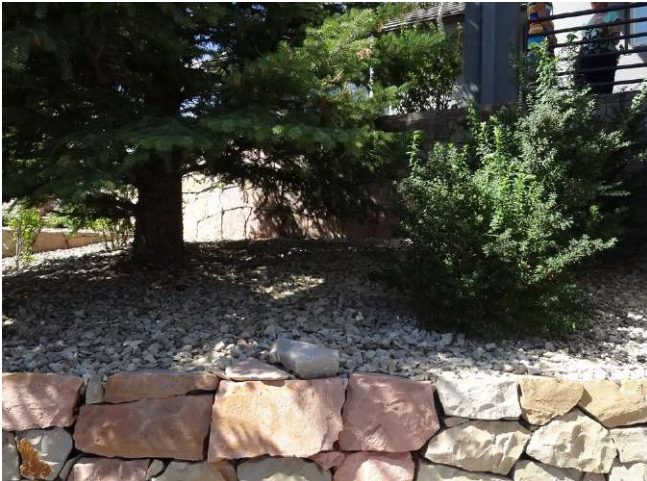
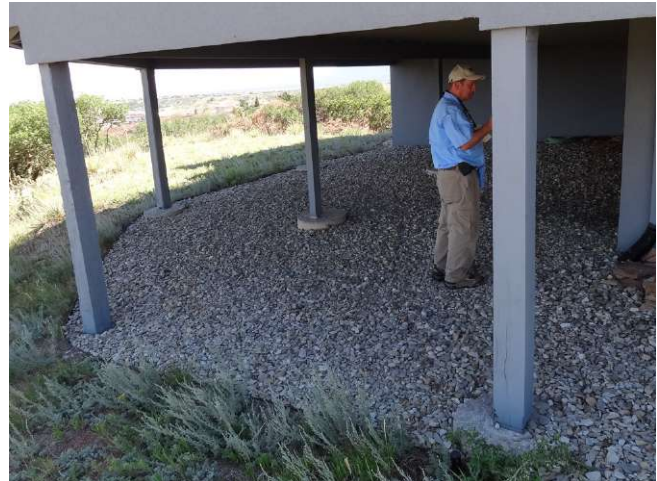
The defensible space for this home is shown in Figures D21 and D22. As seen in these figures, with the exception of the area in the front of the home, the defensible space, particularly in the 0-5 foot “near-home” zone is good. Rock mulch or a concrete walk was used next to the home and under the decks on the other sides of the home. Rock mulch was used at the front of the house, but if ignited, the low-to-ground vegetation, located under the drip line of the adjacent tree, could serve as ladder fuel. Removal of the ladder fuel vegetation and pruning the tree would improve the defensible space in this area.

Figure D21: Defensible space on the front and left side of the home. Source: IBHS.

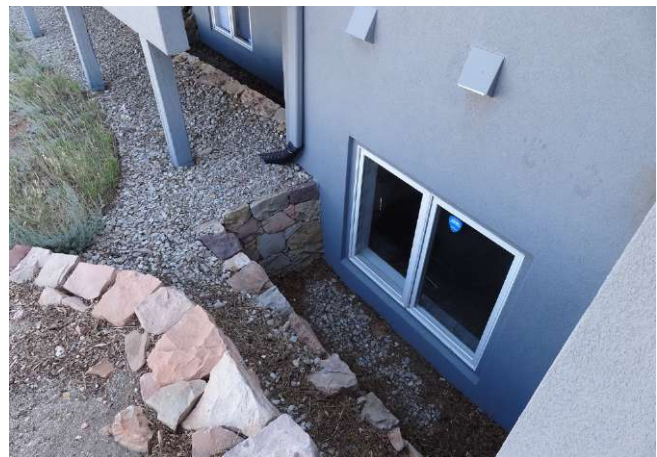
The window well shown in Figure D22 contained accumulated debris. Burned-out embers were observed on the ground, but the number that accumulated was insufficient for ignition. Use of a rock retaining wall, as shown in this photograph, would be a better option.

Figure D22: Defensible space in the right side and rear of the home. Source: IBHS.

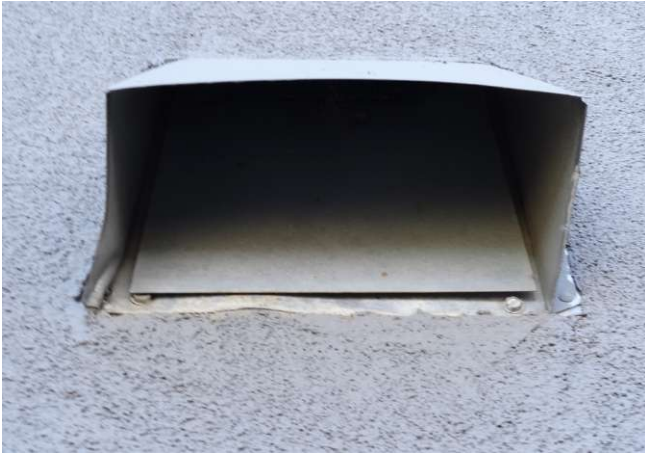
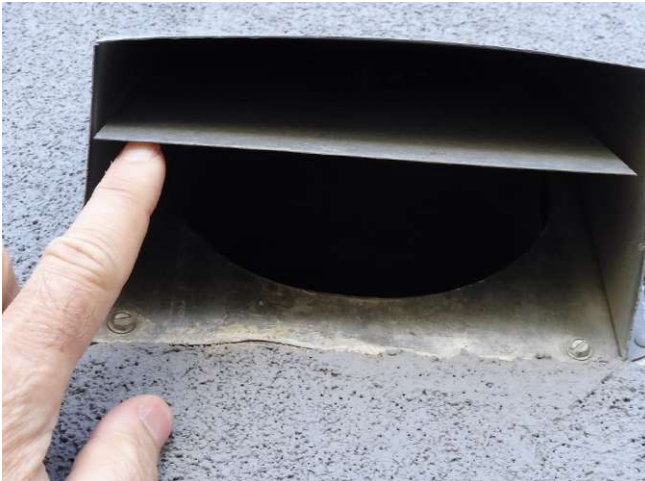
Figure D24: Dryer and other exhaust vents used vents coverings that were normally closed (upper left); when operating positive pressure in the duct would force open the closure flame to at the outlet. Source: IBHS.

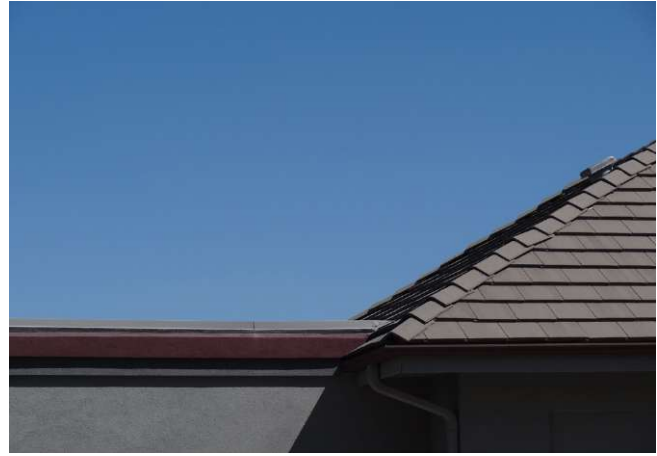
Figure D25: A flat concrete tile was used for the roof covering on this house. Note the openings at the hip and edge of the roof. Source: IBHS.

This house had a flat-tile covering (Figure D25). As was the case with the Outer Vista Point Road home the hip openings were not plugged with a noncombustible materials (e.g., with a mortar mix). As a result of the installation details of this covering, openings also occurred at the end of the roof (i.e., the area above the gutter) along the ridge and hip that must also be plugged with a noncombustible material. These openings should be plugged to minimize the opportunity for embers to get under the noncombustible roof covering, potentially igniting fine fuels that have accumulated.
