UNITED STATES AIR FORCE
AIRCRAFT ACCIDENT INVESTIGATION
BOARD REPORT

B-1B, T/N 85-0089

7TH AIRCRAFT MAINTENANCE SQUADRON
7TH BOMB WING
DYESS AIR FORCE BASE, TEXAS

DATE OF ACCIDENT: 20 APRIL 2022

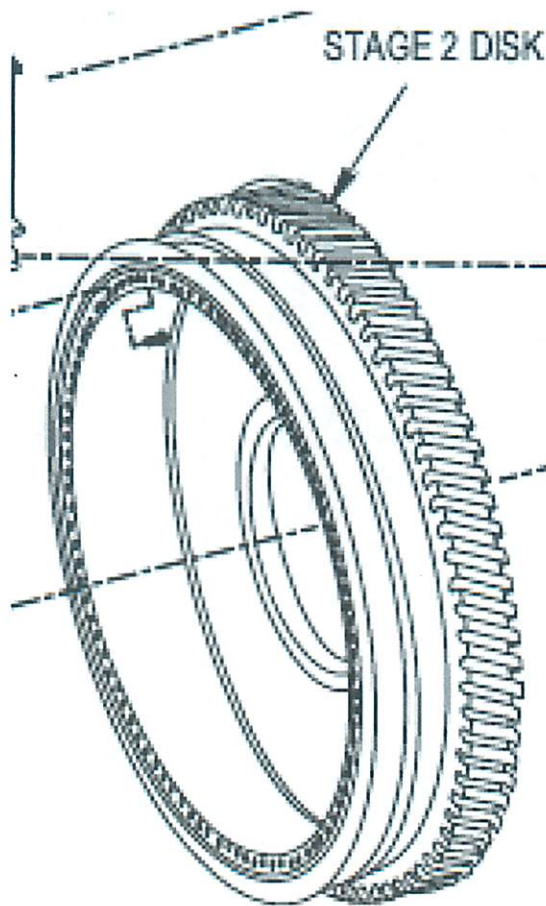
Figure 6. Technical Drawing of 2nd Stage Fan Disk (Tab Z-4)

This technical drawing displays an intact 2nd Stage Fan Disk (Tab Z-4).
