Columbia Crew Survival Investigation Report

NASA/SP-2008-565

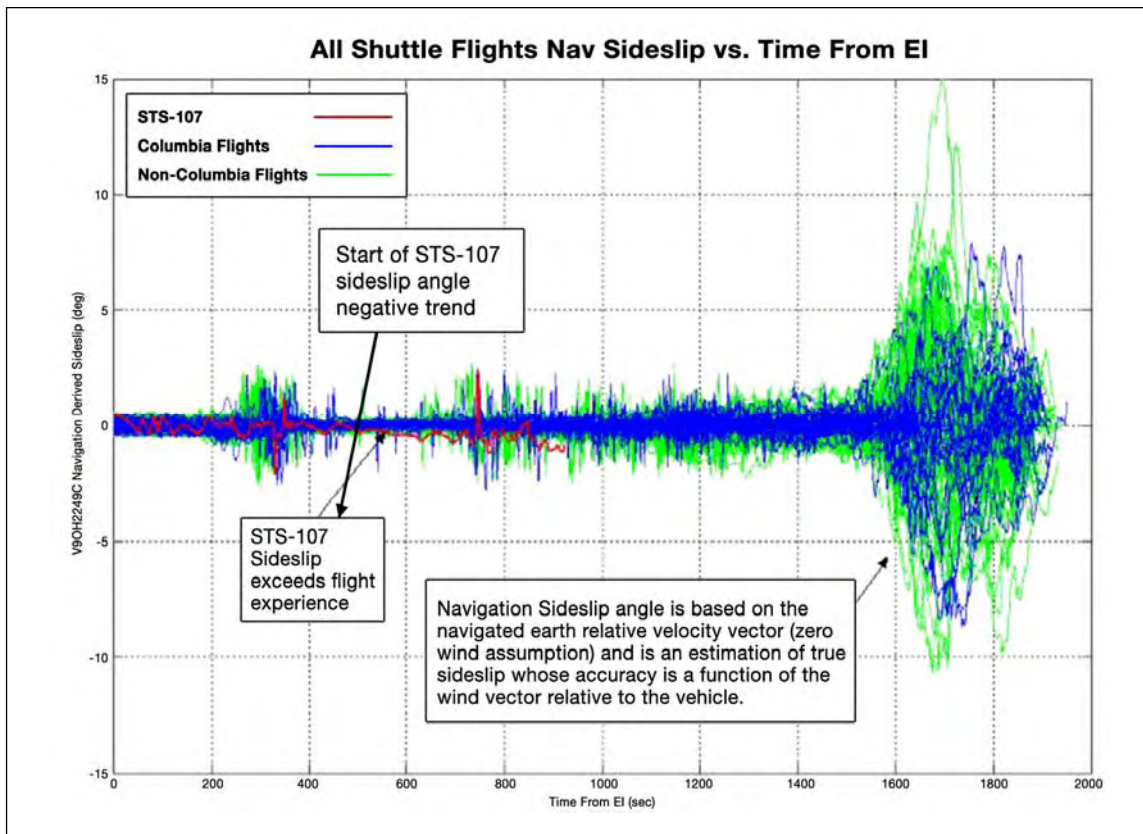
Figure 1.1-10. Negative trend starts at GMT 13:51:46 (EI+457) and exceeds flight experience at GMT 13:53:38 (EI+569).¹¹

At GMT 13:53:38 (EI+569), the sideslip angle (left yaw) exceeded all previous flight experience (figure 1.1-10).

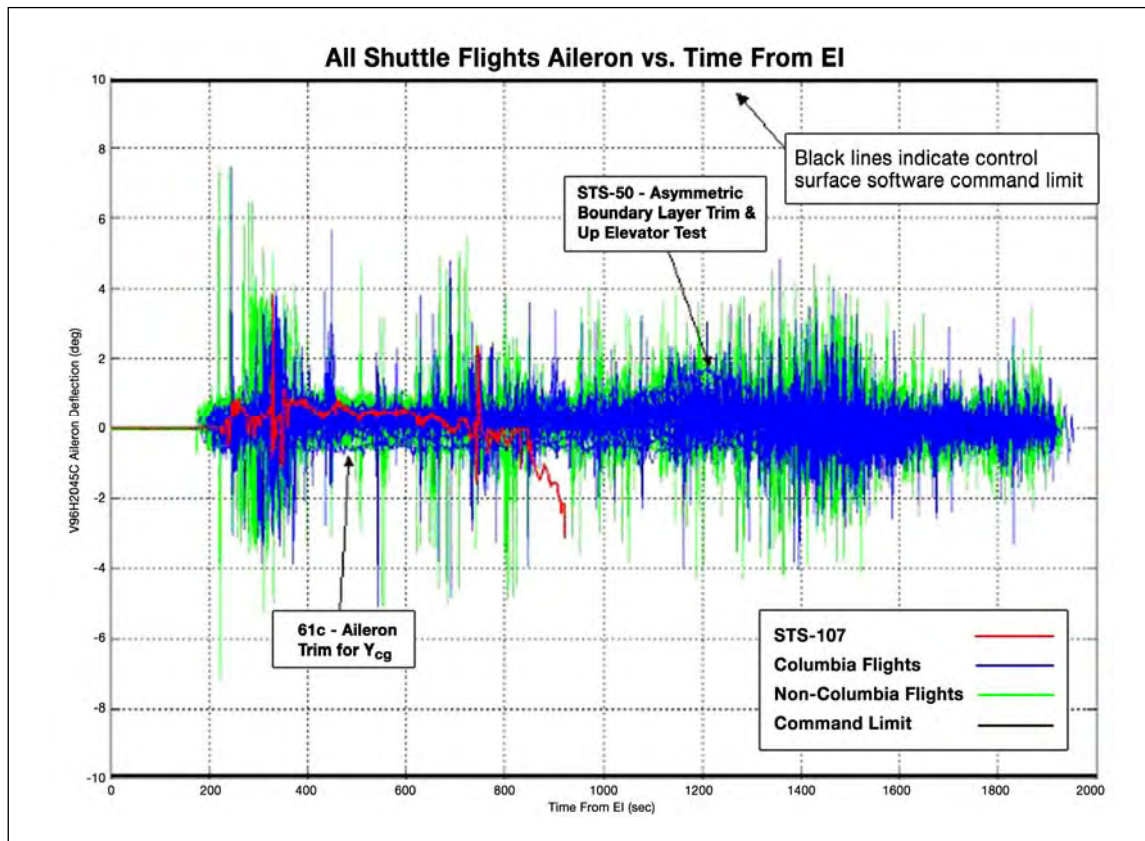
Figure 1.1-11. The sharp divergence from previous flight experience starts at approximately GMT 13:58:19 (EI+850).¹²

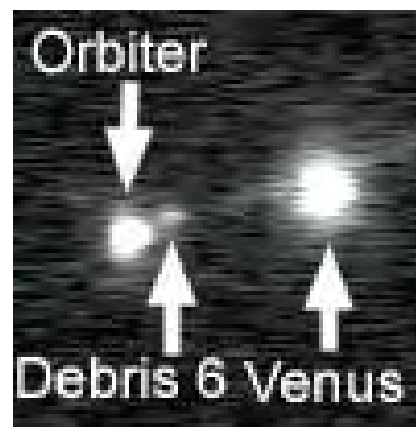
The brightest debris shedding event that occurred in this phase, Debris 6, is first visible on video at GMT 13:54:36 (EI+627) (figure 1.1-14). Ballistic estimates determined that the actual release time was 4 seconds earlier. Luminosity measurements and calculated rates of deceleration were used to determine that the mass was probably a few hundred pounds.¹⁷ There were no data from sensors, instrumental indications, or apparent crew recognition of this debris loss.

Figure 1.1-14. The brightest debris event known to have occurred prior to loss of signal. The orbiter is traveling from right to left.

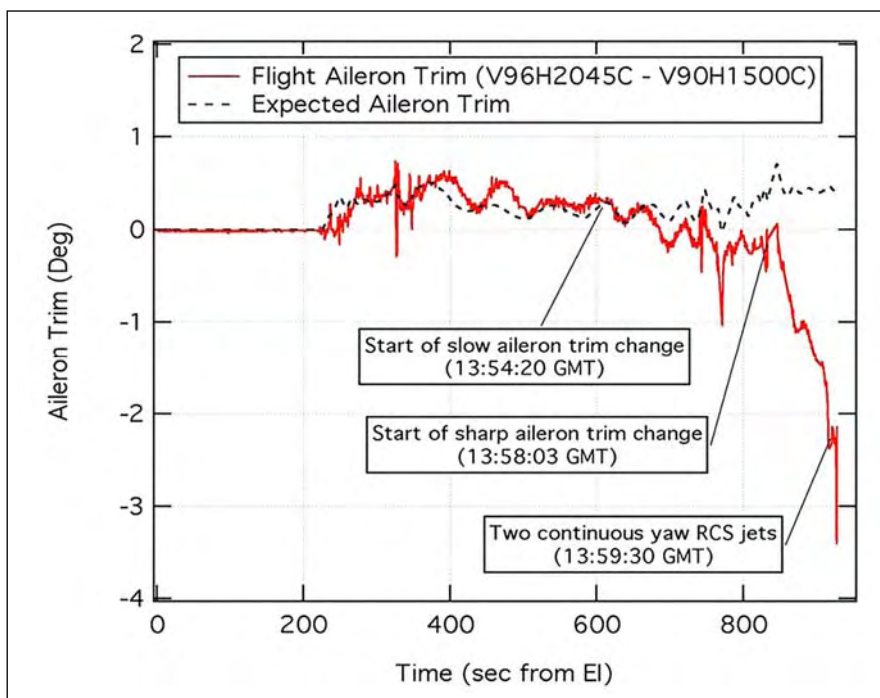
At approximately GMT 13:58:03 (EI+834), the aileron trim begins to diverge sharply from the expected values to counteract the increasing adverse moments due to the left wing damage (figure 1.1-15).

Figure 1.1-15. *Aileron trim discrepancy.*¹⁸

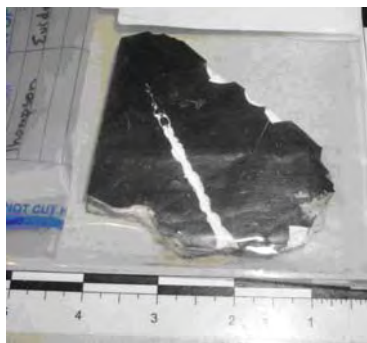
Ballistic analysis indicates that the westernmost piece of recovered *Columbia* debris was released at GMT 13:58:21 (EI+852). This debris, a tile from the left wing upper surface located just inboard of RCC panels 8 and 9, was found in Littlefield, Texas¹⁹ (figure 1.1-16).

Figure 1.1-16. *The Littlefield tile.* [Picture from the *Columbia* Reconstruction Database, debris item no. 14768]

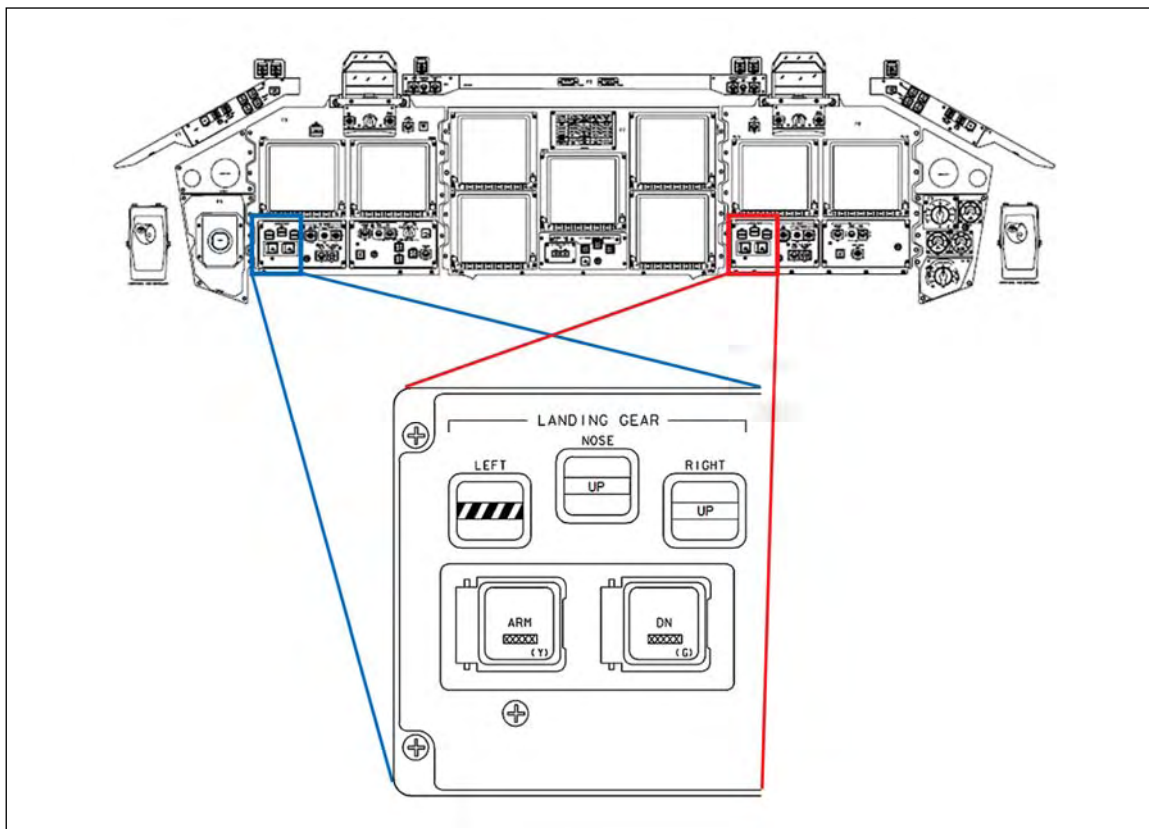
At GMT 13:59:06 (EI+897), 10 seconds after the fourth of four tire pressure fault messages, telemetry indicated the "LEFT MAIN GEAR DOWN" lock sensor transferred to "ON." Other sensors indicated that the landing gear door was still closed and the landing gear was locked in the up (stowed) position. These mixed signals caused the left landing gear position indicator to display a "barber pole" (figure 1.1-17), which indicates an indeterminate landing gear position. Post-accident analysis of the data and recovered debris indicates that the left landing gear was locked in the "up" position and the landing gear door was closed. The signal indicating that the gear was down was a false signal that was likely triggered by damage to the sensor system (sensor, wiring harness, etc.). Based on training experience, the crew was probably attempting to diagnose the situation given that it involved the same landing gear as the tire pressure messages and indicated a potential landing gear deployment problem.

Figure 1.1-17. Landing gear indicator panel, identical on both sides of the flight deck forward display panels. Left indicator showing "barber pole" (indeterminate position). [Adapted from the Space Shuttle Systems Handbook]

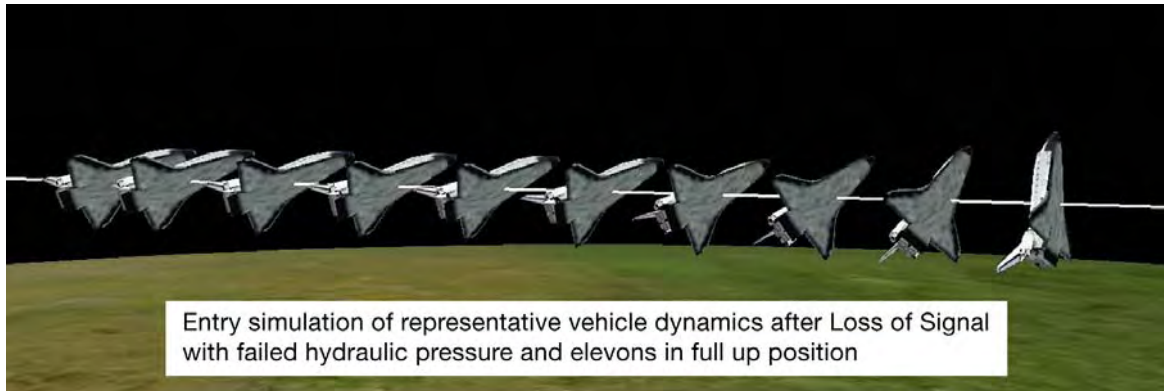
This section discusses key events that affected the crew from LOS at GMT 13:59:32 (EI+923) to the CE, which began at 14:00:18 (EI+969) (figure 1.1-19). During this period of time at about GMT 13:59:37 (EI+928), loss of control (LOC) of *Columbia* occurred. LOC marks the beginning of the transition from controlled flight to an uncontrolled ballistic entry. This phase is 46 seconds long.

Figure 1.1-20. Sequence (1-second intervals) showing a simulation of orbiter loss of control pitch-up from GMT 13:59:37 (EI+928) to GMT 13:59:46 (EI+937). White line indicates vehicle trajectory relative to the ground.

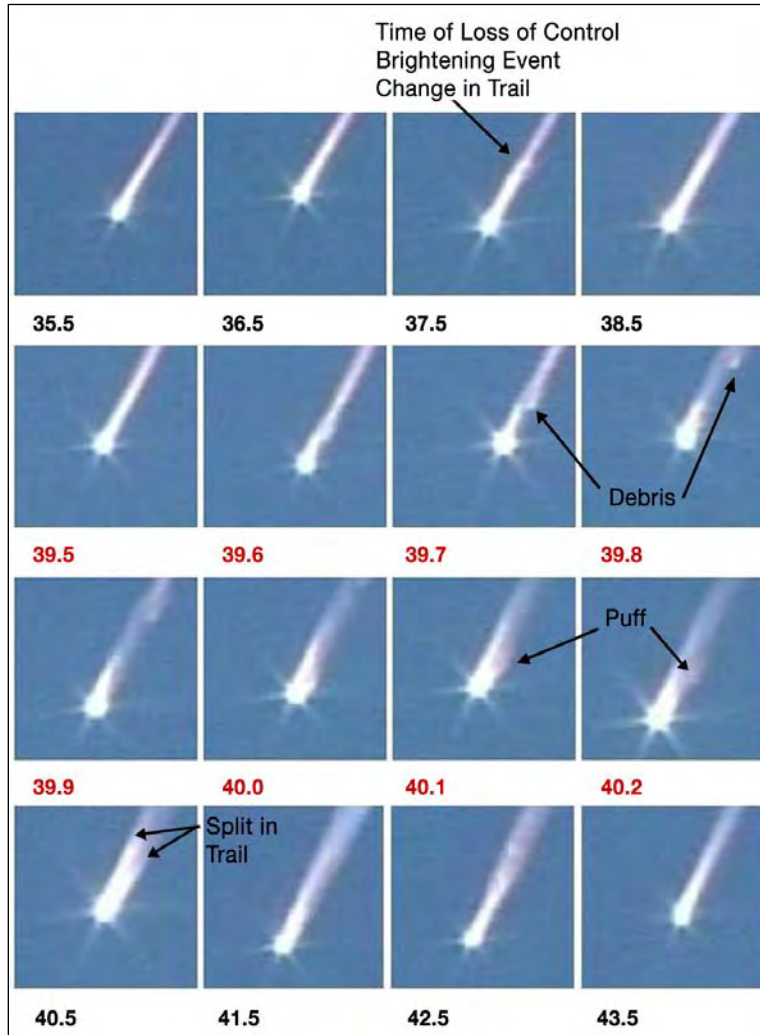
Figure 1.1-21. Video frame captures from ground-based video, beginning at GMT 13:59:35.5 (EI+926) and ending at GMT 13:59:43.5 (EI+937). The numbers below each frame indicate the seconds after GMT 13:59:00. The frames in the first and last rows are 1 second apart. The frames in the second and third rows are 0.1 second apart.

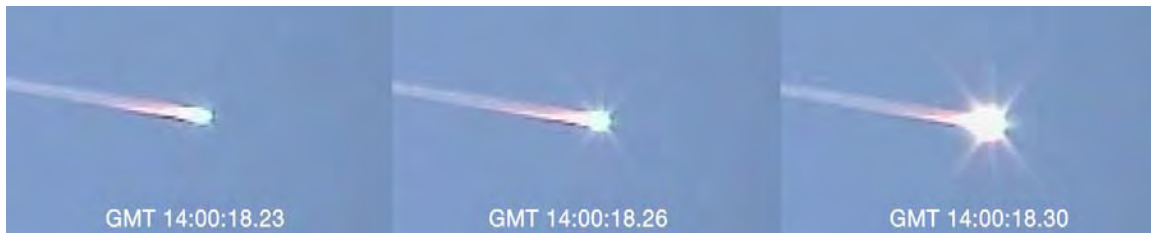
At GMT 14:00:18 (EI+969), video showed that a significant event (the CE) occurred to the orbiter (figure 1.1-24). The GPS Miniaturized Airborne Global Receiver (MAGR) experiment, which was located in the middeck and powered by a fuel cell in the payload bay, experienced a loss of power at the CE. Less than 1 second later, the MADS/OEX recorder, which was also located in the crew module and similarly powered from the payload bay, also experienced a total power loss. The conclusion was that the forward and midbody orbiter segments separated at the CE. The CE is actually the start of a period of several seconds in which the orbiter underwent a major structural breakup. At GMT 14:00:25 (EI+976), there were visual indications that the orbiter was in multiple pieces. Ballistics analysis and structural debris analysis supports this period as the breakup event.

Figure 1.1-24. The Catastrophic Event is depicted in these three frames of video that cover 0.1 second. There is no change in the magnification/zoom factor. The third frame represents GMT 14:00:18.3 (EI+969).

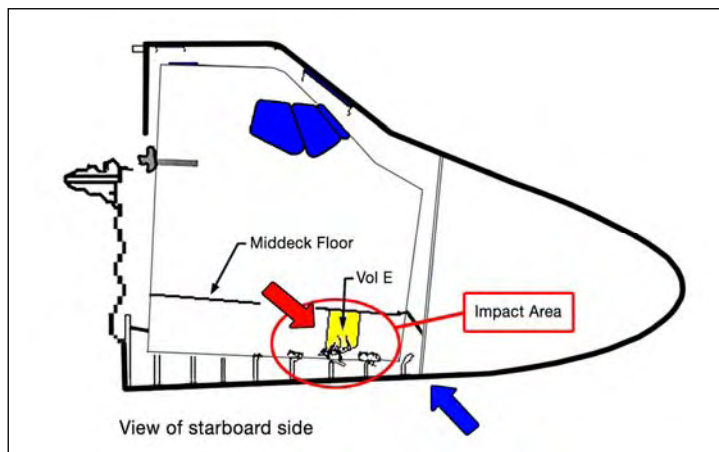
The resulting jerk acting on the crew module attach fittings as the forebody separated from midbody structure caused motion of the crew module within the forward fuselage shell. The crew module pressure vessel impacted the forward fuselage, which apparently resulted in damage to the crew module pressure vessel, internal crew module structure, and forward fuselage structure. Debris evidence shows that internal damage occurred to some volumes and lockers on the middeck in close proximity to the pressure vessel shell. At least one crew module pressure vessel breach occurred in the lower equipment bay or middeck area (figure 1.1-26), probably at or near the time of the CE, but definitely not later than GMT 14:00:35 (EI+986) \pm 5 sec. This time is based on the ballistic analysis of a recovered mission patch confirmed to have come from inside the crew module from one of the volumes (Volume E) that suffered damage.

Figure 1.1-26. Scenario showing how the crew module pressure vessel could impact the forward fuselage, and the middeck Volume E could impact the crew module pressure vessel, with resultant damage.

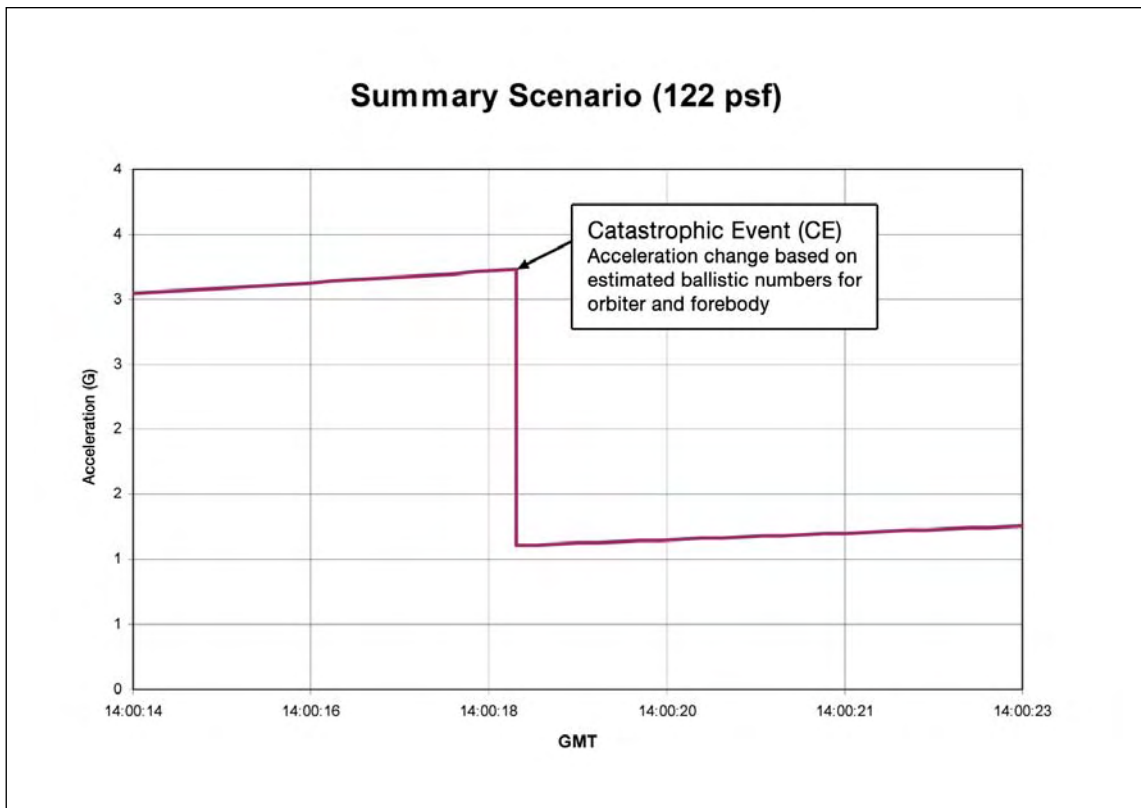
As the forebody broke free from the rest of the orbiter, its ballistic number underwent a sharp change from an average ballistic number of 41.7 pounds per square foot (psf) (out of control intact orbiter) to 122 psf (free-flying forebody). The aerodynamic drag of the forebody instantaneously decreased, resulting in a reduction in the translational deceleration from approximately 3.5 G to about 1 G (figure 1.1-27).

Figure 1.1-27. Estimated change in total G experienced by the forebody due to a change in ballistic number from the orbiter breakup.

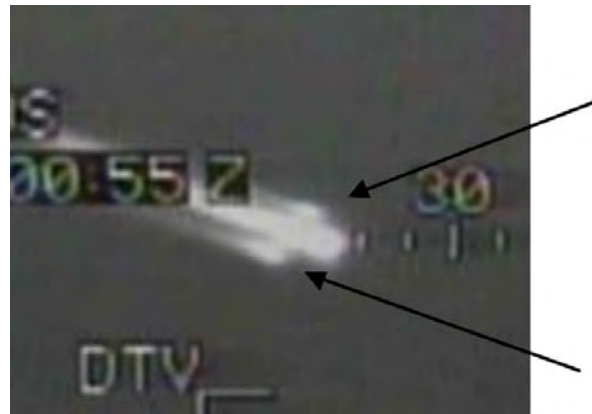
The crew module breakup was rapid (<15 seconds). The range of ballistic numbers of the debris items resulted in quickly diverging individual trajectories such that very little debris-debris interaction occurred. Cluster analysis of the debris field shows that the crew module forward X_{cm}^{35} 200 bulkhead debris is farther west than the crew module aft X_o 576 bulkhead debris. This indicates that the failure of the forward bulkhead happened prior to the failure of the aft bulkhead. The middeck floor debris field begins at the same longitude as the forward bulkhead, suggesting that the failures were nearly simultaneous. Debris evidence from the crew module structure suggests a starboard-to-port breakup of the middeck area, which probably included the forward bulkhead. Cluster analysis and evidence of significant heating of the flight deck floor and the flight deck seats indicates that the flight deck was intact for a short period of time (probably less than 5 seconds) after separation from the middeck. Cluster analysis indicates that the airlock stayed with the flight deck, possibly connected by the aft bulkhead.

Figure 1.1-30. Video frame from the Apache video at GMT 14:00:55 (EI+1006) showing two similar luminosity objects separating from the forebody.

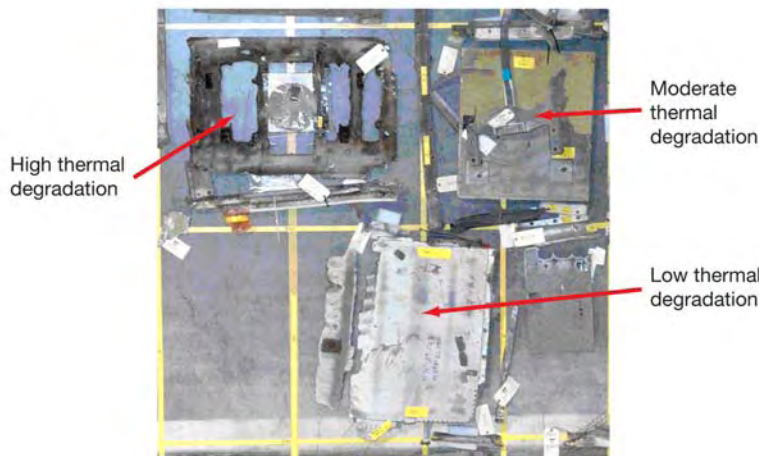
There is no evidence of an explosion or a fire. Analysis of thermal vectors on numerous debris items showed multiple independent heat vectors across the structure. For example, many recovered middeck floor panels were nearly pristine with paint still visible, while floor panels from immediately adjacent locations had melted materials deposited on them and other signs of high thermal exposure (figure 1.1-31). After breakup, individual items experienced their own trajectories and heat exposure. This heat exposure can vary enormously with ballistic number and other effects such as shadowing from other debris items and orientation of the item into the heat vector. The lack of consistent directional heating vectors on crew module debris suggests heating was due to individual item trajectories and random exposure during breakup rather than a major breach resulting in directional heating.

Figure 1.1-31. Middeck floor debris in original relative orientation showing varying thermal exposure.

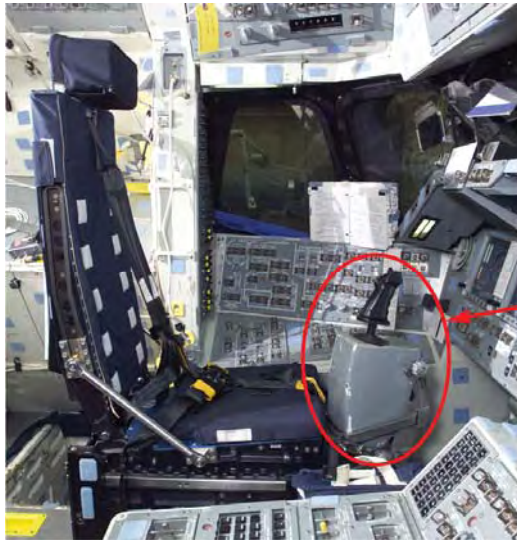
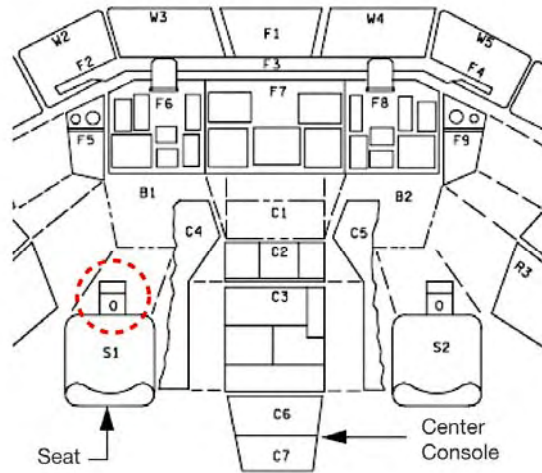
Between GMT 13:36:04 (EI-485) and GMT 13:36:06 (EI-483), the CDR/Seat 1 is performing entry preparation actions that lead to the RHC being bumped (figure 1.2-6).

Figure 1.2-6. Location of Commander's seat and rotational hand controller. [Left picture from the Shuttle Training Simulator looking from starboard to port; right picture adapted from the Space Shuttle Systems Handbook looking from aft to forward]

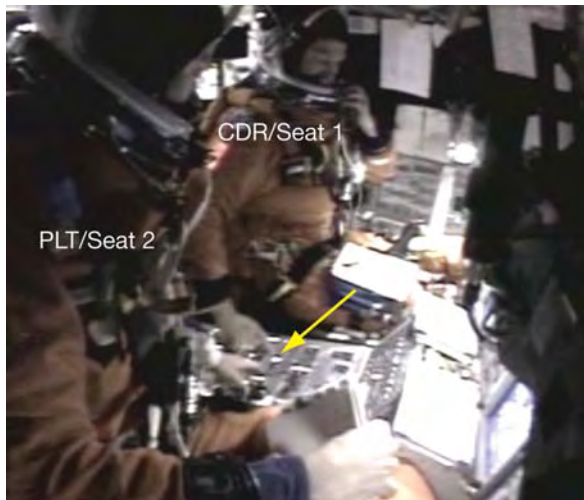
DAP DNMODE RHC. Primary Avionics Software System (PASS) DAP DOWNMODE RHC (time from telemetry analysis). The message indicates that the RHC movement in the previous event was sufficient to mode the DAP out of AUTO into Inertial mode. When this occurs, a “DAP DOWNMODE RHC” caution and warning message is displayed, the INRTL button on the C3 panel is illuminated (see arrow in figure 1.2-7), and a tone, which can be heard in the recovered video tape, is annunciated (figure 1.2-7).

Figure 1.2-7. Digital autopilot button on the C3 panel is illuminated.

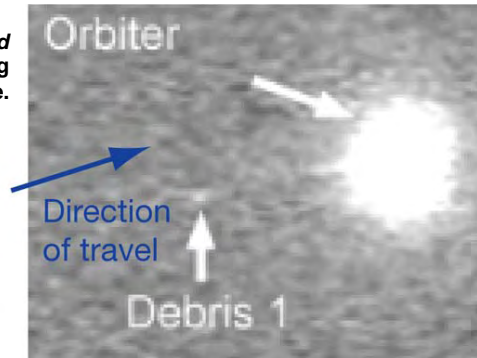
not possible to know whether debris was being shed before this time. Image of Debris 1 is 0.6 second after first visual detection of it. Analysis indicates that the mass of the debris was probably less than 8 lbs. Neither the crew nor MCC personnel were aware of the shedding events (blue arrow shows direction of flight) (figure 1.2-24).

Figure 1.2-24. Video capture of the first observed incident of debris being shed. The orbiter is traveling from left to right in this image.

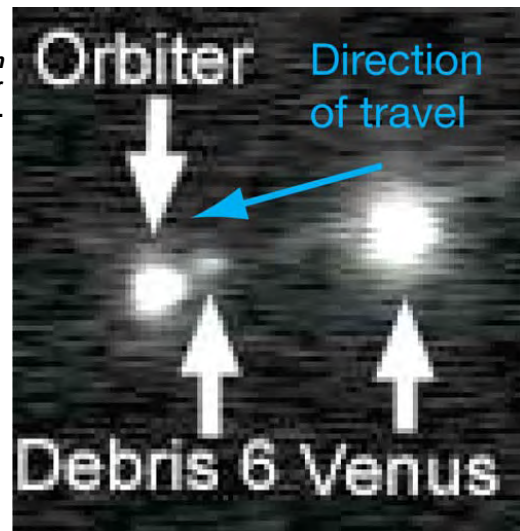
Debris 6 released. The brightest debris-shedding event occurring in this phase, Debris 6, is first visible on video at GMT 13:54:36 (EI+627) (figure 1.2-28). Ballistic estimates determined that the actual release time was 4 seconds earlier. Luminosity measurements and calculated rates of deceleration were used to determine that the mass was probably a few hundred pounds. ⁷ There were no data from sensors, instrumental indications, or apparent crew recognition of this debris loss.

Figure 1.2-28. The brightest debris event known to have occurred prior to loss of signal. The orbiter is traveling from right to left.

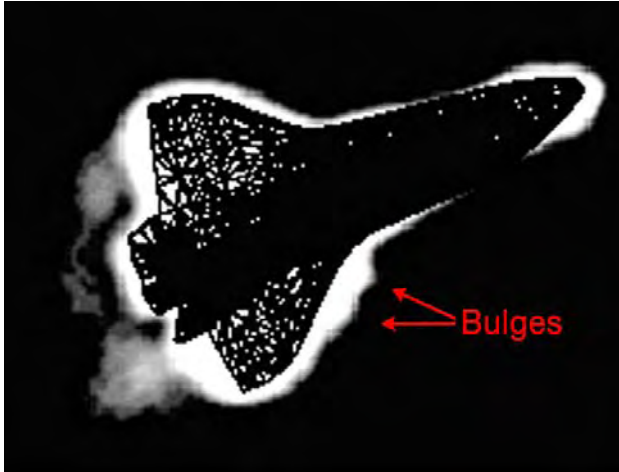
(as marked) at the left wing could not be explained by a nominal condition (figure 1.2-31).

Figure 1.2-31. *Infrared photograph of the shuttle during entry.*⁸

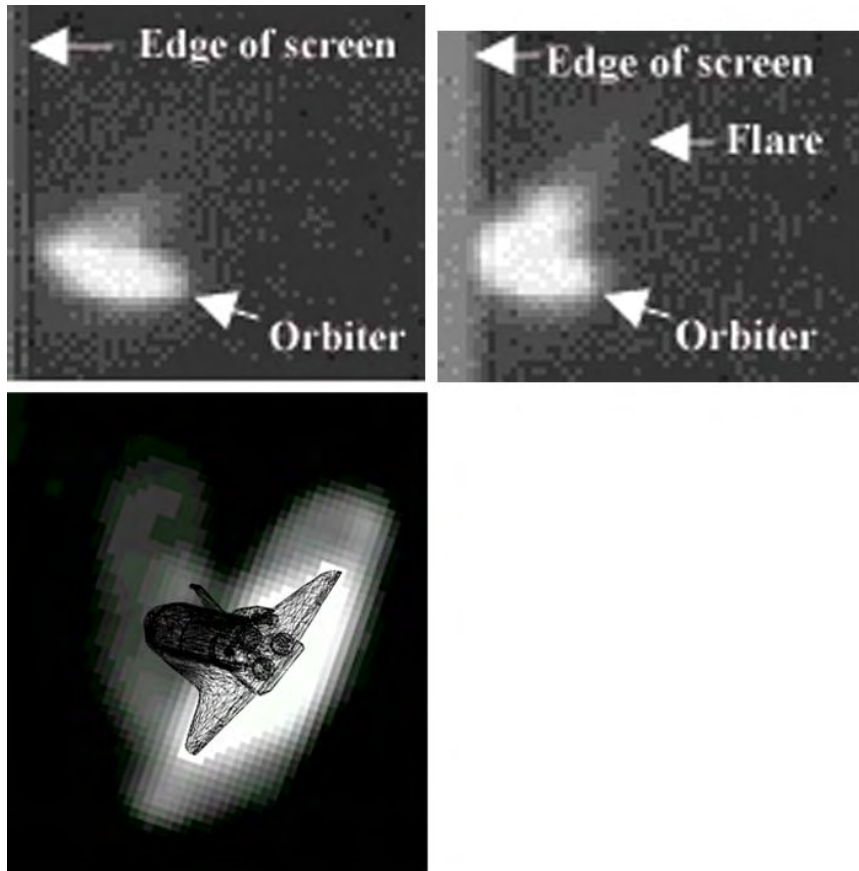
Flare 1 is an asymmetrical brightening of the orbiter shape at GMT 13:57:54.7 (EI+825) ±1 sec. This brightening was detected in images taken by a charge coupled device camera on a telescope, so its image is well magnified. Another brightening event was detected 6 seconds later (see GMT 13:58:00 (EI+831)). The two small images are the raw images from the data. The left image is interpreted to be the orbiter in a nominal condition. The image on the right is 0.4 second later. The larger image has been rotated to its correct viewing orientation and enhanced; a wireframe model of the orbiter at approximately the correct scale and orientation has been overlaid (figure 1.2-32).

Figure 1.2-32. Enhanced video captures showing the first observed flare in the trail.⁹

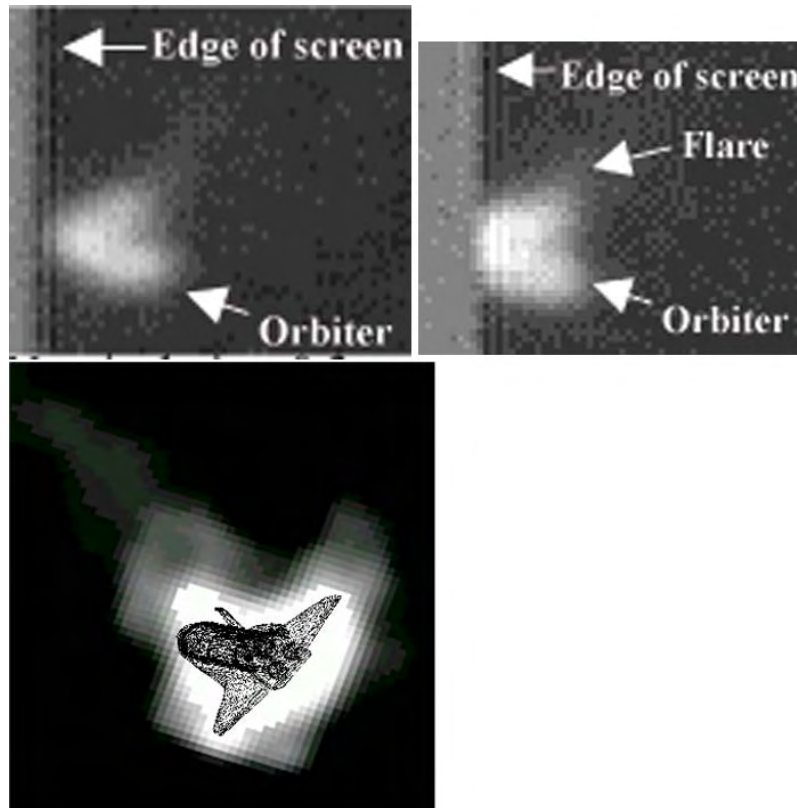
Figure 1.2-33. Enhanced video captures showing the second observed flare in the trail.

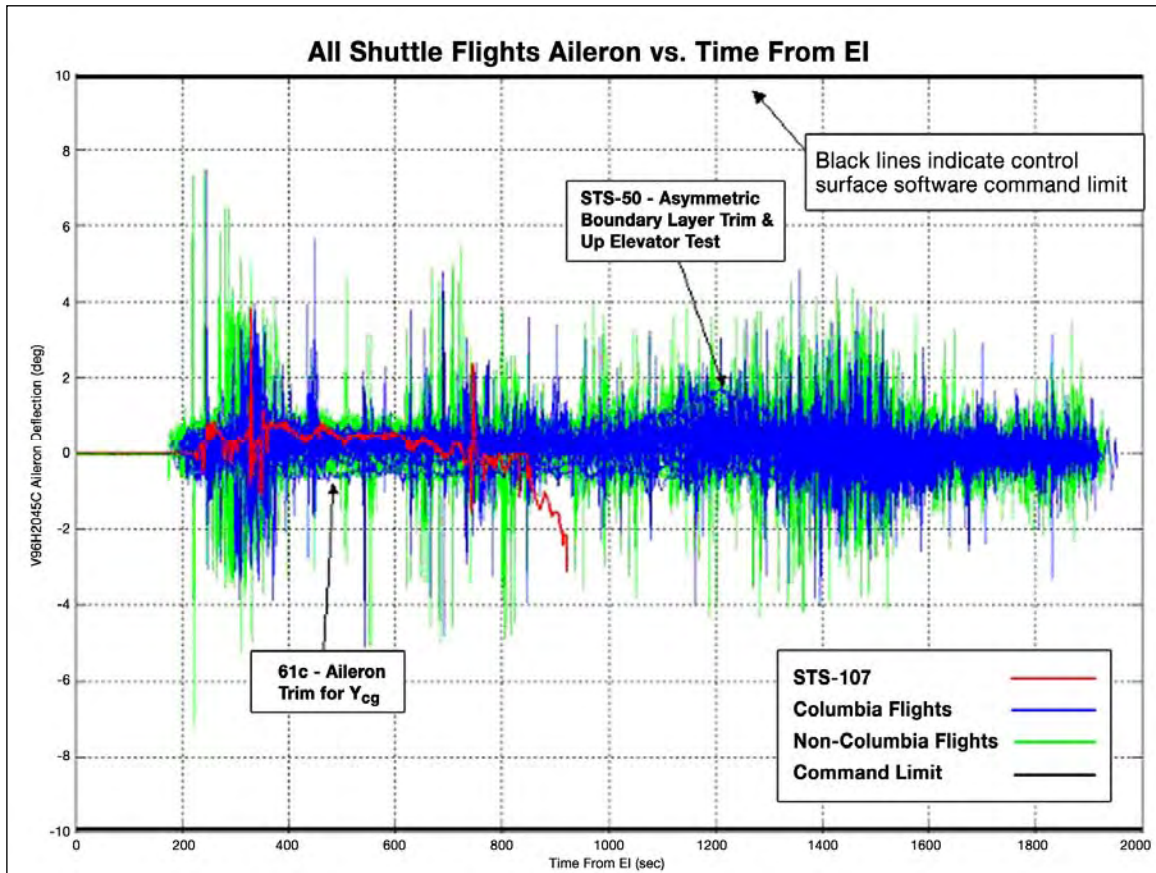
Start of “Sharp” Elevon Trim Increase. The FCS is now compensating for increasingly asymmetric aerodynamic loading and is commanding the elevon trim at a much higher than nominal rate. Time is uncertain (± 10 sec) (figure 1.2-34). [Master Timeline Rev. 15] </p>

Figure 1.2-34. The sharp divergence from previous flight experience starts at approximately GMT 13:58:19 (EI+850).¹⁰

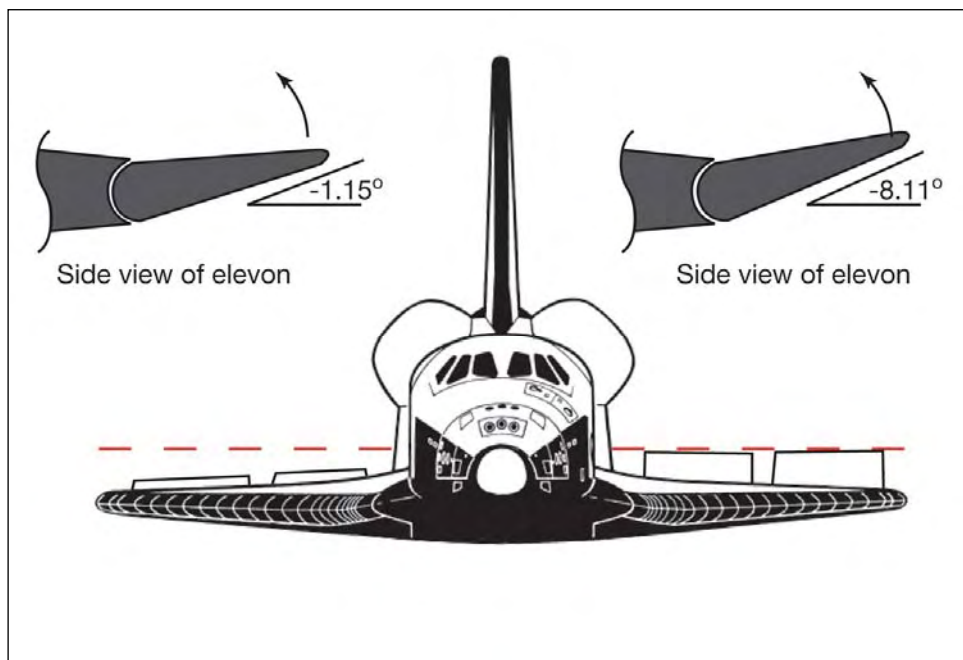
Left: -8.11 deg (deflected up)
 Right: -1.15 deg (deflected up)

Figure 1.2-38. Illustration of the last observed elevon deflections.

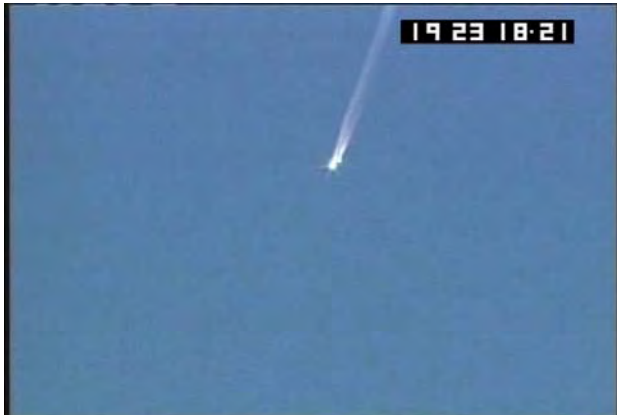
Debris D (possible Left OMS Pod). Video analysis identifies this as the earliest time at which Debris D is observed. Debris D was identified as possibly being the left OMS pod. (figure 1.2-42).</p>

Figure 1.2-42. Debris D is depicted in this frame.

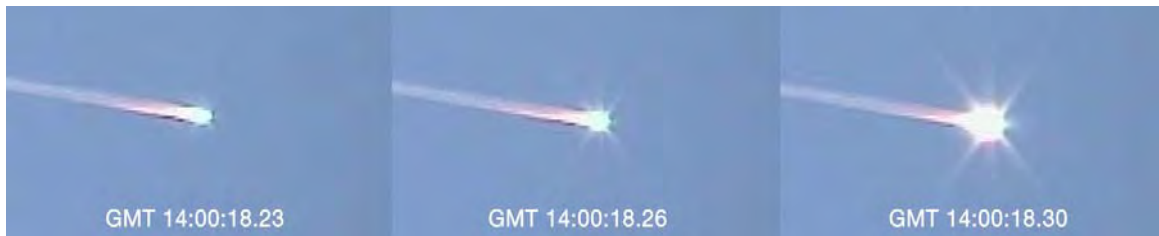
CATASTROPHIC EVENT. The CE is a period of time during which the orbiter vehicle is undergoing a major structural breakup. At this time, the accelerations on the forebody were estimated to be 3.5 Gs. The breakup sequence progressed over several seconds. Analysis of ground-based video of the event established the first detectable signs at GMT 14:00:18 (EI+969). Based on engineering analysis, the CE is thought to have started with the compromise of the PLBDs, exposing the payload bay longeron sill to entry heating. The skin splice between the midbody and the X₀ 582 ring frame bulkhead area, aft of the starboard x-link, failed due to a combination of mechanical and thermal loads. The forebody rotated away from starboard to port, causing the port x-link to fail due to bending loads. As the forebody separated from the midbody, various power, data, and ECLSS lines failed and the crew module was free to move forward and strike the inside of the forward fuselage. At GMT 14:00:25 (EI+976), the separated forebody is marginally visible. The CE is further supported by a collection of evidence that includes ground-based video of a large debris-generating event, the loss of the MADS/OEX recorder function, and the debris footprint (figures 1.2-43 and 1.2-44).

Figure 1.2-43. The Catastrophic Event is depicted in these three frames of video that cover 0.1 second. There is no change in the magnification/zoom factor. The third frame represents GMT 14:00:18.3 (EI+969.3).

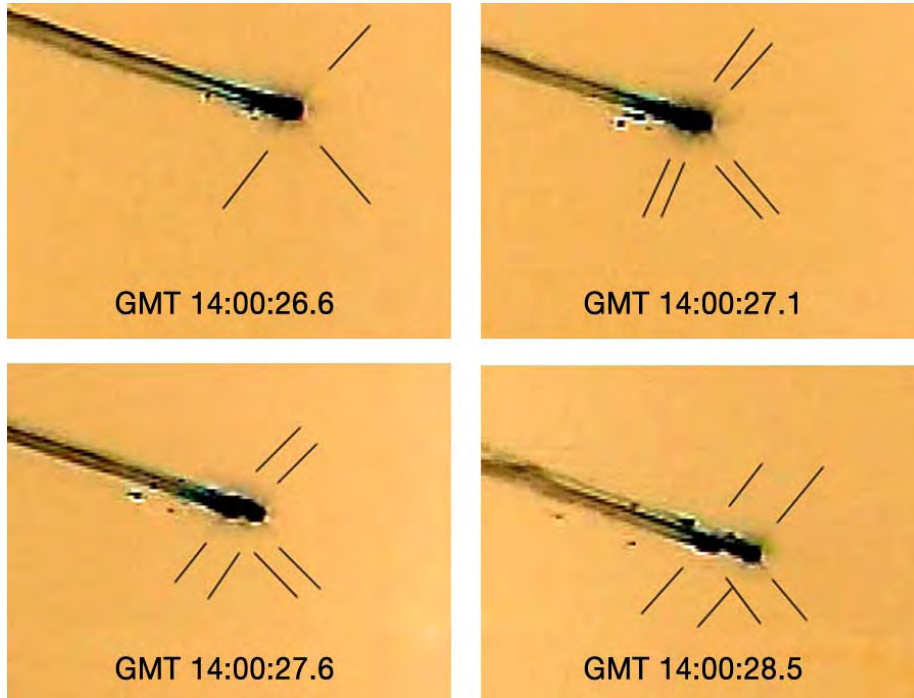
First visual indication that the orbiter had broken into multiple pieces (figure 1.2-46).

Figure 1.2-46. Color-inverted video images of the start of the double star event, GMT 14:00:26.6 (EI+977.6). Black lines have been added to more clearly identify the two separate objects.

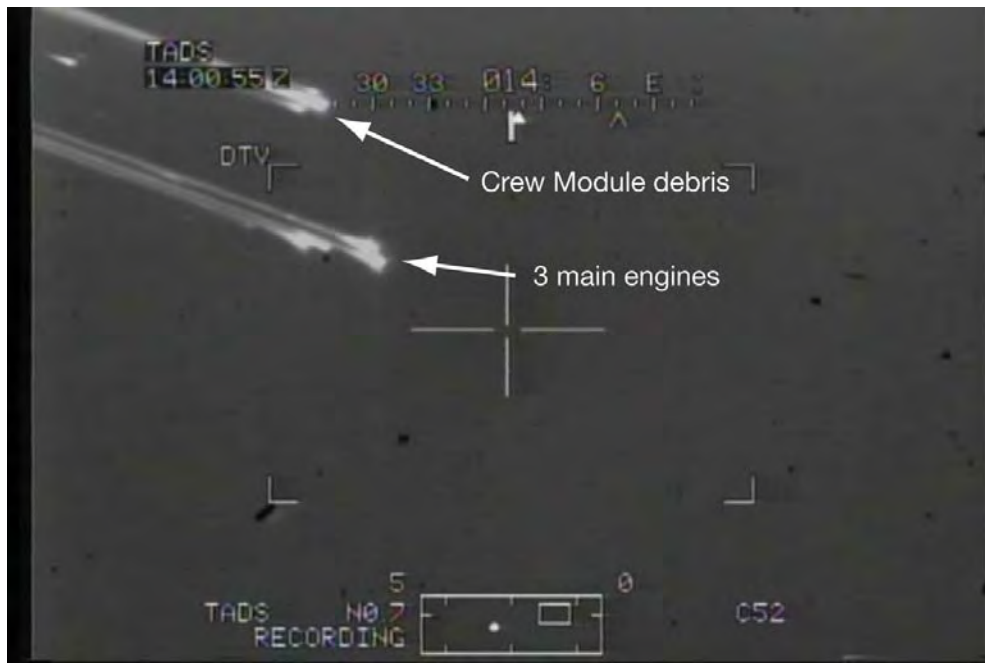
CREW MODULE CATASTROPHIC EVENT Begins. The CMCE is the initiation of a period of time during which the forebody was undergoing a major structural breakup. The breakup sequence progressed over several seconds and ends at approximately GMT 14:01:10 (EI+1021). Analysis of ground-based video of the event established the first detectable signs at GMT 14:00:53 (EI+1004). Based on engineering analysis, CMCE is thought to have started with the failure of the forward fuselage. Once the forward fuselage began to break away, the exposed crew module rapidly failed due to the combined effects of the high G-loads, aerodynamic forces, and thermal loads. The flight deck maintained structural integrity longer than the middeck (figure 1.2-47).
--------------------	--

Figure 1.2-47. Image from Apache³⁵ video showing crew module debris (top cluster) and the three main engines (cluster to left of cross hairs).

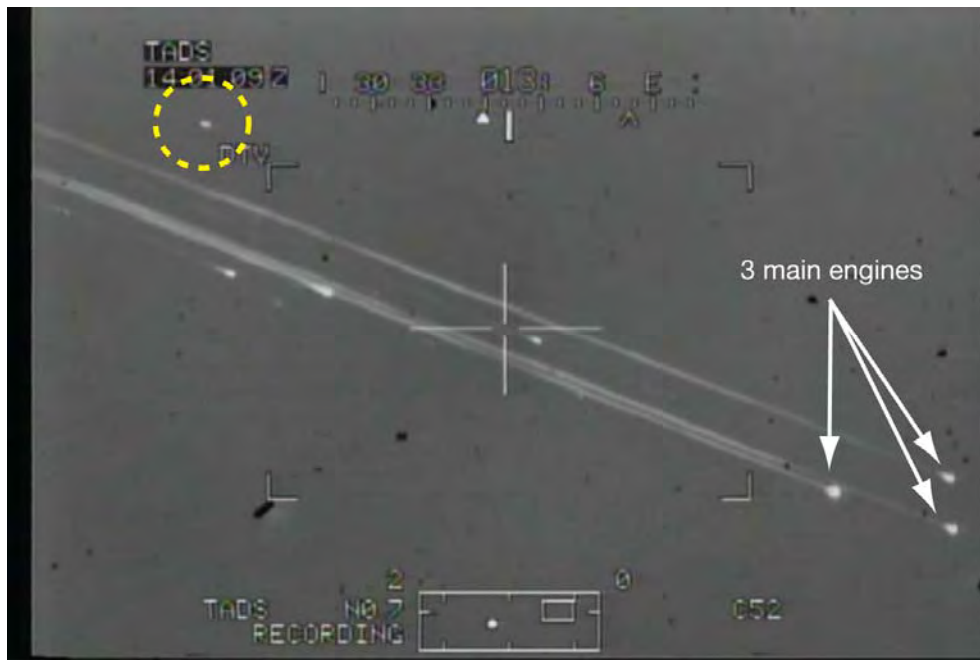
TD – Forward fuselage and crew module have fragmented into pieces too small to be detected on any of the ground-based videos (figure 1.2-48).
--------------------	--

Figure 1.2-48. Image is from the Apache video. Dotted circle indicates area where crew module debris is last visible. The three points in the lower right are the three main engines.

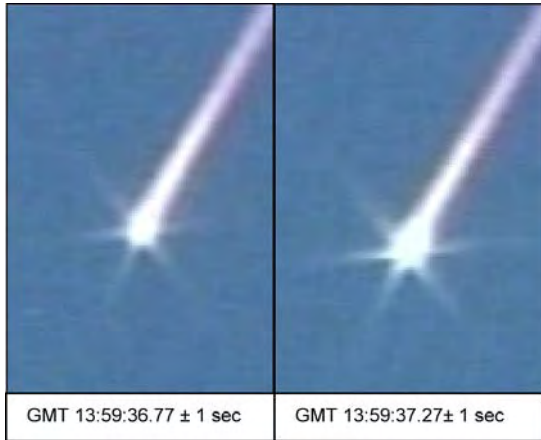
Significantly, ground-based video shows a marked change in the appearance of the orbiter’s trail at GMT 13:59:37 (immediately after the end of the first RGPC data set, RGPC-1) (figure 2.1-5). The width of the trail increases at this time, which likely indicates a change in the orbiter’s flight condition. In addition to the change in the width of the trail, the trail appears to pulse or “corkscrew” over a period of less than 1 second. It is possible that a large debris event (such as loss of a major portion of the wing) may have caused

Figure 2.1-5. Noticeable change in brightness at GMT 13:59:37±1 second.

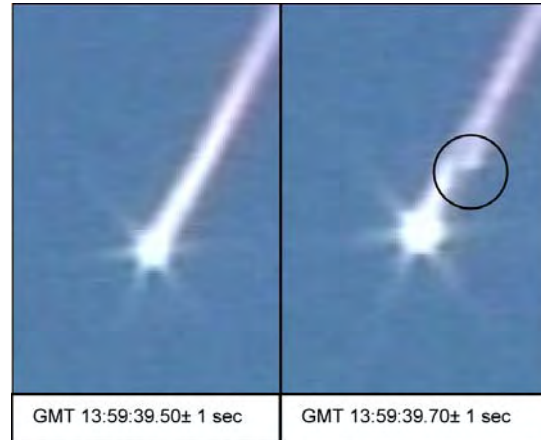
the LOC. However, the debris event closest to the LOS that was apparent in the video occurred 2 seconds, or more than 60 frames (figure 2.1-6), after the change in the trail's appearance. This suggests that it was subsequent to the LOC and was not the cause. Video time errors are up to 1 second, but the relative sequence of the events (brightening, followed by a debris event) is not changed.

Figure 2.1-6. Noticeable debris shedding event (circled at right) at GMT 13:59:39±1 second.

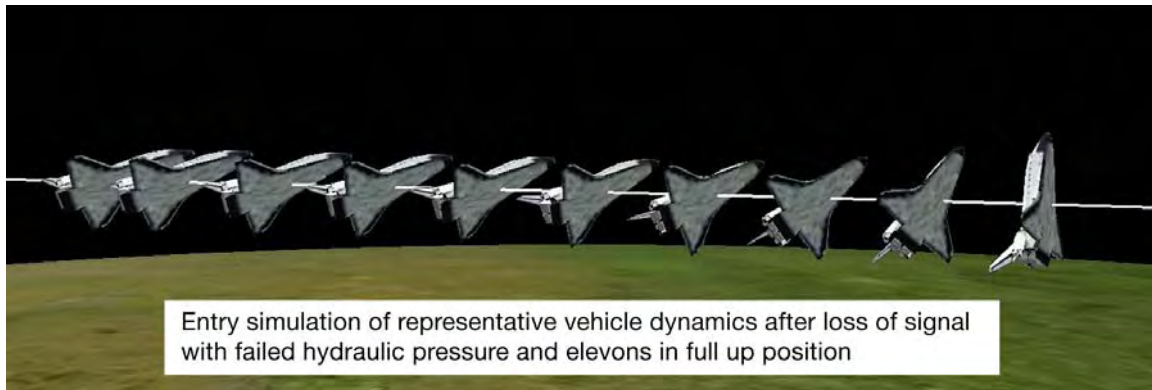
It was concluded that the most credible scenario for LOC was the loss of all hydraulic systems, causing the aerosurfaces to float and resulting in an uncontrolled pitch-up. Since the left wing contains locations where all three hydraulic systems have lines that are in close proximity (including the left gear well), it is probable that the loss of hydraulics was due to thermal damage as a result of the breach in the wing. Consequently, the SCSIT defined the vehicle LOC to begin at GMT 13:59:37, immediately after the LOS, when it was determined by inference that hydraulic power to the aerosurfaces was lost. Prior to this time, *Columbia's* DAP was still in control of the orbiter. The FCS was commanding the elevons and the RCS yaw jets to counteract the increasing drag on the damaged left wing. The LOC marks the time when the *ability* to control the vehicle was lost, not when *Columbia* departed known attitudes (which occurred shortly thereafter).

Figure 2.1-7 shows the increasing angle-of-attack simulation. The figure shows the orbiter attitude at 1-second intervals, beginning at GMT 13:59:37 and ending at GMT 13:59:46. The white line in the figure is the reference trajectory.

Figure 2.1-7. Sequence (1-second intervals) showing a simulation of orbiter loss of control pitch-up from GMT 13:59:37 to GMT 13:59:46. White line indicates vehicle trajectory relative to the ground.

Recommendation L3-2. Future vehicles should be designed with a separation of critical functions to the maximum extent possible and robust protection for individual functional components when separation is not practical.

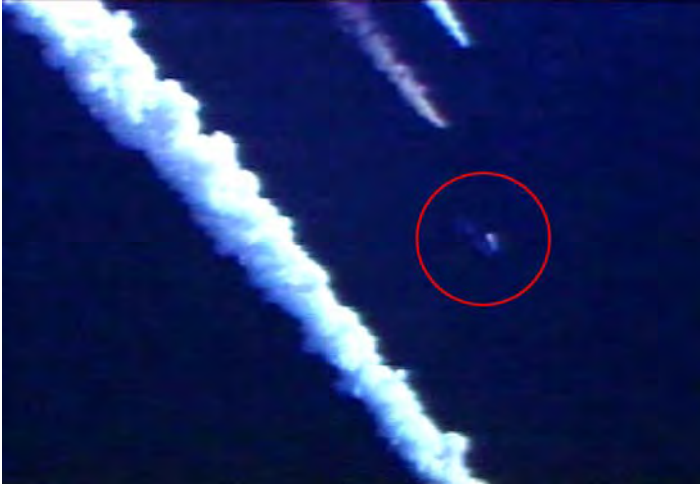
The SCSIT received anecdotal information that the *Challenger* CM was believed to have reached a stable attitude (“trimmed”) in a nose-into-the-wind condition. This belief was based on a video that shows a brief clear view of the CM in this orientation (figure 2.1-19), and the fact that the CM appeared to have impacted the water in a slightly nose-down condition.¹² As a result, the assumption upon which crew procedures are based (see Section 3.3) was that in an LOC/breakup scenario, the CM would trim nose-down after reaching terminal velocity. Although many types of data regarding the *Challenger* accident are available, they are almost entirely limited to information about the cause of the accident and are not related to crew survival. Relevant information was generally located by contacting personnel who worked at NASA at the time. No data could be found to support this anecdotal conclusion other than the video. Ground-based video of the forebody of *Columbia* implied that the forebody was rotating. Consequently, the SCSIT set out to assess the assumption that the *Columbia* forebody came to an aerodynamically stable attitude.

Figure 2.1-19. Video-capture showing Challenger crew module (circled in red) pointed nose into the direction of travel.

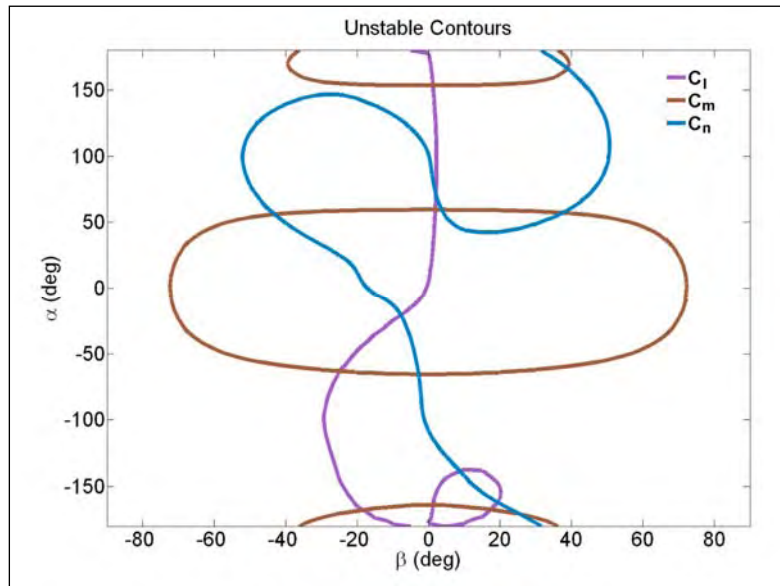
However, evaluation of the rolling and yawing moment coefficients, C_l and C_n showed that the statically stable attitudes in pitching moments (C_m) are not stable in either yaw or roll. Figure 2.1-22 shows the contour plot of all three moments across an alpha and a beta sweep. Locations where all three moments coincide would be stable in all three axes. Although at alpha approximately +50 degrees the moments appear very close to coinciding, close inspection showed that they do not.

Figure 2.1-22. Contour plot of pitch, roll, and yaw moments for a crew module showing no stability due to slight offset in lateral center of gravity.

Finding. The forebody and the CM of the orbiter are not aerodynamically stable in attitude with any initial rates or lateral center of gravity (c.g.) other than zero.

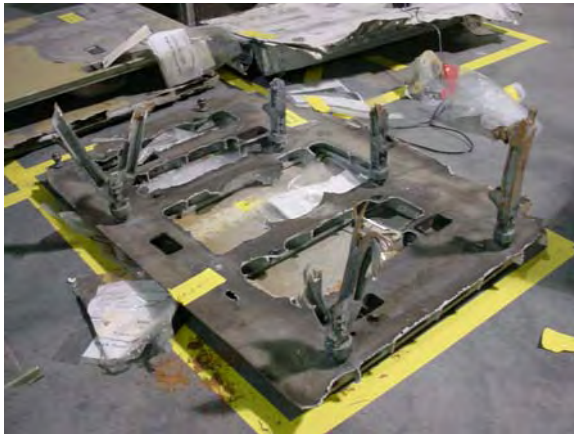
The lithium hydroxide (LiOH) stowage volume door was recovered with portions of the two seats still attached (figure 2.1-33). The LiOH door is located on the middeck floor with seats 6 and 7 attached to the door (figure 2.1-34). The condition of the door was markedly different from other segments of the middeck floor in that significant thermal erosion of the thinner areas had occurred (see Section 2.4). The hypothesis was formed that additional mass attached to this piece of debris resulted in higher heating. A thermal analysis was performed to determine whether the additional mass provided by the two seats and/or two crew members would result in the observed thermal damage.

Figure 2.1-33. Recovered lithium hydroxide door with some seat legs still attached.

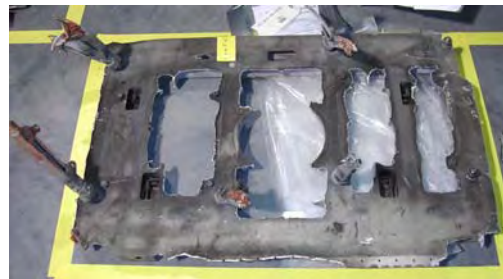
Photographs of the recovered LiOH door are shown in figures 2.1-36 and 2.1-38. The thermal failure corresponds to the thin sections of the door. Sections that are thicker show little or no thermal erosion. From observations of the material deposition patterns and the burn-throughs on the recovered door, the major thermal effects were directional, with flow impinging primarily on the bottom side (the side with the stiffeners). This is supported by the highly directional deposition on seats 6 and 7 (see Section 3.1).

Figure 2.1-36. Top surface of the recovered lithium hydroxide door, facing the middeck.
