Columbia Crew Survival Investigation Report

NASA/SP-2008-565

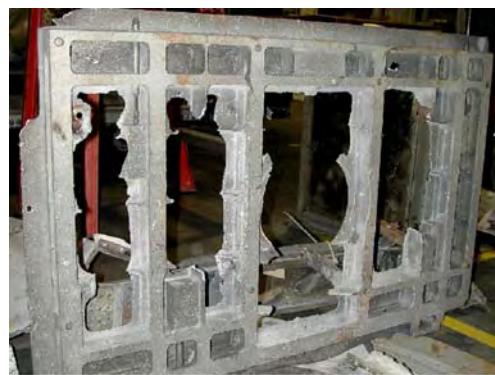
Photographs of the recovered LiOH door are shown in figures 2.1-36 and 2.1-38. The thermal failure corresponds to the thin sections of the door. Sections that are thicker show little or no thermal erosion. From observations of the material deposition patterns and the burn-throughs on the recovered door, the major thermal effects were directional, with flow impinging primarily on the bottom side (the side with the stiffeners). This is supported by the highly directional deposition on seats 6 and 7 (see Section 3.1).

Figure 2.1-38. Lower surface of the recovered lithium hydroxide door, facing the lower equipment bay.

For the GMT 14:00:59 estimated release time, the analysis implies the third and fourth configurations (door with one and two crew members, respectively) can produce the thermal damage observed on the recovered LiOH door. Since visual inspection of the recovered door suggests that the object was not tumbling, the stable fourth configuration is the most thermally viable solution. However, both the third and the fourth configurations are improbable because the thermal effects would have melted the seat straps and released the crew members. The surrounding debris was evaluated to determine whether the LiOH inside the compartment caught on fire. Significant portions of LiOH canisters were recovered as well as other items stored in the compartment. Both the canisters and the structures of the compartment were not seriously thermally damaged, which strongly suggests that a fire did not occur.

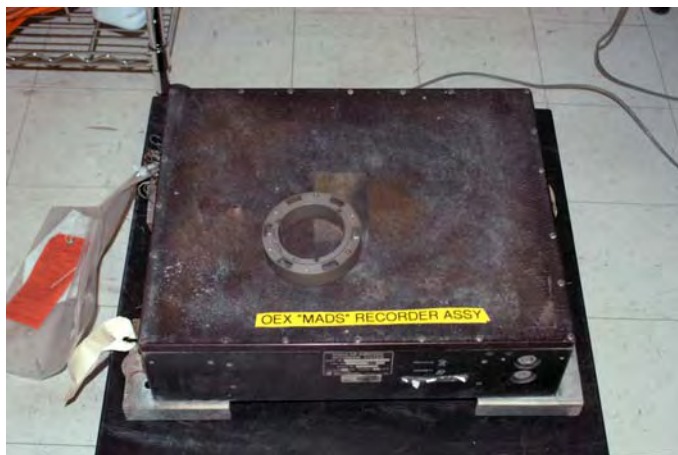
The OEX recorder, which was part of *Columbia*’s MADS, was found near Hemphill, Texas in near-perfect condition. Figure 2.1-44 shows the recovered OEX recorder. The data on the tape in this recorder were critical to the accident investigation, making the recorder one of the most important recovered items from *Columbia*.

Figure 2.1-44. Recovered orbiter experiment recorder from STS-107. [Columbia Reconstruction Database, debris item no. 54057]

The rectangular shape of the box made it a good candidate for ballistic analysis providing a release time with high confidence. The box showed no signs of thermal erosion or exposure to high temperature environment. Text labels that have been imprinted on the box still remain. The data that were recovered from the recorder were recorded on magnetic tape that delaminates at 125°F (52°C). An analysis was performed to estimate the thermal damage that a free-flying OEX recorder would receive due to aerothermal heating after release from inside the CM.

The lack of external thermal damage is quite noteworthy. Anodizing is still mostly present, as are the exterior labels. Exposed wires still have insulation. Finally, since aluminum is a good conductor it is expected that the internal wall temperature would have been close to the surface temperature. Since the recorder’s magnetic tape delaminates at 125°F (52°C), this also suggests that the aluminum may not have reached the predicted high temperature of 470°F (243°C).

The conclusion is that the OEX recorder was not released from the CM independently. If the temperatures reached as high as predicted, the magnetic tape would have delaminated and the casing would have likely been deformed. This analysis combined with the relatively pristine condition of the recorder seems to imply that something must have protected the recorder during entry before it was completely exposed to the aerothermal heating environment. Ultimately, no conclusion can be made as to what ancillary structure or other mechanism protected the OEX, only that it was protected.

Recommendation L3-3. Future spacecraft design should incorporate crashworthy, locatable data recorders for accident/incident flight reconstruction.

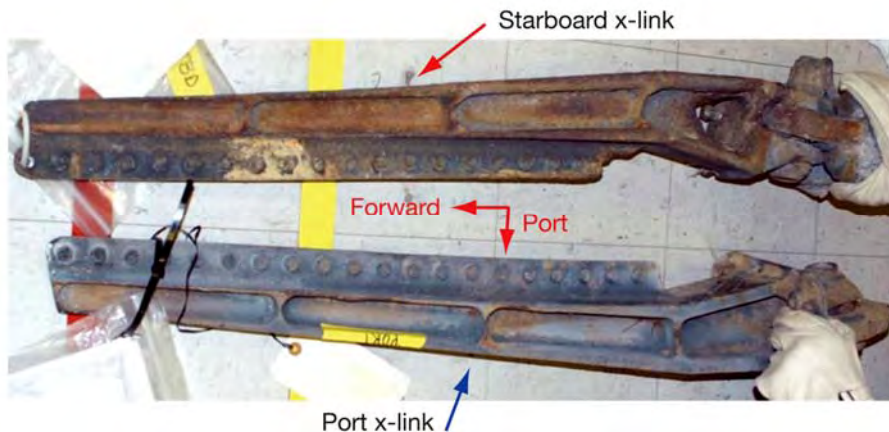
Figure 2.1-47. Comparison of port and starboard x-links recovered from Columbia. [Columbia Reconstruction Database, debris item no. 1678, and Columbia Reconstruction Database, debris item no. 1765]

The heating experienced by the starboard x-link was severe enough to melt away the top flange and to burn a hole through the 0.25-in.-thick web. Figure 2.1-48 shows another comparison of the two x-links with a better viewing angle to see the flange damage. Figure 2.1-49 shows a close-up view of the starboard x-link where a hole has been melted through the web.

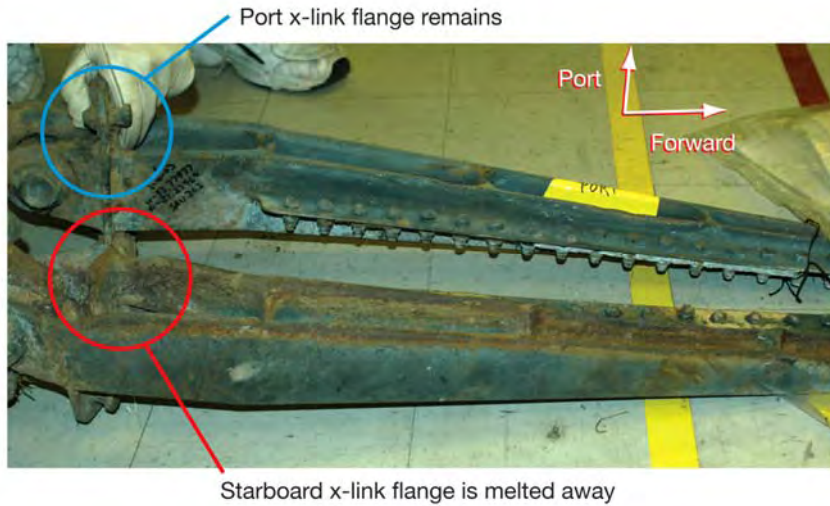
Figure 2.1-48. Comparison of port and starboard x-link flanges. [Columbia Reconstruction Database, debris item no. 1678 (top) and Columbia Reconstruction Database debris item no. 1765 (bottom)]

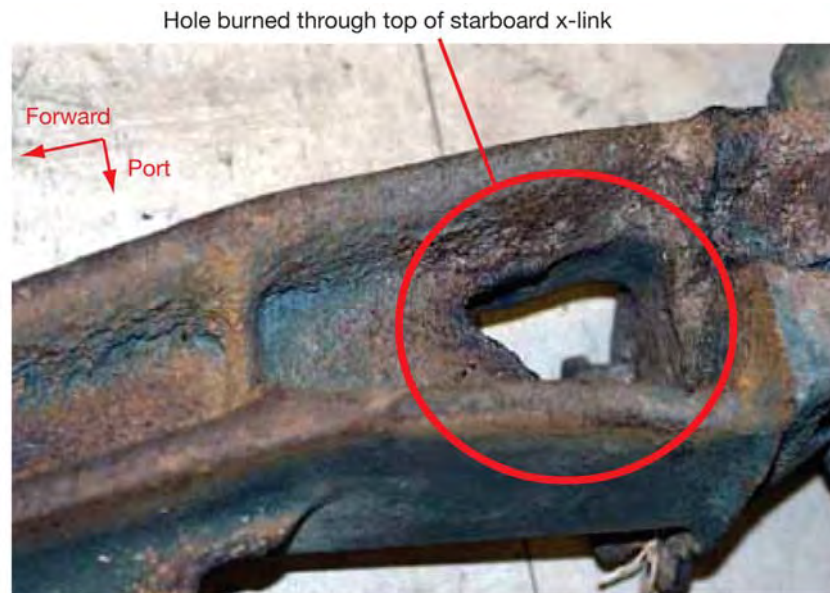
Figure 2.1-49. Close-up of the hole in the starboard x-link. [Columbia Reconstruction Database, debris item no. 1765]

Knowing the heat of ablation per unit of mass allows a first-order estimate of the required heating that must be applied to cause that burn-through hole in the starboard x-link. The dimensions of the burn-through area are 2 in. by 2 in. and the thickness of the x-link in that area is 0.25 in.

Finding. Thermal analyses predicted that entry aeroheating alone was insufficient by an order of magnitude to produce the observed thermal damage on the x-links. Therefore, the x-links must have experienced other heating mechanism(s) in addition to normal entry heating.

Conclusion A13-2. The heating from a Type IV shock-shock impingement and titanium combustion (in some combination) likely resulted in the damage seen by the forward payload bay door rollers and the x-links.

Recommendation A13. Studies should be performed to further characterize the material behavior of titanium in entry environments to better understand optimal space applications of this material.

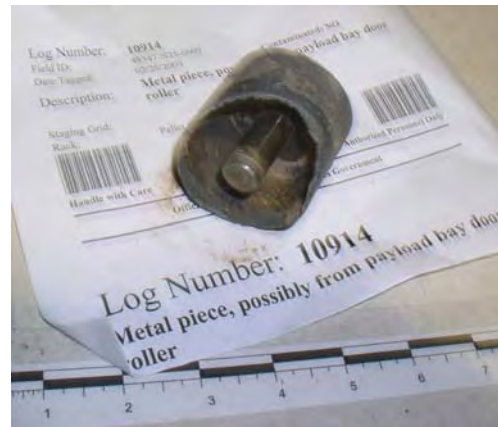
Another instance of the thermal erosion of high-temperature materials was seen in the PLBD rollers, which contain notable amounts of titanium. Initially, the interest in the PLBD rollers resulted from a search of possible sources for the titanium deposition that was found on the overhead windows (see Section 2.4).¹⁸ A search for forward structures containing titanium showed that the nearest source of titanium material to the windows was the forward PLBD rollers. These rollers are made of aluminum, titanium, and an Inconel sleeve, and the PLBDs rest on them when the doors are closed. The forward rollers are attached to the top of X_o 582 ring frame bulkhead in close proximity to the windows on which the titanium depositions were found (figure 2.1-52). Several recovered rollers from this location showed pronounced erosion of the exposed titanium surfaces, and one roller was recovered with only part of the Inconel sleeve remaining; all titanium and aluminum inner structures were missing (figure 2.1-53). Table 2.1-2 shows the material properties of stainless steel (A286), Inconel 718, aluminum 2000 series, and titanium 6Al-4V. As shown, the Inconel and aluminum alloys used in the rollers both have lower melting temperatures than the titanium alloy.

Figure 2.1-53. Recovered payload cylinder bay door roller with inner material absent and Inconel sleeve remaining. [Columbia Reconstruction Database, debris item no. 10914]

The next question was whether the observed amount of material loss was reasonable for the timeframe. As mentioned before, heating only occurs when the object is facing into the direction of travel, yet it is not believed that the forebody stabilized in a specific attitude. Additionally, the nature of the window deposition indicates that the titanium and titanium/aluminum deposition event was continuous and not cyclical. Therefore, the entire titanium/titanium aluminum ablation event had to occur in a relatively short period of time. Given an attitude change of approximately 36 deg/sec (0.1 rev/sec), the maximum duration of heating considered reasonable was about 3 seconds. In any attitude other than directly into the velocity vector, heating is less but is still present. Therefore, the CFD analysis only showed the peak heat was possible. It seems probable that some additional mechanism would be required to deeply erode the rollers.

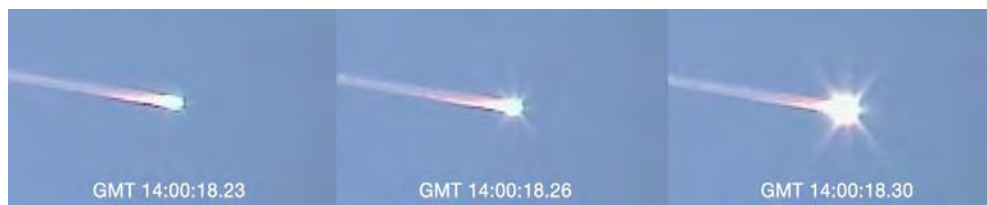
The second significant event that is seen in video is the CE. Figure 2.2-5 shows the CE; there is no change in magnification between frames. The video of the CE is a distinct visual event in which the orbiter envelope brightens significantly and the trail width doubles. Additionally, some color change to orange is evident just prior to the CE. The color change is not readily visible in the still image frames that are taken from the video. In videos of the *Challenger* accident, an orange color was also seen in the videos and was assumed to be hydrazine, the material that is contained in the Orbital Maneuvering System (OMS) pods and RCS tanks. It is unknown whether the orange color seen in *Columbia*'s trail correlates to OMS or RCS tanks, or to some other cause.

Figure 2.2-5. The Catastrophic Event is depicted in these three frames of video that cover 0.1 second. There is no change in the magnification/zoom factor. The third frame represents GMT 14:00:18.3.

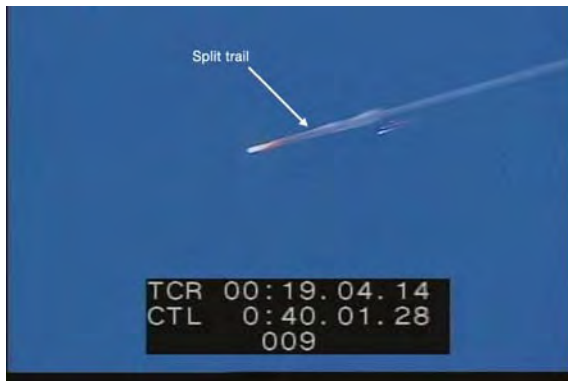
Shortly after the brightening event and color change, a split trail is seen (figure 2.2-6). This strongly supports that the orbiter broke into multiple pieces at the time of the CE. The NBC video shows that the orbiter has an intermittent split trail prior to the CE. Prior to the CE, the split trails are tied to the separation of pieces of debris, and a singular main body trail continues after the separation of the debris. The split trail seen after the CE is constant; it does not dissipate and does not resolve back to a singular trail (figure 2.2-7).

Figure 2.2-6. Split trail after the Catastrophic Event. [GMT 14:00:18.6]

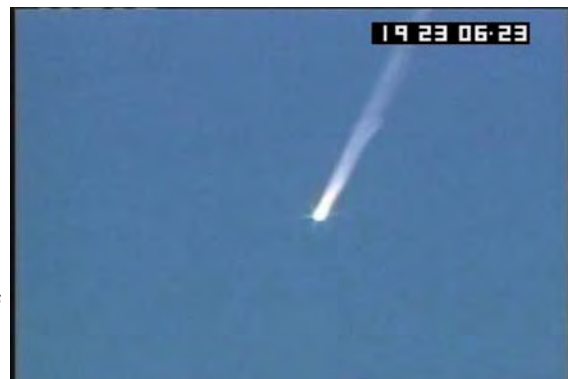
Figure 2.2-7. Persistence of the split trail 23 seconds after the Catastrophic Event. [GMT 14:00:41.1]

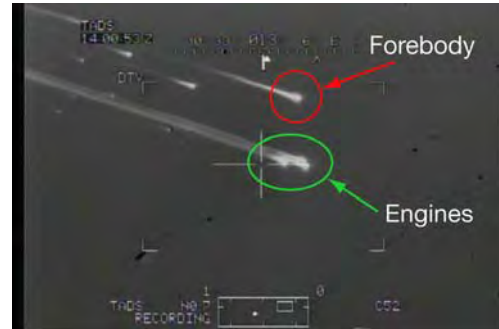
The last time at which the main engines visually appeared to be a single unit is GMT 14:00:50.6; this is defined as the starting point for engine separation. Figure 2.2-10 shows the engines at GMT 14:00:53, the three pieces below the forebody which are circled in green. Their separation is already well under way. Considering that visual separation of the orbiter pieces after the CE took about 10 seconds, the actual time of separation of the engine components from one another may have been

Figure 2.2-10. Clear visual separation of the three main engines.

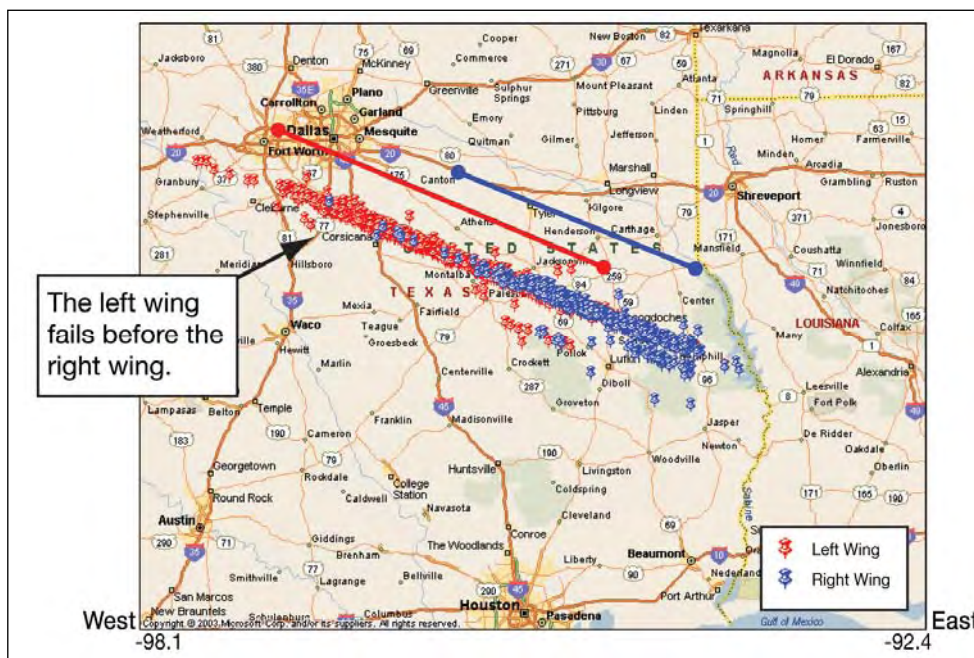
Figure 2.2-12 identifies where the wing structure is in relationship to the other orbiter structural components. TPS tile is included in these figures, as some tile adhered to structure and it was not easily possible to separate out individual tiles. Figure 2.2-13 shows a ground debris map that is similar to that produced in the CAIB Report, Volume I, p. 75; however, figure 2.2-13 shows all the debris for the wings whereas the CAIB map shows only the RCC panels. As the CAIB reported, the left wing failed before the right wing. This is implied in figure 2.2-14 as well. Overlay mapping of debris at their correct latitudes and longitudes prevents easy recognition of their actual ground footprints. The bars shown on the map and in later ground debris maps represent the main cluster of the debris. If coverage extends beyond the map shown, an arrow indicates that the footprint continues off the map. The bar shown above each histogram indicates the longitude range covered by the overlay mapping.

Figure 2.2-13. Debris field of the left and right wings.

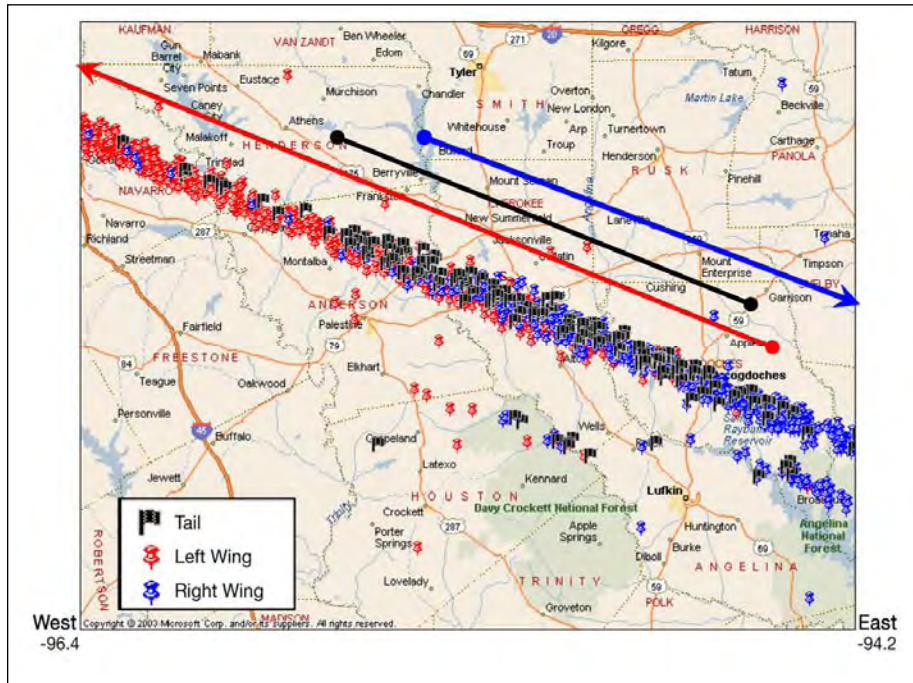
Figure 2.2-14 illustrates the debris of the tail section in relation to the wing debris. The bulk of the tail debris impacted west of the bulk of the right wing debris. Figure 2.2-15, which is a histogram of longitude vs. the number of debris items, shows this as well. The lines above the histogram indicate the approximate area of the histogram that the debris map covers. Figure 2.2-15 suggests that the tail possibly began to depart between the left wing and the right wing.

Figure 2.2-14. Partial debris field of the left wing, right wing, and tail.

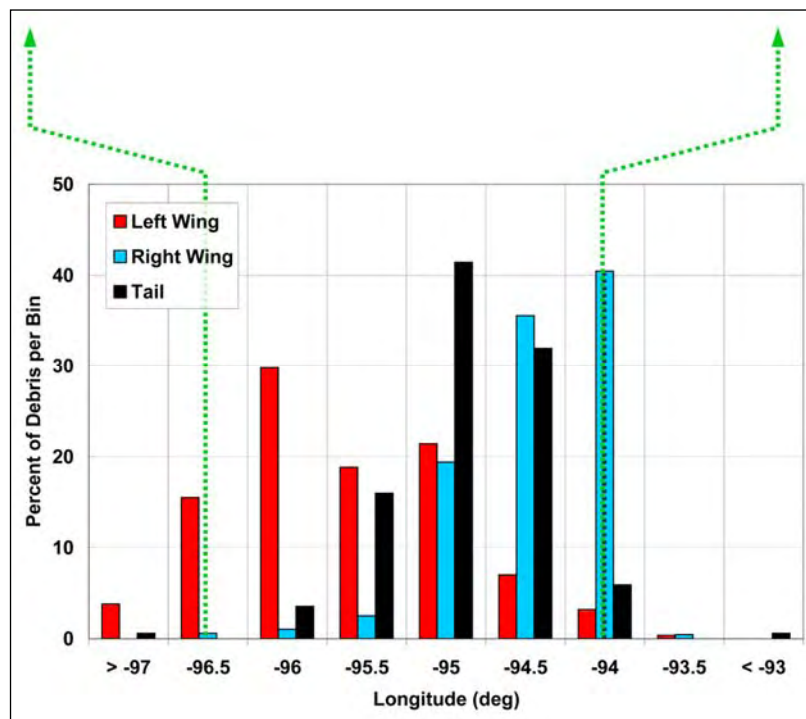
Figure 2.2-15. Histogram of the left wing, right wing, and tail debris. The green dotted lines are the projection onto the histogram of the longitude range shown in the map.

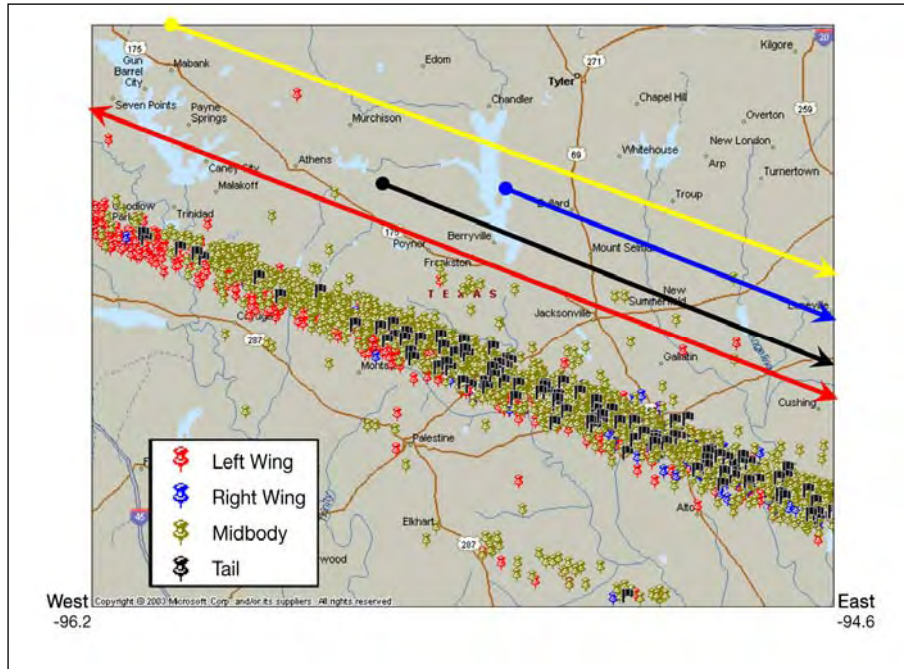
Figure 2.2-12 identifies where the midbody is related to the other orbiter structural components. The midbody consisted of the mid fuselage, payload bay, and PLBDs (SPACEHAB is not included in this chart). The midbody began losing structure and shedding objects after the left wing but prior to the tail (figures 2.2-16 and 2.2-17). The midbody debris shown is comprised predominantly of PLBD structure, although pieces of the midbody are scattered throughout the entire debris field.

Figure 2.2-16. Partial debris field of the left wing, right wing, midbody, and tail.

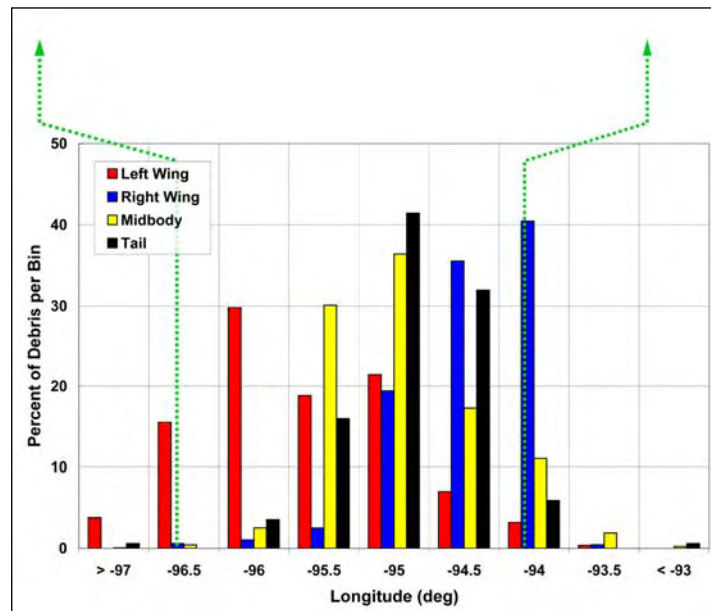
Figure 2.2-17. Histogram of the percentage of debris found vs. longitude for the left wing, right wing, midbody, and tail. The green dotted lines are the projection onto the histogram of the longitude range shown in the map.

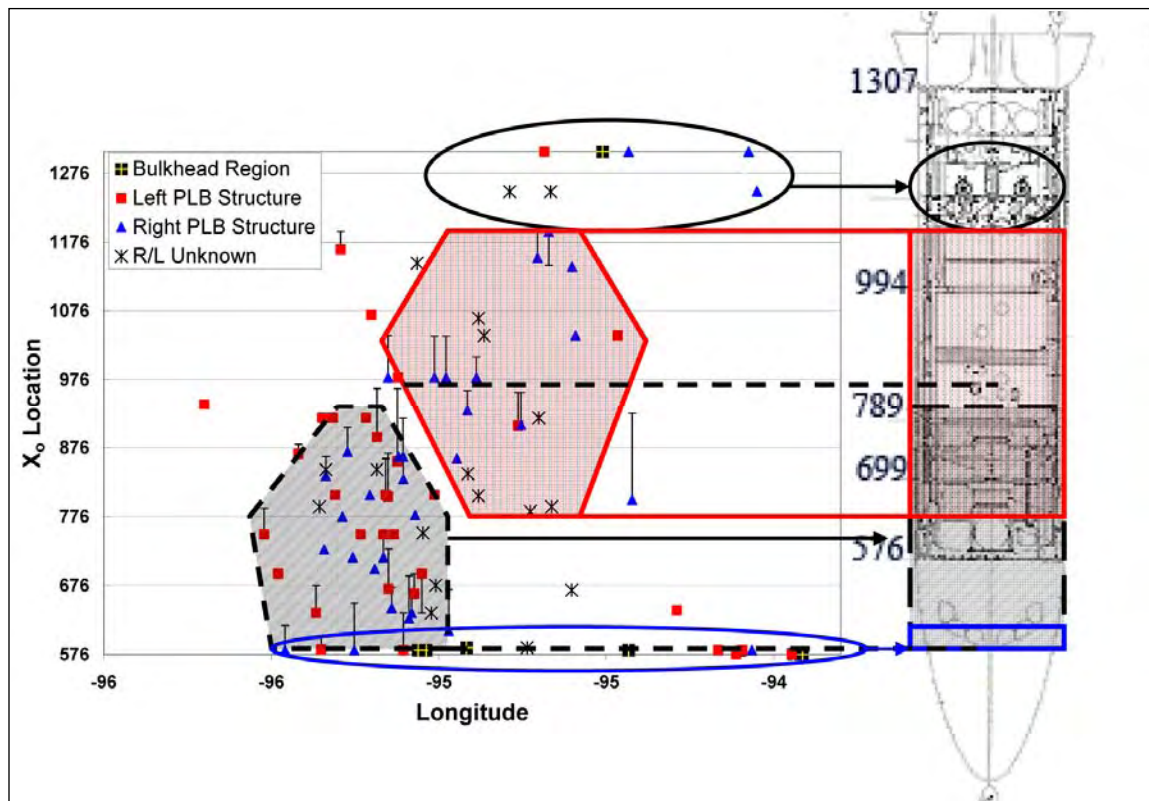
The westernmost piece of ground debris from the midbody structure with a known X_o location was a port location just aft of SPACEHAB. However, this appears to be an outlier data point. Figure 2.2-18 indicates that based upon recovered midbody structure, the midbody first suffered a major failure ranging from about X_o 582" to X_o 919".

The next grouping of debris predominantly originates from X_o 776" (towards the aft of SPACEHAB) to aft of the Fast Reaction Experiments Enabling Science, Technology, Applications, and Research (FREESTAR) payload near X_o 1124", although there are a few pieces near the forebody bulkhead (X_o 582").

The final cluster is from the aft region of the midbody. As debris originating from near the midbody aft bulkhead (X_o 1307") appears farthest east in the debris field, this suggests that some midbody payload bay structure remained attached to the aftbody.

Figure 2.2-18. Longitude vs. the X_o origin of the structural debris of the mid fuselage. To the right is a drawing of the mid fuselage with key X_o positions marked.

The data in figure 2.2-18 cannot be used to determine a port or starboard initiation of breakup of the midbody. Size of individual items was also examined with the assumption that ballistic numbers of objects of roughly the same size and shape will land in the order in which they separate from the orbiter. The number

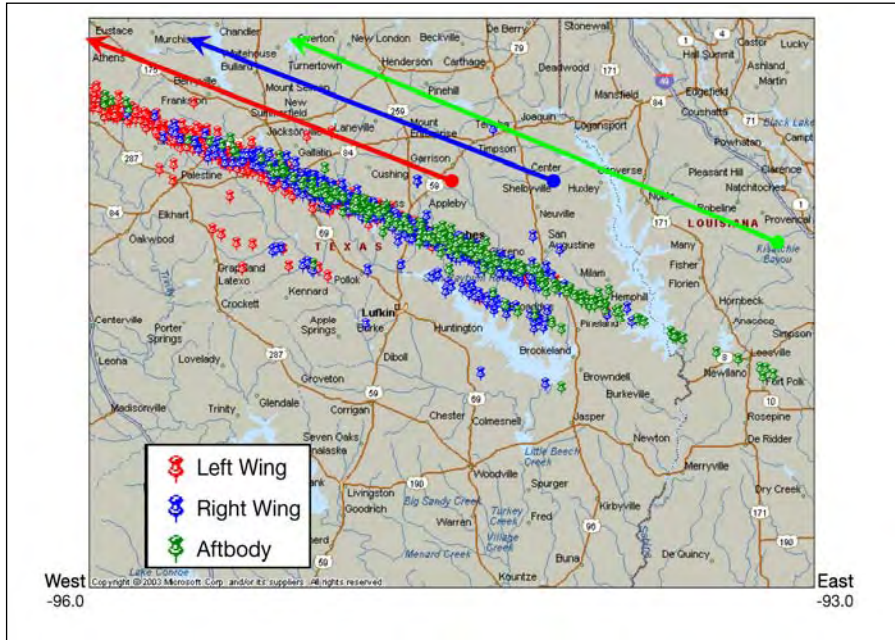
Figure 2.2-19. Partial debris field of the left wing, right wing, and aftbody.

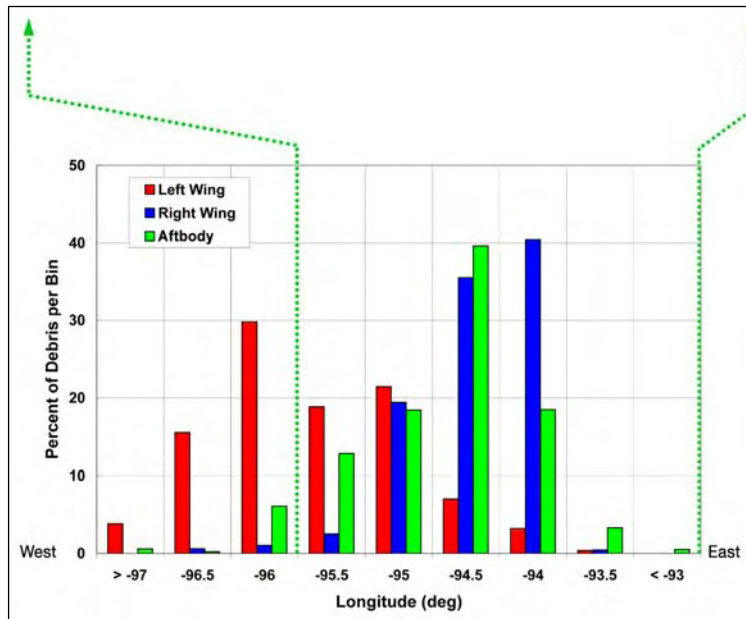
Figure 2.2-20. Histogram of debris of the wings and aftbody (including orbiter main engines). The green dotted lines are the projection onto the histogram of the longitude range shown in the map.

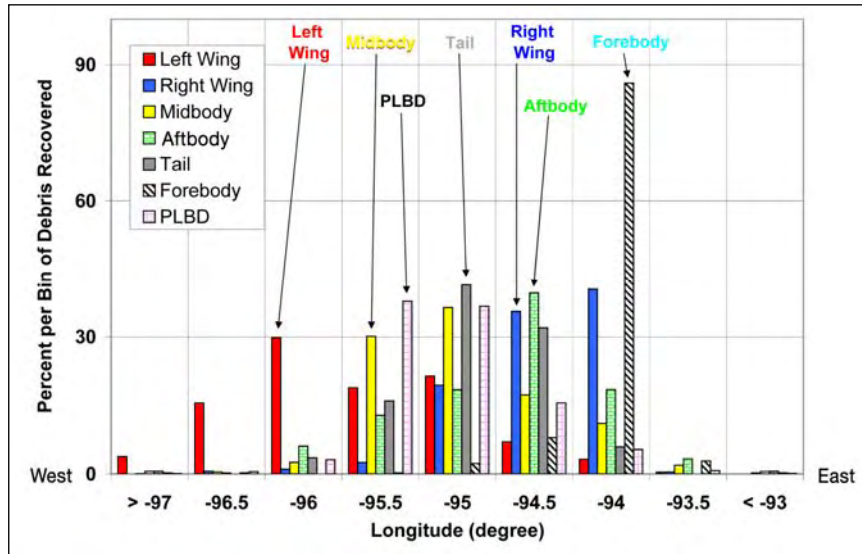
In summary, figure 2.2-21 shows an overall assessment of debris clusters. The westernmost longitude bin of each group that exceeded 30% of the recovered debris group is referenced with an arrow; the label above the bin identifies the debris group. It was observed that when the number of recovered debris items from one orbiter structural zone reached approximately 30%, the next group began to appear in rapidly increasing numbers. The significance of this observation is not known. It may be an artifact of data processing, or it may be characteristic of a cascade effect of structural breakup. This is a topic that may warrant further research and investigation.

Figure 2.2-21. Histogram of the relative order of the major debris groups recovered.

There was no evidence from the ballistic or debris cluster analysis that the forebody suffered any major breach before it separated from the midbody. Figure 2.2-21 (in the debris cluster assessment section) shows that forebody debris does not begin to appear in the debris field until other midbody debris is present in large quantities.

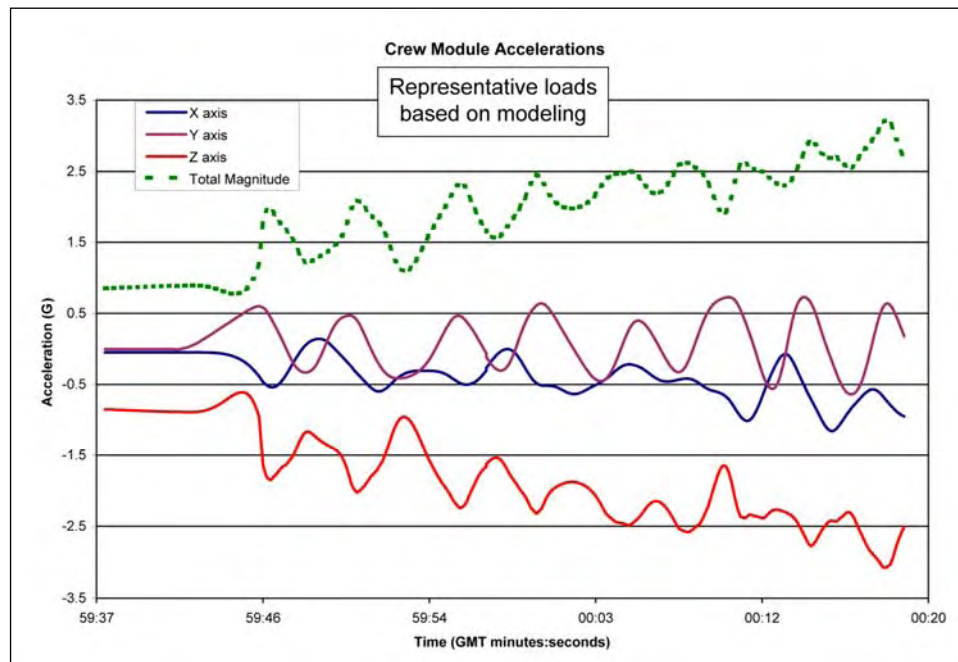
It is unlikely that any part of the FF experienced major structural failures under the estimated loading before the CE. A motion analysis was performed to compute loads at key locations after the LOC of the orbiter (see Section 2.1). Figure 2.2-26 shows that the estimated G loading at the CM increased to slightly more than 3 G just prior to the CE. Acceleration along the vehicle's Z axis (G_z) is the major component. This analysis assumed intact PLBDs. Loss of the doors may have increased loads in unknown ways such that the motion may have been affected. Assuming that the PLBDs were still intact, the results indicated that inertial loads were within the orbiter vehicle design limits.

Figure 2.2-26. Resultant acceleration (G) vs. time prior to the Catastrophic Event in the orbiter coordinate frame.

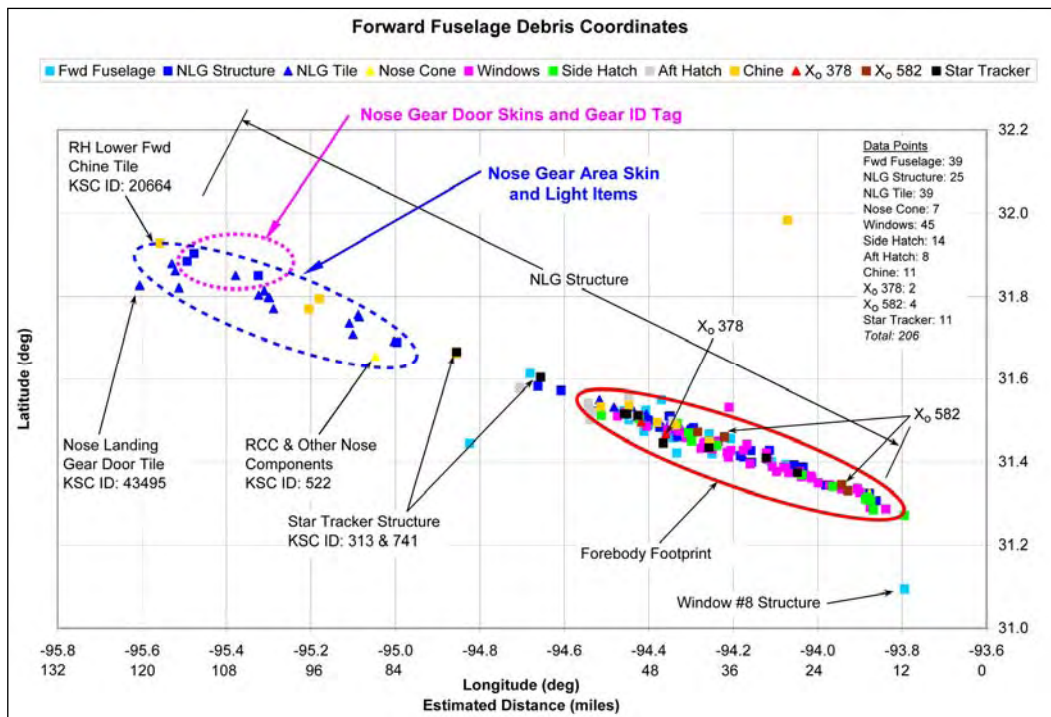
Most of the FF debris components that were recovered west of the main forebody debris field were TPS fragments and external items such as star tracker doors that came from the forward section of the FF, probably due to warping of the skin and aerodynamic loads as the forebody rotated (figure 2.2-27). Approximately 87% of the remaining FF structural debris has the same footprint as the CM debris footprint. This implies that the significant FF structural breakup occurred nearly coincidental with the CM shell breakup.

Figure 2.2-27. Forward fuselage debris field.

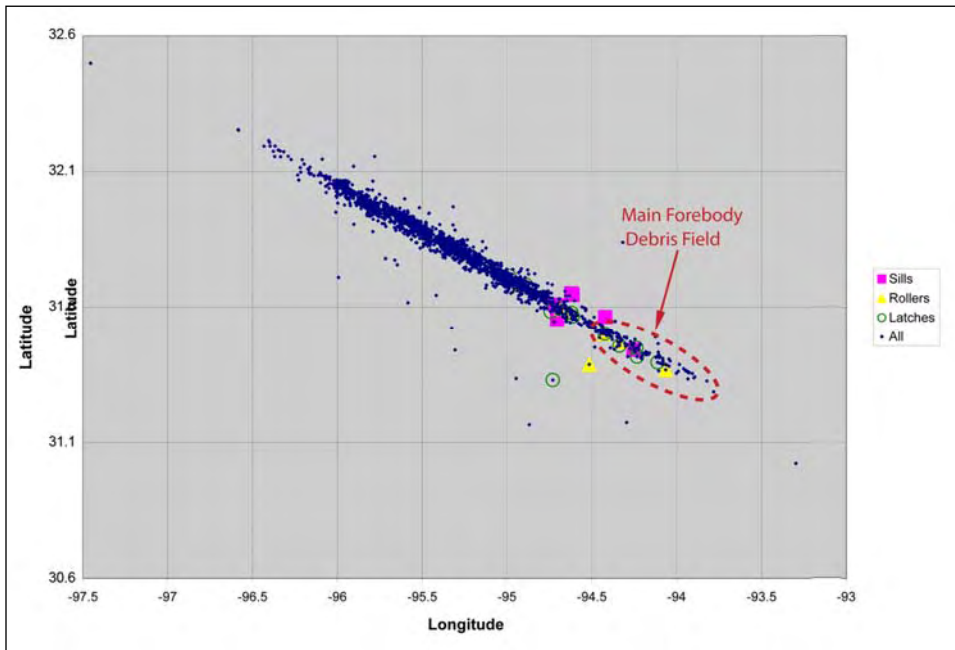
Figures 2.2-28 and 2.2-29 show the debris field coordinates for the recovered PLBD debris and a comparison of the PLBD vs. payload bay structures. Ballistics analysis showed very late release times (well past the CMCE)

that were considered suspect and assumed to contain errors due to lift generation and/or cascading events. Evaluation of the PLBD debris vs. payload bay structures shows that the debris field was extremely long, suggesting a very complex breakup and cascading event.

Figure 2.2-28. Payload bay door debris footprint relative to the main crew module debris field.

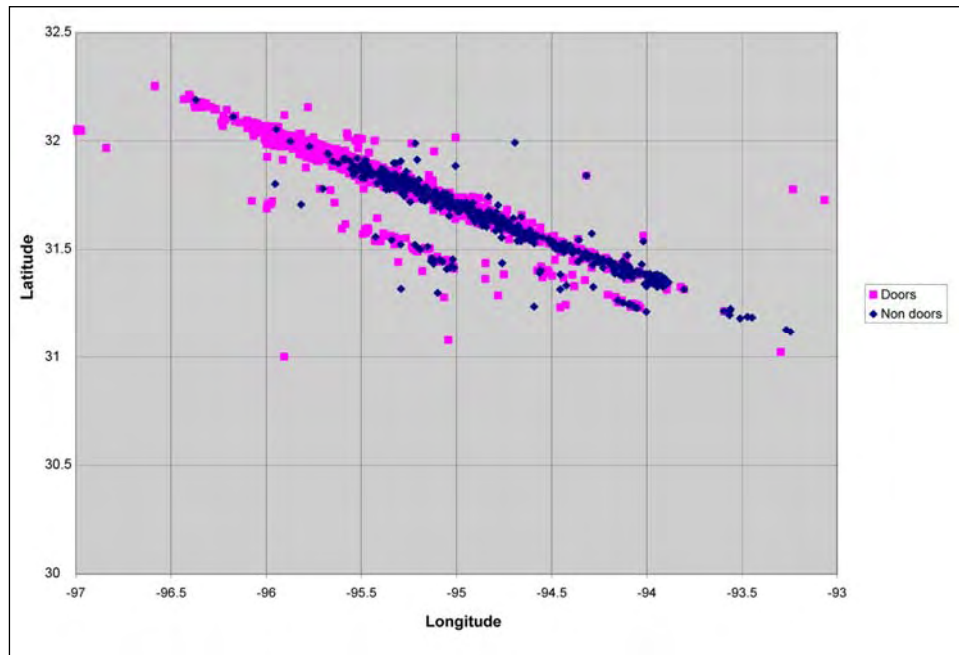
Figure 2.2-29. Payload bay door debris footprint relative to the payload bay structure.

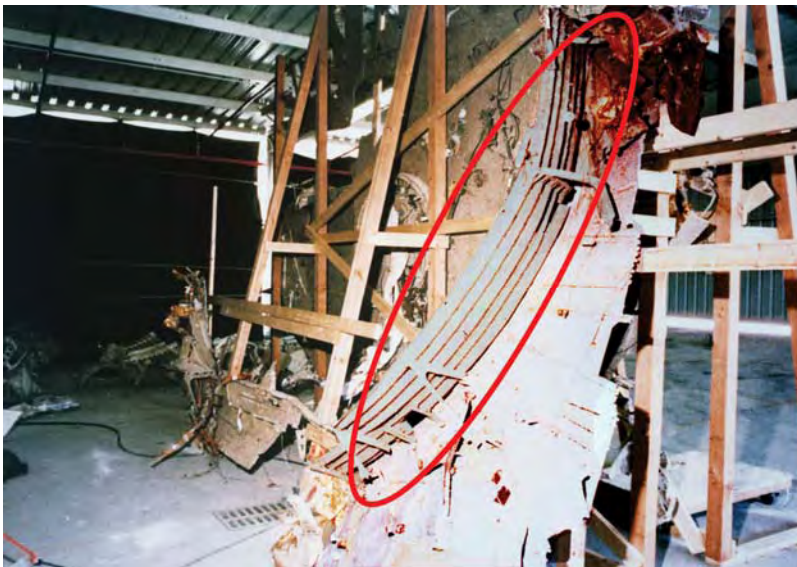
However, the SCSIT review of *Challenger* debris photographs clearly showed that part of the X_o 582 ring frame bulkhead was recovered with the *Challenger* X_o 576 bulkhead debris (figure 2.2-30).

Figure 2.2-30. Recovered X_o 576 bulkhead of the *Challenger* crew module showing a portion of the X_o 582 ring frame bulkhead (circled in red).

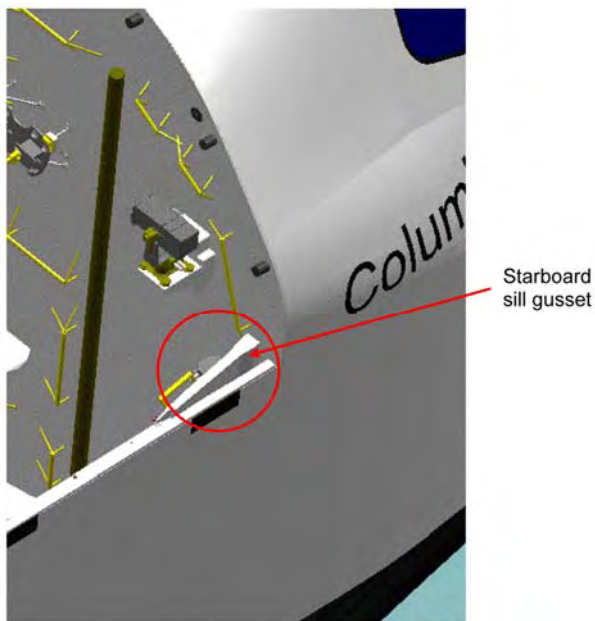
Without the PLBDs, the weak zone between the forebody and the midbody is the sill joint gusset on the aft side of the X_o 582 ring frame bulkhead (figure 2.2-31). This gusset is an offset structural connection that transfers the major X-axis loads from the CM to the midbody sill longeron via the x-links.

Figure 2.2-31. Close-up of the starboard sill gusset area.

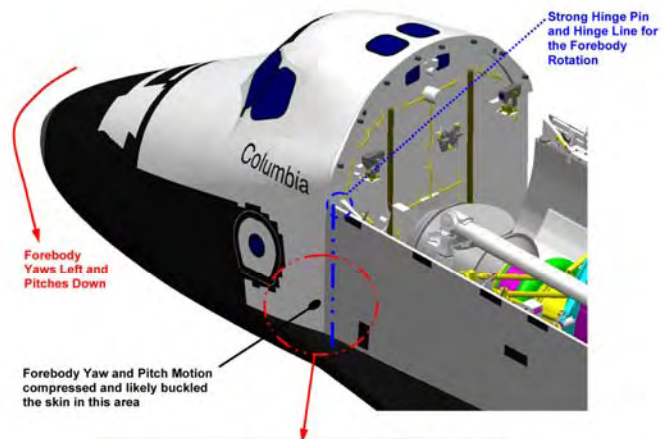
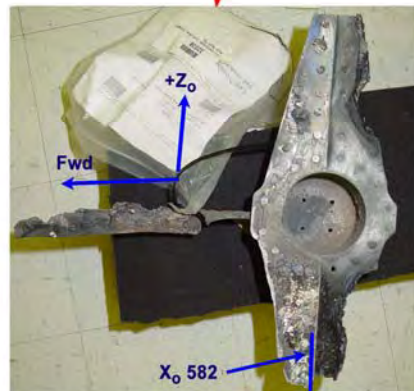
The condition of the recovered forward portside hoist fitting (figure 2.2-34) indicates that the Xo 582 ring frame bulkhead likely broke away from the midbody skin via mechanical failure, prior to any thermal effects. The Bay 1 side skin pulled away because of mechanical failure. The midbody skin splice severed the fasteners from the titanium hoist fitting by mechanical force, some Hilok bolts were cut off, and some flush bolt heads pulled through the skin splice. This damage, which may have occurred at the CE, suggests that the forebody yawed left and pitched down relative to the midbody. This motion may also have broken the port x-link lug (discussed in the next section). This kind of mechanical failure could only happen when the hoist fitting was still attached to the FF, when sufficient mass existed to exert this level of force.

Figure 2.2-34. Forward port hoist fitting, Columbia Reconstruction Database debris item no. 32038.

Unlike the starboard hoist fitting, the skin panel forward of the port hoist fitting was not recovered. One possible explanation is that the FF skin on the forward side of this item was deformed or wrinkled by compression loading at the CE when the forebody yawed left and pitched down. This may be supported by the fact that the port forward hoist fitting was recovered in the middle of the forebody debris field while the starboard hoist fitting was found in the western end of the debris field. Wrinkled skin most likely debonded TPS tiles, so this area would be subjected to thermal flow damage on at least the skin-side surface starting at the CE, then on both sides after it departed from the forebody after the CMCE. Alternatively, the port area may have simply stayed intact longer and received more entry heating following the CMCE.

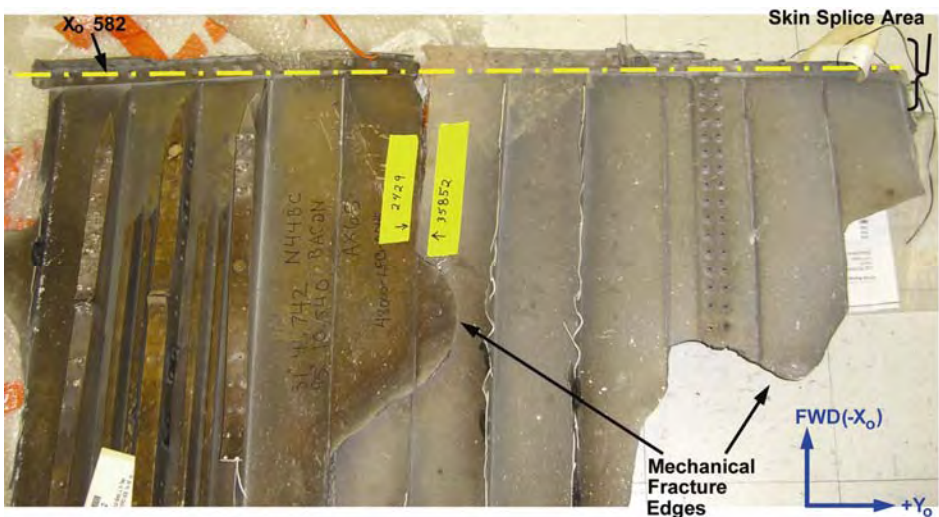
The recovered midbody bottom skin pieces from Bay 1 (the most forward bay in the midbody, immediately aft of the X₀ 582 ring frame bulkhead (figures 2.2-35, 2.2-36, and 2.2-37)) show little or no heat damage to the skin at the splice aft of the X₀ 582 ring frame bulkhead. The damage is mainly mechanical breakup of the frame to skin splice.

Figure 2.2-35. Bay 1 midbody bottom skin, Columbia Reconstruction Database debris item nos. 2429 and 33852.

The *Columbia* Reconstruction Team noted that thermal damage to the midbody was not generally severe.¹⁰ The thin skin and stringers of Bay 1 experienced some heating but not sufficient to melt the material. One scenario that may explain this is that this bay corresponded to the X location of the structural failure and disintegrated quickly during or immediately after the CE. Even if the bay skin remained with the midbody at the CE, without the X_o 582 ring frame bulkhead frame aerodynamic loads would peel off the Bay 1 skin quickly. This is consistent with the interpretation that the forebody and midbody separated in this area.

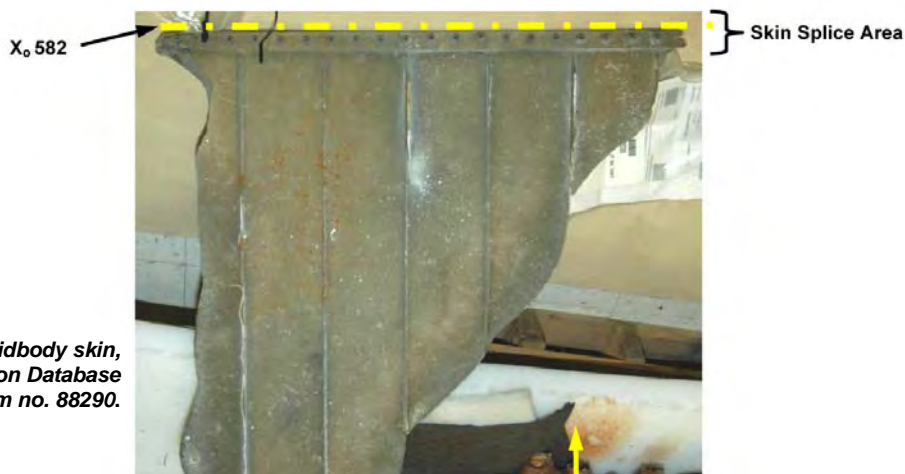
Figure 2.2-36. Bay 1 midbody skin, Columbia Reconstruction Database debris item no. 88290.

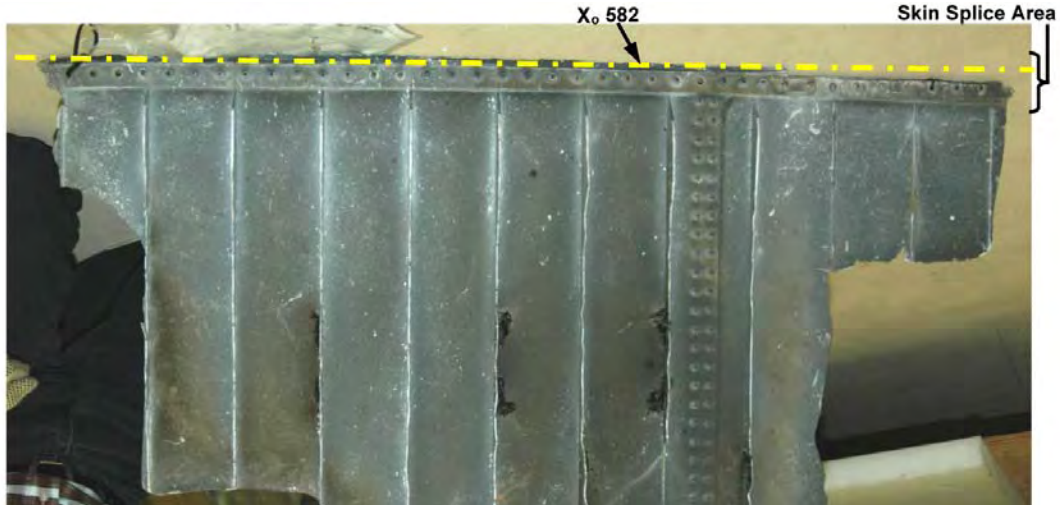
Figure 2.2-37. Bay 1 midbody skin, Columbia Reconstruction Database debris item no. 14908.

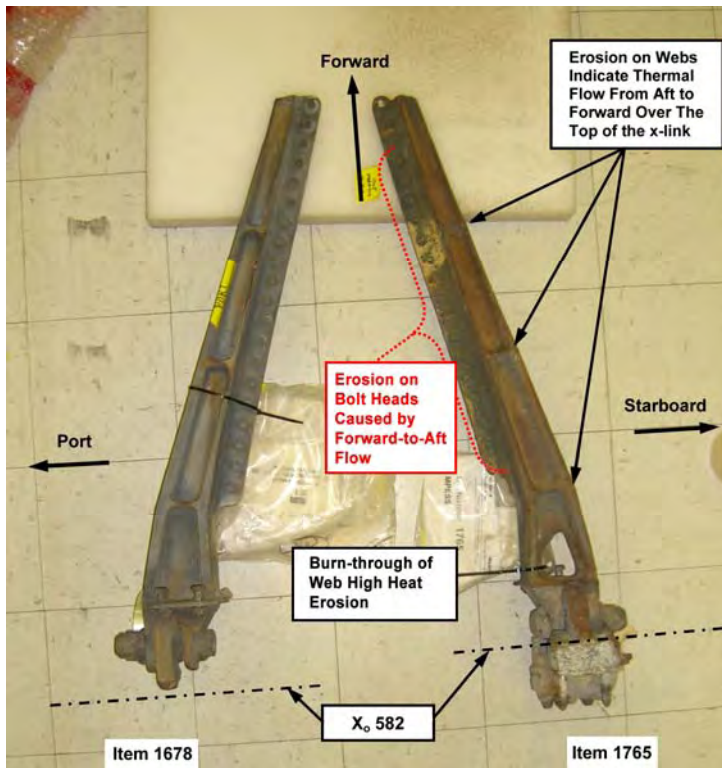
Comparison of the recovered port and starboard x-links (figure 2.2-38) shows two important differences. First, the starboard x-link was recovered with a portion of the X_o 582 ring frame bulkhead and starboard sill attached, while the port x-link failed forward of the X_o 582 ring frame bulkhead. Second, the starboard x-link experienced much more thermal erosion than the port x-link. It is clear that the directionality of the thermal damage (aft to forward flows above the x-links, and forward to aft flows along the bolt heads) is the same on both links. This orientation was shown to be unlikely due to a common trim attitude when free-flying (see Section 2.1). This strongly suggests that they were in the same relative orientation (still attached to forebody structure) when exposed to heating. The common thermal pattern on the x-link body is discussed in Section 2.4.

Figure 2.2-38. Port and starboard x-links.

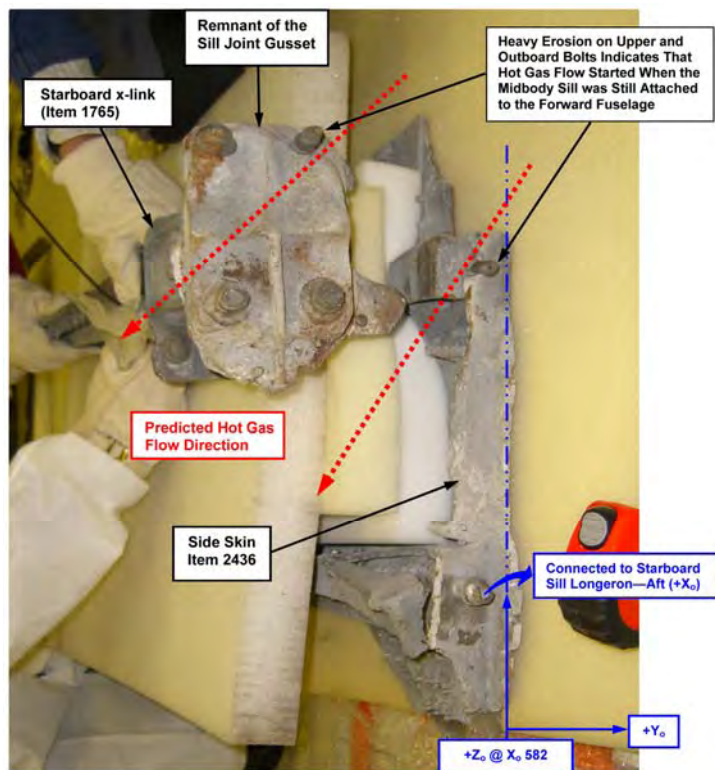
Figures 2.2-39 and 2.2-40 show the heavy thermal erosion on the sill joint gusset that is attached to the starboard x-link. The portion of side skin splice from just outboard of the starboard x-link was also recovered. Heavy heat erosion was noted on the midbody side (aft side of X_o 582 ring frame bulkhead), but was not significant elsewhere on the debris. This skin panel was recovered near the center of the forebody debris field. Together, this confirms that the CM stayed inside the FF shell until the forebody breakup, and suggests that the trailing edge (midbody side) was exposed to heating.

The structure aft of the X_o 582 ring frame bulkhead on both the starboard covering side skin and the starboard x-link was heavily damaged by heat. The heat erosion pattern on bolt heads on the aft side shows that the higher (+Z) and outboard (+Y) bolts experienced more heat erosion than the lower/inboard bolts. The resulting shape of eroded bolt heads indicates

Figure 2.2-39. View looking forward at the starboard x-link and side skin.

that hot gas flowed down and inboard (figures 2.2-39 and 2.2-40). This suggests that the aft side of the starboard x-link area was exposed to hot gas while the starboard midbody sidewall/sill was still attached to the X₀ 582 ring frame bulkhead and FF.

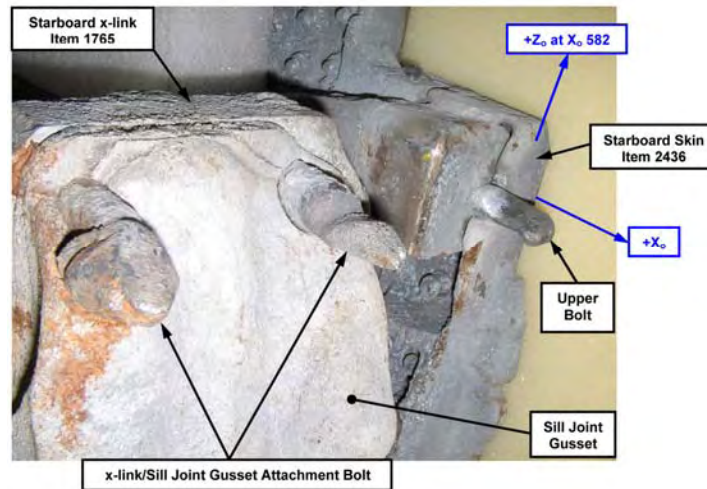
Figure 2.2-40. Detail of thermal erosion on the upper bolts at the starboard x-link and skin.

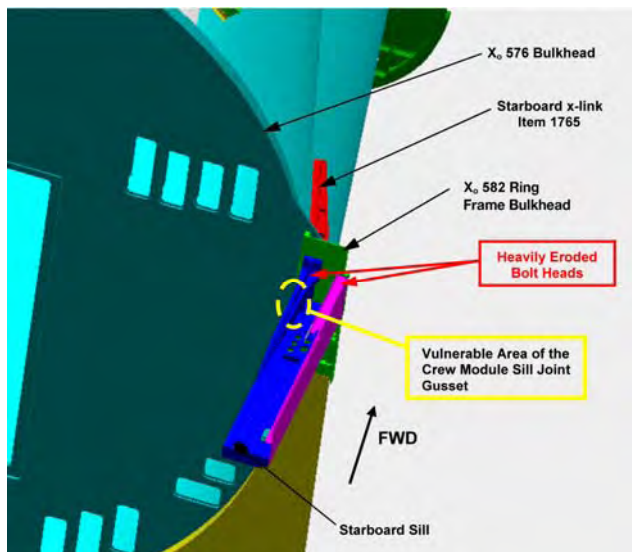
To summarize the assessment, the point of the orbiter that was weakest under dynamic rotational loading was likely to be the sill gusset immediately aft of the x-link and the X₀ 582 ring frame bulkhead. Debris shows that for the starboard sill, the failure of the midbody sill joint occurred at a location aft of the X₀ 582 ring frame bulkhead, perhaps near the middle of the gusset (figures 2.2-41 and 2.2-42). Since orbiter load limits were apparently not exceeded, this implies that thermal degradation was required.

Figure 2.2-41. Weak links – sill joint gusset, starboard side.
