Columbia Crew Survival Investigation Report

NASA/SP-2008-565

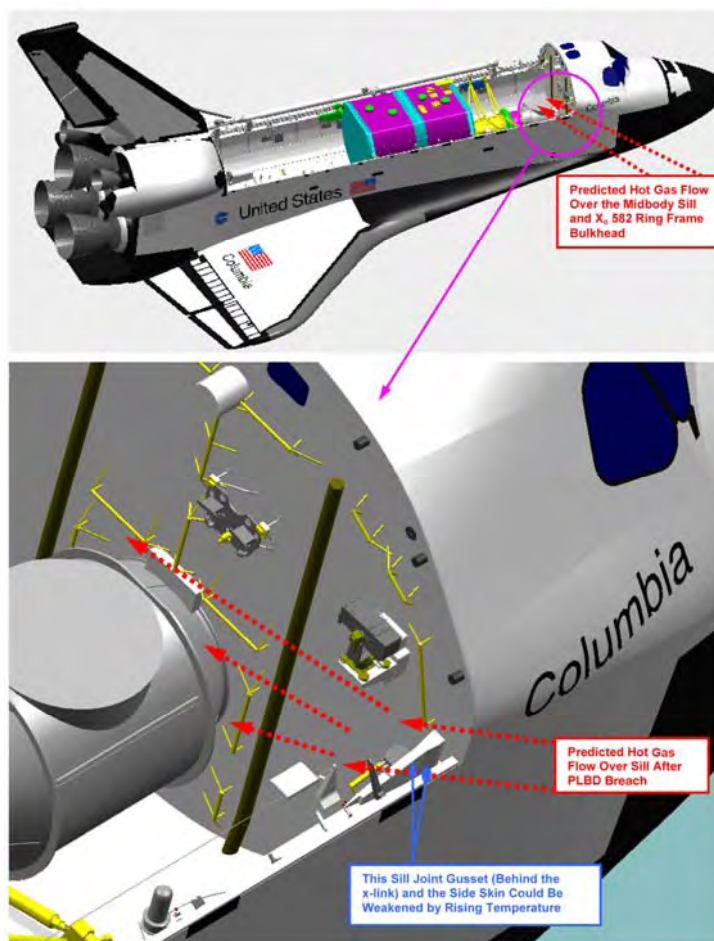
This thermal degradation could have occurred prior to the CE if the PLBDs departed or were compromised in that area (figure 2.2-43). Debris evidence shows that the starboard sill joint experienced more thermal damage than the port sill joint. This suggests the possibility that rising temperature on the starboard sill area weakened the sill joint until it failed mechanically. Although orbiter motion generally resulted in “belly-into-the-wind” orientation (see Section 2.1), with the large pitch and roll oscillations hot gas could flow beyond the belly of the orbiter, up and over the sill. However, hot gas exposure to the sill area could only be short and intermittent (<3 seconds at a time). Debris field and ballistic assessment of PLBD debris is inconclusive. However, a local failure or compromise on the starboard PLBD near the sill could have resulted in this scenario without evidence being apparent in these assessments.

Figure 2.2-43. Hot gas flow heats up starboard sill and the adjacent x-link.

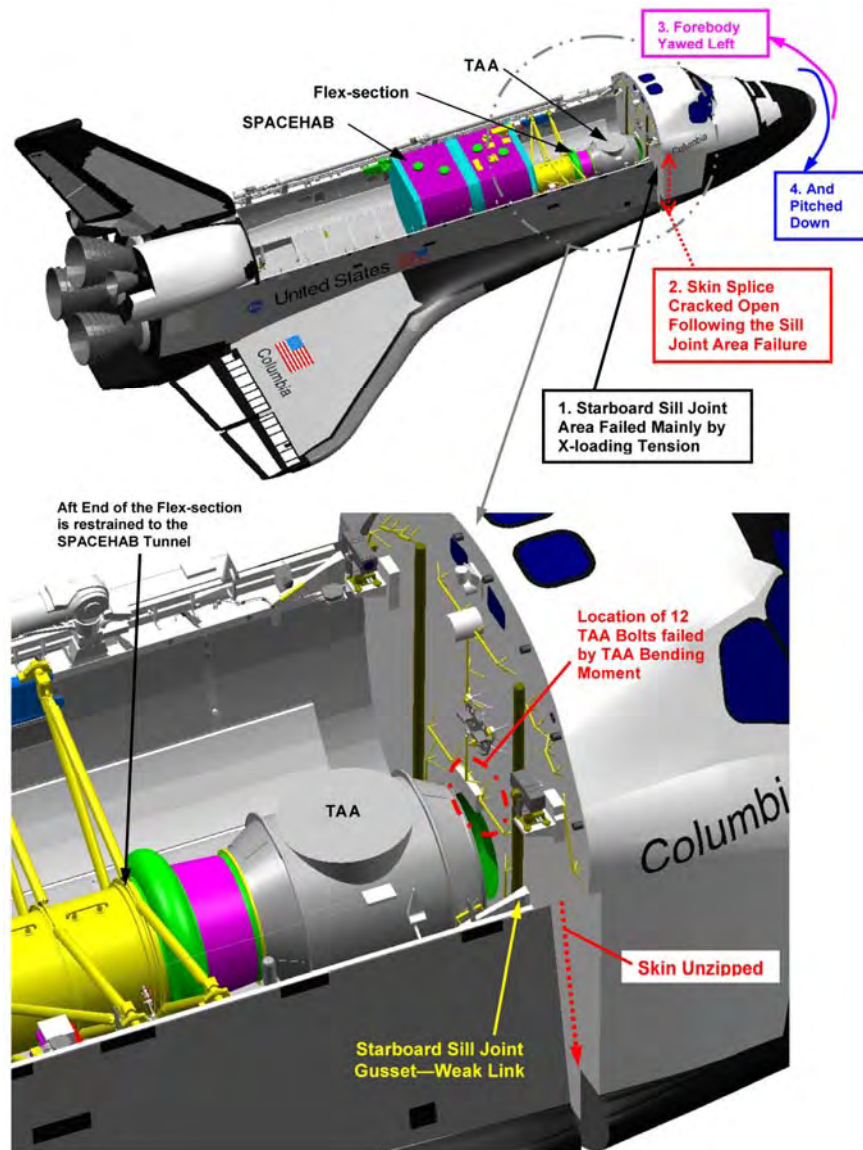
As illustrated in figure 2.2-44, failure of the starboard sill joint area would trigger a separation of the forebody away from the midbody. Starting from the starboard side, the midbody skin splice would fail progressively, opening from starboard to port at the forebody aft bulkheads.

Figure 2.2-44. Forebody departed the midbody at the Catastrophic Event.

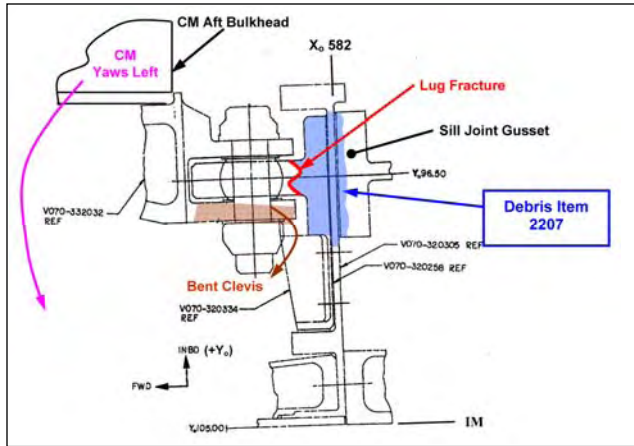
A portion of the X_o 582 ring frame bulkhead and portside sill fitting, which has a lug that supports the port x-link, was recovered and inspected. The lug broke near its base mainly because of a bending load caused by the x-link and the forebody yawing to the left (figure 2.2-45). This yawing motion was identified by the yielding on the outboard flange of the clevis on the aft end of the port x-link (figure 2.2-46).

Figure 2.2-45. How the port x-link failed, cross-section view looking down.

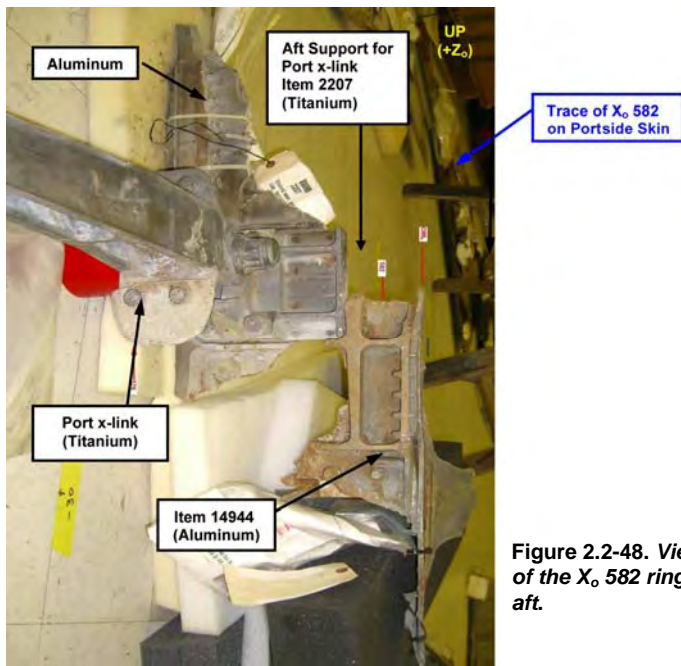
Figure 2.2-48. View of the port x-link and a portion of the X₀ 582 ring frame bulkhead debris items, looking aft.

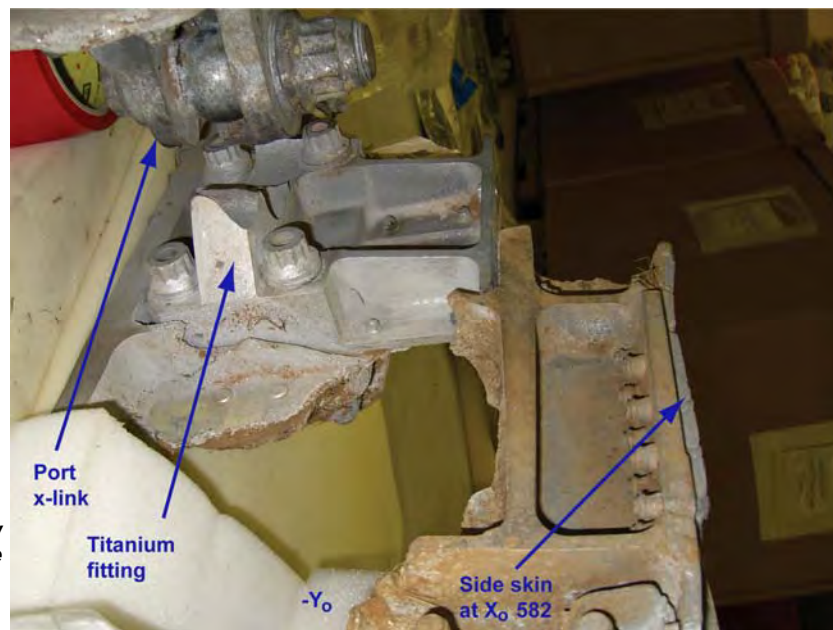
Figure 2.2-49. View looking up and aft at the port x-link.

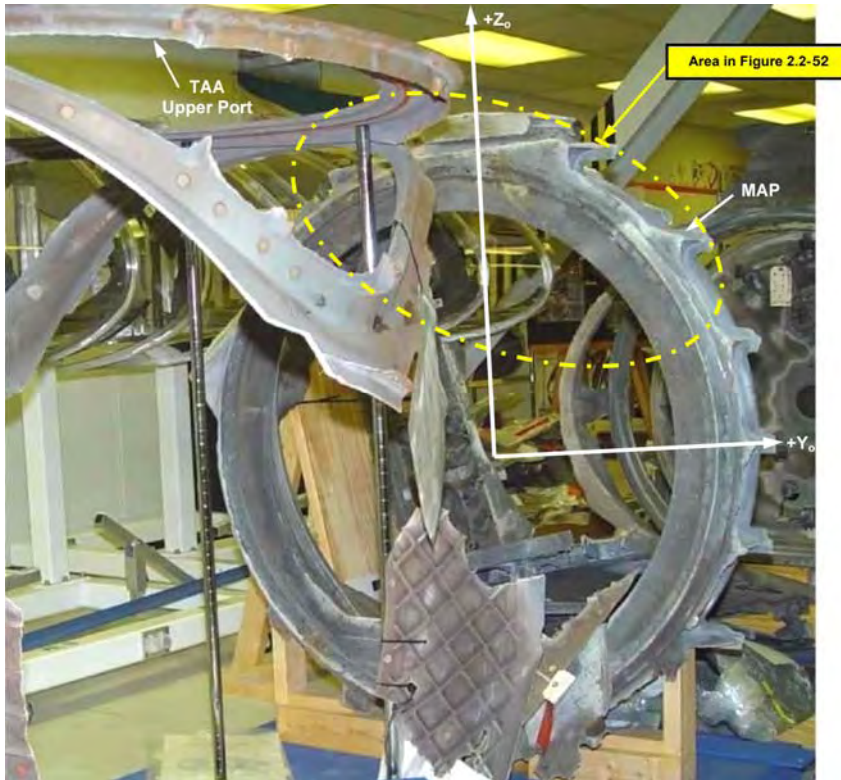
As shown in figures 2.2-51 through 2.2-54, the 12 high-strength bolts (180,000 pounds per square inch (psi)) that attached the forward ring of the TAA to the MAP failed with shanks still remaining in the inserts. This suggests that this area was subjected to high tension and bending while the remaining bolts were not subjected to the same loading. It implies that this TAA joint reacted to a bending moment (M_{TAA}) plus aft tension loading (figure 2.2-54). When the aft end of the TAA was restrained by the SPACEHAB tunnel to the midbody, the forebody yawing left and pitching down relative to the midbody could create the same bending effects. This suggests that the TAA broke away from the MAP when the forebody separated from the midbody at the CE or shortly afterwards.

Figure 2.2-51. Tunnel adapter assembly and the manufacturing access panel debris, view looking forward at "B" hatch opening.

Darker shading color on the surface of the MAP, as was noted on figures 2.2-51 and 2.2-52, indicates that this area was shielded by the missing portion of the TAA ring and suggests that the MAP surface outside of the TAA ring was subjected to thermal flow before the TAA departure. If the TAA departed at the CE, the MAP or the aft bulkhead of the CM was exposed to the thermal flow for some period of time prior to the CE (figure 2.2-44). This would agree with the theory that the PLBDs were compromised prior to the CE.

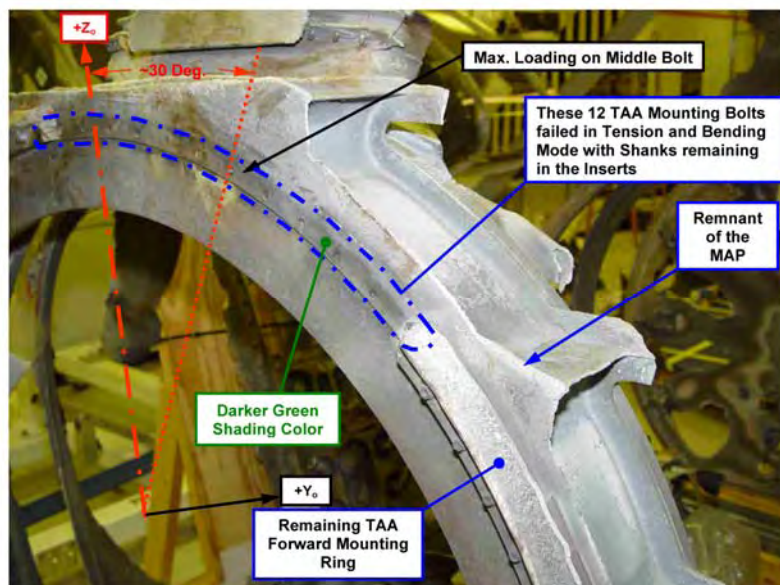
Figure 2.2-52. Tunnel adapter assembly debris showing that the bolt shanks failed mainly by tension and bending.

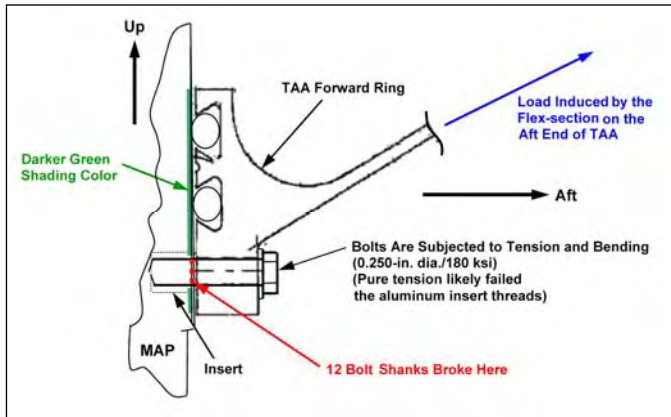
Figure 2.2-53. Cross section through tunnel adapter assembly mounting bolt.

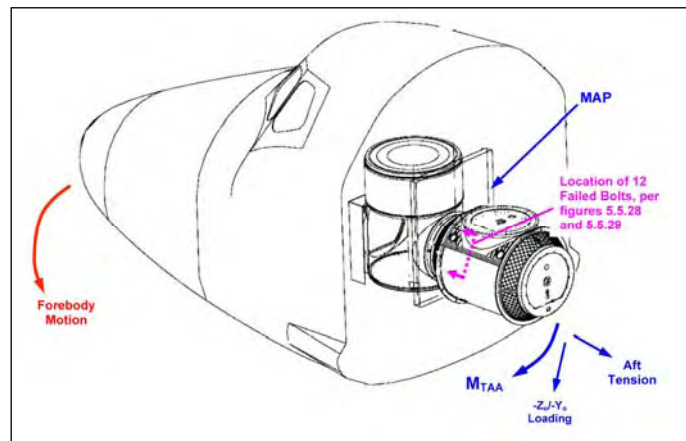
Figure 2.2-54. Predicted motion based on debris evidence.

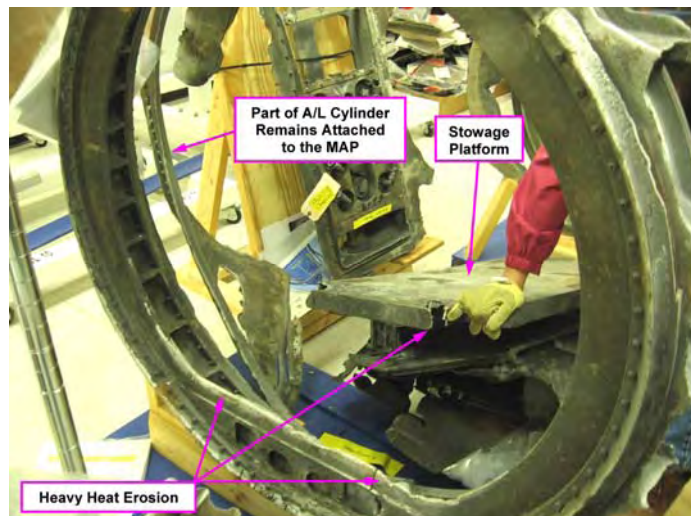
Extreme thermal erosion at the lower edge opening on the MAP where the forward end of the TAA is attached indicates that after the TAA broke away from the MAP, hot gas flowed in over the lower edge of the “B” opening in the MAP. This thermal flow also caused heat erosion to the two aft corners of the stowage platform, which was mounted to the airlock floor (figure 2.2-56). This is consistent with the rotational motion of the forebody post-CE, when such an exposure could have occurred.

Figure 2.2-56. View looking forward at the “B” hatch opening on the X₀ 576 bulkhead.

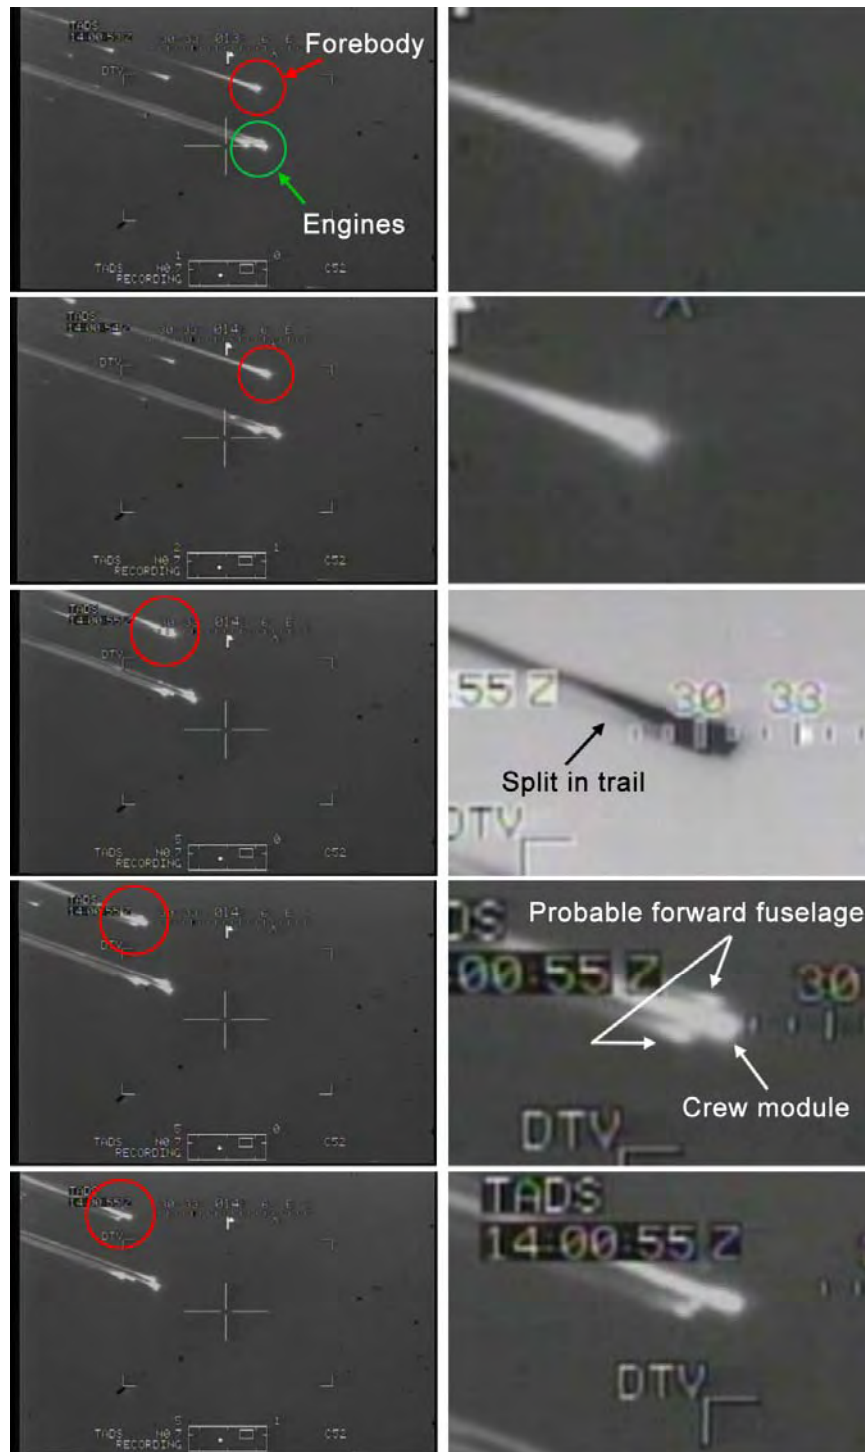
Figure 2.4-1 shows a set of five paired images covering less than 2 seconds of time. On the left is the original image and on the right is a close-up of the forebody and CM. The first frame shows when the forebody begins to brighten. The second frame, which was taken one-third of a second later, shows the slight increase in apparent size of the envelope of gases of the orbiter. The third image, almost 1 second later than the previous image, shows the first definitive indication (although it can be recognized a few frames earlier) that the forebody is beginning to fail. The magnified image has been inverted to emphasize the split in the trail of the forebody. The next frame, which occurs about one-third of a second later, shows what are believed to be two significant portions of the FF separating from the CM. The last image, taken one-fifth of a second later, shows how quickly the FF is breaking into pieces that are too small to be seen by the camera. The CM breaks up over the next 16 seconds.

Figure 2.4-1. Five time-paired images covering under 2 seconds of time showing the Crew Module Catastrophic Event. Image on the left is the full frame, image on the right is an enlarged view.

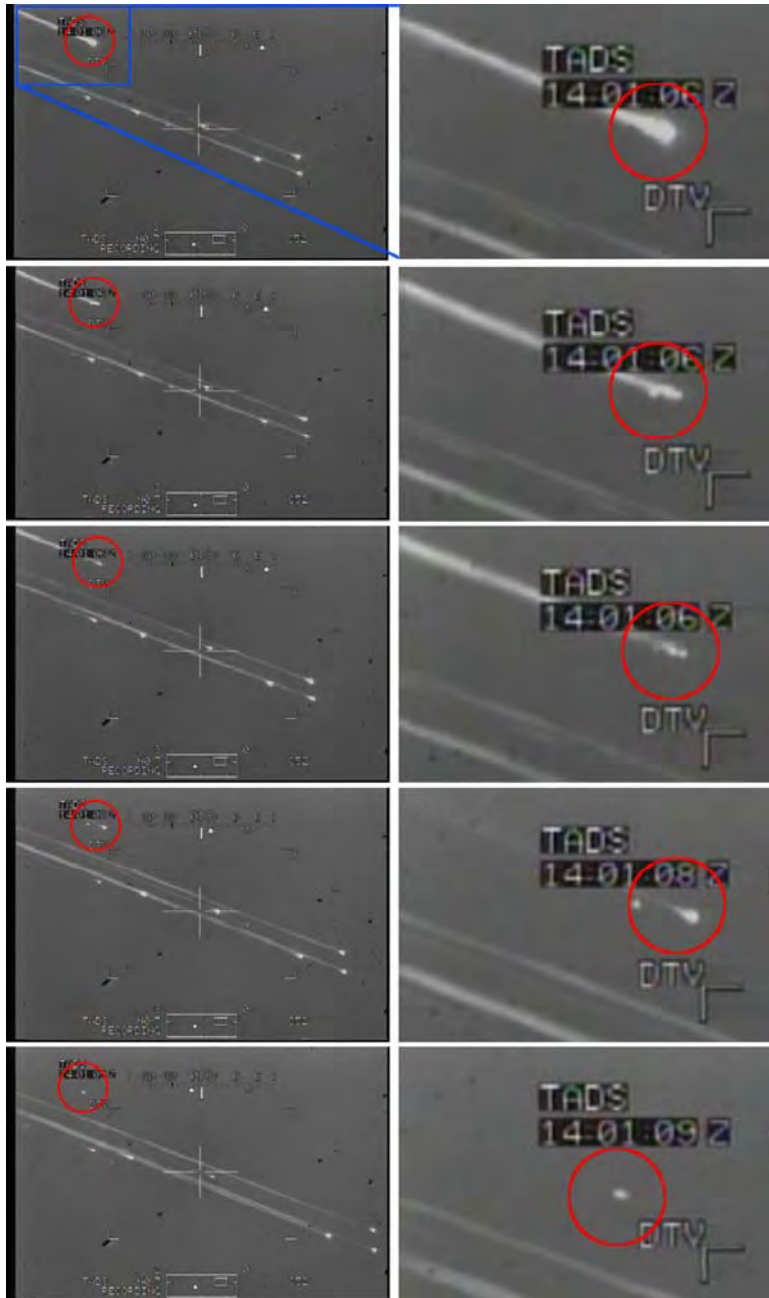
As the images illustrate, when structural integrity of the CM completely failed, it did so in a fraction of a second. The times for the images (figure 2.4-2), from top to bottom, are GMT 14:01:06.73, GMT 14:01:06.87, GMT 14:01:06.97, GMT 14.01.08.3, and GMT 14:01:09.67. In the next frame, the CM is no longer visible.

Figure 2.4-2. Apache video of the Total Dispersal, spanning from GMT 14:01:06.73 to GMT 14:01:09.67. The forebody/crew module is circled in red.

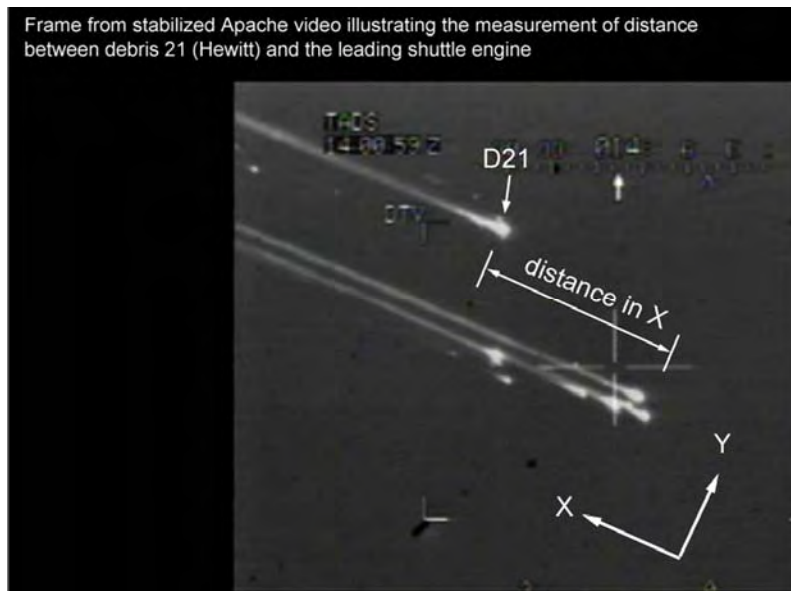
Figure 2.4-3. An analyzed frame from the Apache video.

The relative motion of the CM to the engines appears to suggest a high deceleration event occurred during the breakup of the forebody (between the CMCE and the TD). Later understanding of the breakup sequence revealed that this deceleration was related to the disintegration of the CM and the resulting cloud of debris. Rather than a specific high-G event that was experienced by an intact CM, it represents the cloud of individual items separating and rapidly decelerating. Heating was sufficient to keep the individual objects visible for a short period of time, and these items were close enough together that they could not be distinguished as separate items. This also explains why the CM's visible disappearance occurred in a fraction of a second, as the deceleration passed the threshold of sufficient heat generation for visibility in the video.

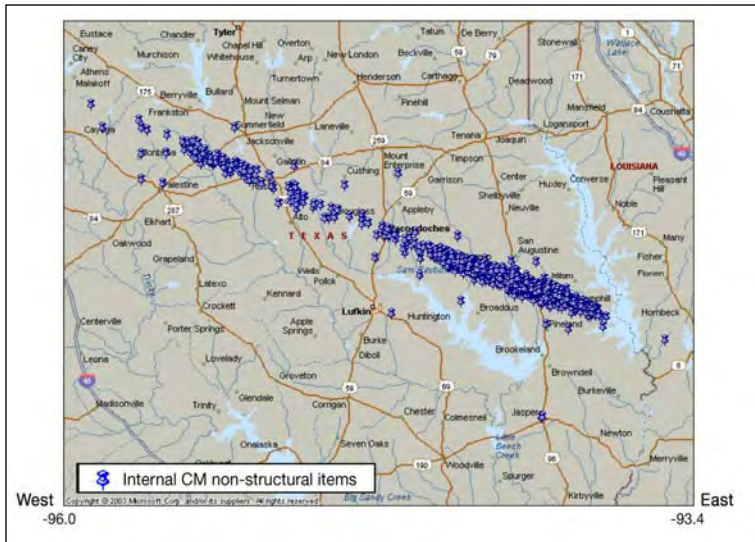
Many of the westernmost debris items came from internal stowage volumes. This implies that internal structural damage occurred at the CE. A full description of cabin depressurization is contained in Section 2.3. The integrated assessment concluded that depressurization occurred NET GMT 14:00:18 (CE) and NLT GMT 14:00:35. It ended NLT GMT 14:00:59, and most likely earlier.

Figure 2.4-5. Debris field of the nonstructural items from inside the crew module pressure vessel.

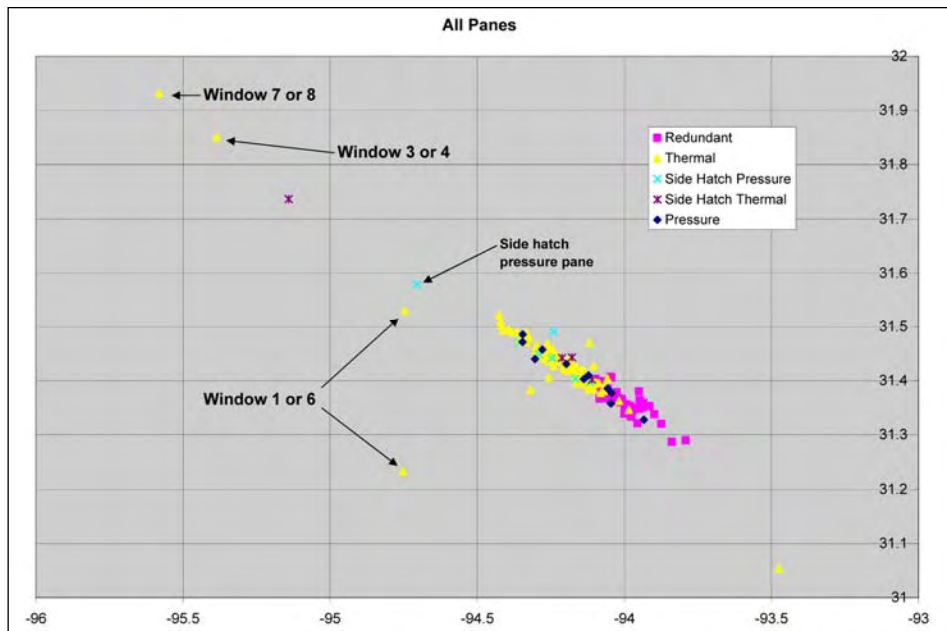
Figure 2.4-8. Recovered debris field for window glass.

Of the 201 recovered glass fragments, only six pieces of loose glass that are confidently believed to be from the orbiter were found west of the main forebody debris field. All were thermal (outer) panes with the exception of one piece of probable side hatch pressure pane. However, a piece of pressure pane that was recovered in the western end of the debris field does not alone indicate a source of depressurization. Pressure panes may be damaged due to objects moving around inside the CM as it rotated, impacting the windows. If the cabin is depressurized from a different source, these pieces can evacuate through other breaches.

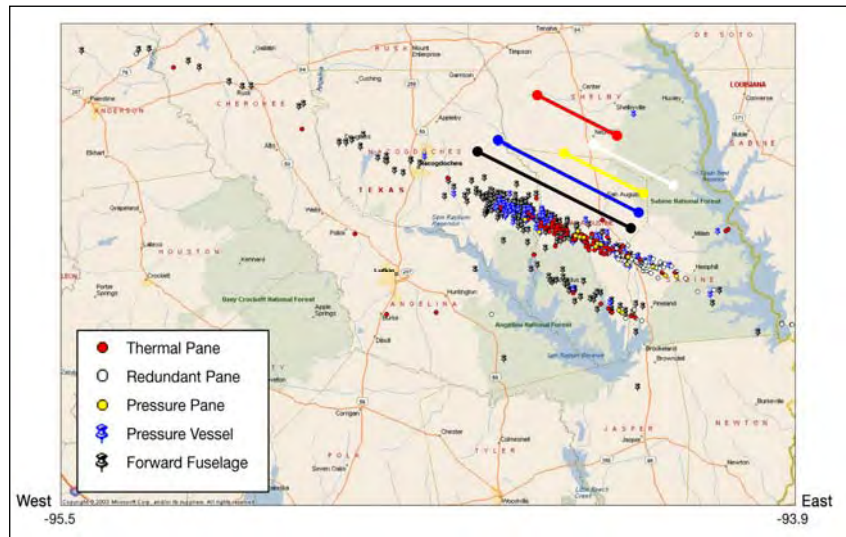
Figure 2.4-9. Debris field of the window panes, forward fuselage, and crew module pressure vessel.

Figure 2.4-9 shows that thermal pane debris was recovered east of the beginning of the main forebody debris, suggesting that the windows broke at or after the CMCE. Pressure panes were recovered west of the bulk of the redundant panes, possibly because the redundant panes were extraordinarily thick and heavy and may have traveled farther east because their ballistic number was higher. Determining the failure sequence of the windows based on ground plots alone was somewhat suspect because some of the window frames remained attached to other window frames as a unit, and the shape of the windows can potentially generate lift. Regardless, because the debris field does not contain significant pane debris west of the main CM debris field, it is concluded that the windows were not the source of a CM breach or a part of the initiating event of the forebody breakup.

Finding. The *Columbia* windows remained largely intact up until the CMCE and were not a cause of cabin depressurization.

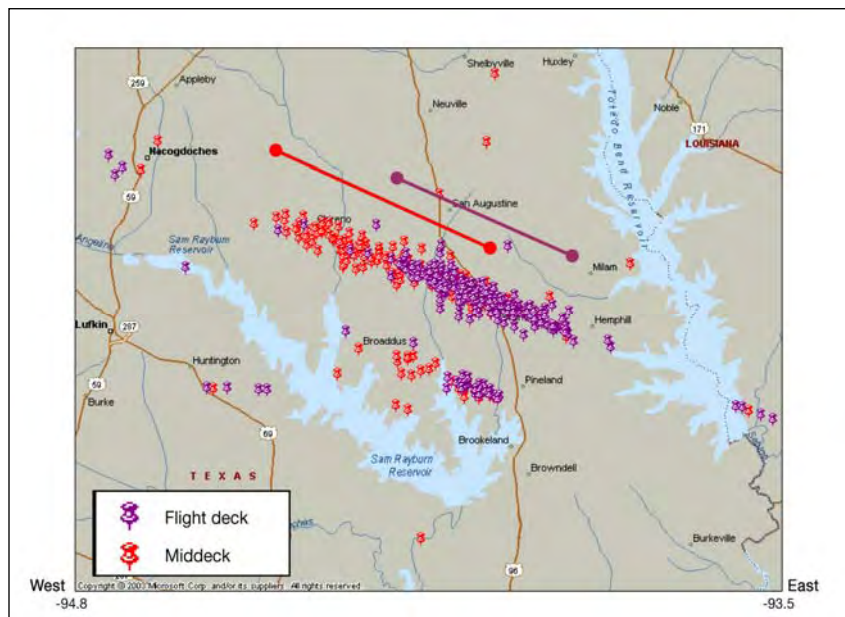
Figure 2.4-12 shows the distribution of middeck and flight deck structure. The middeck structure appears farther west in the debris field, while the flight deck debris cluster is concentrated at the eastern end. This suggests that the flight deck remained intact longer and traveled farther downrange than the middeck.

Figure 2.4-12. Debris field of the middeck and the flight deck.

This conclusion is supported by the fact that almost all of the middeck floor debris was in fair to very good condition. However, very little of the structurally stronger flight deck floor was recovered. Furthermore, the flight deck items that were recovered were heavily thermally eroded. This would be the case if the flight deck stayed together and received more thermal damage as a result of having a higher ballistic number than the individual middeck components.

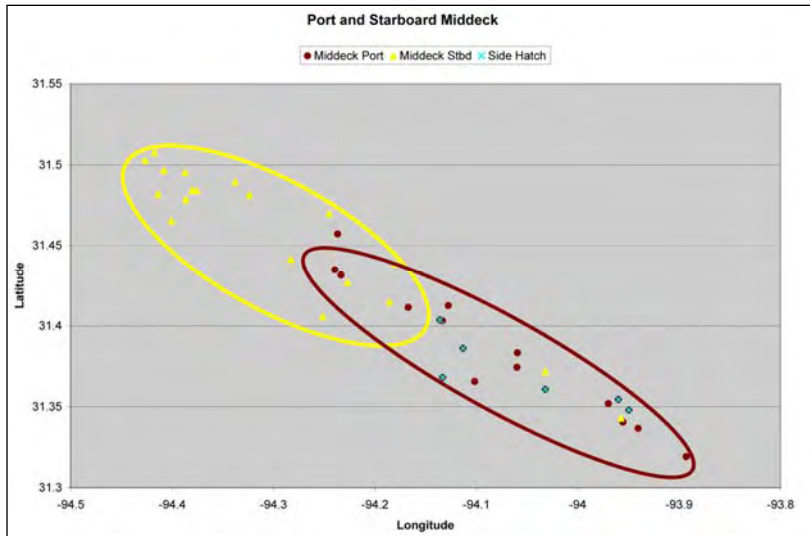
Figure 2.4-13. Middeck structural debris port vs. starboard.

There was a substantial amount of debris for the middeck analysis. Middeck starboard debris was recovered west of the middeck port debris, suggesting that the starboard side failed before the portside. Many of the items from the starboard side were lightweight items from the sleep station with low ballistic numbers, which may also affect this debris field. The debris field is consistent with a yaw to the portside, exposing the starboard side to greater thermal and aerodynamic loads. However, the flight deck panels appear inconclusive relative to a specific failure sequence of forward to aft or port vs. starboard. Not many panels were recovered from port or starboard, which makes interpretations risky.

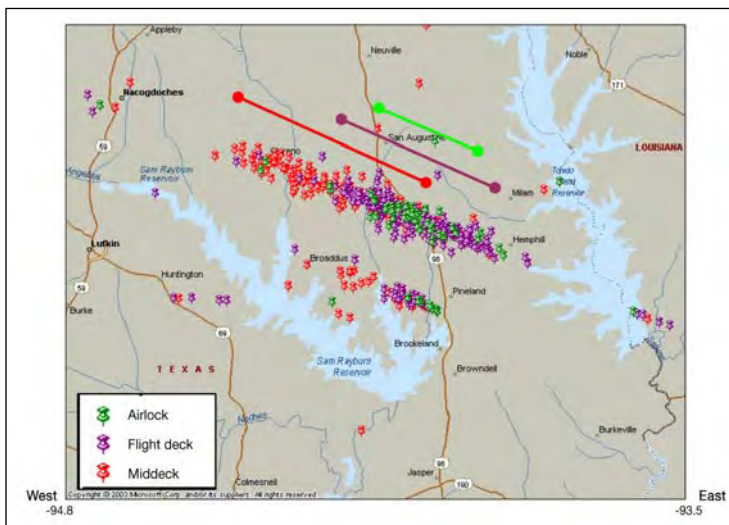
The internal airlock is structurally attached to the CM aft of the X₀ 576 bulkhead. It likely stayed with the aft bulkhead after the middeck departed. Figure 2.4-17 indicates that the airlock structural debris is also squarely in the middle of the flight deck structural debris. This suggests that the flight deck and airlock remained connected to each other by the aft bulkhead.

Figure 2.4-17. Debris field of the middeck, flight deck, and airlock.

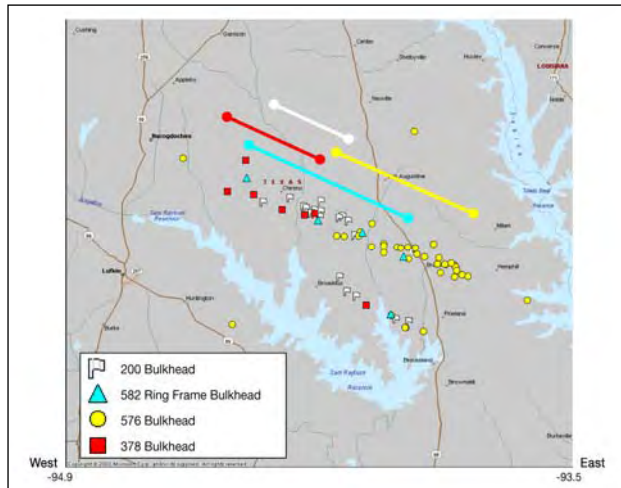
Figure 2.4-19. Debris field of the key forebody bulkheads.

The debris field clusters suggest that the two forward bulkheads appeared to fail earlier than the aft bulkheads. Also, the outer (fuselage) bulkheads failed prior to their corresponding inner (CM pressure vessel) bulkheads. The debris footprint for the CM forward bulkhead (X_{cm} 200) coincides with the center of the middeck debris field, suggesting that the X_{cm} 200 departed with the middeck. The CM aft bulkhead (X_o 576) appears to have remained with the flight deck until it disintegrated, likely also connected to the airlock since that debris field coincides as well.

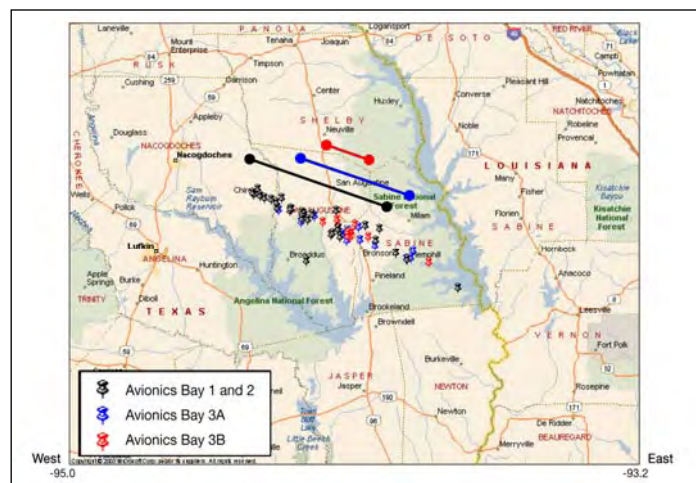
Figure 2.4-21. Debris field of the avionics bays.

Debris from Bays 1 and 2 was recovered west of Bays 3A and 3B. This order matches the CM bulkhead order, supporting that the front (X_{cm} 200) bulkhead departed before the aft (X_o 576) bulkhead.

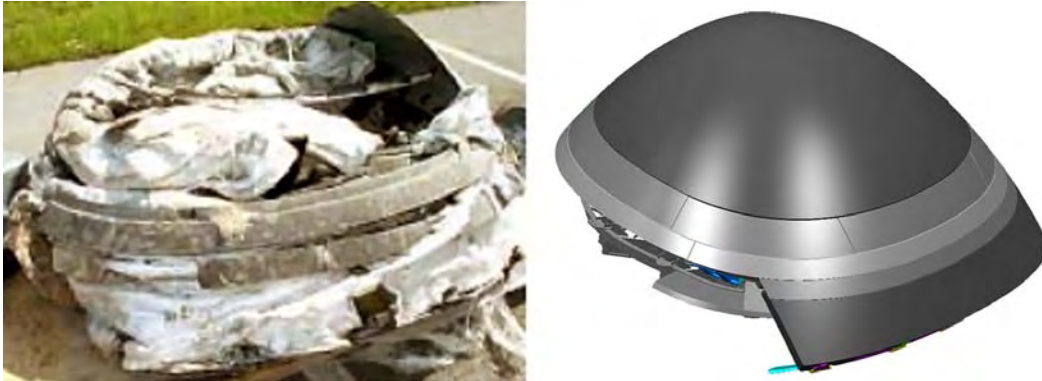
The recovered FF components are predominantly skin/stringer segments. Most components exhibited mechanical overload as the primary failure mechanism. Roughly 40% of the FF was recovered with no difference in damage levels comparing left to right or upper to lower. Two recovered RCC components, the nose cap and the chin panel (figure 2.4-23), show evidence of mechanical breakup with low thermal damage. It should be noted that the nose cap, based on field reports, apparently hit a tree before hitting the ground. The presence of intact Koropon primer on many FF components indicates that significant heating did not occur. Temperatures above 400°F (204°C) degrade the primer’s appearance, and high temperatures

(>900°F) (486°C) will completely ablate it. The presence of Koropon indicates that the breakup of these elements was caused by mechanical overload rather than thermal effects.

Figure 2.4-23. Nose cap Columbia Reconstruction Database debris item no. 1114 vs. the original nose cap with chin panel.

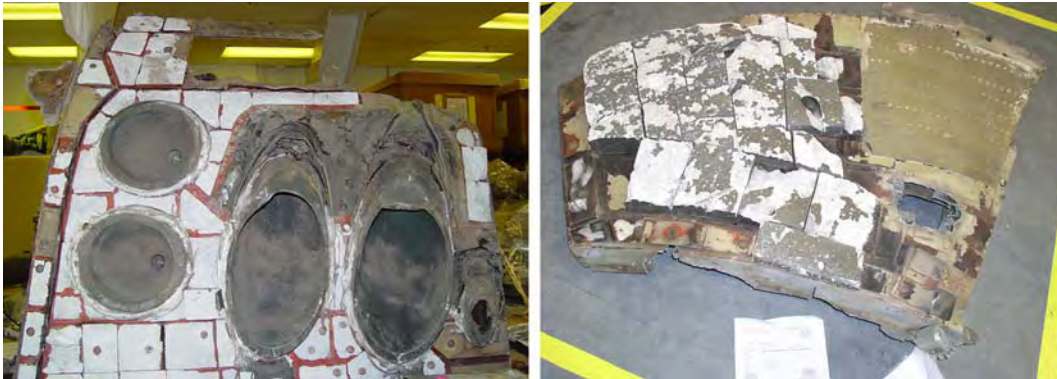
Some large pieces of the forward RCS were recovered (figure 2.4-24). These exhibit evidence of mechanical overload as the primary failure mechanism. Heating did not appear to play a significant role in the component degradation and appears to have occurred during or subsequent to the mechanical breakup.

Figure 2.4-24. Two large forward Reaction Control System debris pieces, Columbia Reconstruction Database debris item nos. 792 (left) and 82061 (right).

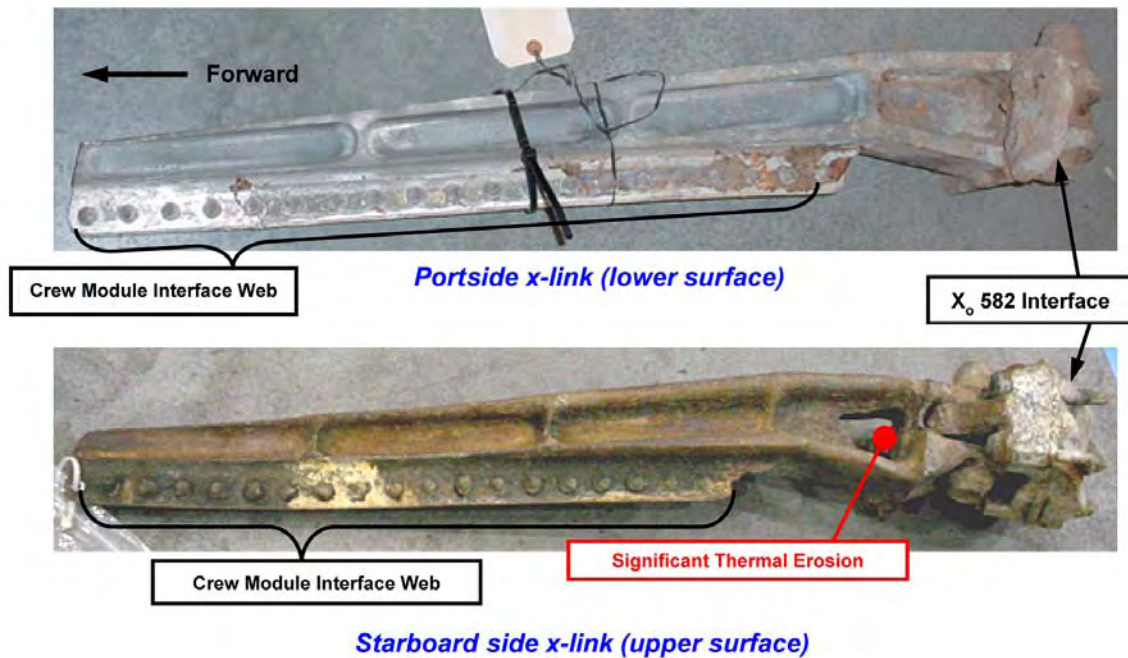
Both the port and the starboard x-links (figure 2.4-25) were recovered nearly intact with evidence of high heating. The titanium fittings on both links experienced significant thermal exposure/melting, predominantly on the upper surfaces. Additionally, the starboard side fitting experienced significantly greater heating and erosion than the portside.

Figure 2.4-25. Crew module x-links, Columbia Reconstruction Database debris item nos. 1678 (top) and 1765 (bottom).

The titanium x-link components did not fail. The attach area on the CM side of the x-link is stronger than the FF side since it is reinforced by the flight deck floor and the X_o 576 bulkhead. The failures occurred at the weaker X_o 582 ring frame bulkhead connection points. The port x-link experienced a mechanical lug failure at the X_o 582 ring frame bulkhead interface, while the starboard side fittings pulled through the X_o 582 ring frame bulkhead at the CE. The starboard x-link retained some of the sill and X_o 582 ring frame bulkhead while the portside did not. Furthermore, it was concluded that at the CE, the forebody rotated left and pitched down, separating from the midbody (see Section 2.2.4).

Heat damage patterns on the webs of both x-links indicates that, at some point, there was hot gas flow from aft to forward above both x-links. The starboard x-link has more damage than the port x-link. Thermal analysis (see Section 2.1.6.7) of the x-links shows that entry heating alone was not capable of causing such heavy erosion. Additionally, because the surrounding structure was aluminum with a much lower melting temperature, entry heating alone would have resulted in the weakening of the surrounding structure first and release of the x-links. Section 2.1.7 discusses the other thermal mechanisms that were likely involved, shock-shock interactions and combustion. Both of these mechanisms are possible with the forebody geometry as understood from the debris.

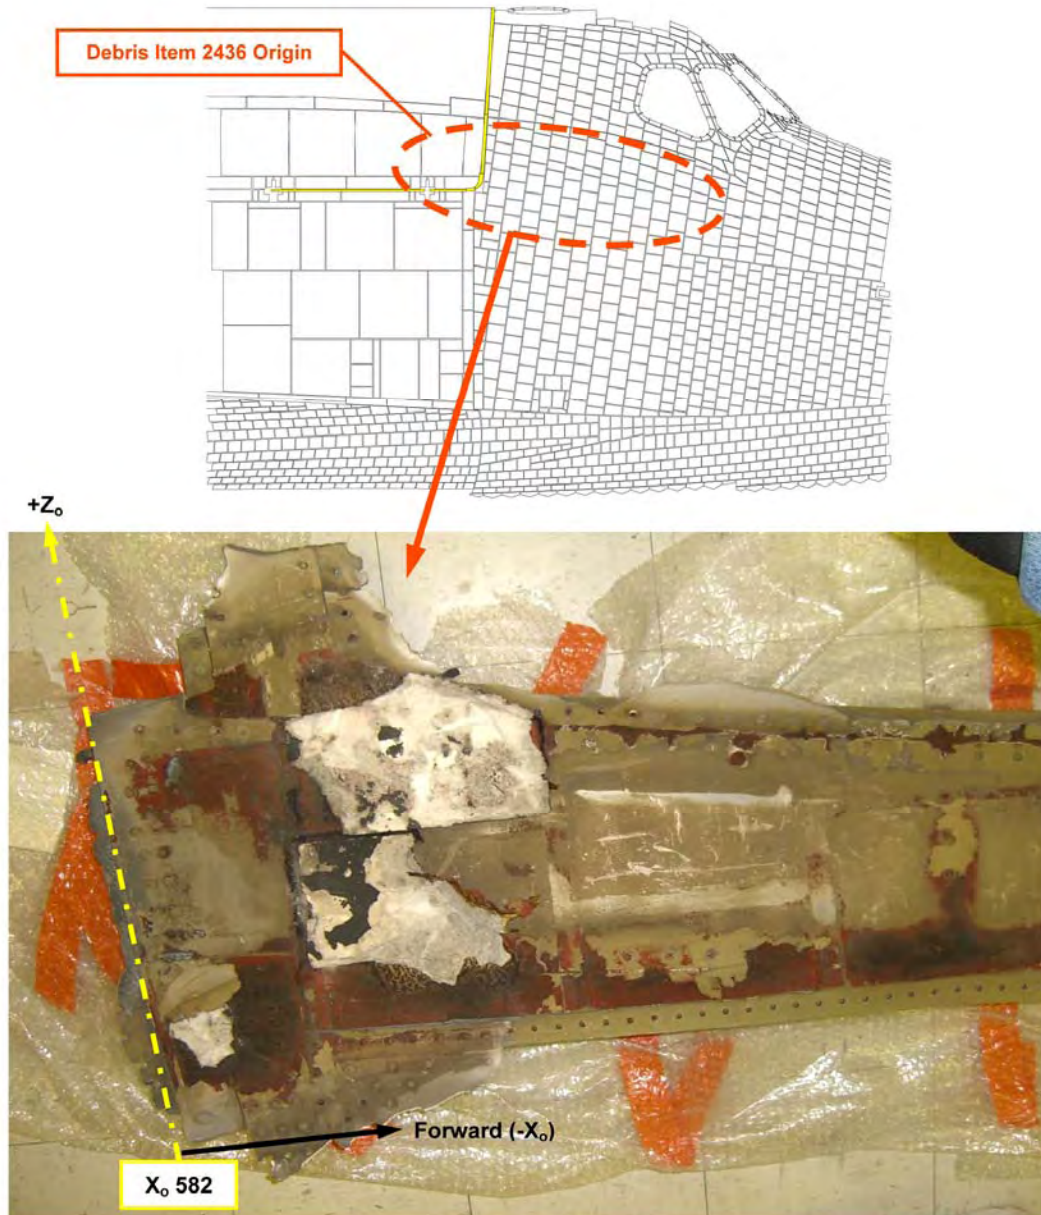
Debris item no. 2436 is a piece of FF skin panel outside of the starboard x-link (figure 2.4-26). It was subjected to heat erosion mainly at the aft edge (along the X_0 582 ring frame bulkhead) (figure 2.4-27). The pattern of deposited molten aluminum on the inboard side indicates that it was subjected to thermal flow aft to forward over the x-link (see arrows, figure 2.4-27).

Figure 2.4-26. Starboard-side skin, view looking inboard, Columbia Reconstruction Database debris item no. 2436.

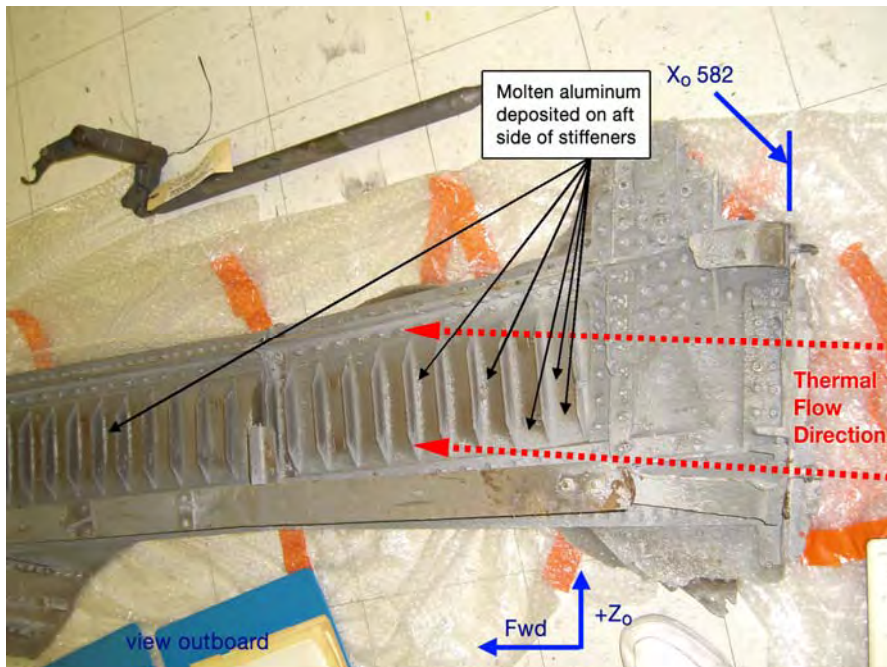
Figure 2.4-27. Inboard side of the starboard-side skin, Columbia Reconstruction Database debris item no. 2436.

This debris shows high heat erosion at the aft end while the remaining edges failed mechanically. The pattern of molten aluminum deposition indicates that the hot gas flowed mainly from aft to forward. If the thermal event happened after this panel broke away from the FF shell, all edges should experience a similar level of thermal damage, and the deposition of molten aluminum on the inside surface of the skin should have a random pattern instead of a directional pattern (figure 2.4-27). This suggests that this piece of FF skin was in place when the thermal event occurred. It is not known when this thermal event occurred. Since the forebody was rotating, the aft portion of the forebody may have periodically been presented to thermal flow for brief periods between the CE and the CMCE. The thermal event may also have happened around the CMCE, when the FF pulled away and exposed the area to thermal flow.

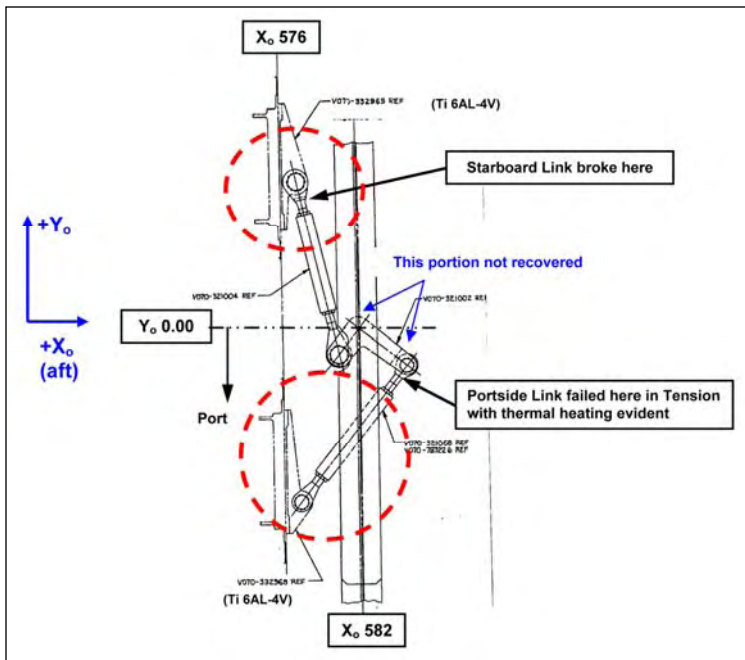
The y-links attach the aft bulkhead of the CM (X_o 576) to the X_o 582 ring frame bulkhead at the lower central portion of the bulkhead. It is possible that the two y-links remained intact at the CE, since most of the X_o 582 ring frame bulkhead is believed to have stayed with the FF. After the CE, any Y-direction movement of the CM relative to the X_o 582 ring frame bulkhead would exert high tension or compression loads on these links. Failure by tension is evident on the recovered debris of these links. The portside y-link shows that it also was softened by thermal exposure along with the tension failure. This portion protrudes beyond the X_o 582 ring frame bulkhead, which would have been exposed periodically to hot gas flow following the CE as the forebody rotated (figures 2.4-28 and 2.4-29).

Figure 2.4-28. View looking from the top at the y-links.

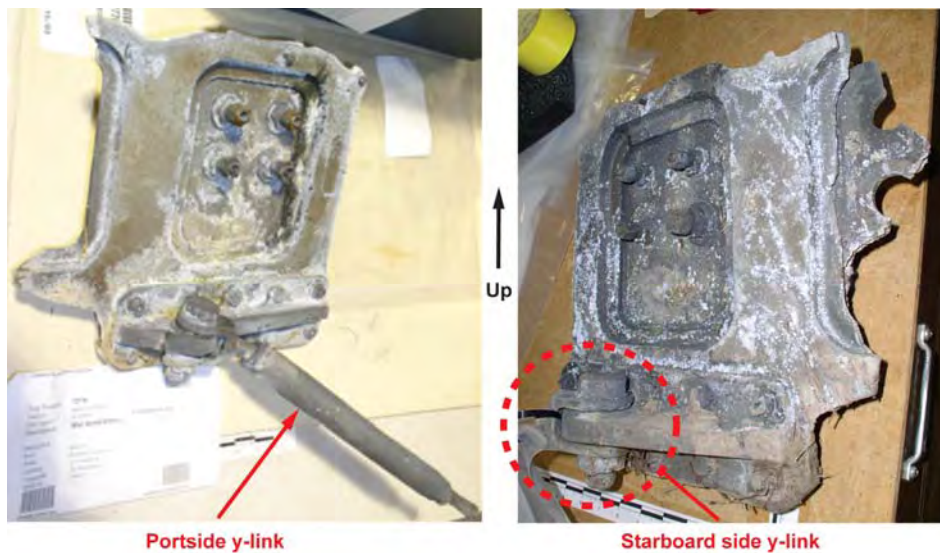
Figure 2.4-29. The y-link debris, still attached to the mounting on the X_o 576 bulkhead, Columbia Reconstruction Database debris item nos. 72770 (left) and 9280 (right).

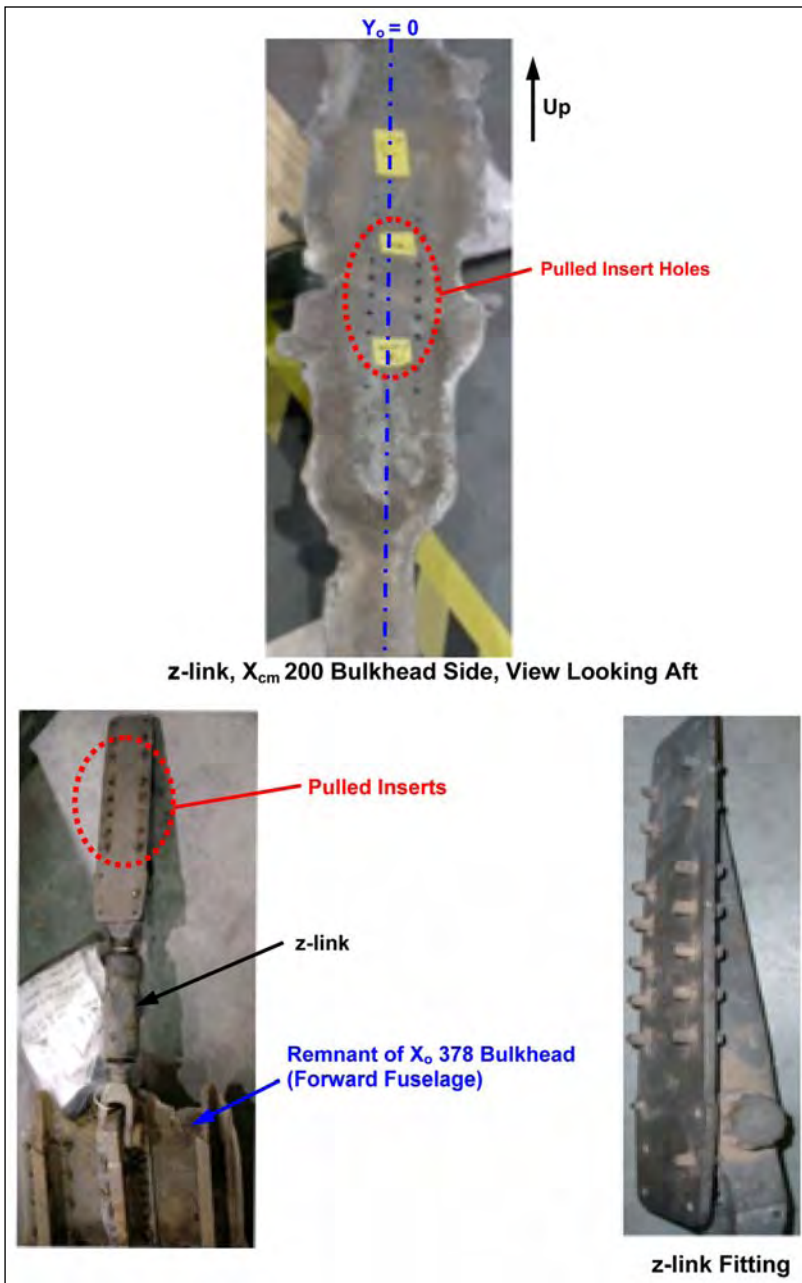
The z-link failed at the attach point to the X_{cm} 200 bulkhead (figure 2.4-30). The joint failed by a combination of fastener tensile failure and fastener insert pullout. Insert pullout requires thermal weakening of parent material because, by design, the insert is stronger than the fastener (under normal temperatures, the fastener should fail before the insert pulls out). Heating may have been occurring as the forebody rotated, allowing hot gas into the plenum between the CM and the FF. Failure resulted at the CMCE.

Figure 2.4-30. The z-link debris photographs, Columbia Reconstruction Database debris item no. 53828 (top).

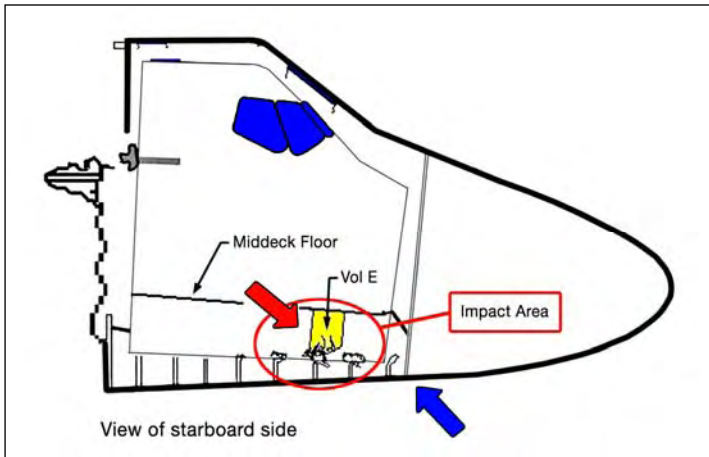
Detailed inspection of Volume E debris indicates that it was subjected to mechanical damage prior to thermal damage. The outer perimeter “picture frame” of the bottom panel was recovered and shows evidence of impact from below. Impact from the CM skin below Volume E would push the aft/outboard corner of the volume upward and then split the edge of the upper frame, as seen in the debris (figures 2.4-32 and 2.4-33).

Figure 2.4-33. Scenario showing how the crew module pressure vessel could impact the forward fuselage, and the middeck Volume E could impact the crew module pressure vessel, with resultant damage.

It is likely that at or shortly after the CE, the FF structure impacted the CM skin below Volume E and, in turn, caused an impact between the CM skin and Volume E. The impact was severe enough to crack open the Volume E box, possibly near the lower portion, spilling some of its contents, including the patches. The patches then escaped the CM during CM depressurization.
